Fendalton Community Centre
Quantitative Engineering
Evaluation

Reference: 232643
Prepared for:
Christchurch City Council

Address: 170 Clyde Road, Christchurch

Date: 11 February 2014

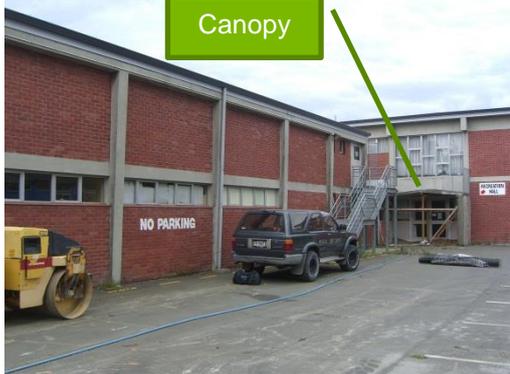
Critical structural weaknesses were identified to the canopy located on the southern elevation (see photographs, Ref 10 and 11). A temporary structure is currently installed and adequate to prevent hazards.

10	South-west elevation of the Fendalton Community Centre. South façade of the Auditorium.

About the concrete canopy, it is recommended to be completely demolished and rebuilt.

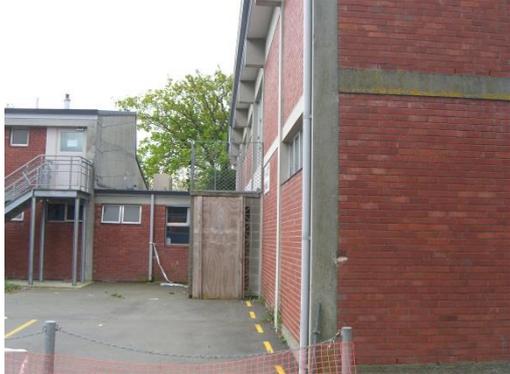
11	South elevation of the Fendalton Community Centre between the main modules. Lower Part (kitchen, toilet) acting as an expansion gap.

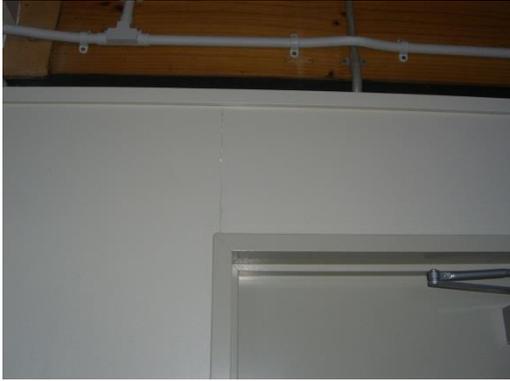
- Cracks in the gib panels starting from opening's upper corners (windows, doors, etc.) (typical) (see photographs, Ref 22),
- Displacement signs at connections between architectural and structural elements (see photographs, Ref 23),
- Small brick damage on the Playcentre's exterior wall (see photographs, Ref 24).

22	Cracks in the gib panels starting from opening's upper corners (windows, doors, etc.) (typical).

In regards to the section of the building which links the two modules together, structural modifications should be made in order to allow the independent movement of the modules. These modifications should mainly involve the timber beam-concrete column connections. Then structural repairs to the cracks could be made to the concrete elements and blockwork in the kitchen or Main Hall. In other areas of the building, cracking in concrete elements can be repaired with epoxy. All architecturally related damages can also be repaired without structural concerns.

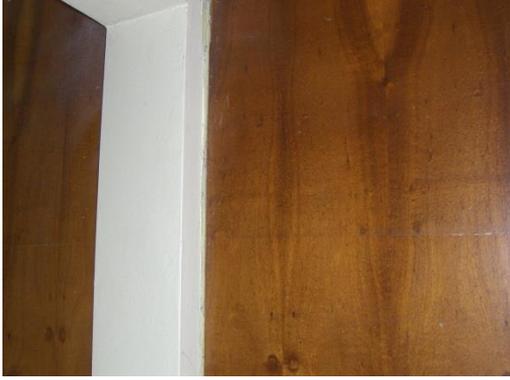
23	Displacement signs at connections between architectural and structural elements.

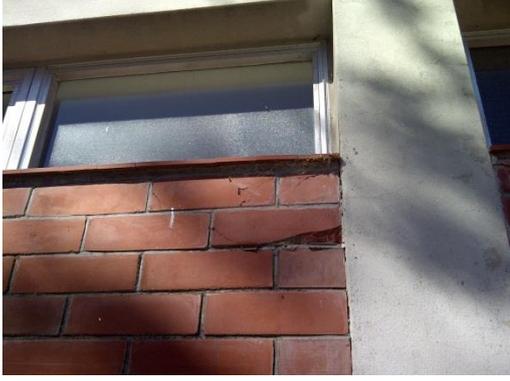
24	Small brick damage on the Playcentre's exterior wall.

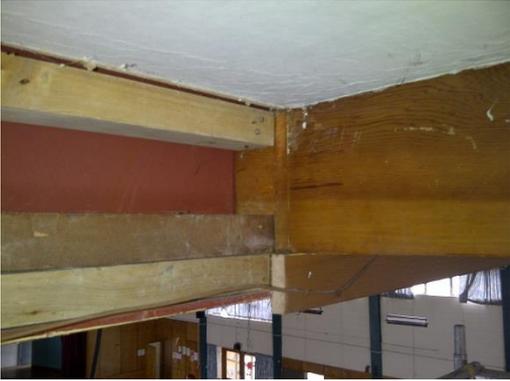
We feel inclined to highlight our concerns in regards to the purlins in the Main Hall module, even though it may not cause a global failure of the structure. As observed, no cleat connects the purlin and the rafter (see photographs, Ref 29). Consequently, purlins are only supported by the lower flange of the rafter and laterally stabilized by timber blocking. Even if the structural element performed well during the earthquakes, this set up is not considered as good practice and may cause future problems.

29	Connection between purlins and rafter in the Main Hall.

As previously mentioned in *4.2 Critical Structural Weaknesses*, no cleat connects the purlin and the rafter of the Main Hall module. Consequently, we recommend installing angle cleats welded to the rafter and bolted to the purlins.

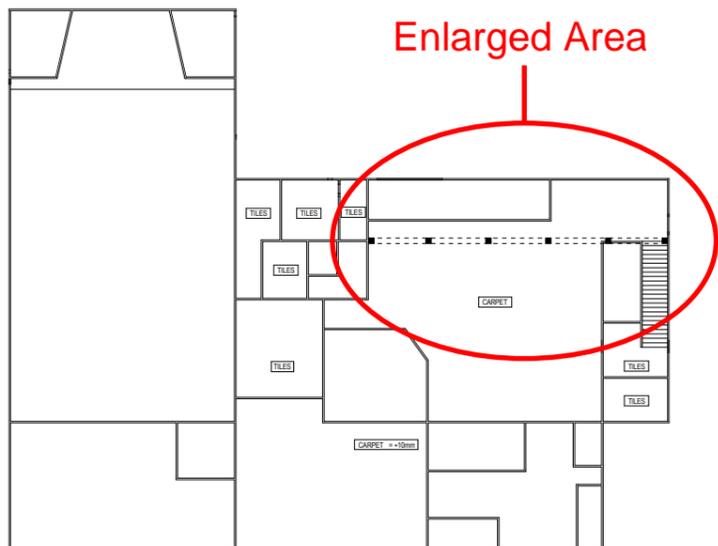
Drawn:	D.Goodwin	Date:	5/04/2013
Project: Fendalton Community Centre			
Drawing Title: Floor Slopes - Ground Floor			
Job Number:	232643	Drawing:	S-03 Rev: 01

Slopes less than 0.5%
