Fendalton Library & Service Centre BU 0450-001 EQ2

**Detailed Engineering Evaluation
Quantitative Assessment Report**

Date: November 2012
Reference: 6-QUCCC.27
Status: Final

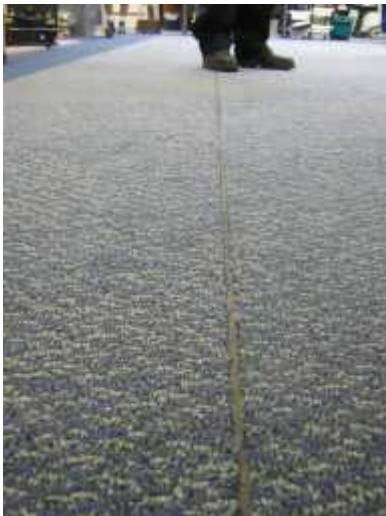
Photo 1: 25 March 2011

Opening up of construction joints in the Fendalton Library concrete floor slab was noted following the February 2011 earthquake¹. This movement was evident from relative displacements the carpet edges (see Photo 1). Christchurch City Council has advised that gaps of this size in the carpet were not present prior to the September 2010 earthquake, and that any such gaps would have been rectified as a health and safety (potential trip hazard) matter.

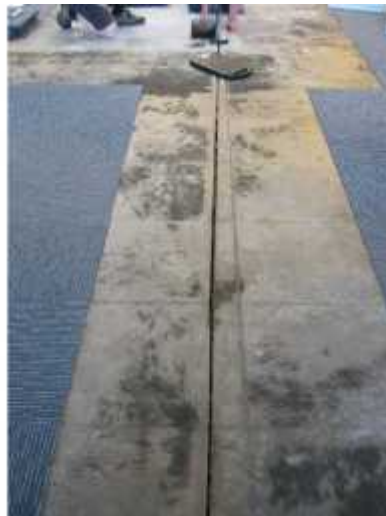
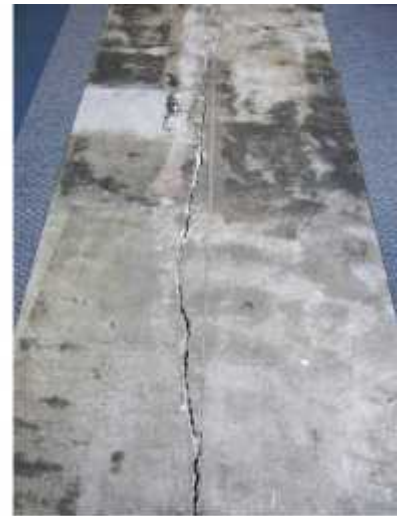
The cracking has been investigated further by exposing the cracks and cutting out a section of the slab (see Photos 2 and 3). A plan showing the locations and sizes of cracks is shown on the attached drawing. Cracks have opened at construction joints and only some of the sawcuts. The largest crack is located at or adjacent to a saw cut crack control joint running east-west between grid lines 4 and 5 (shown offset from the correct location on the drawing), near to the centre of the building. The horizontal displacement across this joint is approximately 10-13mm, with a maximum vertical displacement of 5mm.

The mesh reinforcing has fractured at the crack large crack. The evidence from the exposed area of dpc is that it has not been ruptured.

1. The crack had initiated prior to the February earthquake due to shrinkage strains in the concrete.
2. The earthquake resulted in increased horizontal thrust forces at the base of the portal frames and forces from the response of the slab mass, causing the slab to slide and the crack to widen. Coincident vertical accelerations may have contributed by reducing the friction restraint under the slab.

1. Fill the large (10mm) crack with shrinkage compensated grout. Seal off medium size cracks (>2mm) by towelling in a cement mortar. Smaller cracks may be left unsealed.
2. Grind and level off uneven and spalled areas of the slab surface with a high-bond fairing screed.
3. Provide continuity of reinforcing across the 10mm crack by grouting reinforcing bars into slots cut into the floor slab.

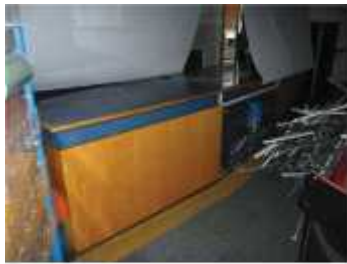
5. Public Facilities			
Main counter

Non-Compliant – public counter is not accessible for staff or public using it	Modification of existing counter required to provide accessible portion.
10. Showers			
Accessible Shower

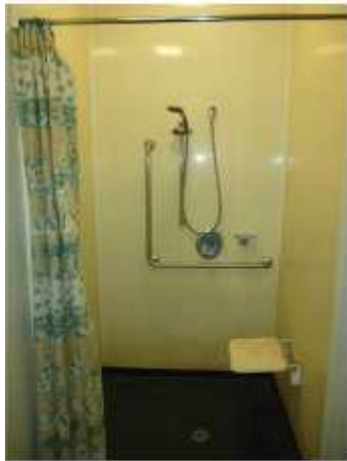
Compliant – Building is not required to provide accessible shower facilities Shower seat is too small	OPUS recommends replacing the existing shower seat with new compliant seat
11. Door and Window Controls and Light Switches			
Socket Outlets

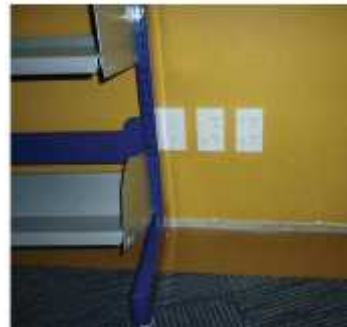
Non-Compliant – Low level socket outlets measure 300mm AFFL	No Action – not feasible to relocate all low level socket outlets due to costs
13. Alerting Devices			
Refer to the Fire Report

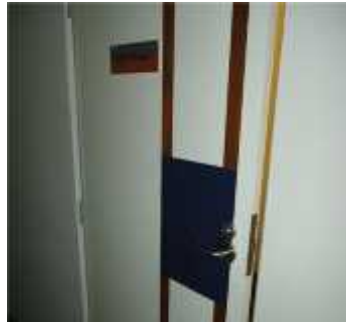
Accessible Shower

Compliant – Building is not required to provide accessible shower facilities

Non-compliant signage to door

OPUS recommends new unisex accessible shower symbols to door
