**Greenhurst Courts
Sockburn
PRO 1563**

**Detailed Engineering Evaluation
Quantitative Assessment Report**

1-4 Takaro Avenue, Sockburn

Date: March 2013
Reference: 6-QUCC2.21
Status: Final

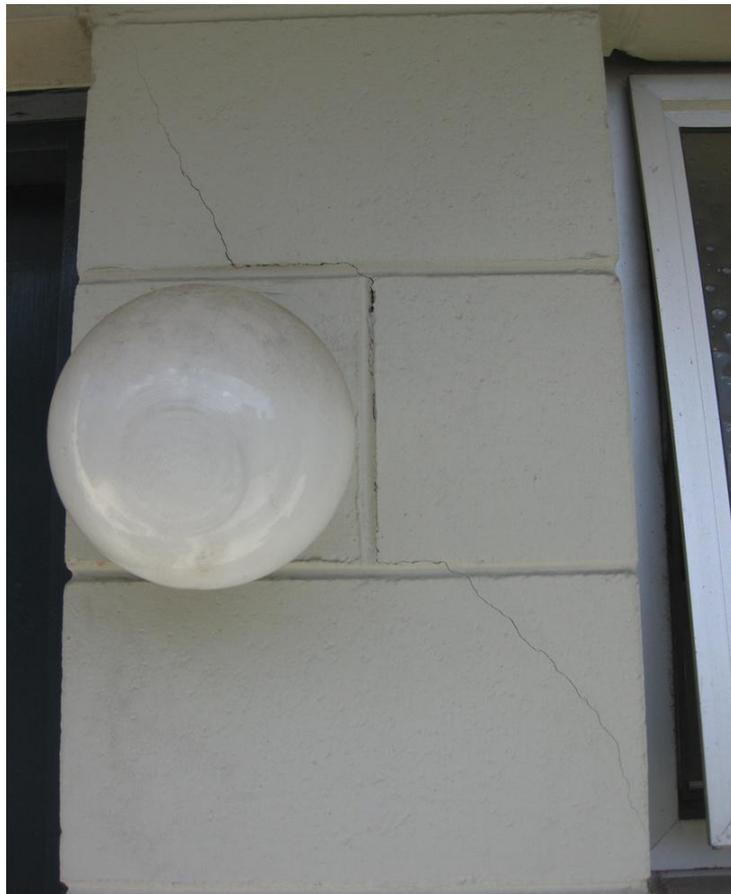
No structural damage was observed to any of the units. A minor crack to external blockwork has been noted at one location (refer Appendix 1, photo 6).

Photo 6: Cracking to Blockwork at Rear of Block 1

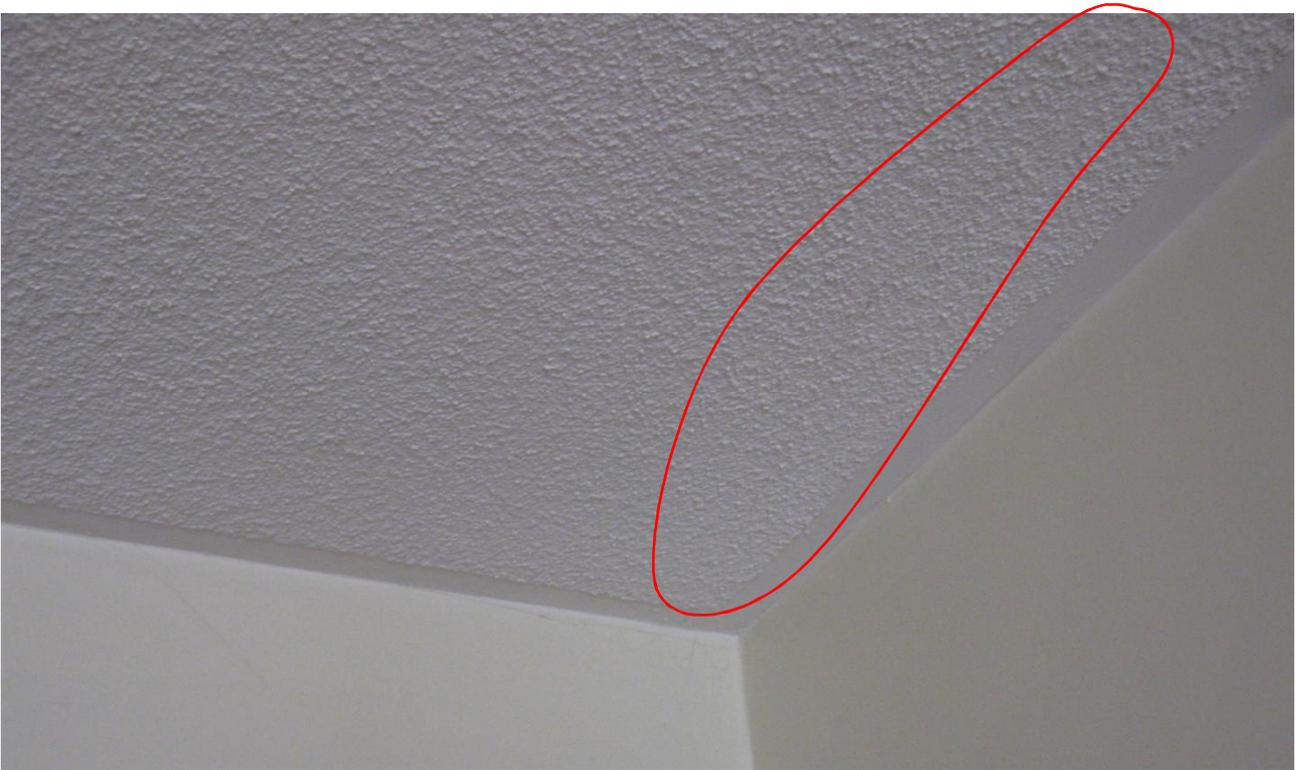
Additionally, minor cracking to ceiling lining was recorded during the rapid assessment (refer Appendix 1, photo 7).

Photo 7: Minor Cracking to ceiling

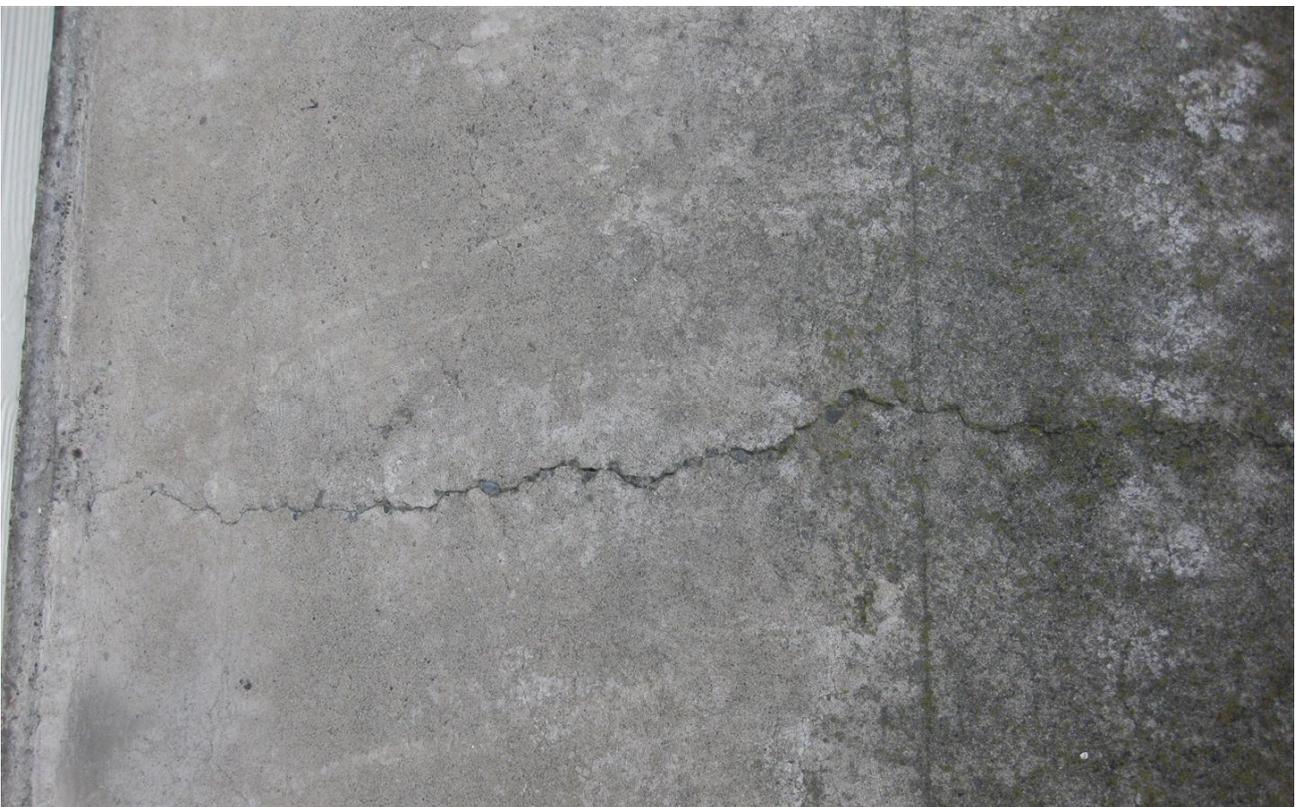
Photo 8: Cracking to concrete pavement
