Christchurch City Council
PRK_3035_BLDG_001
Greenwood Park Wool Shed
450 Summit Road

QUANTITATIVE ASSESSMENT REPORT

FINAL

- Rev B
- 22 November 2013

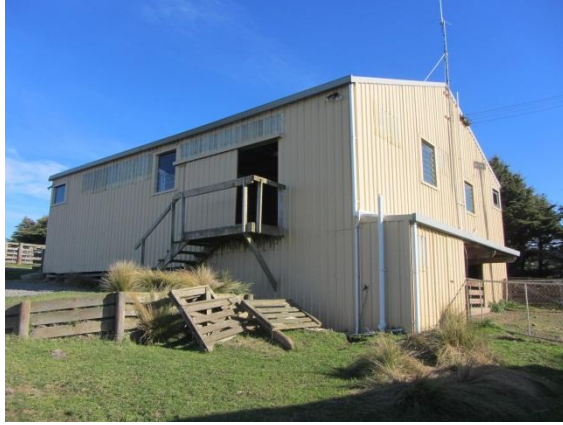
Photo 1: Exterior view of Greenwood Park Wool Shed

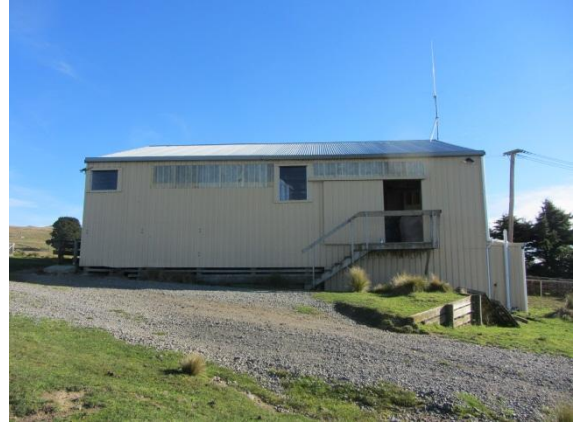
Photo 2: East elevation

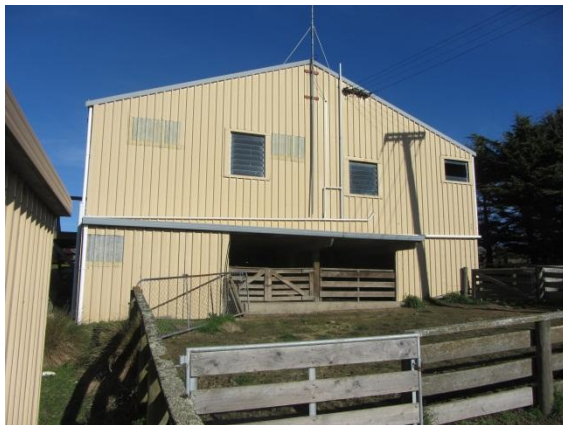
Photo 3: North Elevation

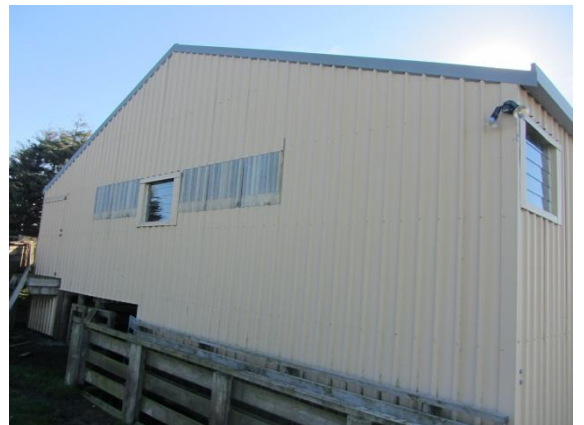
Photo 4: South Elevation

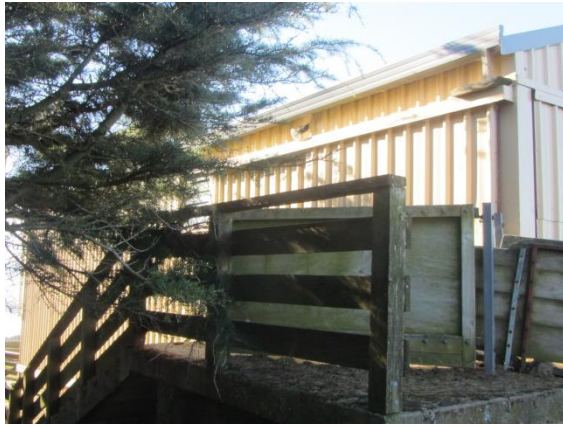
Photo 5: West elevation

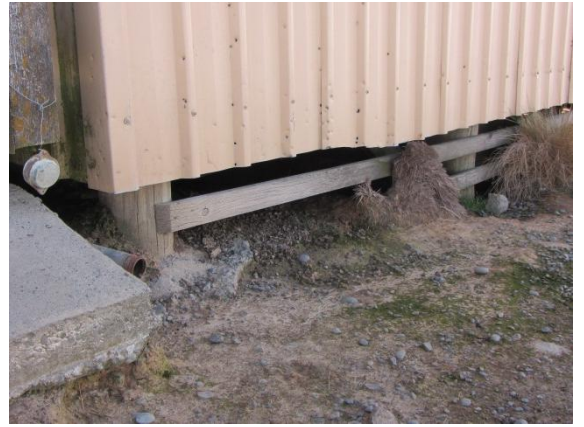
Photo 6: Exterior view of foundation

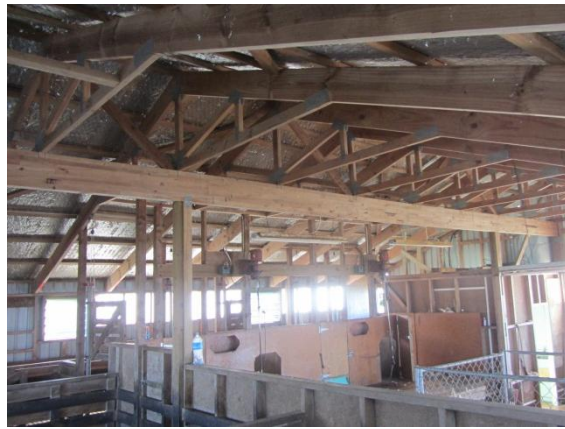
Photo 9: Interior view of Wool Shed (3) showing roof structure

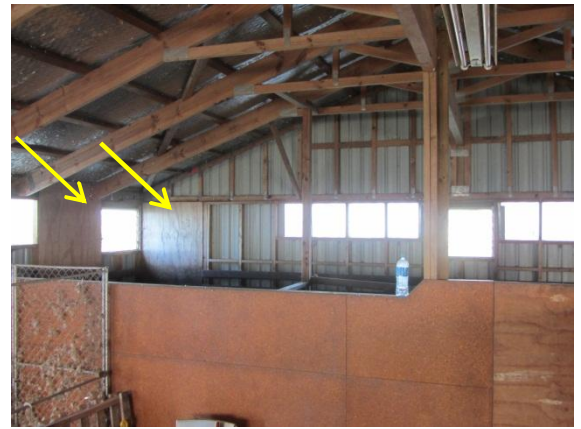
Photo 10: Interior view of Wool Shed showing plywood bracing in north west corner of building

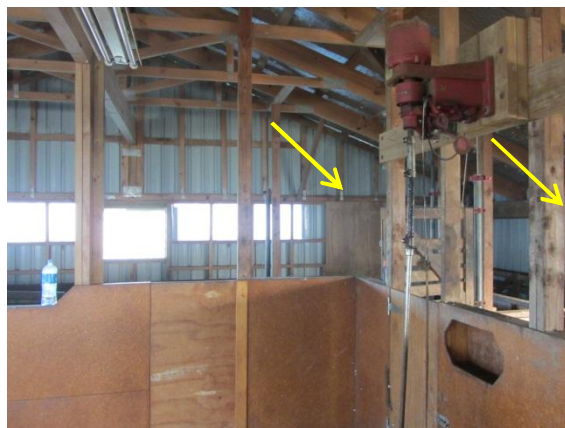
Photo 11: Interior view of Wool Shed showing plywood bracing in south west corner of building

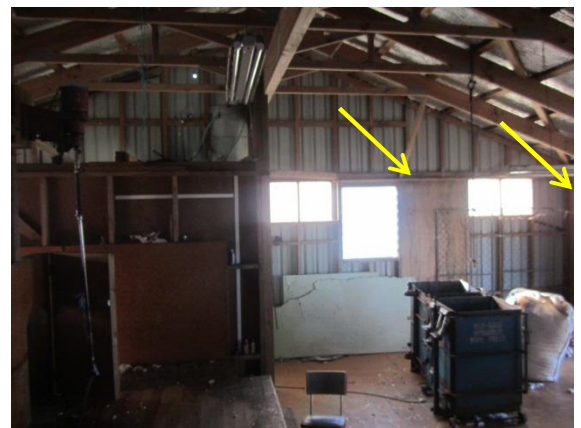
Photo 12: Interior view of Wool Shed showing plywood bracing in north east corner of building

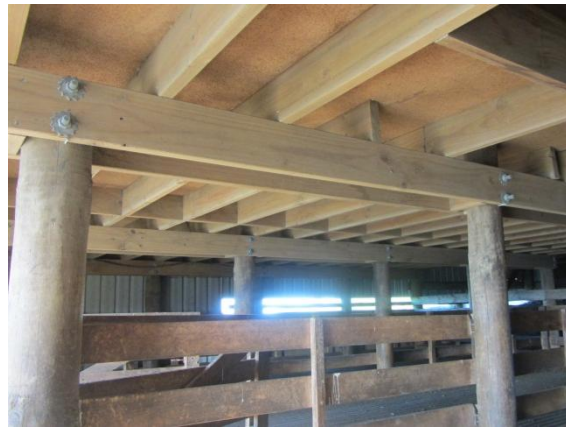
Photo 13: View of subfloor showing floor structure

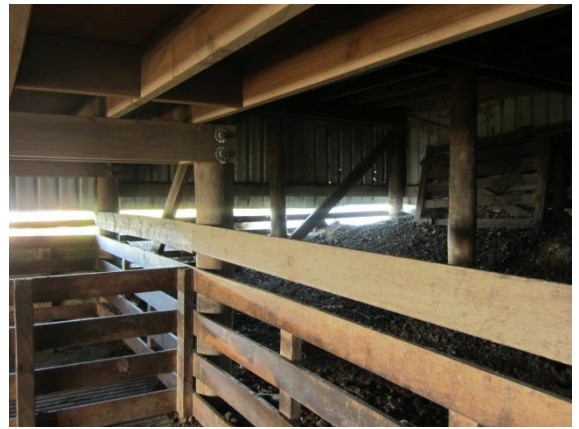
Photo 14: View of subfloor showing subfloor bracing in south east corner of building (1)

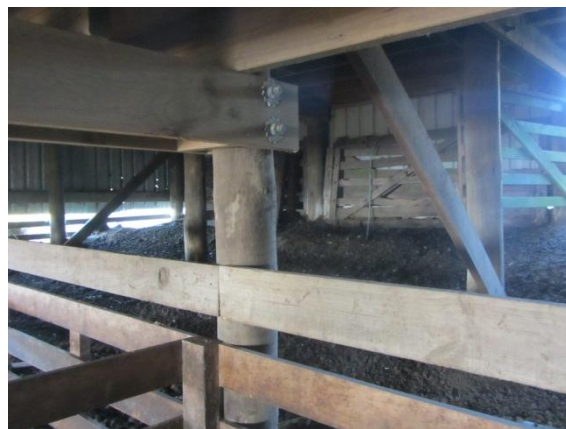
Photo 15: View of subfloor showing subfloor bracing in south east corner of building (2)

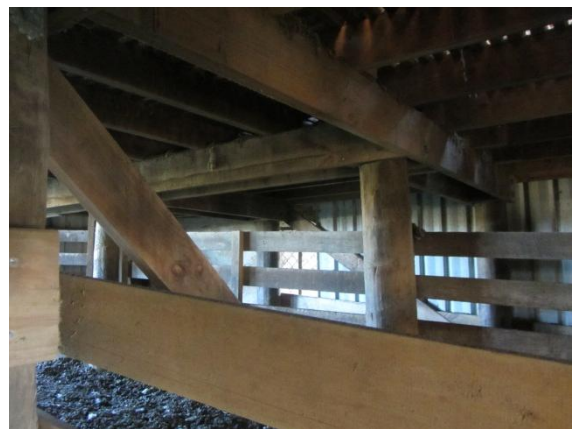
Photo 16: View of subfloor showing subfloor bracing in south west corner of building

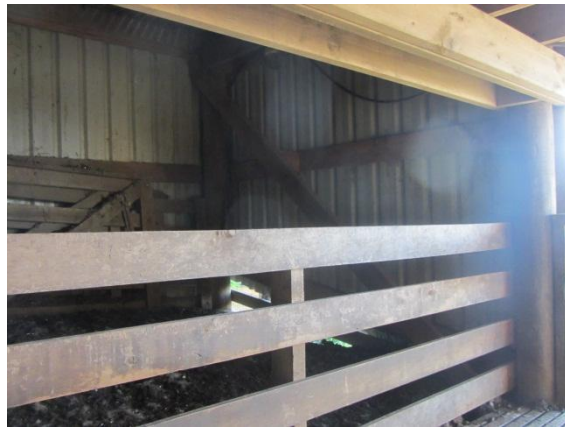
Photo 17: View of subfloor showing subfloor bracing in north west corner of building

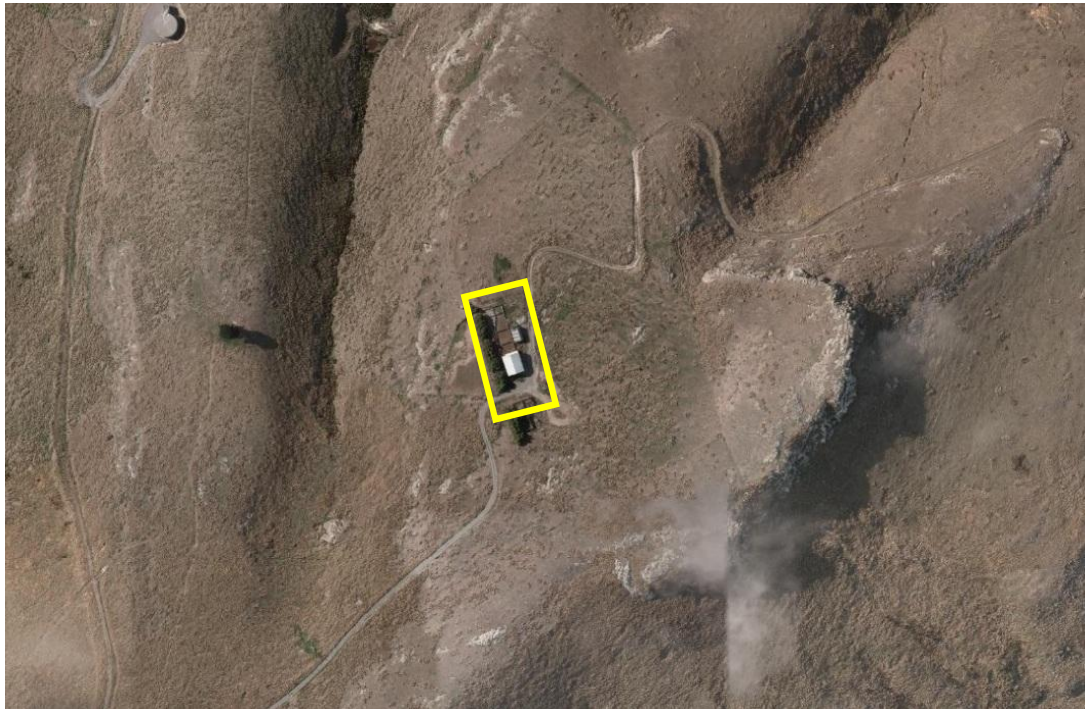
- **Figure 4 – Aerial photography from 24 Feb 2011 (http://maps.cera.govt.nz/advanced-viewer/?Viewer=CERA__Public)**

Aerial photography taken after the 22 February 2011 event shows no evidence of land damage in the vicinity of the site. There is a rock bluff located to the east of the site; however rockfall would travel to the east away from the site.
