CHRISTCHURCH CITY COUNCIL
PRK_0348_BLDG_005 EQ2
The Groynes – Dwelling No.1
182 Johns Road

**QUANTITATIVE ASSESSMENT REPORT
FINAL**

- Rev B
- 26 March 2013

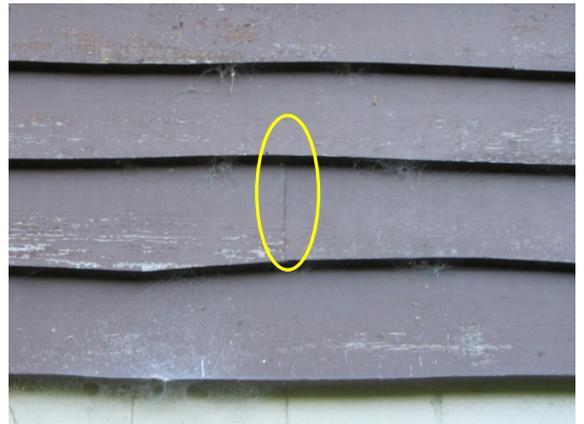
- 1) No visual evidence of settlement was noted at this site. Therefore a level survey is not required.
- 2) Vertical joints in cedar cladding boards have opened up. This is possibly existing damage that has been exacerbated by the earthquake. (PHOTO 4 & 5).
- 3) Vertical joints in the timber fascia board under the guttering have opened up. This is possibly existing damage that has been exacerbated by the earthquake. (PHOTO 6 & 7).
- 4) Concrete patio has moved away from the building along the northern and eastern sides. This has created a gap between the patio and the building of approximately 10mm (PHOTO 8, 9 & 10).
- 5) Hairline cracking present to the concrete patio in the north-east corner. Crack widths are approximately 0.3mm wide. Small amount of spalling to the concrete patio next to the north-east corner of the building. (PHOTO 11, 12 & 13).

Photo 4: Hairline Cracking along Joints in External Cladding

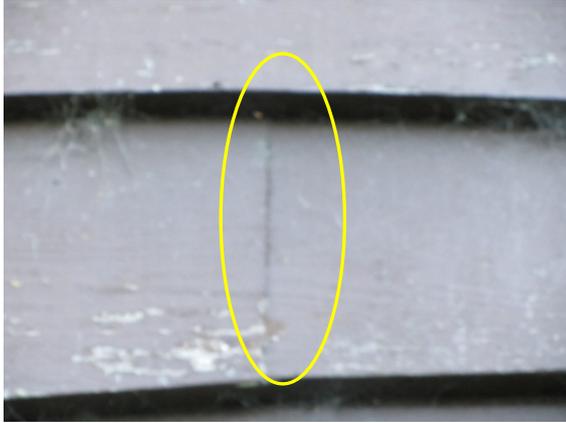
Photo 5: Close Up of Photo 4

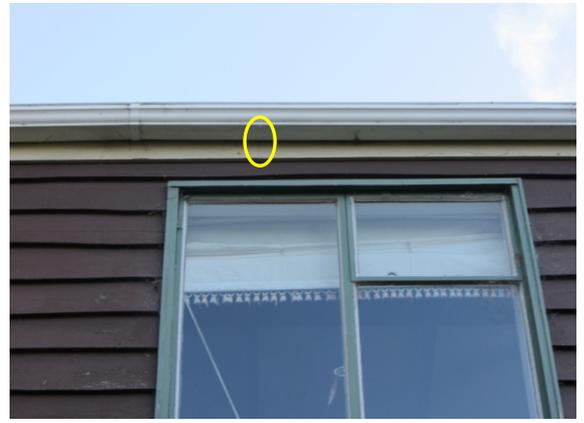
Photo 6: Hairline Cracking along Fascia Board Joints

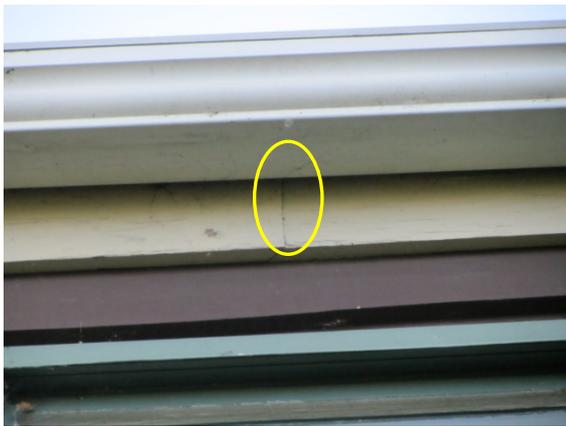
Photo 7: Close Up of Photo 6

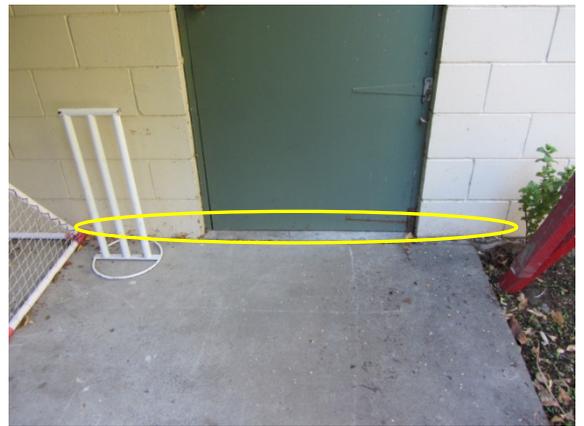
Photo 8: Gap Between Concrete Patio and Building along North Side of Building

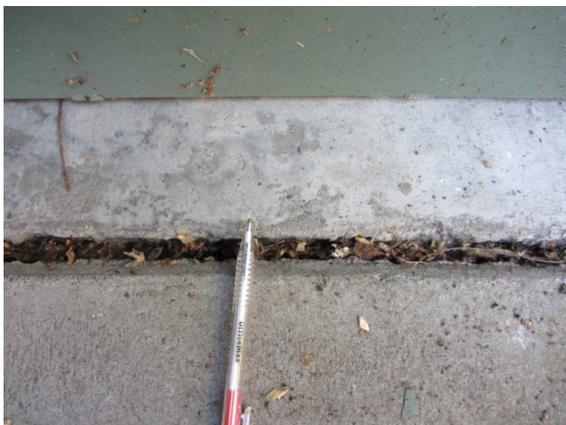
Photo 9: Close Up of Photo 8

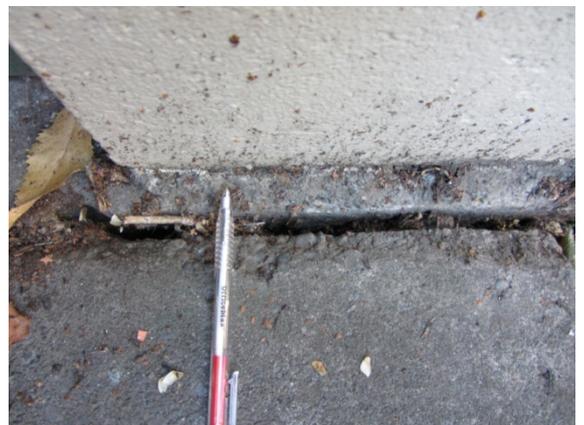
Photo 10: Close Up of Photo 8

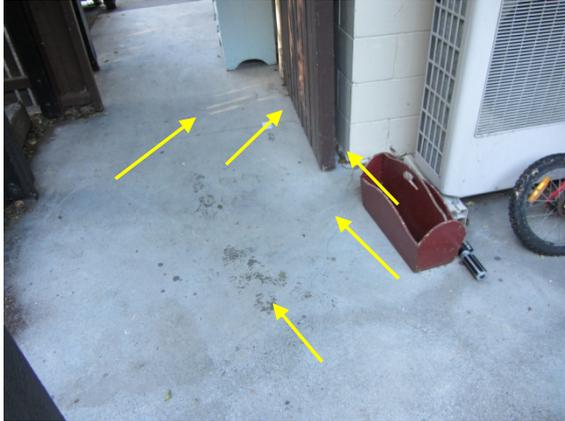
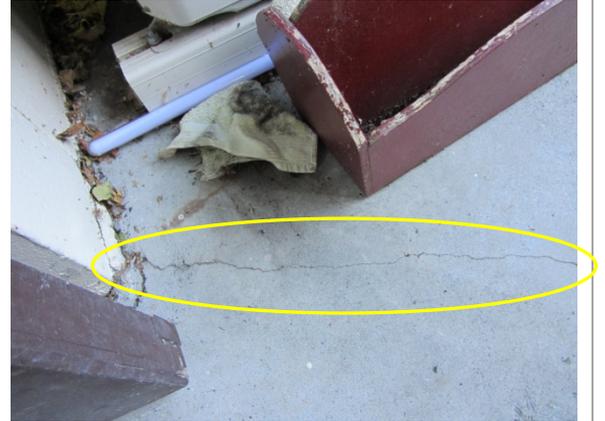
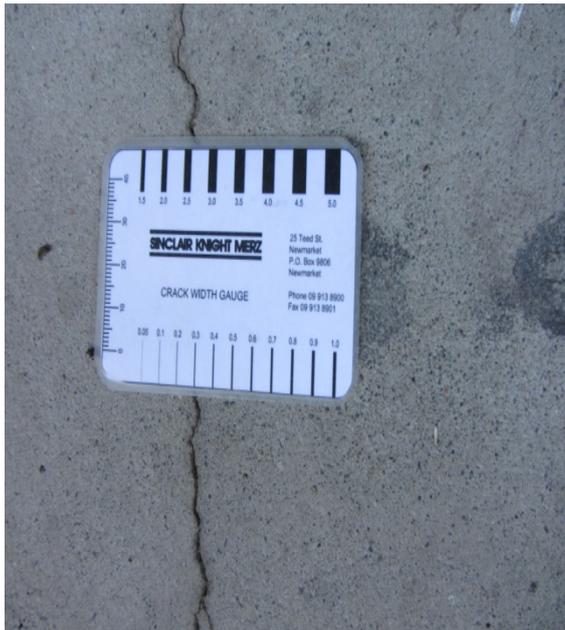
Photo 11: Hairline Cracking to Concrete Patio in North-East Corner

Photo 12: Close Up of Photo 11

Photo 13: Close Up of Photo 11

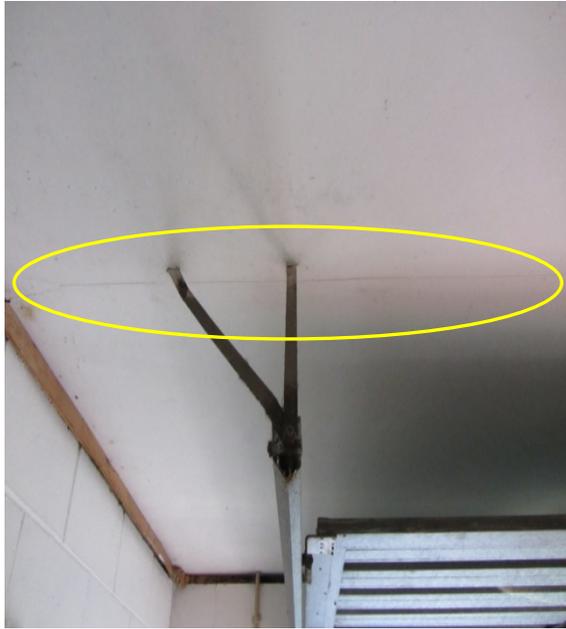
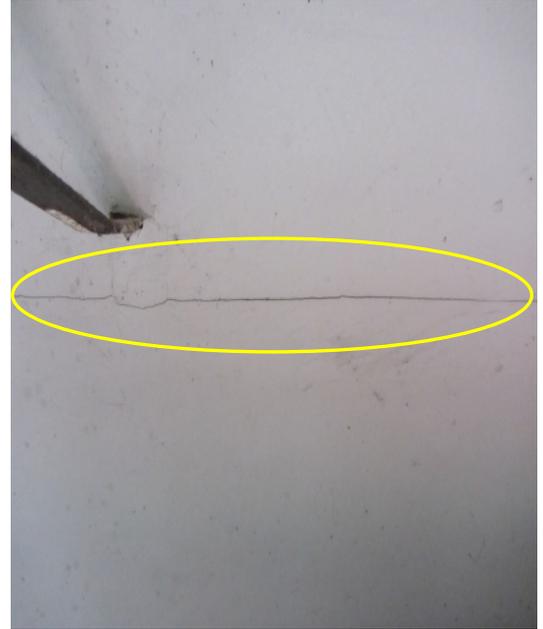
- 6) Hairline crack present along the ceiling lining joint, located in the eastern half (PHOTO 15 & 16).
- 7) Crack approximately 0.4mm wide present in concrete slab near the main entrance (PHOTO 17 & 18).
- 8) Crack approximately 0.2mm wide present in concrete in the south-east corner.
- 9) Crack approximately 0.3mm wide present in concrete slab. Crack runs north-south and continues through to the small northern storage room (PHOTO 25, 26 & 27).

Photo 15: Hairline Cracking to Ceiling Lining Joint in Main Garage

Photo 16: Close Up of Photo 15

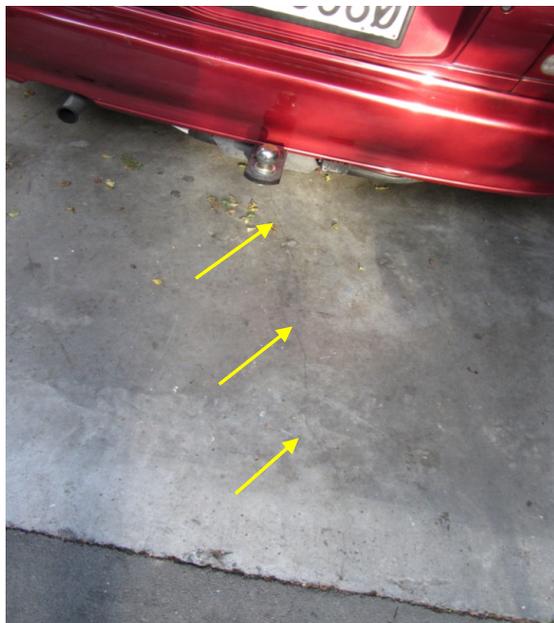
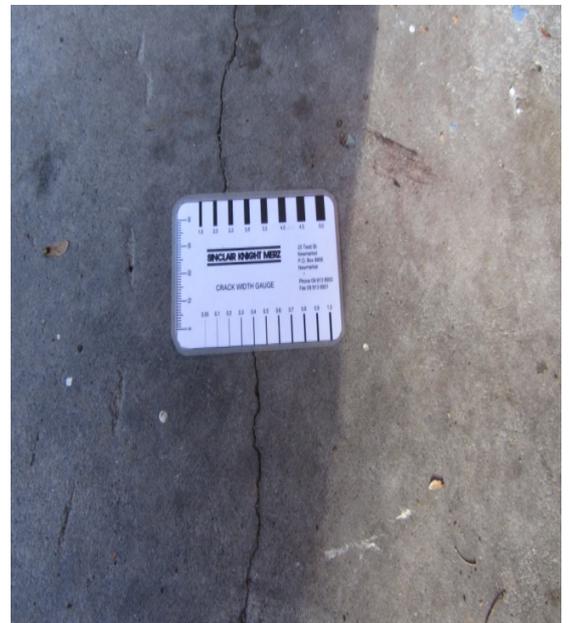
Photo 17: Hairline Cracking to Concrete Slab in Main Garage

Photo 18: Close Up of Photo 17

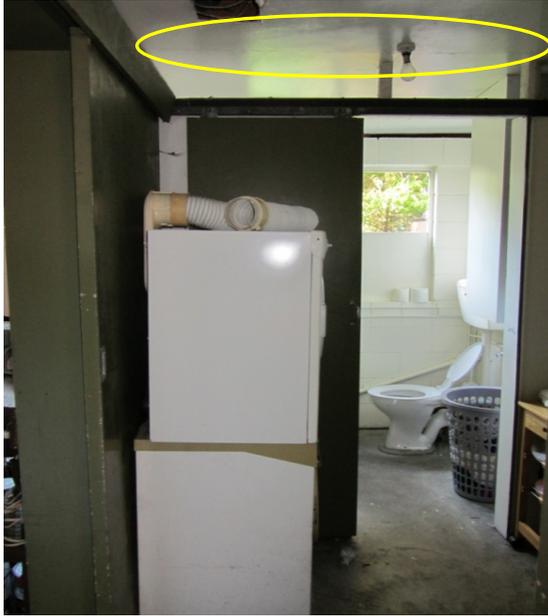
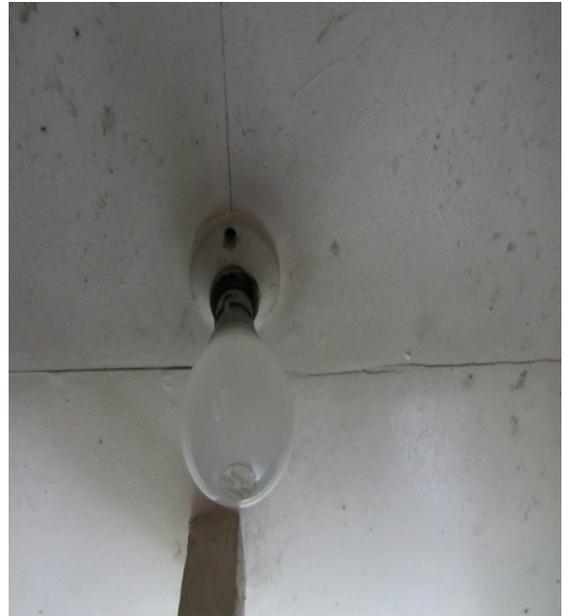
- 10) Hairline cracking present along ceiling lining joints (PHOTO 19 & 20)

Photo 19: Hairline Cracking to Ceiling Lining Joints in Laundry

Photo 20: Close Up of Photo 19

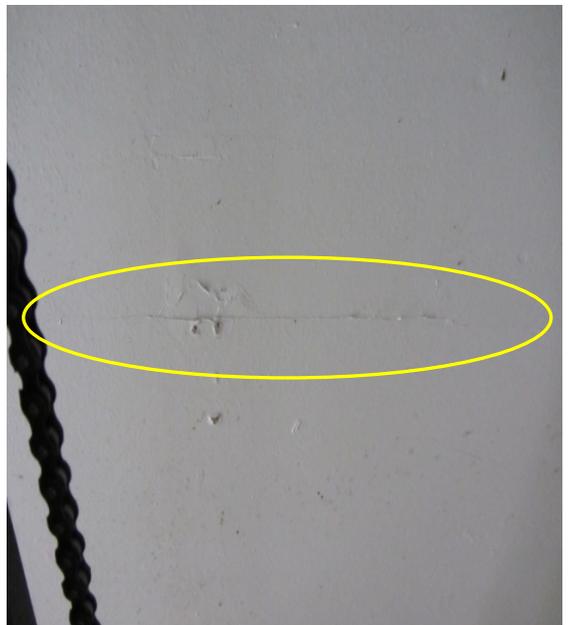
- 11) Hairline cracking present along ceiling lining joints in the north-west garage/ storage room (PHOTO 21 & 22).

Photo 22: Hairline Cracking to Ceiling Lining Joint in NW Garage / Storage Room

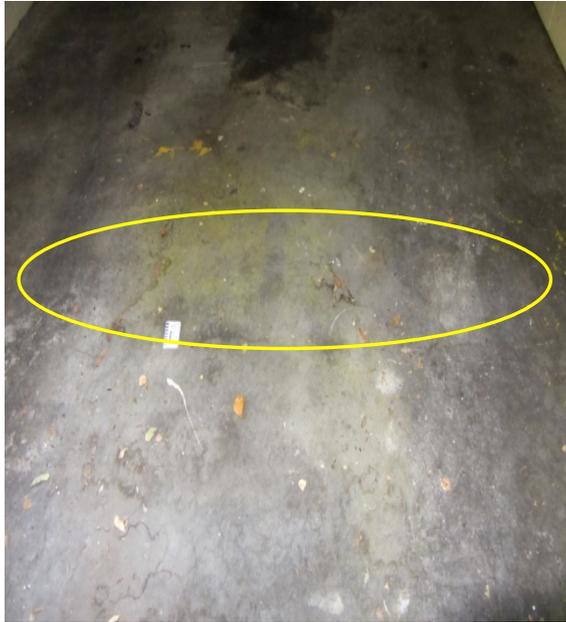
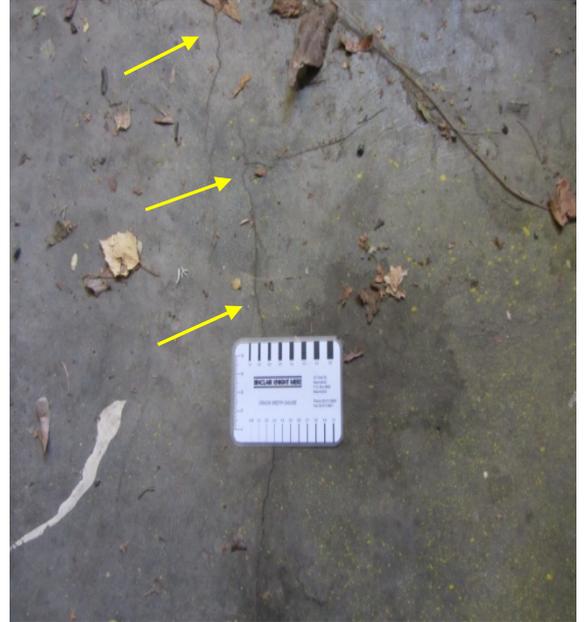
12) Crack approximately 0.2-0.3mm wide present in slab (PHOTO 23 & 24).

Photo 23: Hairline Cracking to Concrete Slab in NW Garage / Storage Room

Photo 24: Close Up of Photo 23

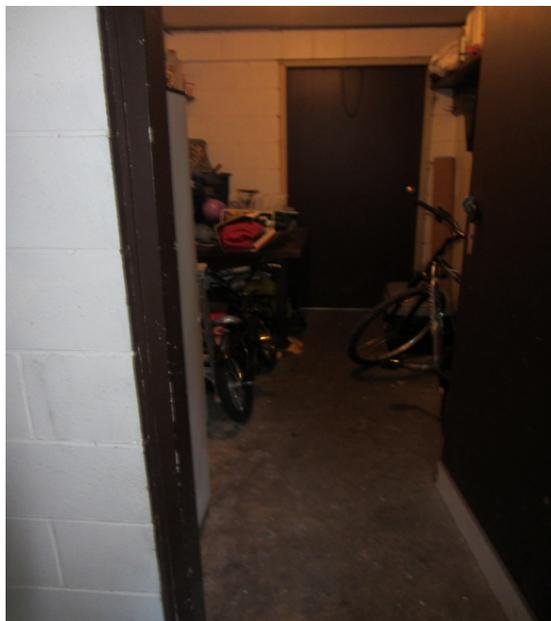
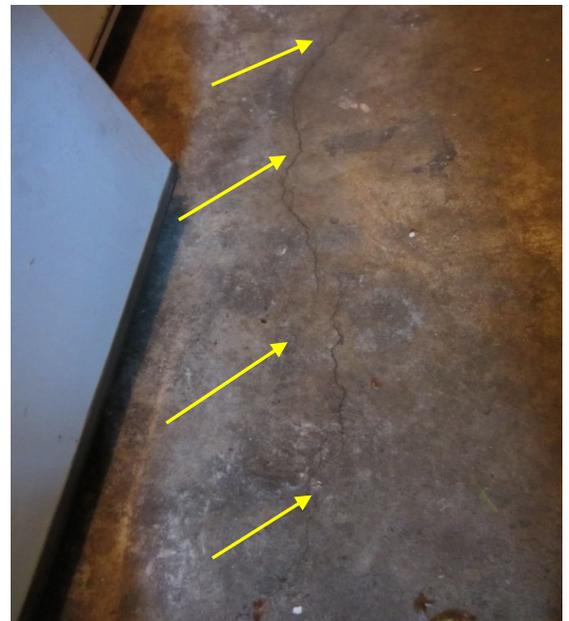
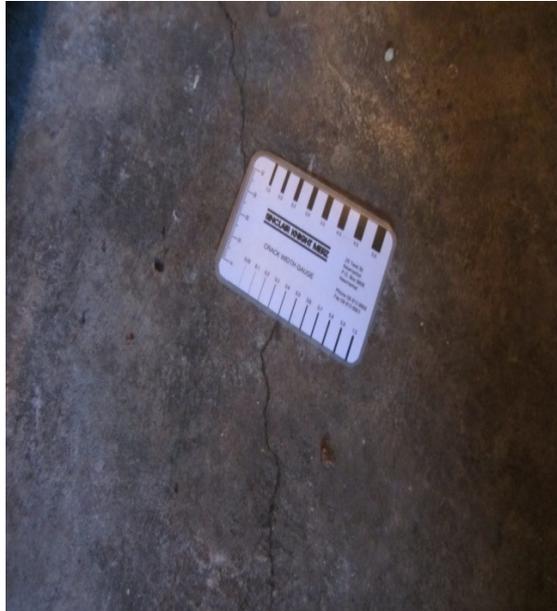
Photo 25: Continuation of Hairline Crack running N/S in Main Garage Floor Slab

Photo 26: Close Up of Photo 25

Photo 27: Close Up of Photo 26

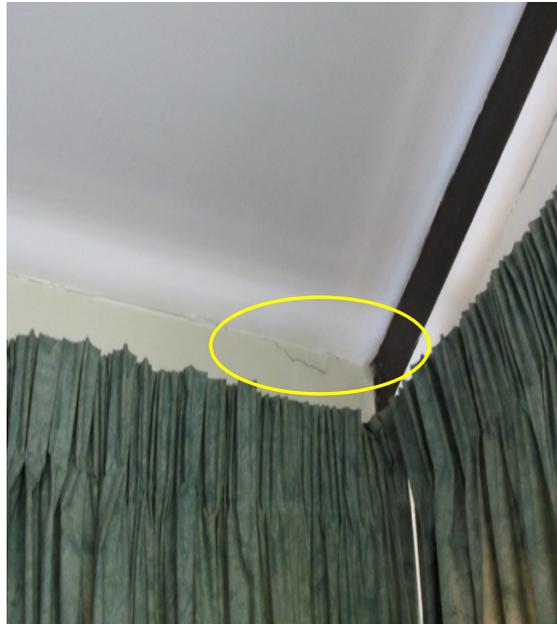
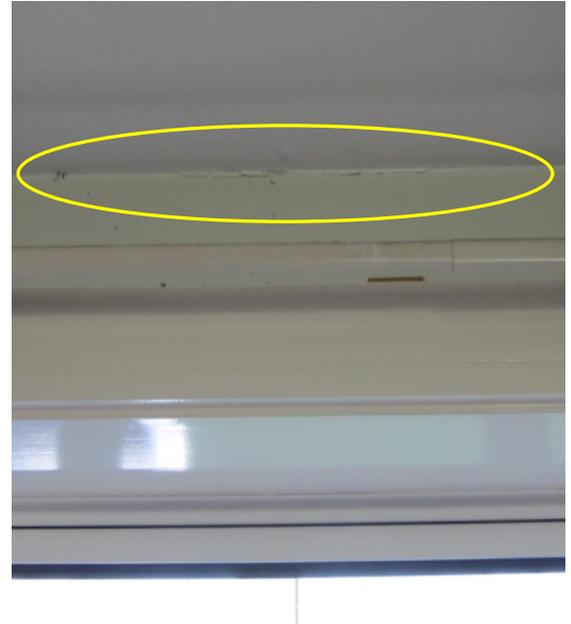
13) Hairline cracking present to wall lining in the north-east corner. Cracking continues along the wall lining and ceiling lining joint on the north wall (PHOTO 29 & 30).

Photo 29: Hairline Cracking to Wall Lining in NE Corner

Photo 30: Hairline Cracking Present along Wall and Ceiling Lining Joint on North Wall

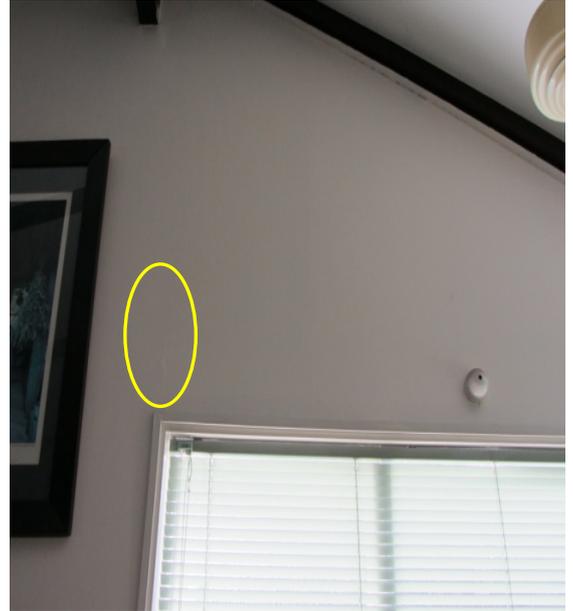
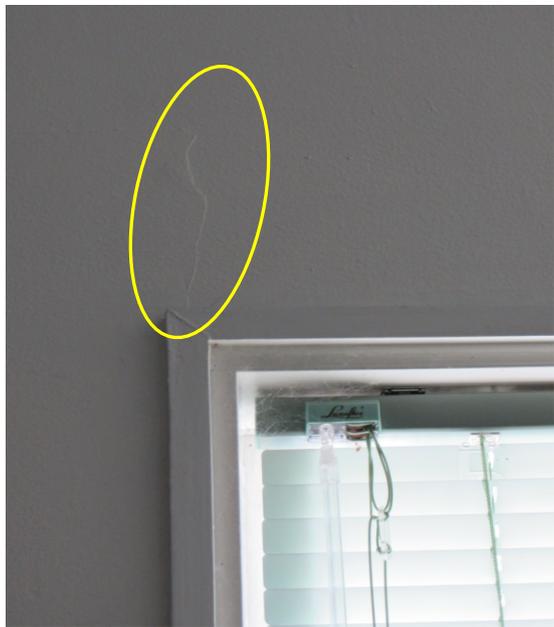
15) Hairline cracking present in wall lining joint above east wall window (PHOTO 32 & 33).

Photo 32: Hairline Cracking along Wall Lining Joint above Window

Photo 33: Close Up of Photo 32

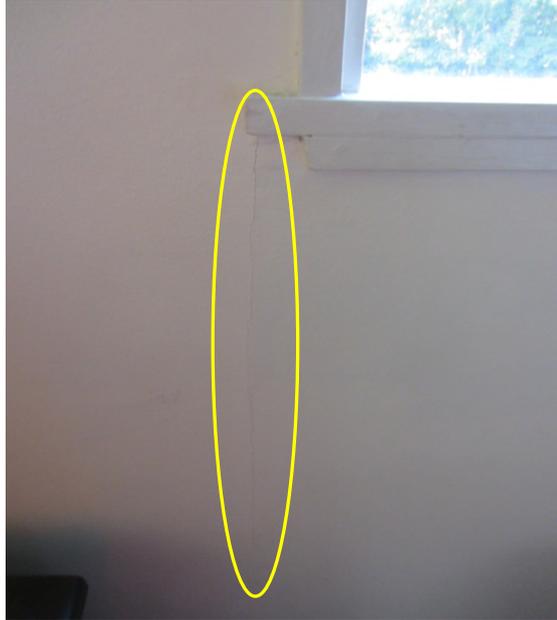
16) Vertical hairline crack present at wall lining joint under the eastern corner of the south wall window (PHOTO 34 & 35).

Photo 35: Hairline Cracking Present along Wall Lining Joint under South Wall Window

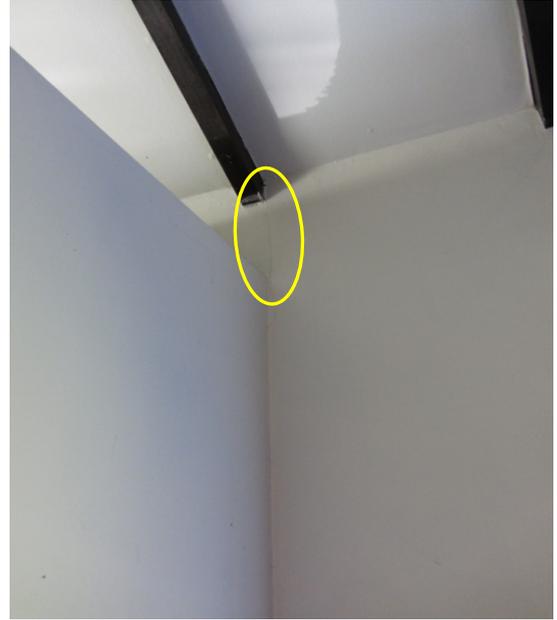
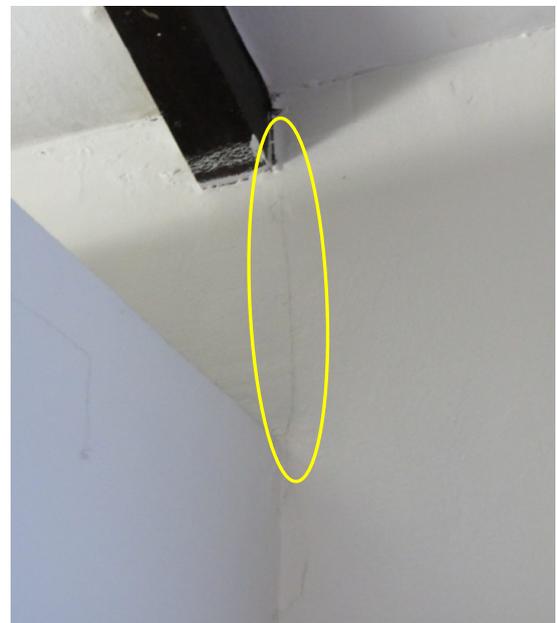
17) Hairline crack present at wall lining joint on the south wall. Crack located above the kitchen partition wall (PHOTO 34, 36 & 37).

Photo 36: Hairline Cracking Present along Wall Lining Joint on South Wall above Kitchen Partition

Photo 37: Close Up of Photo 36

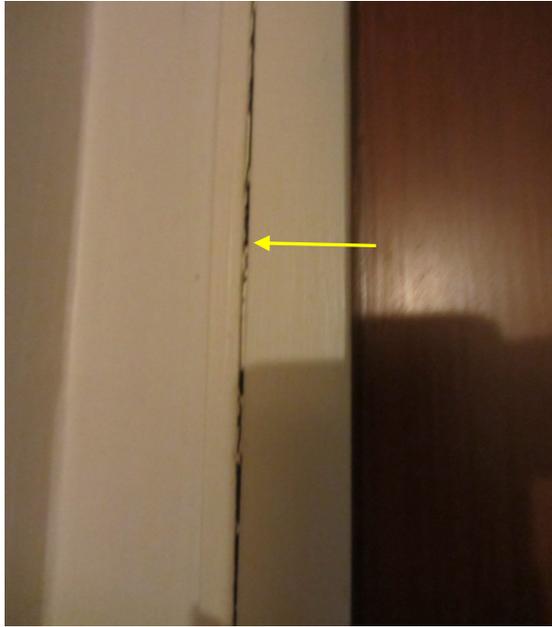
Photo 39: Gaps between Door Architrave and Door Jamb on East Wall have Opened Up

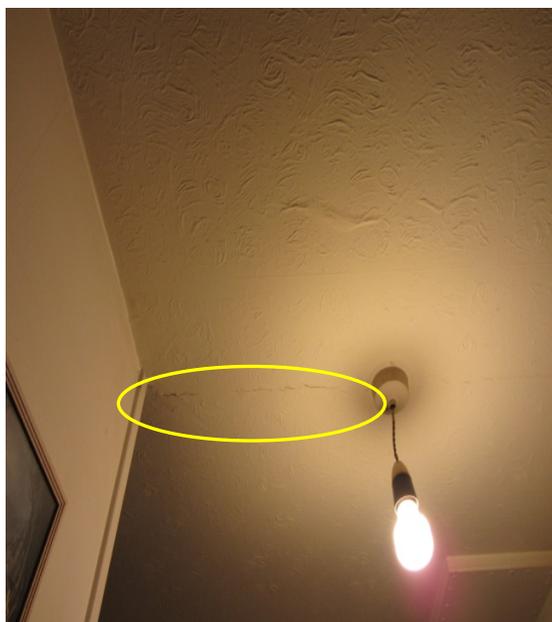
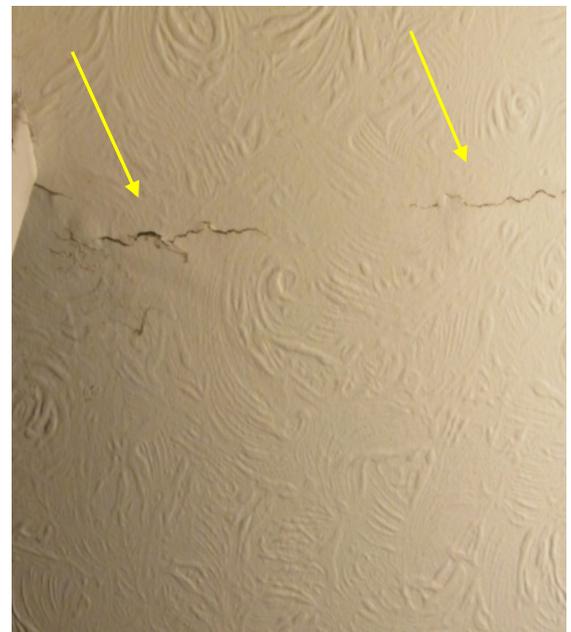
19) Hairline crack present in the ceiling lining joint in the south-west corner (PHOTO 40, 41 & 42).

Photo 41: Hairline Cracking to Ceiling Lining in SW Corner of Hallway

Photo 42: Close Up of Photo 41

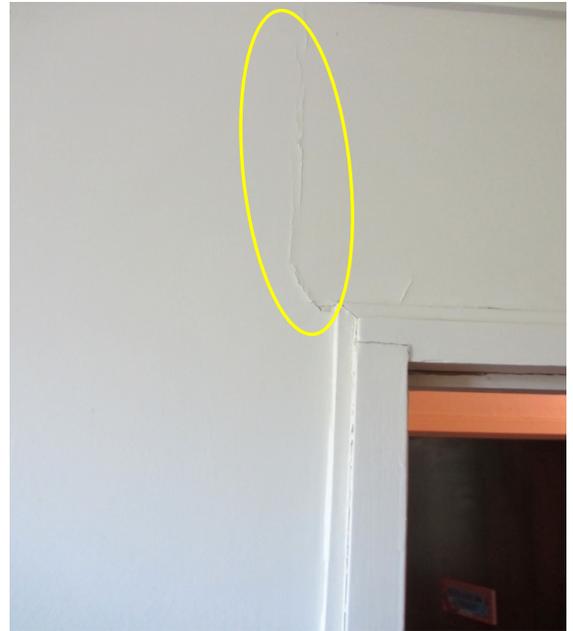
20) Hairline cracking present along wall lining joint above the southern corner of the bathroom doorway (PHOTO 43 & 44)

Photo 44: Hairline Cracking to Wall Lining above Bathroom Doorway

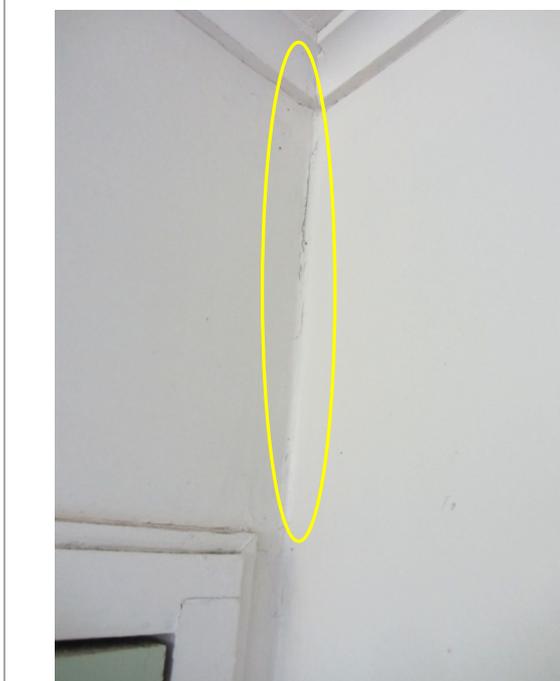
21) Hairline cracking along wall lining joint in the north-west corner (PHOTO 43 & 45)

Photo 45: Hairline Cracking along Wall Lining Joint in NW Corner of Bathroom

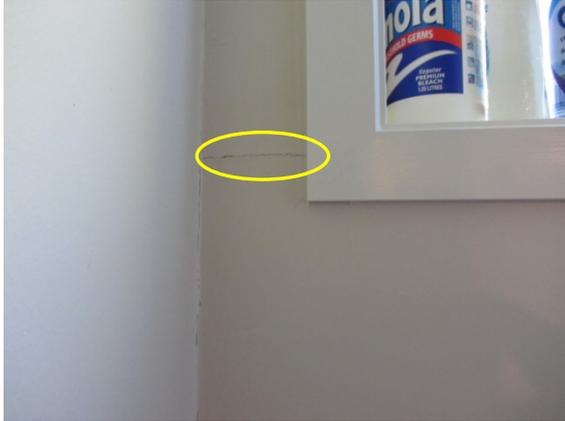
23) Hairline cracking present along the wall lining joints each side of the window (PHOTO 46 & 47).

Photo 47: Hairline Cracking along Wall Lining Joint
Each side of Toilet Window

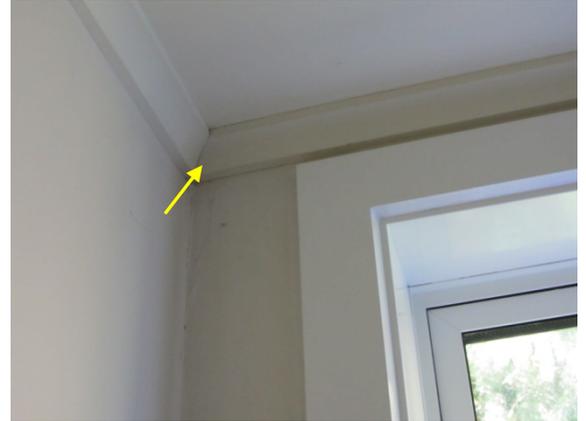
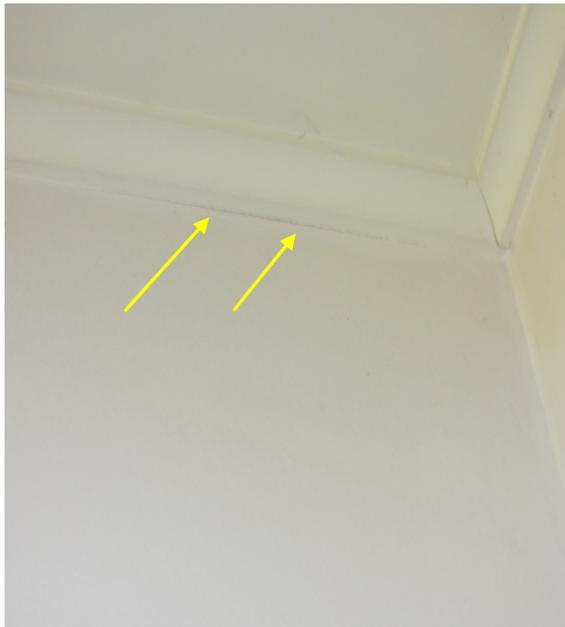
- 24) Hairline cracking present along the scotia and wall lining joint in the south-east and south-west corners (PHOTO 48 & 49).
- 25) Hairline cracking present along the top joints of the door architrave (similar to PHOTO 50 & 51).

Photo 48: Hairline Cracking along Scotia and Wall
Lining Joint

Photo 49: Close Up of Photo 48

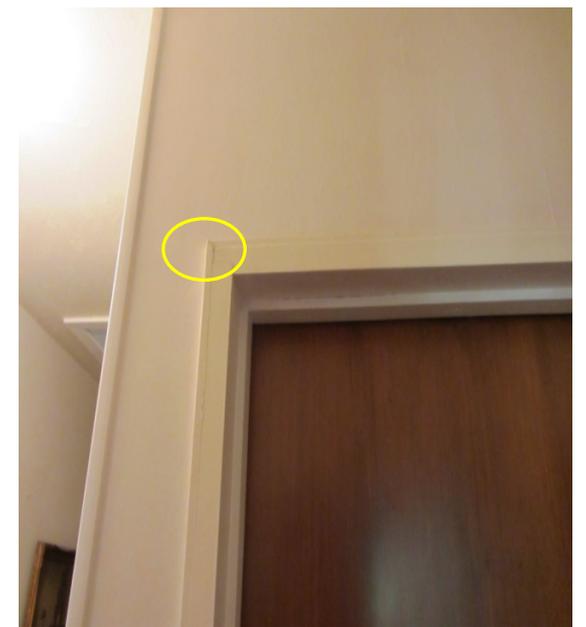
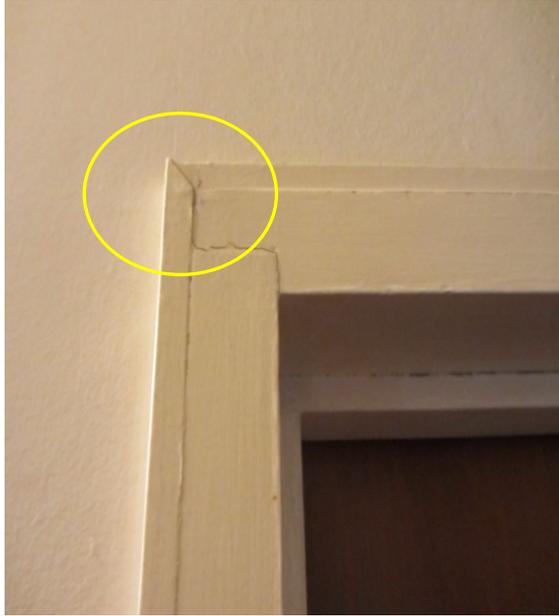
22) Hairline cracking present along the top joints of the door architrave (PHOTO 50 & 51)

Photo 50: Hairline Cracking to Toilet & Bathroom
Door Architrave Joints

Photo 51: Close Up of Photo 50

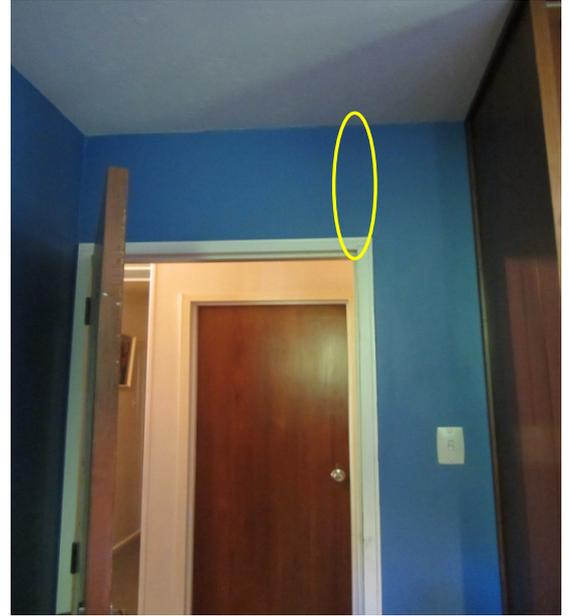
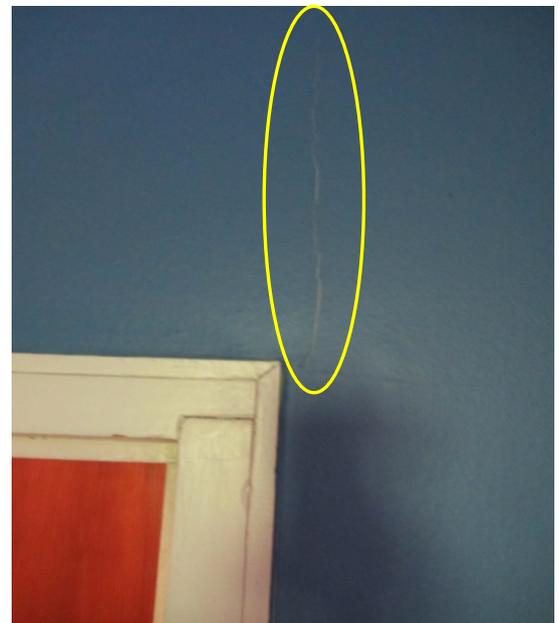
- 26) Hairline cracking present along the wall lining joint above south corner of doorway (PHOTO 52 & 53).

Photo 52: Hairline Cracking along Wall Lining Joint above Doorway in SW Bedroom

Photo 53: Close Up of Photo 52

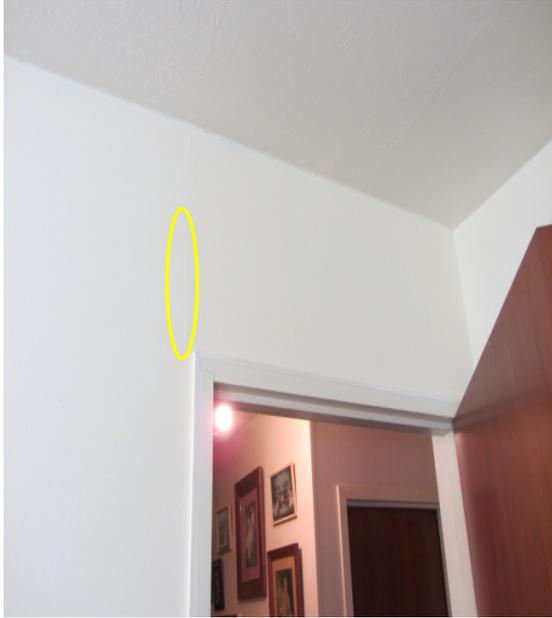
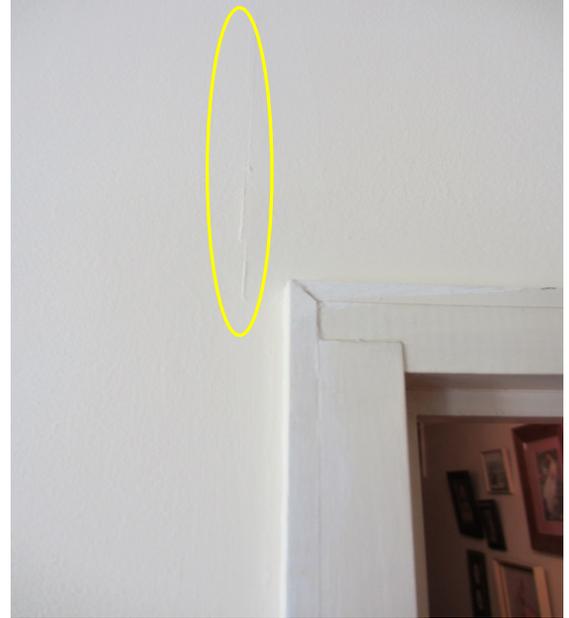
- 27) Hairline cracking present along the wall lining joint above the north corner of the doorway (PHOTO 55 & 56).
- 28) Hairline cracking present along the wall lining joints above all north wall window corners (PHOTO 57 & 58).
- 29) Hairline cracking present along the wall lining and ceiling lining joint. Occurs on the western and southern walls (PHOTO 59 & 60).
- 30) Hairline cracking present along the ceiling lining joint near the west wall window (PHOTO 61 & 62).

Photo 55: Hairline Cracking along Wall Lining Joint above Doorway in Master Bedroom

Photo 56: Close Up of Photo 55

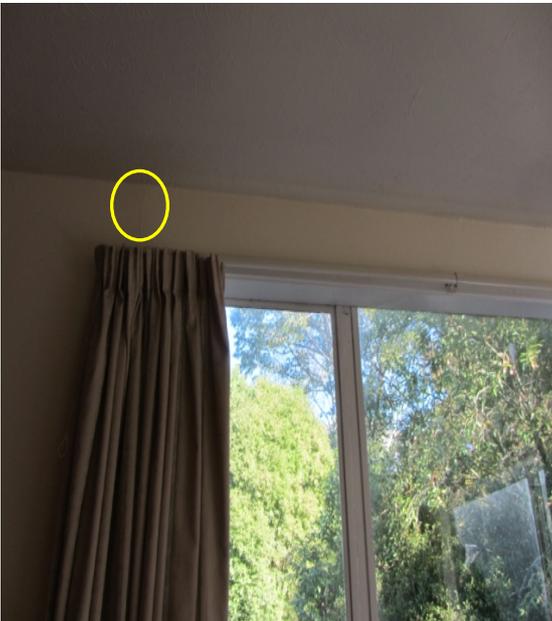
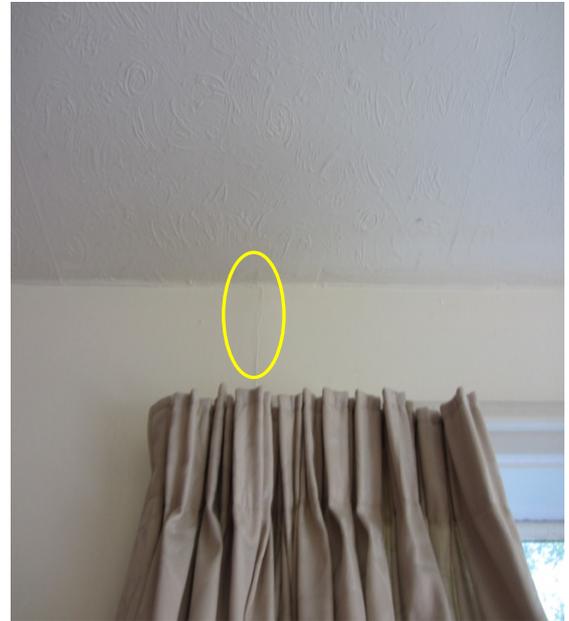
Photo 57: Hairline Cracking along Wall Lining Joints above Windows in Master Bedroom

Photo 58: Close Up of Photo 57

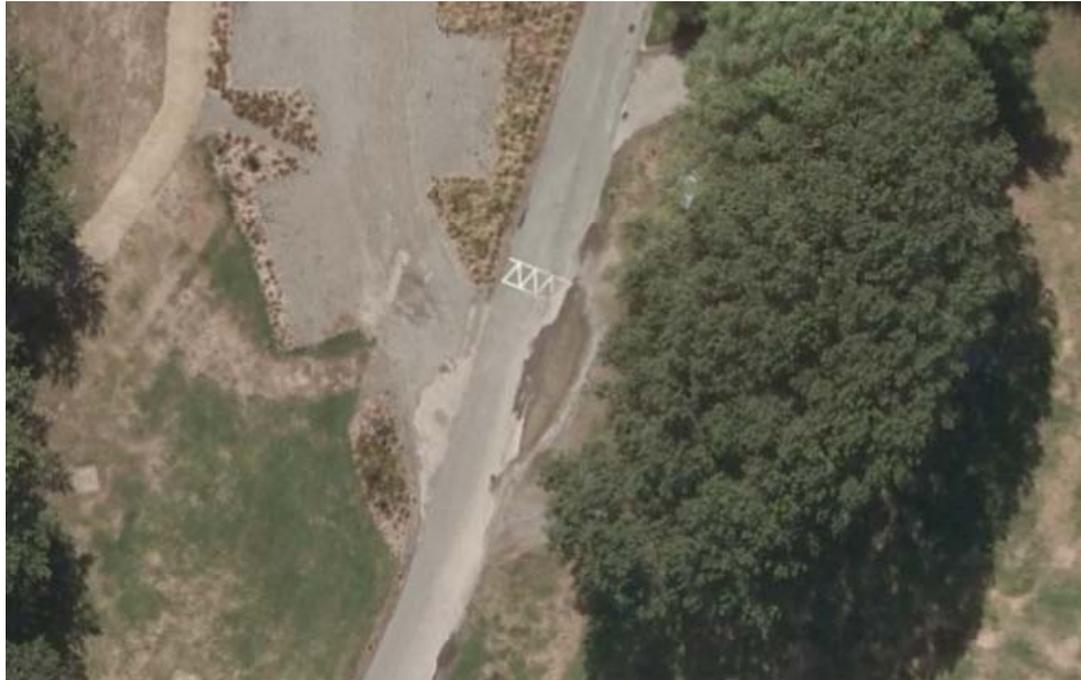
- **Figure 4 Aerial photograph showing liquefied material ejected near road way** (<http://viewers.geospatial.govt.nz/>)

The aerial photographs appears to show some evidence of liquefaction occurring on site due to the 22 February earthquake, with localised sand boils and liquefied material ejected near the road way visible in figure 4.
