PRK_0348_BLDG_004 EQ2

Changing Rooms/Toilets No 1

The Groynes, 182 Johns Road

QUALITATIVE ASSESSMENT REPORT FINAL

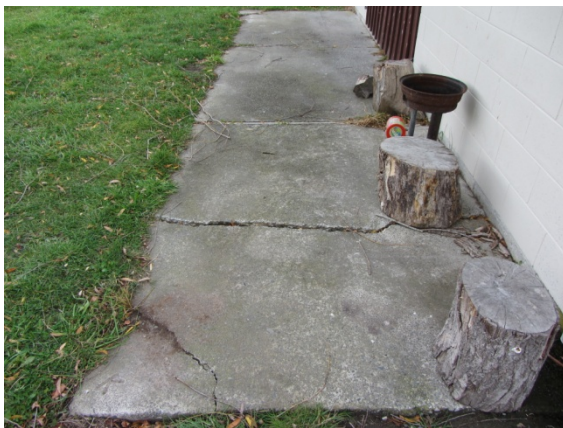
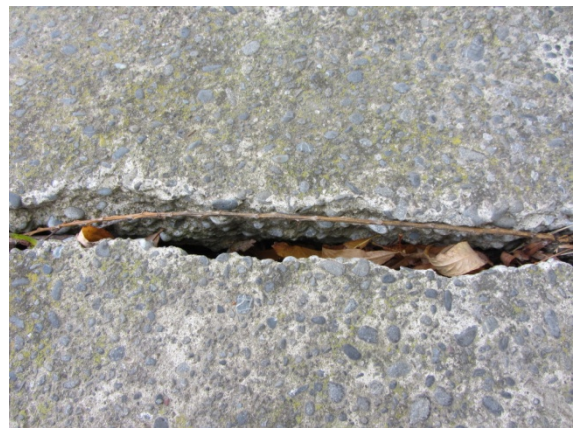
- 1) Construction joints in floor slab have opened up 1.5mm
- 2) Chimney has separated away from the main structure and created a 1.5mm crack
- 3) Cracking in pavement. This damage may have already occurred prior to the Canterbury earthquakes, in which case the earthquakes would have exacerbated the cracking.

Photo 7: Cracking in pavement

Photo 8: Close up view of cracking in pavement from photo 7

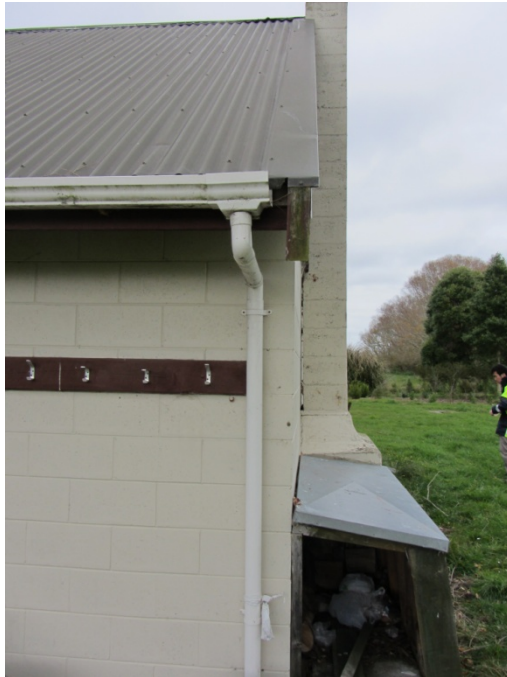
Photo 9: View of chimney

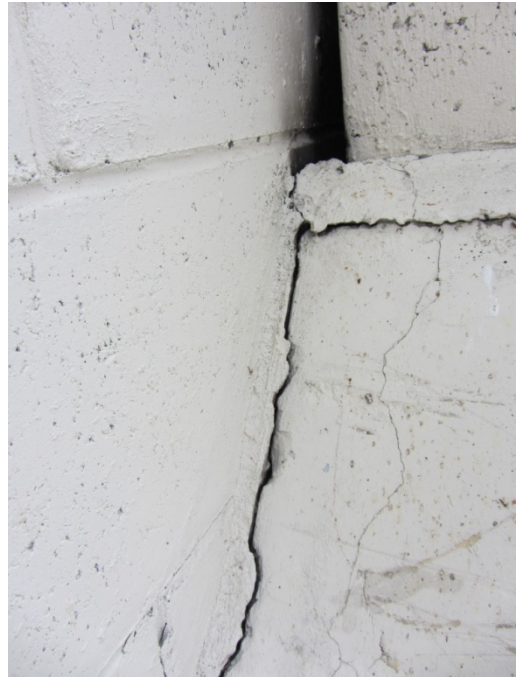
Photo 10: Close view of 1.5mm crack between chimney and main structure

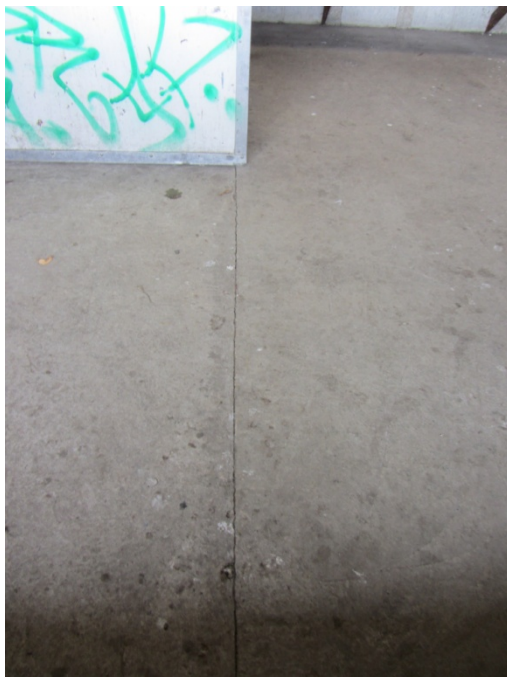
Photo 11: View of interior floor slab

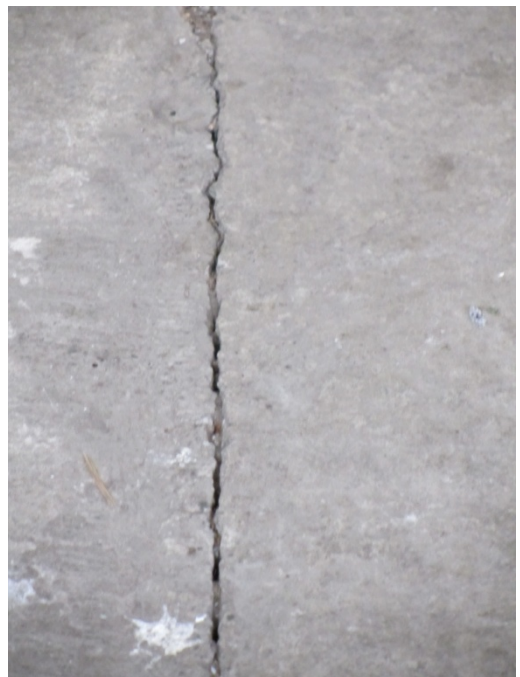
Photo 12: Close up view of 1.5mm interior floor slab crack

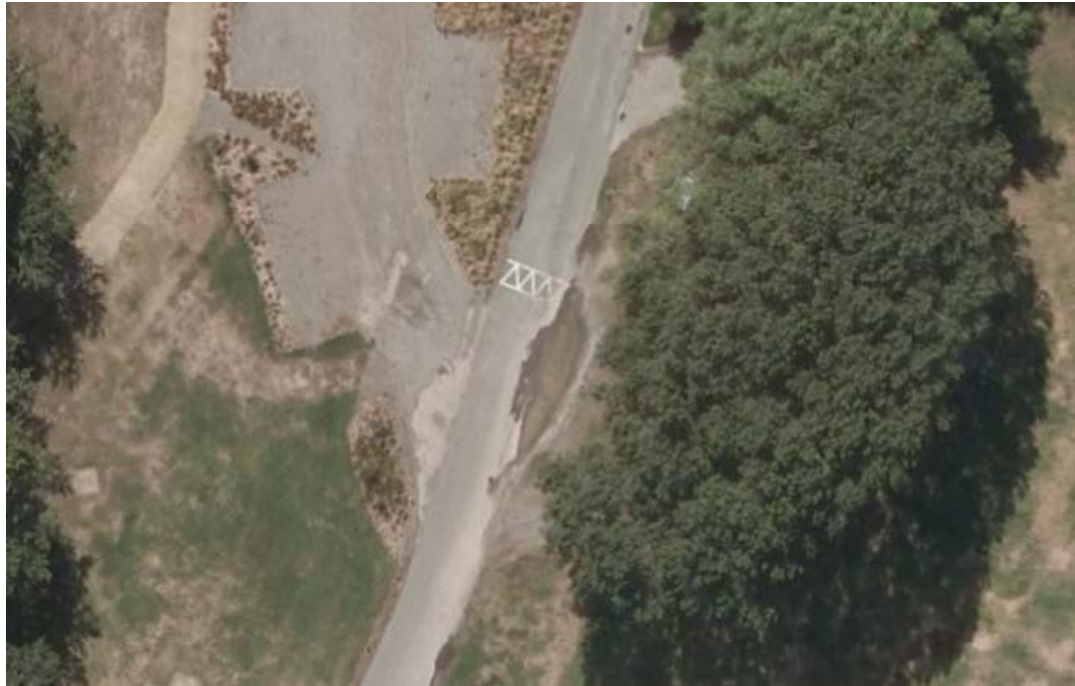
- **Figure 4 Aerial photograph showing liquefied material ejected near road way**
(<http://viewers.geospatial.govt.nz/>)

The aerial photographs appears to show some evidence of liquefaction occurring on site due to the 22 February earthquake, with localised sand boils and liquefied material ejected near the road way visible in figure 4.
