Owner Occupied HP Smith Courts

Quantitative Engineering Evaluation

Functional Location ID: PRO 0675

Address: 66 Perth Street, Christchurch

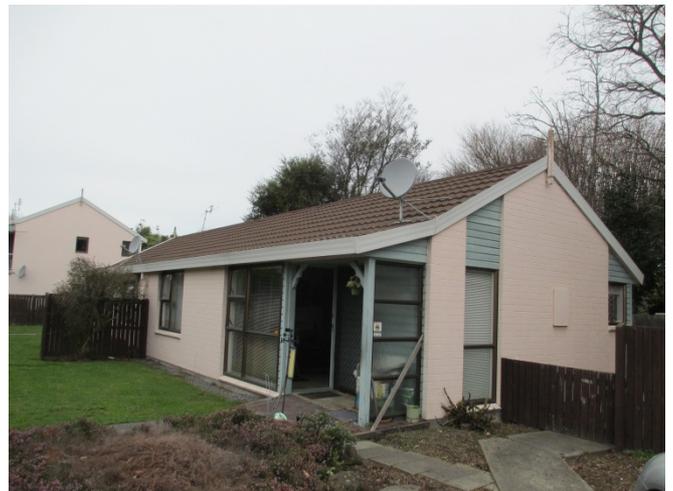
North view of the building.

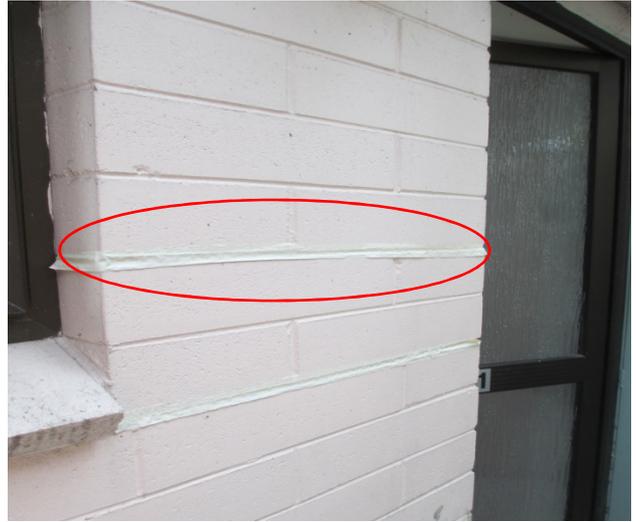
Cracks in the blockwork veneer covered by a paper tape.

- Grout repair cracking to the masonry joints;
- Cracking to internal wall and ceiling fibrous plaster linings should be repaired similar to that used for GIB linings in accordance with GIB 'Guidelines for repairing GIB plasterboard linings in wind and earthquake damaged properties'; and
- Re-hanging the frames of the doors which do not operate well.

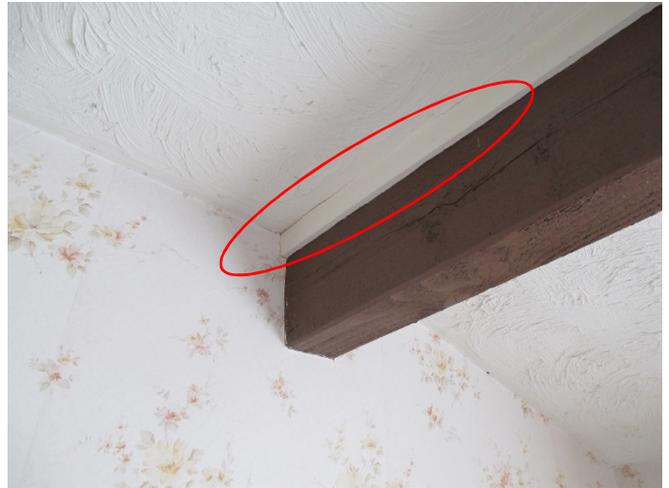
Cracks in the corner of the moulding.

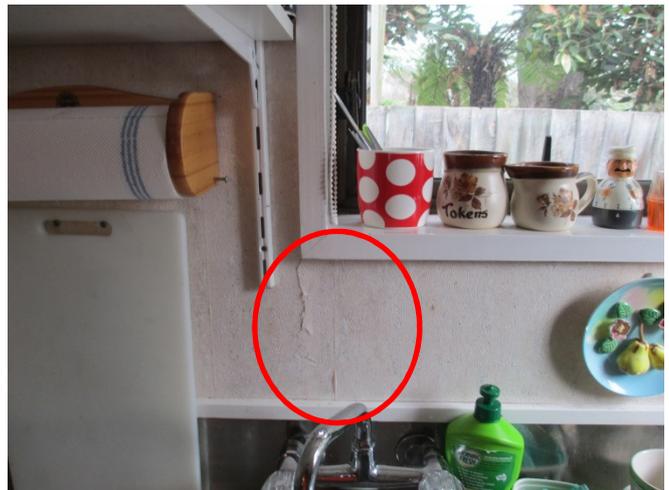
Cracks in the plasterboard wall at the corner of windows.

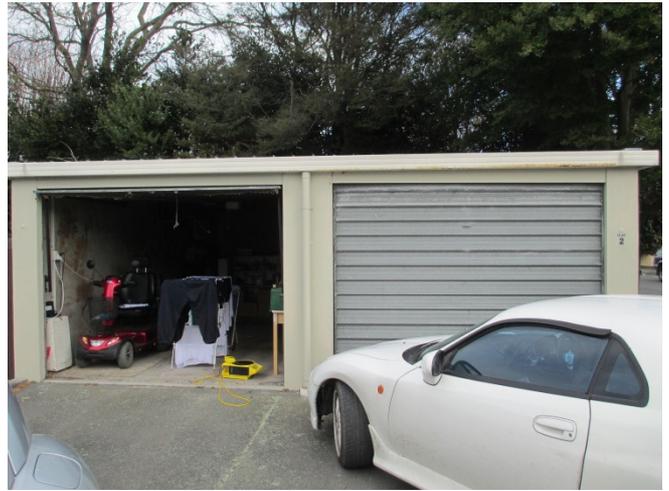
North view of the garages.

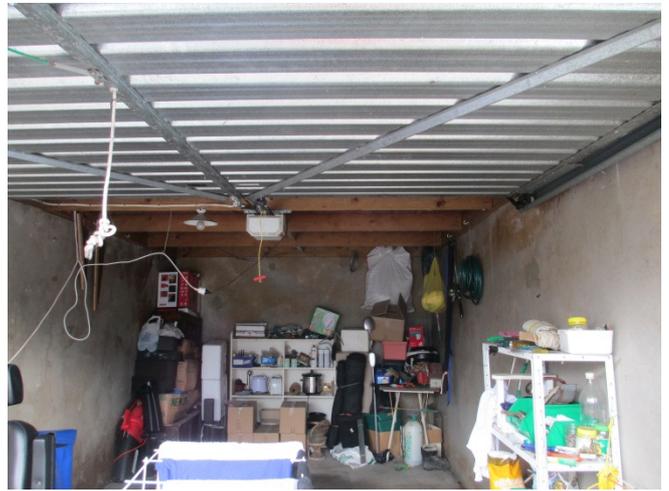
The garage have concrete walls in the along and across directions but they do not have an appropriate roof diaphragm to transfer earthquake induced forces to the back walls in the along direction. The capacity is limited to the moment capacity of the piers which provide a strength of 35% NBS.

Timber framed roof of the garage.

Strengthening of the building and garages is recommended. We recommend strengthening to 67% NBS or 100% NBS if possible. Strengthening would most likely involve installation of a cross-bracing for the roof of the garages and adding/replacing a number of walls in along and across directions for the residential building.

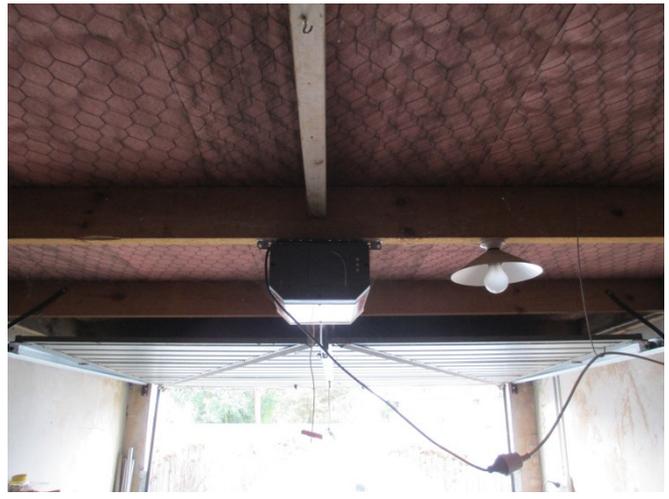
Roof of the garage.

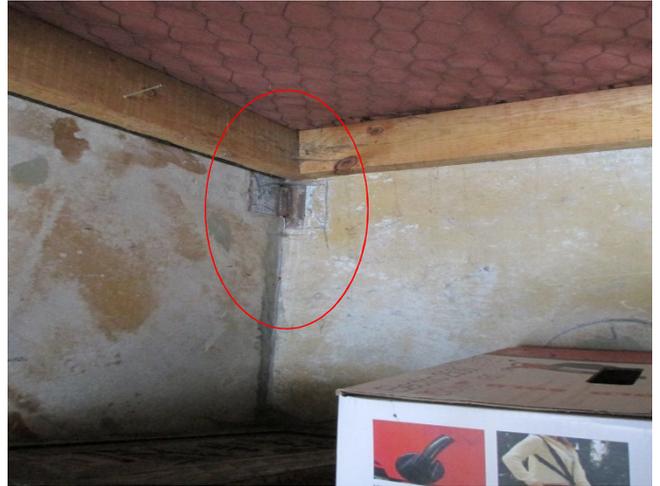
Precast wall to precast wall connection.

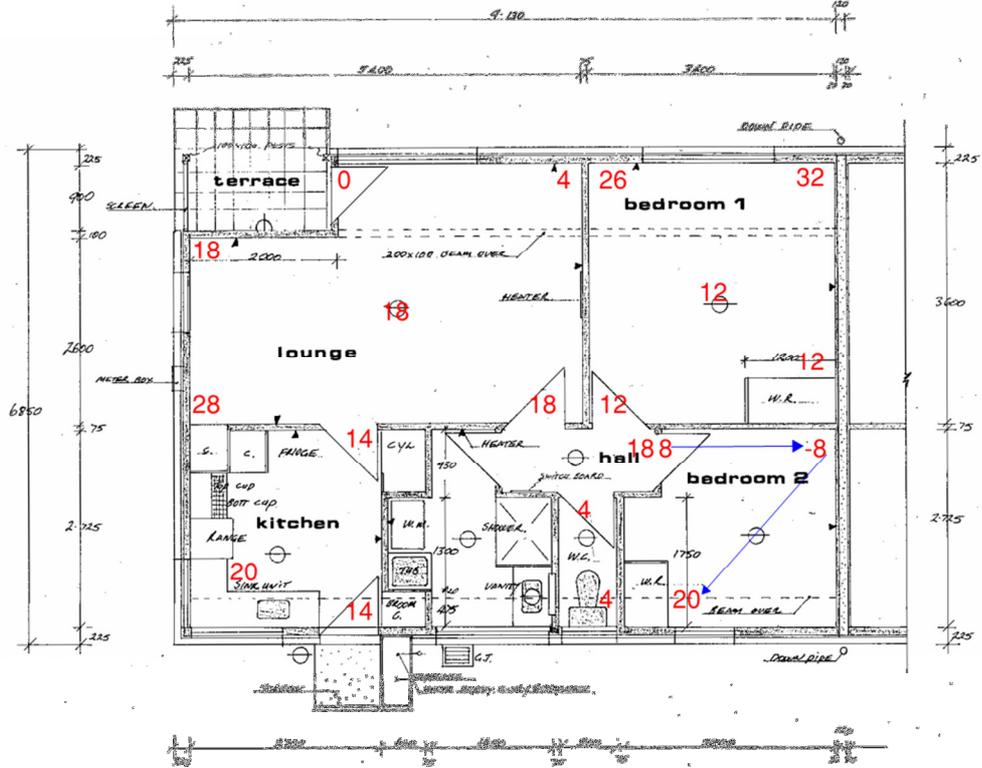
FLOOR PLAN Unit 1

- In kitchen area of unit 1, a fall of 18 mm over an approximate length of 3 meters gives a slope of 0.6 %.
- In bedroom 2 of unit 1, a fall of 20 mm over an approximate length of 3 meters gives a slope of 0.7 %
- In bedroom 2 of unit 2, a fall of 28 mm over an approximate length of 3 meters gives a slope of 0.9 %.

Since the building has a concrete slab on piles, the observed slopes are still within the tolerable limit for the building and no re-levelling is recommended.

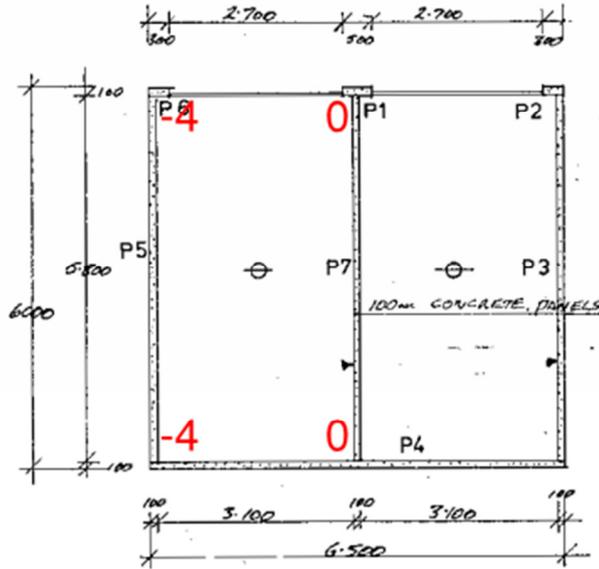
Level survey – garages

Other areas of the building and the garages were within the recommend limit of 0.5%.
