Haast Courts Block A
BU 0792-001 EQ2
Detailed Engineering Evaluation
Quantitative Report
Version FINAL

Units 1 to 4, 43 Haast Street, Linwood

Christchurch City Council

Date
13 November 2012

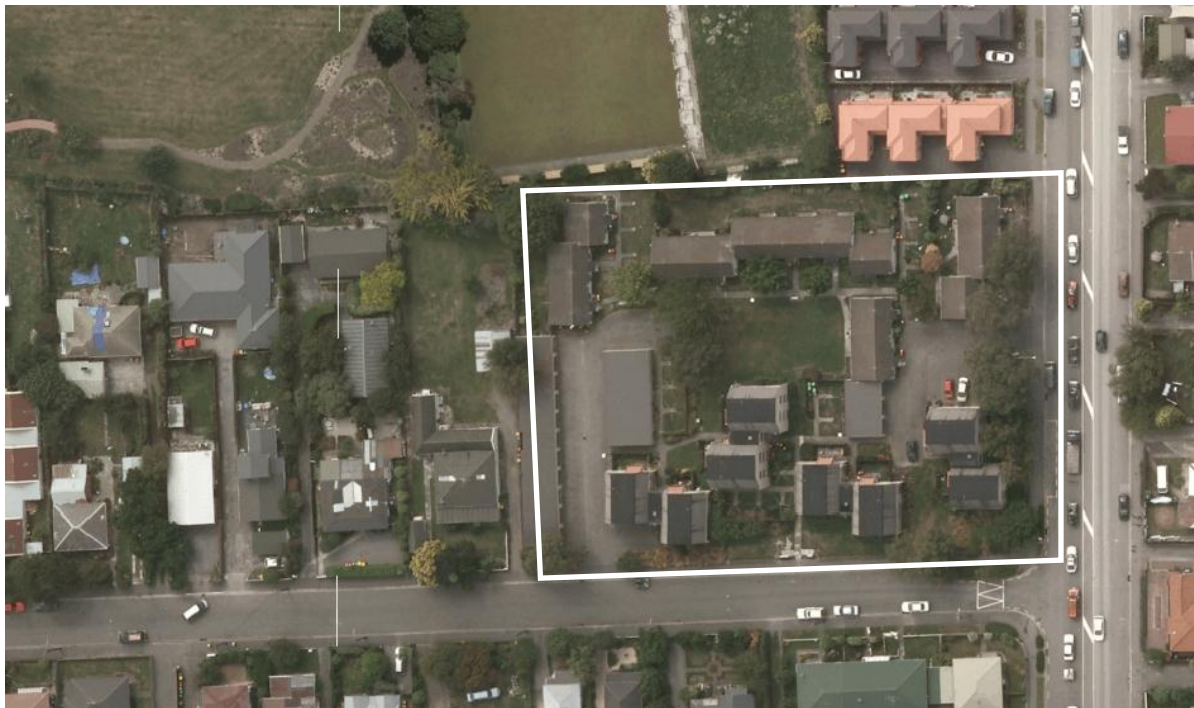
Figure 3 Post February 2011 Earthquake Aerial Photography³

Aerial photography taken following the 22 February 2011 earthquake shows no signs of liquefaction outside the building footprints or adjacent to the site, as shown in Figure 3.

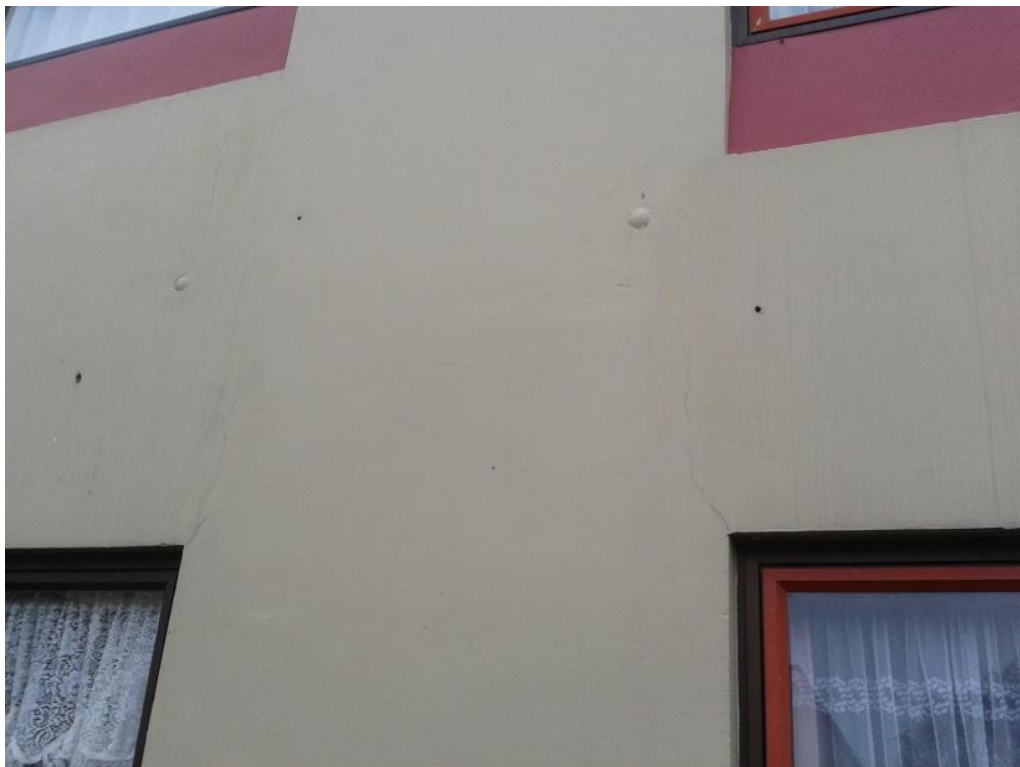
Minor cracking was noted to the exterior of the buildings. These cracks may be original shrinkage cracks that may have opened up slightly during the recent seismic activity.

Photograph 2 Cracking to exterior walls at window corners.

GHD Limited recommends that any cracking greater than 0.2mm wide to the concrete panel walls and suspended concrete floors are repaired by epoxy injection to restore the buildings to their pre-earthquake condition.

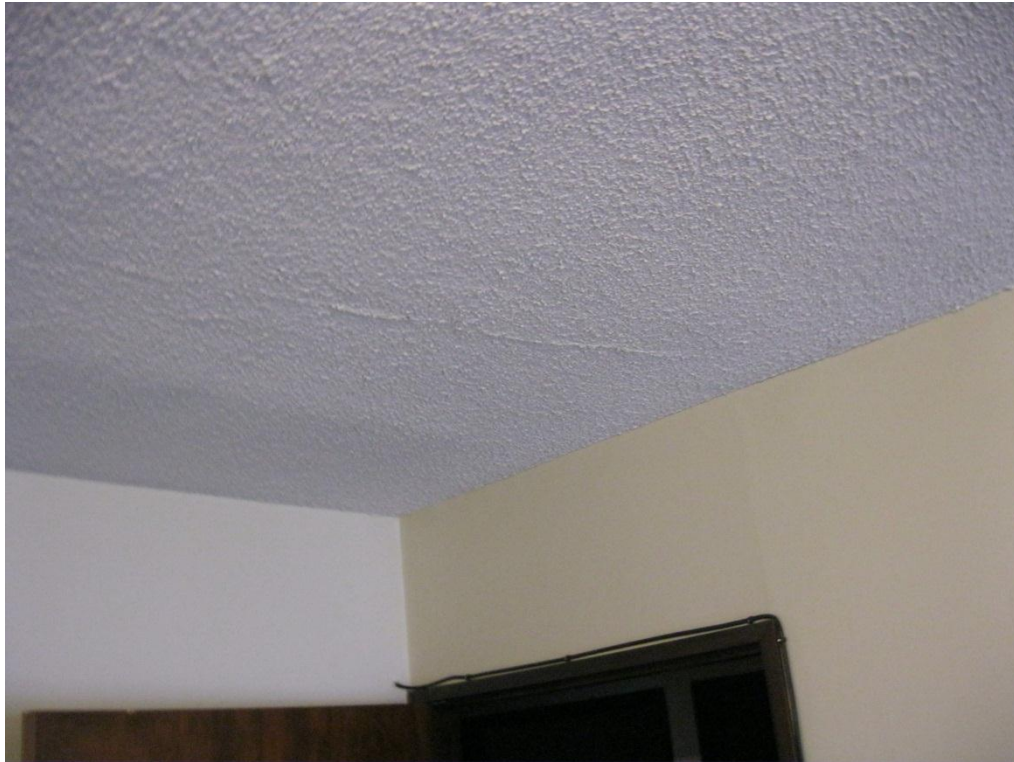
Minor cracking was evident in the asbestos plaster finish to the underside of the first floor slab. It was not clear if these cracks penetrate through to the concrete slab.

Photograph 3 Cracking to plaster finish on the underside of the suspended floor slab.

Due to the presence of cracking to the asbestos plaster ceiling lining in a number of the units throughout the complex, GHD Limited recommends that all the ceiling linings are inspected by asbestos specialists and dealt with according to their recommendations.

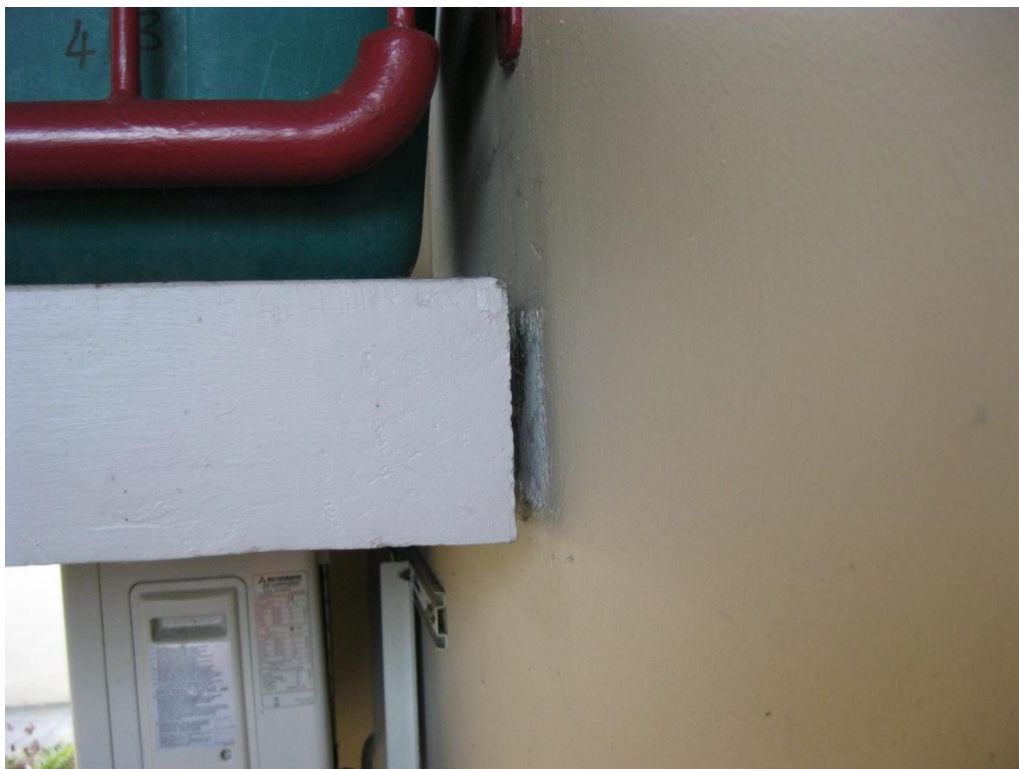
The dowel connection between the common landings and the building panel walls allows for differential movement of the staircase and wall panel in one direction only (out-of-plane of the wall panel). At the doors of apartments, the seismic gap between the landings and walls is filled but this seal does not appear to be flexible which would cause the transfer of loads between the two blocks of the building. Should differential seismic movement in the plane of the supporting panels occur, there is the potential for shear failure of the steel dowels which could cause failure of the staircase. This has the potential to cause serious injury to residents who might be using a stairs during, and may also prevent egress following a large seismic event.

Photograph 7 Seismic gap between stairs landing and precast concrete wall panel.

As a result of the lack of seismic separation between the staircase and the supporting precast panel walls, it is recommended that secondary supports be provided to all landings in the form of equal angle supports fixed to the supporting panel walls. As the stairs are the only means of egress from the upper floors, this issue should be addressed immediately.

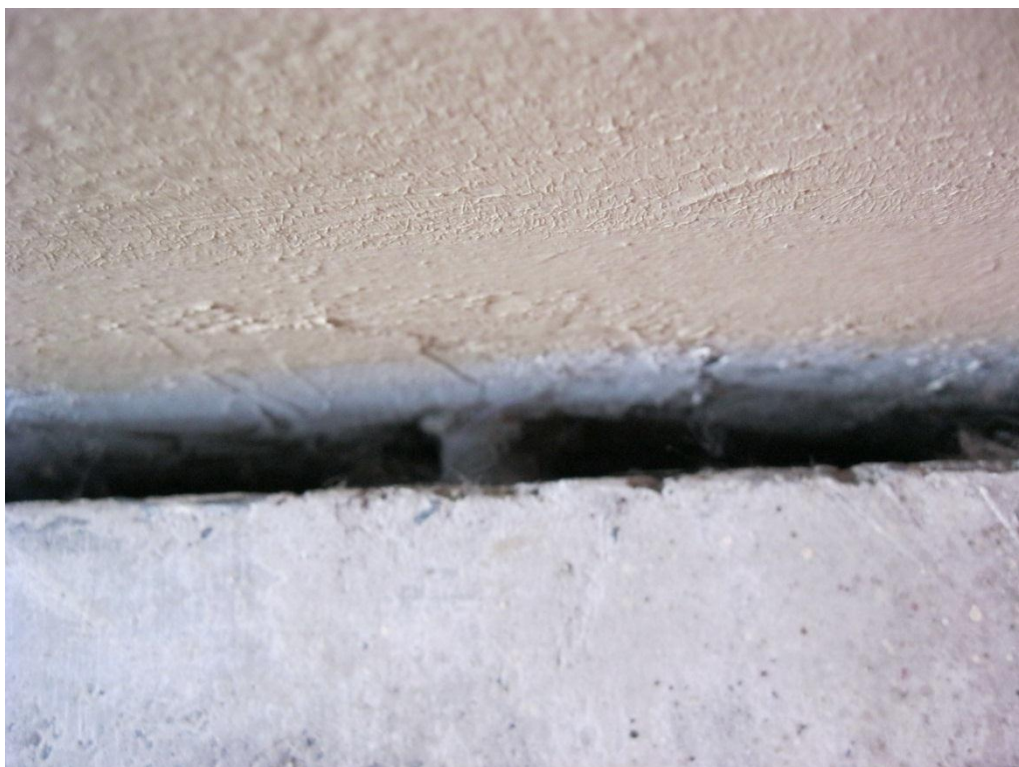
Photograph 8 Seismic gap between stairs landing and precast concrete wall panel showing steel dowel pin connection.

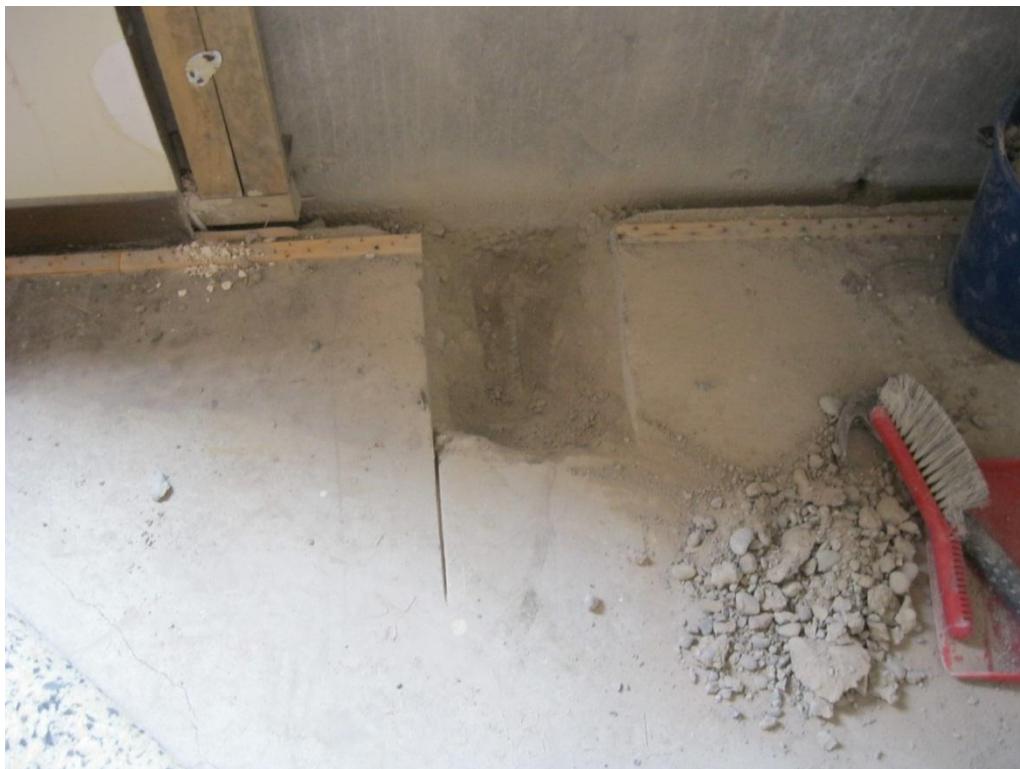
Photograph 20 Suspended slab steel reinforcement cage found not to be tied into precast wall from the top.

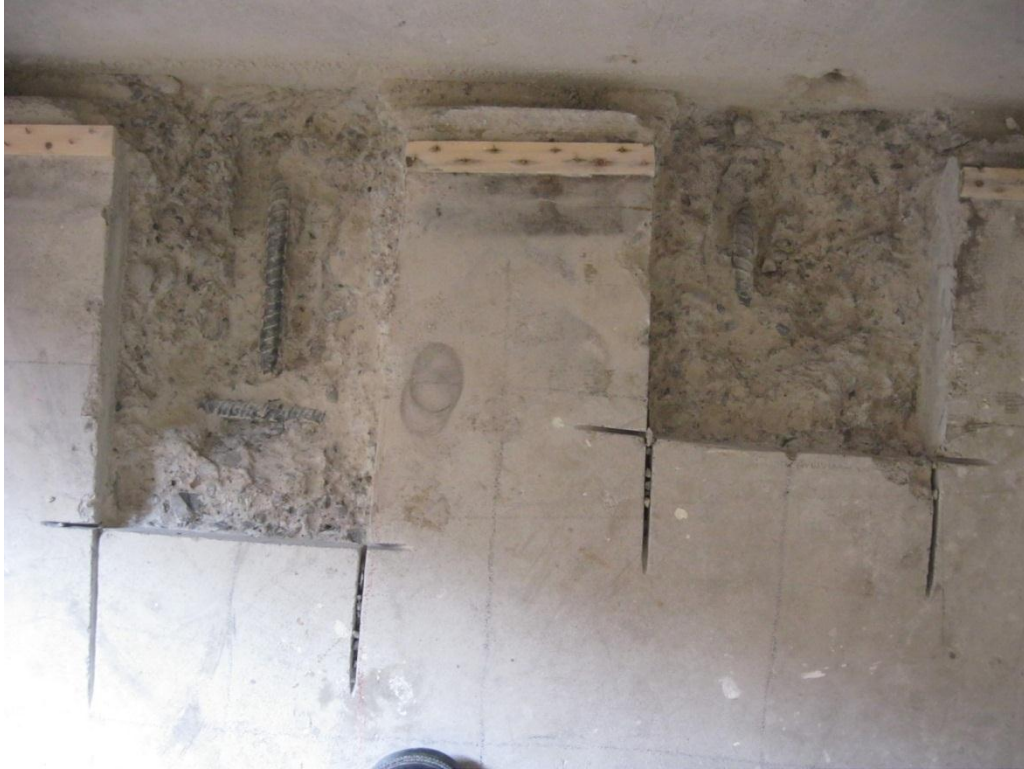
Photograph 21 Further opening up of the suspended slab showed the steel reinforcement cage not to be tied into precast wall from the top.

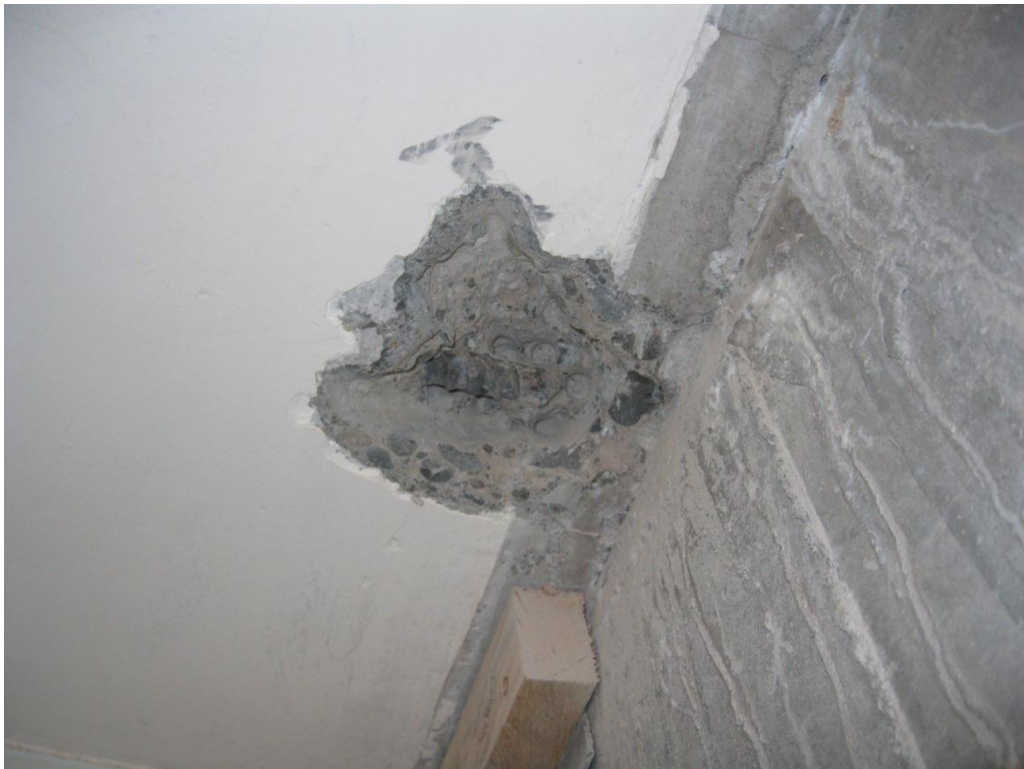
Photograph 22 Opening up to the underside of the second floor suspended slab showed the steel cage reinforcement not tied into the precast wall.

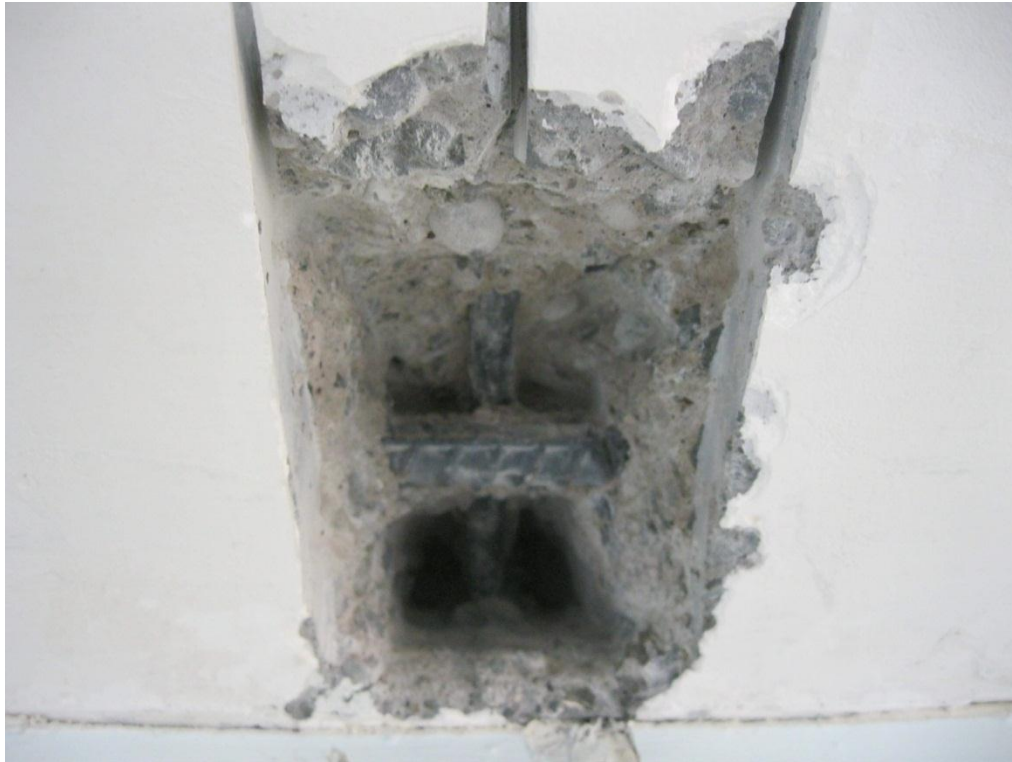
Photograph 23 Opening up in another location revealed a 10mm diameter steel bar tying the suspended slab back into the precast concrete wall panels.

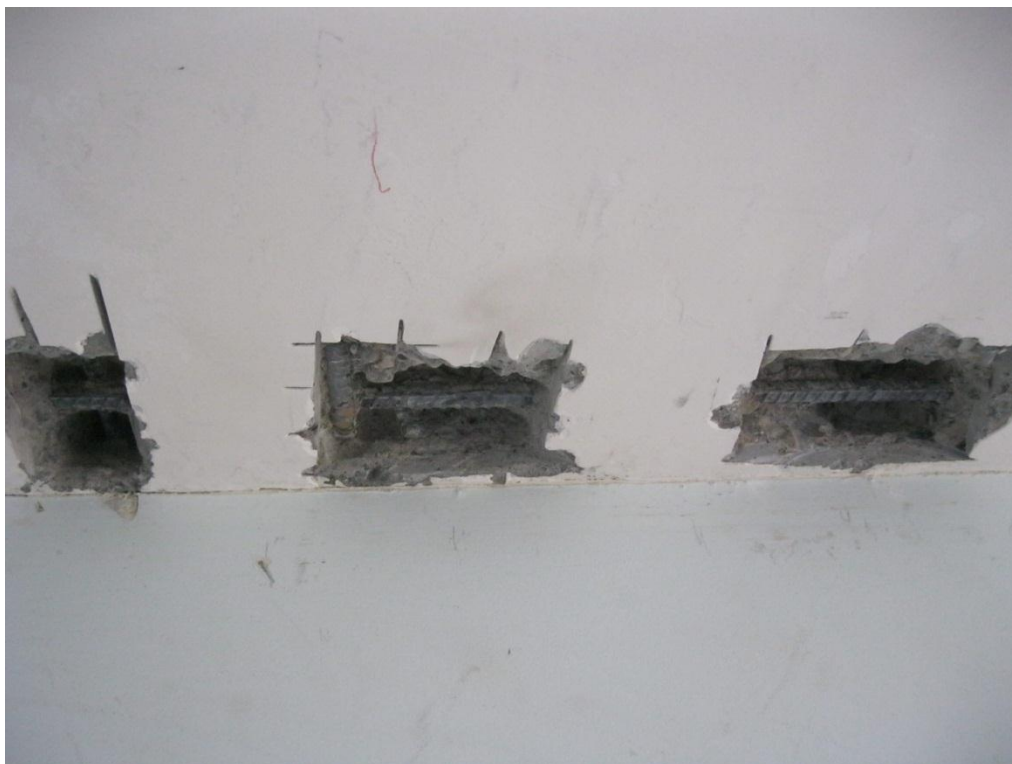
Photograph 24 Further opening up and reinforcement scanning revealed regular spacing of bars tying the slab into the precast panels at 250mm centres along all walls.
