**Haast Courts Block B**  
**BU 0792-002 EQ2**  
Detailed Engineering Evaluation  
Quantitative Report  
Version FINAL

Units 5 to 10, 43 Haast Street, Linwood

Christchurch City Council

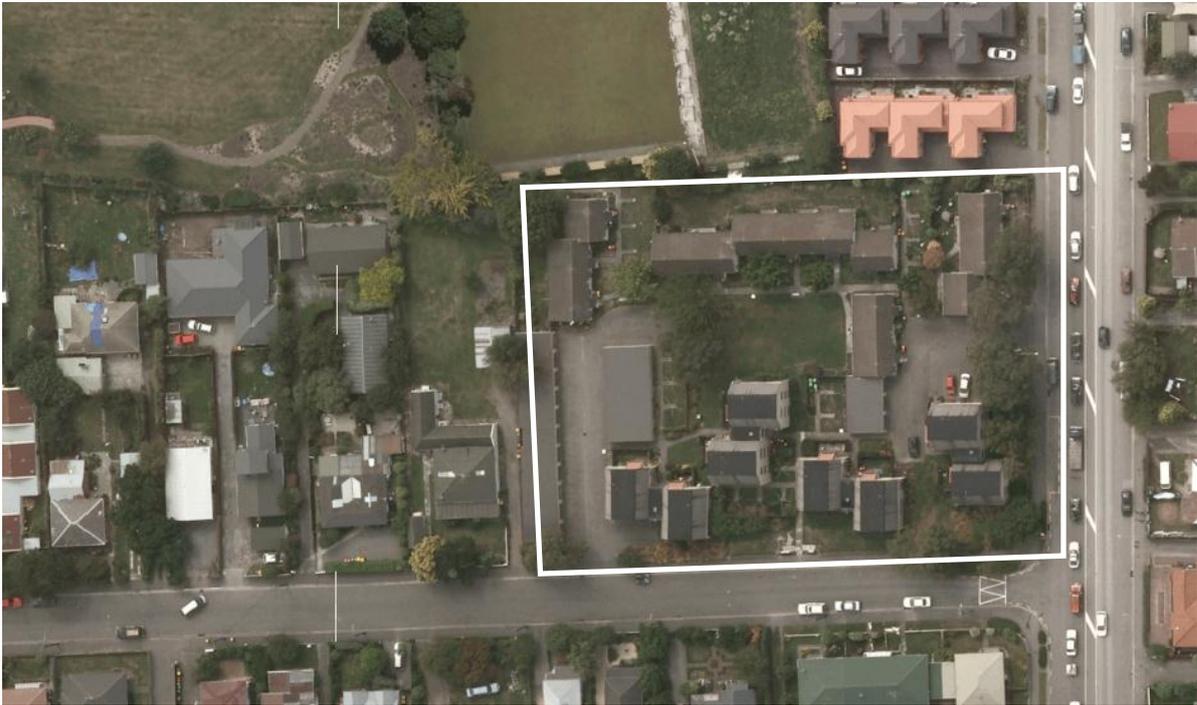
**Figure 3 Post February 2011 Earthquake Aerial Photography<sup>3</sup>**

Aerial photography taken following the 22 February 2011 earthquake shows no signs of liquefaction outside the building footprints or adjacent to the site, as shown in Figure 3.

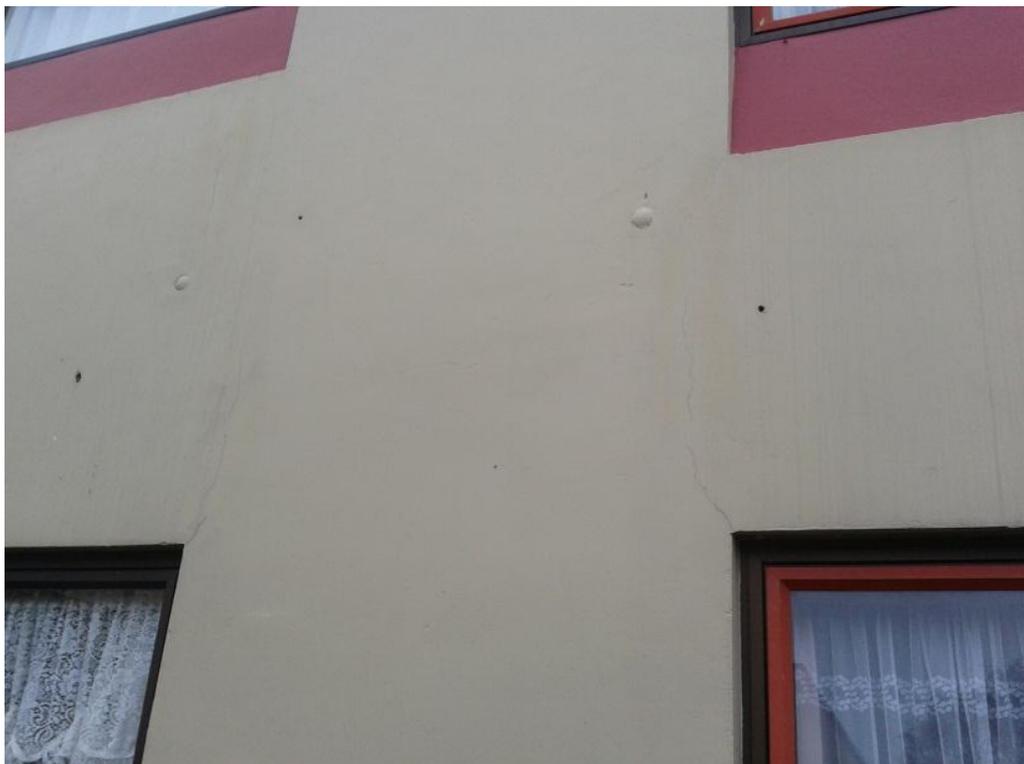
Minor cracking was noted to the exterior of the building. These cracks may be original shrinkage cracks that may have opened up slightly during the recent seismic activity.

**Photograph 2 Cracking to exterior walls at window corners.**

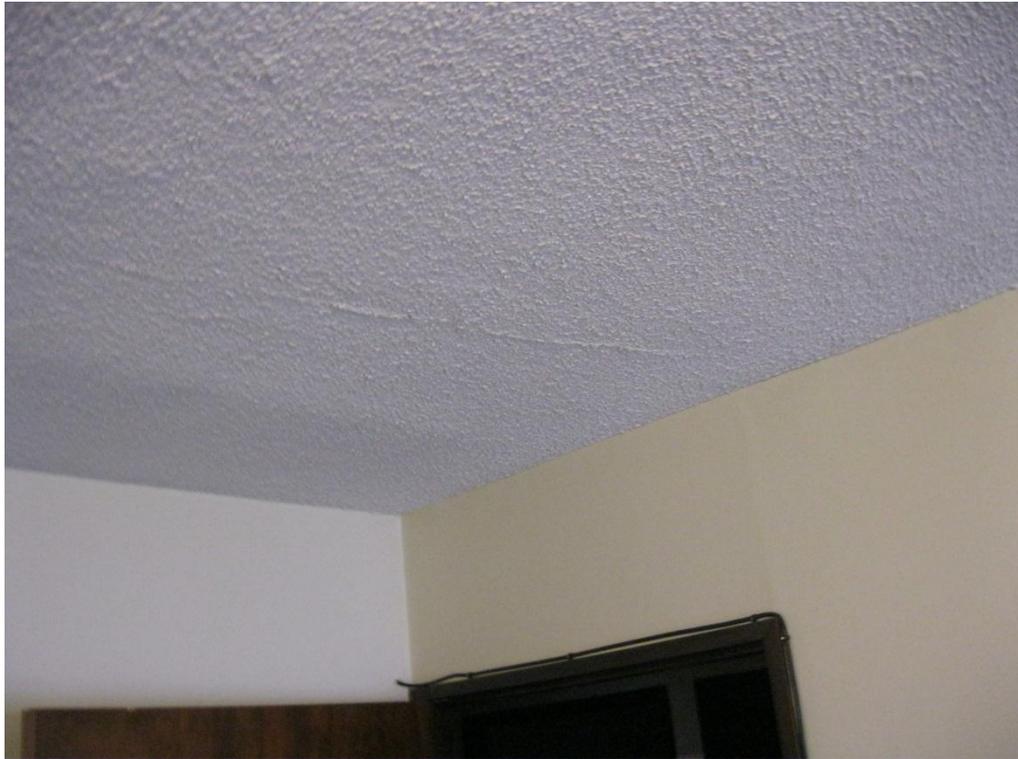
Minor cracking was evident in the asbestos plaster finish to the underside of the first floor slab. It was not clear if these cracks penetrate into the concrete slab.

**Photograph 3 Cracking to plaster finish on the underside of the suspended floor slab.**

Due to the presence of cracking to the asbestos plaster ceiling lining in a number of the units throughout the complex, GHD Limited recommends that all the ceiling linings are to be inspected by asbestos specialists and dealt with according to their recommendations.

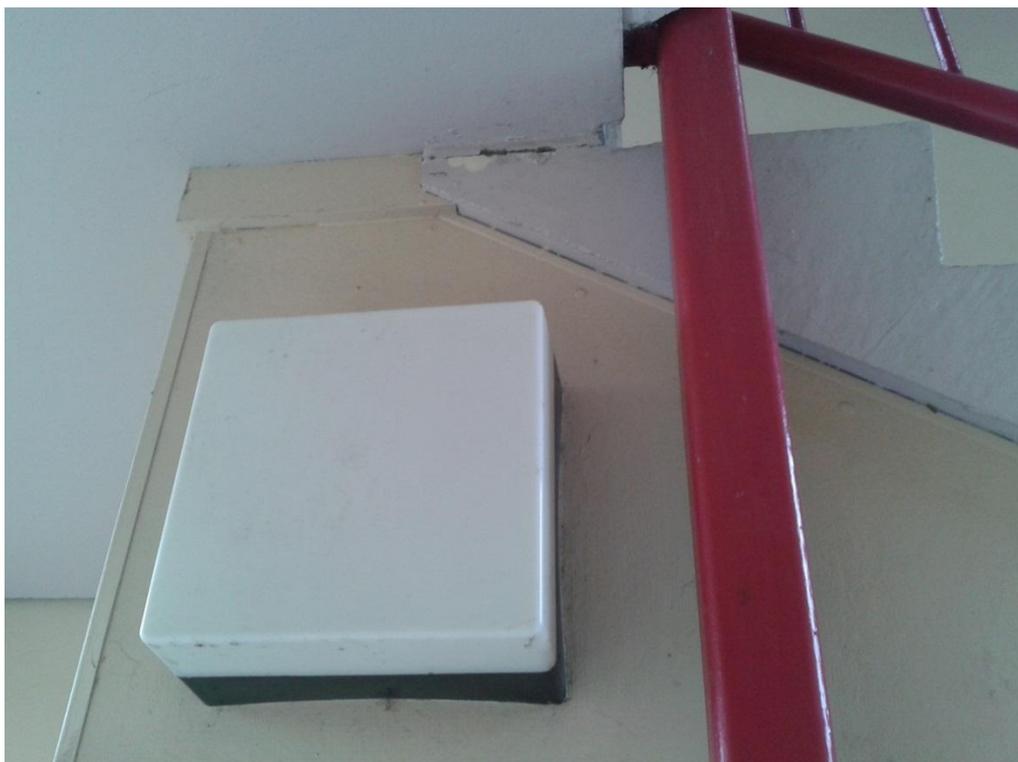
**Photograph 4 Connection of stairs to first floor landing.**

As the connections between the staircase and the supporting precast panel walls do not allow for adequate seismic lateral movement in the plane of the panel, it is recommended that secondary supports be provided to all landings in the form of equal angle supports fixed to the panel walls. The stairs are the only means of egress from the upper floors and this issue should be addressed immediately.

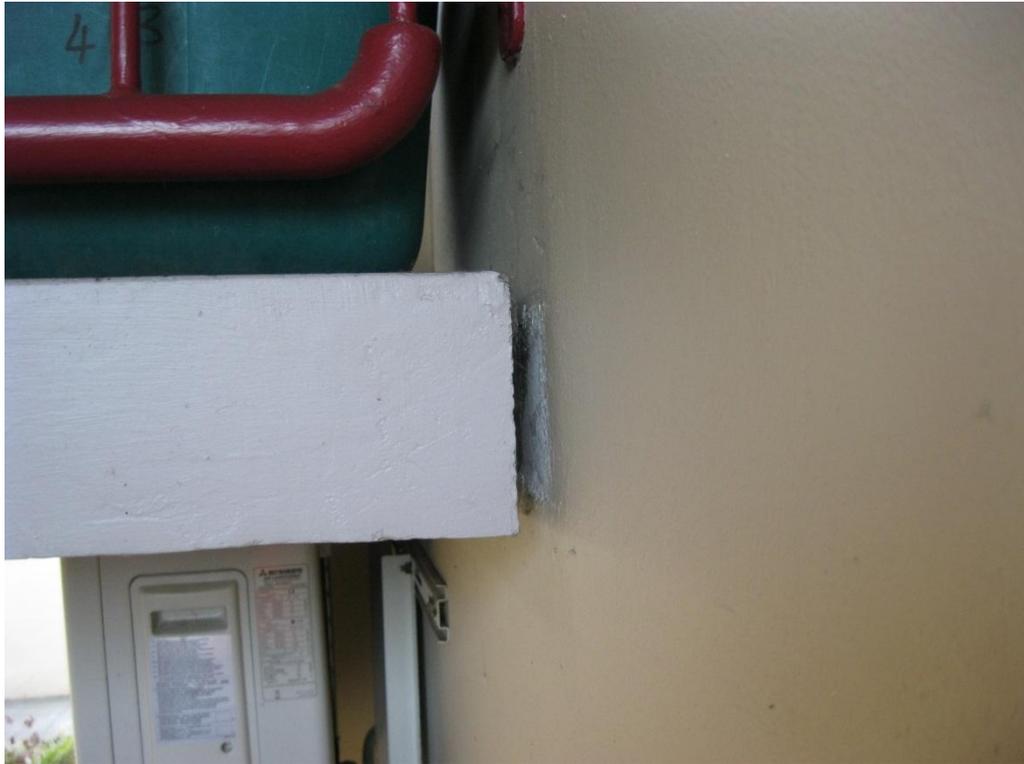
**Photograph 7 Seismic gap between stairs landing and precast concrete wall panel.**

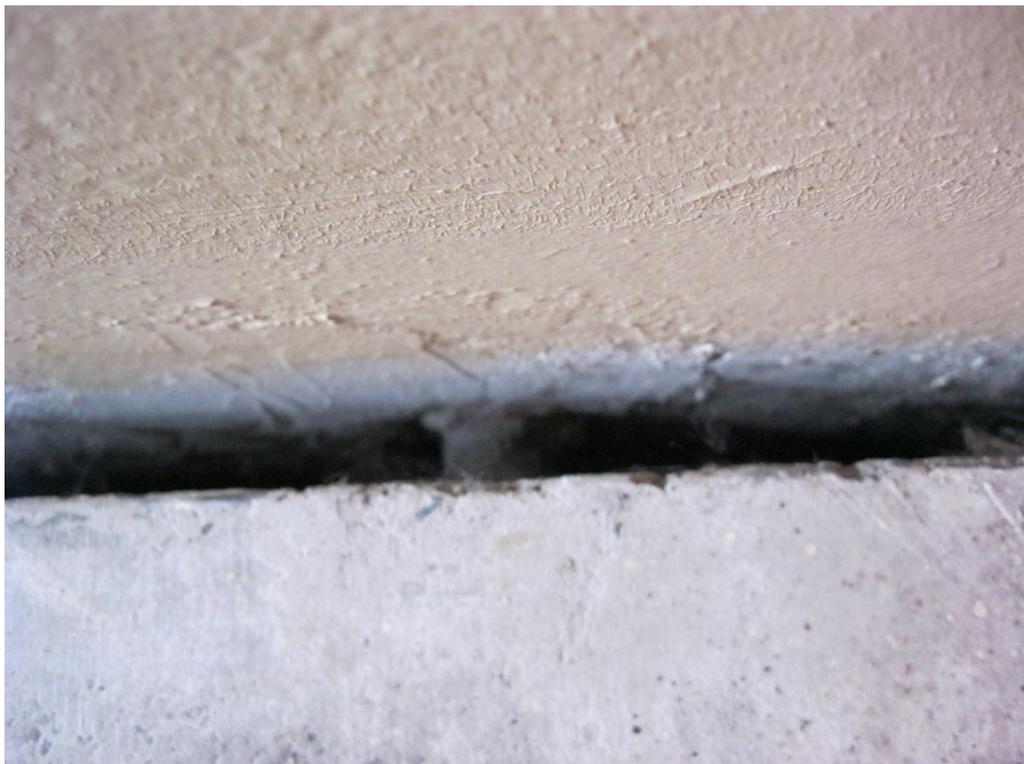
**Photograph 8 Seismic gap between stairs landing and precast concrete wall panel showing steel dowel pin connection.**

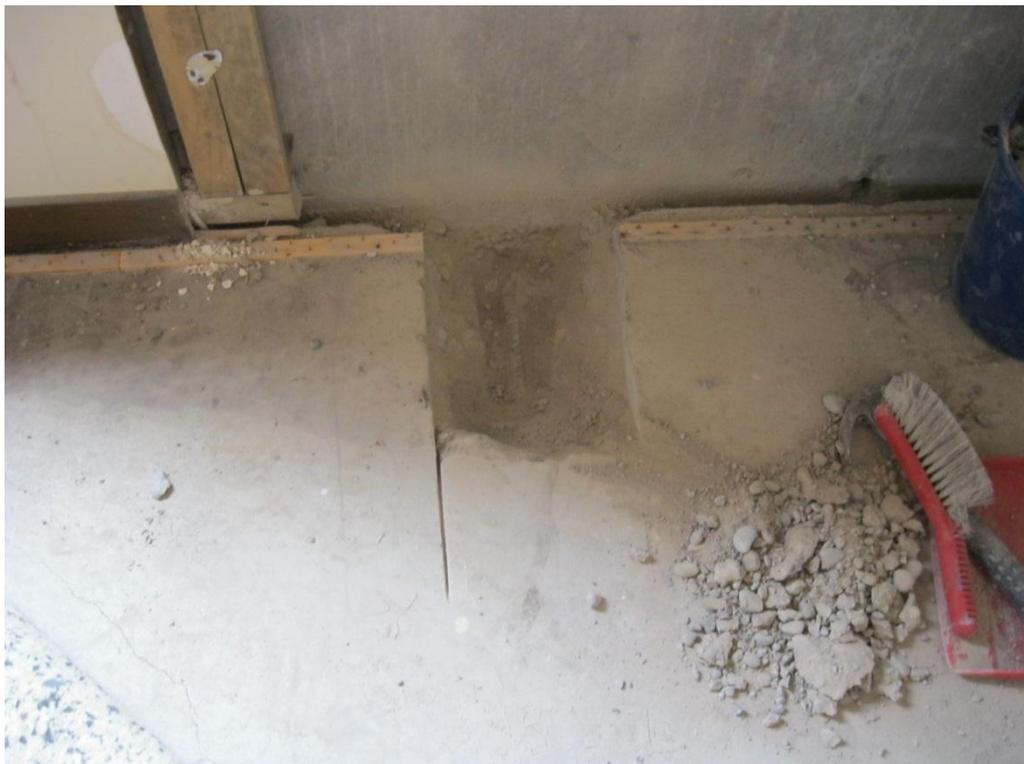
**Photograph 20 Suspended slab steel reinforcement cage found not to be tied into precast wall from the top.**

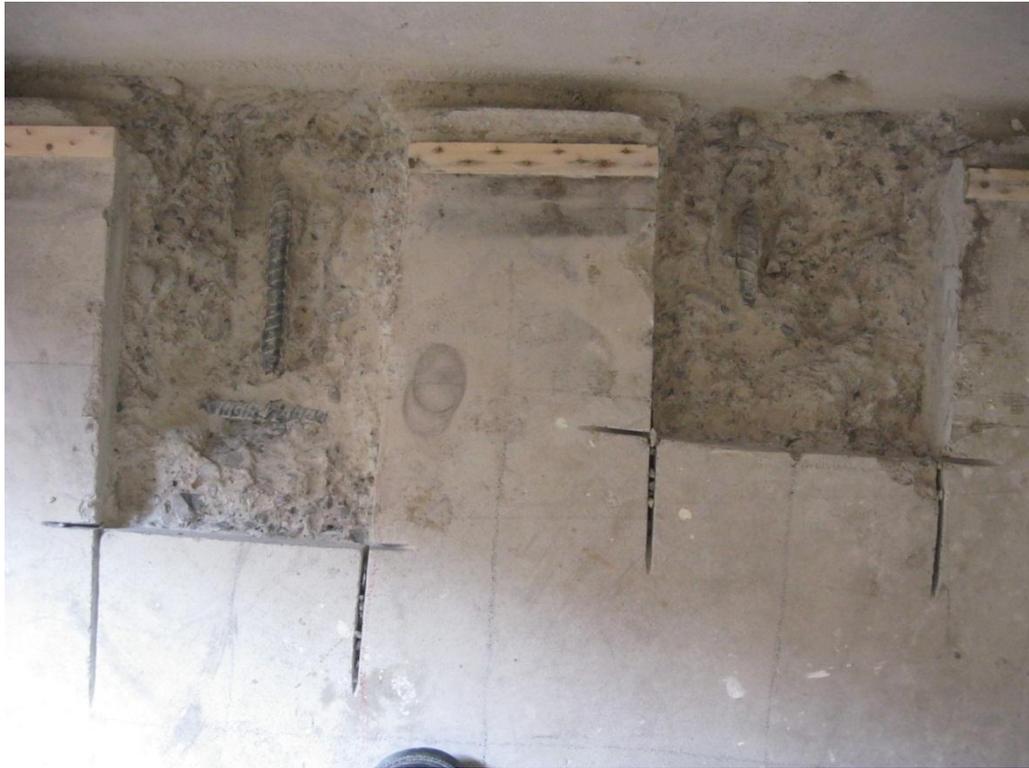
**Photograph 21** Further opening up of the suspended slab showed the steel reinforcement cage not to be tied into precast wall from the top.

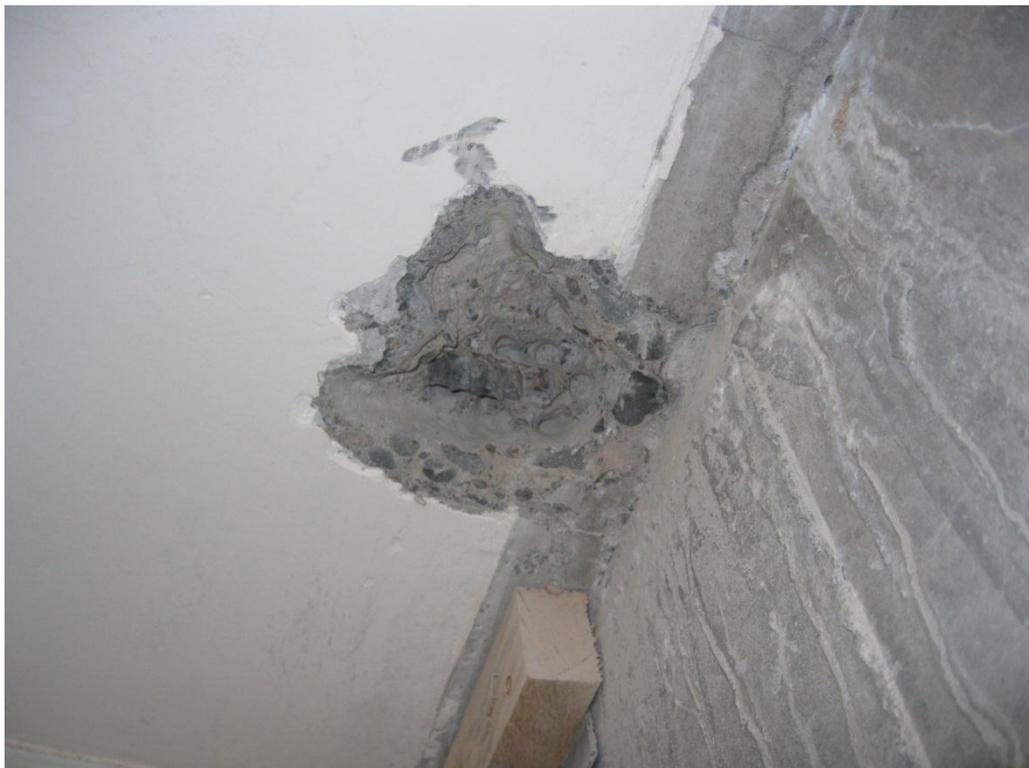
**Photograph 22** Opening up to the underside of the second floor suspended slab showed the steel cage reinforcement not tied into the precast wall.

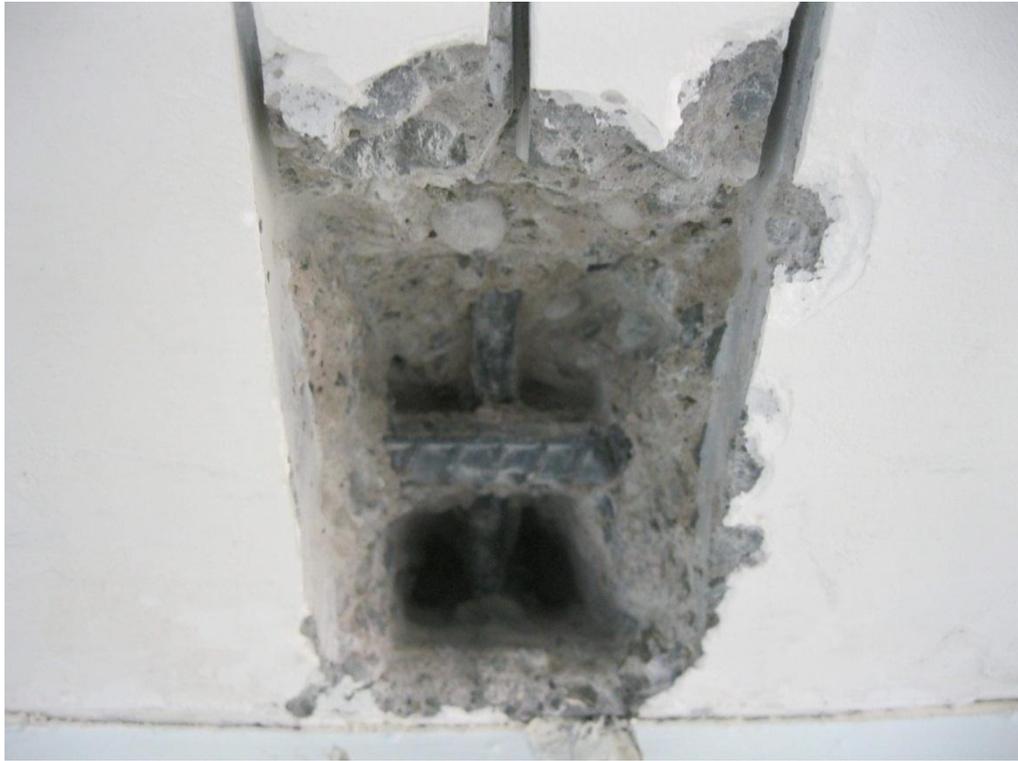
**Photograph 23** Opening up in another location revealed a 10mm diameter steel bar tying the suspended slab back into the precast concrete wall panels.

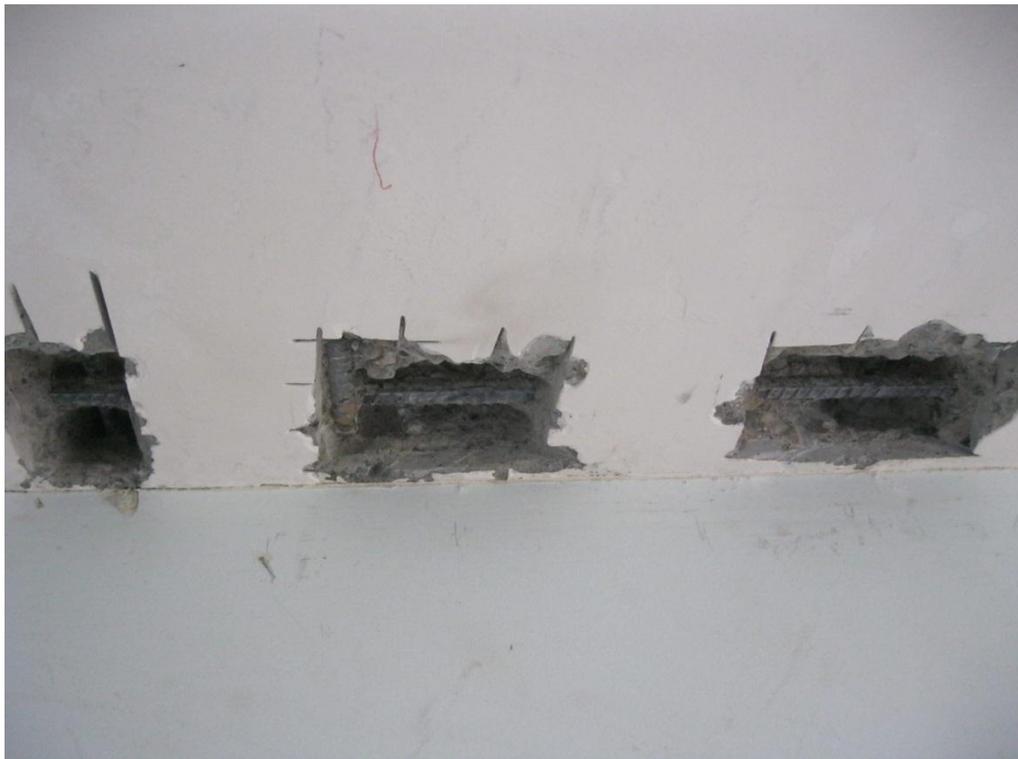
**Photograph 24** Further opening up and reinforcement scanning revealed regular spacing of bars tying the slab into the precast panels at 250mm centres along all walls.
