**Haast Courts Block H**  
**BU 0792-008 EQ2**  
Detailed Engineering Evaluation  
Quantitative Report  
Version FINAL

151 Stanmore Road, Linwood

Christchurch City Council

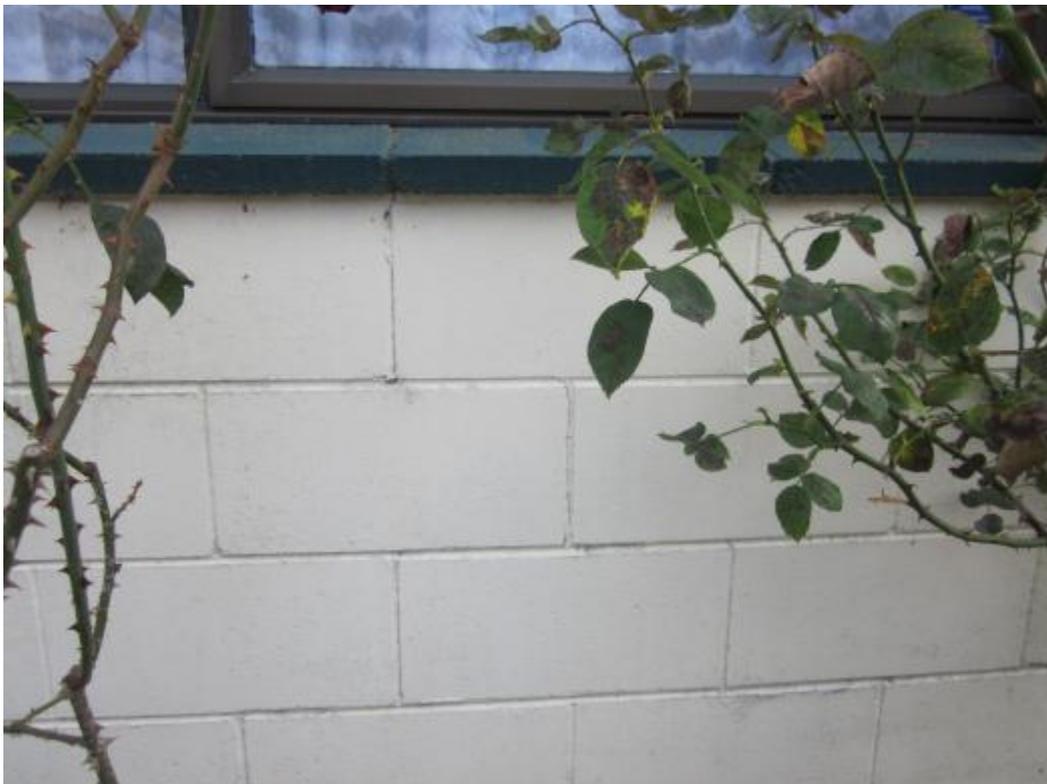
- Cracking to blockwork of south gable wall

Photo 10 Zigzag cracks at south block masonry wall.

- ▶ The upper section of the gable walls are either removed or tied back to the building frame immediately as collapses of these sections are possible under earthquake load.
- ▶ The masonry walls are apparently unreinforced and the drawings do not indicate that there are tied back to the wall framing. Localised removal of the linings is recommended to identify if the veneer is tied back.
- ▶ If the veneer is found not to be tied back to the wall framing it is recommended that the veneer is either removed and replaced with light weight cladding or is tied back to the framing with masonry ties.
- ▶ The areas adjacent to the unreinforced gable walls should be cordoned off until the above recommendations have been completed.

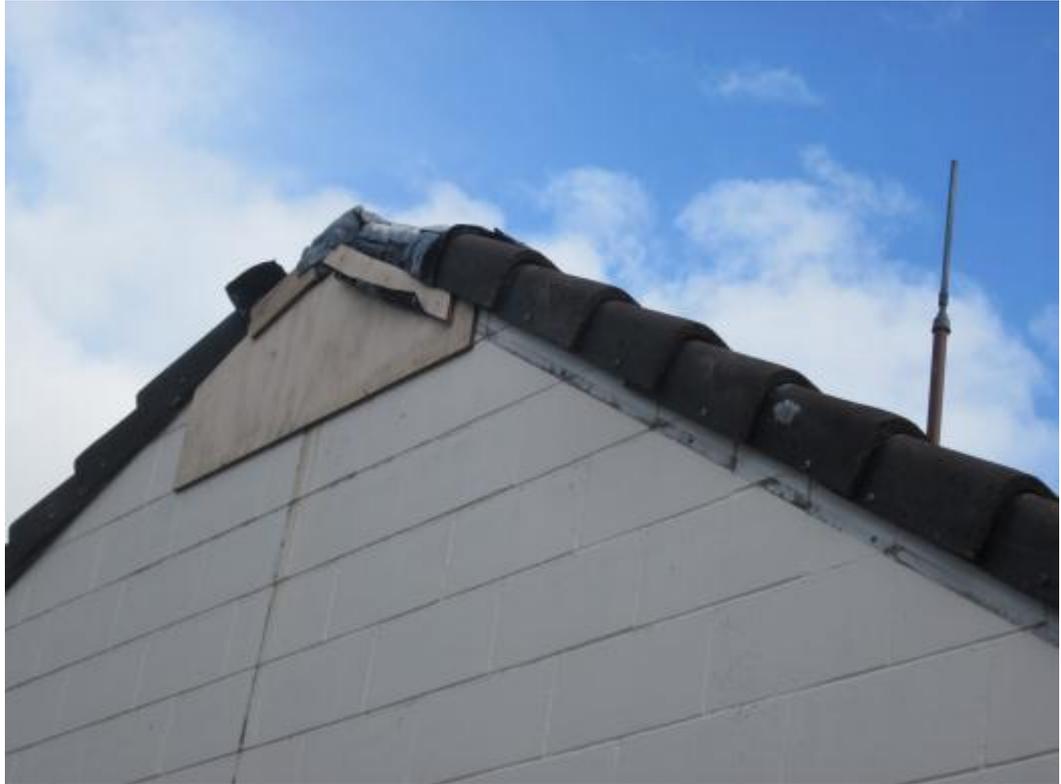
Photo 11 Cracks at apex tip of south gable wall.

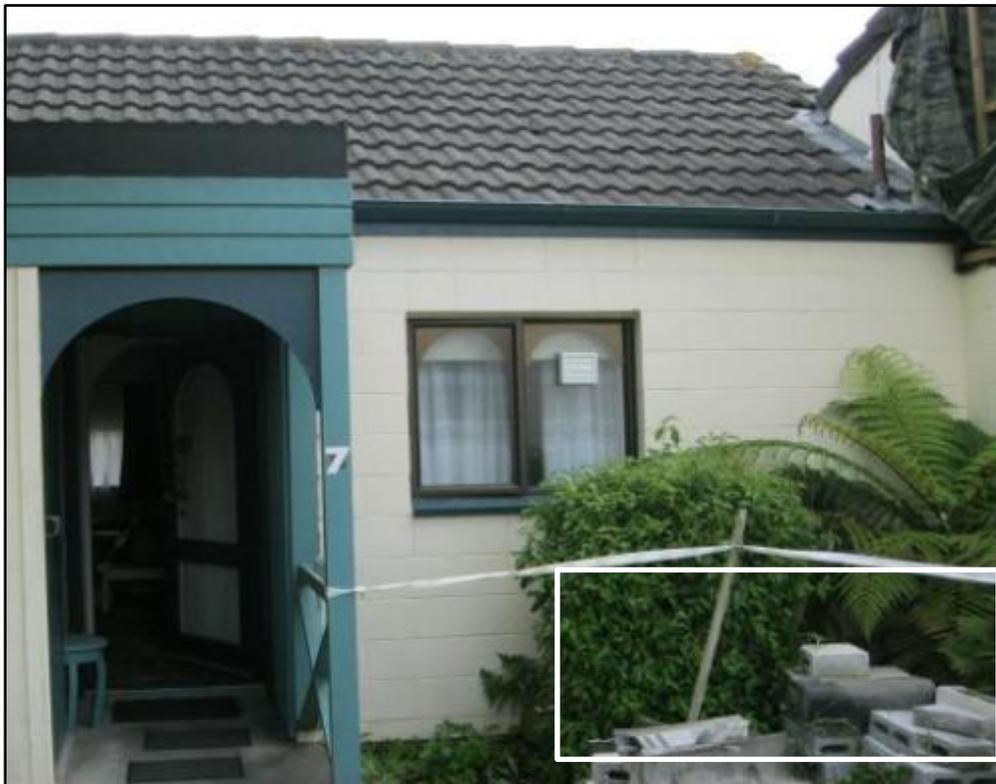
The masonry cladding appears to be unfilled or partially unfilled and unreinforced. This is visible in a collapsed gable end of block G, see (Photo 11). Where the gable has collapsed it is unfilled and unreinforced, this detail may also apply to the other masonry elements of the building. The archived construction drawings also appear to confirm the unreinforced nature of the masonry cladding. Each unit is also separated by a thicker 200mm wall of partially filled reinforced concrete bond beam style masonry construction, which continues above eave level to meet the roof.

Photo 12 Masonry blocks showing unreinforced gable of Block G, indicative of building style that may have been used in Block H.

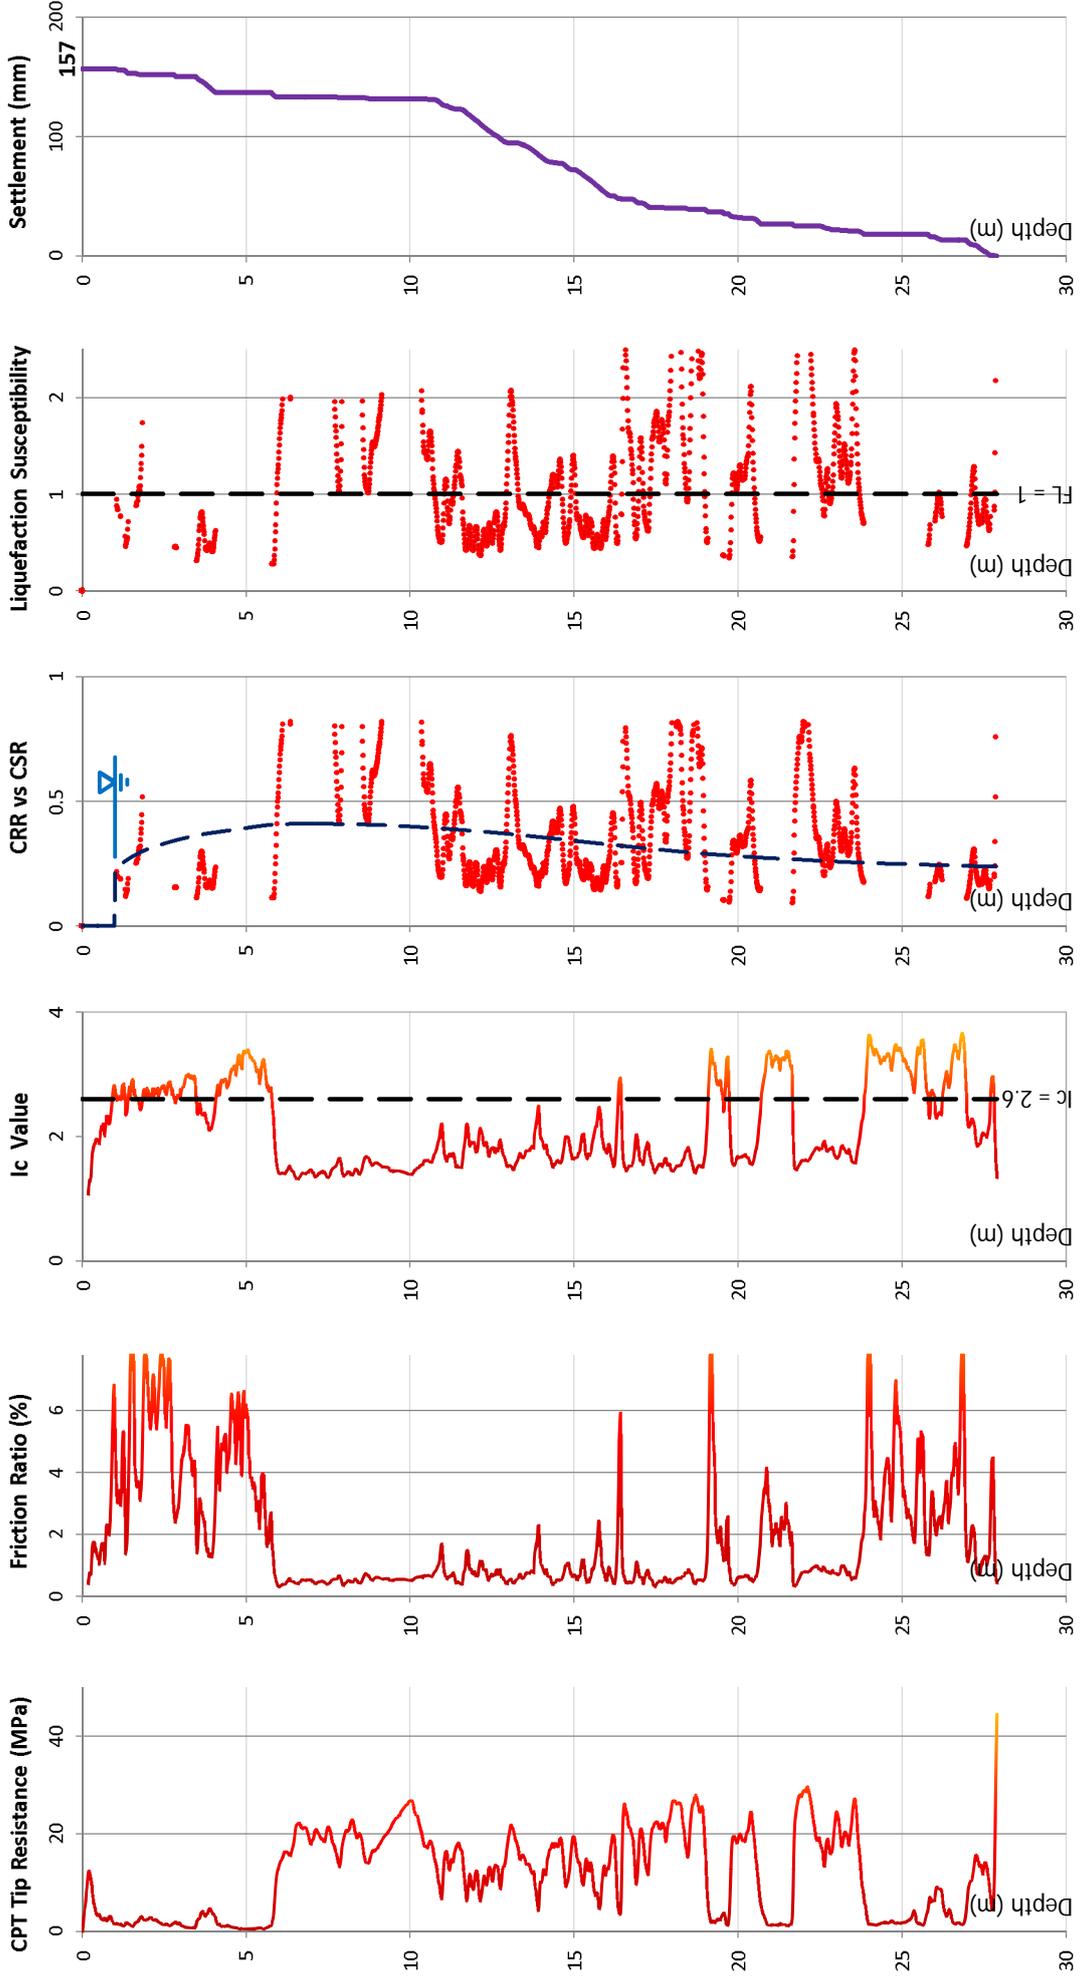
LOCATION : CPT 2  
 PROJECT : Haast Courts - 149 Stanmore Road  
 JOB NO : 51 30596 41  
 TEST DATE : 28 Jun 2012  
 SHEET : 2  
 CALCULATED : HNN  
 CHECKED BY :  
 DATE : 4 Jul 2012

Settlement estimates for the CPT points are between 150mm and 270mm for ULS conditions.

PGA ( $a_{max}$ ): 0.35 g  
 EQ Magnitude: 7.5  
 Groundwater Level (m bgl): 1.0  
 Atmospheric Pressure (kPa): 101  
 Bore depth (m): 27.89  
 Test data step (m): 0.01  
 Total Estimated Settlement (mm): **157**

- The soil class of **D** (in accordance with NZS 1170.5:2004) recommended in Section 8 of the Qualitative DEE/IEP is still believed to be appropriate; and,
- Any remedial works to foundations (or proposed new structures) be undertaken in accordance with DBH's guidelines for **TC3** land, due to the high levels of estimated settlement.
