Haast Courts-Block I - Garages 1-10 + 5A
BU 0792-009 EQ2
Detailed Engineering Evaluation
Quantitative Report
Version FINAL

43 Haast Street, Linwood

Christchurch City Council

Date
20th December 2012

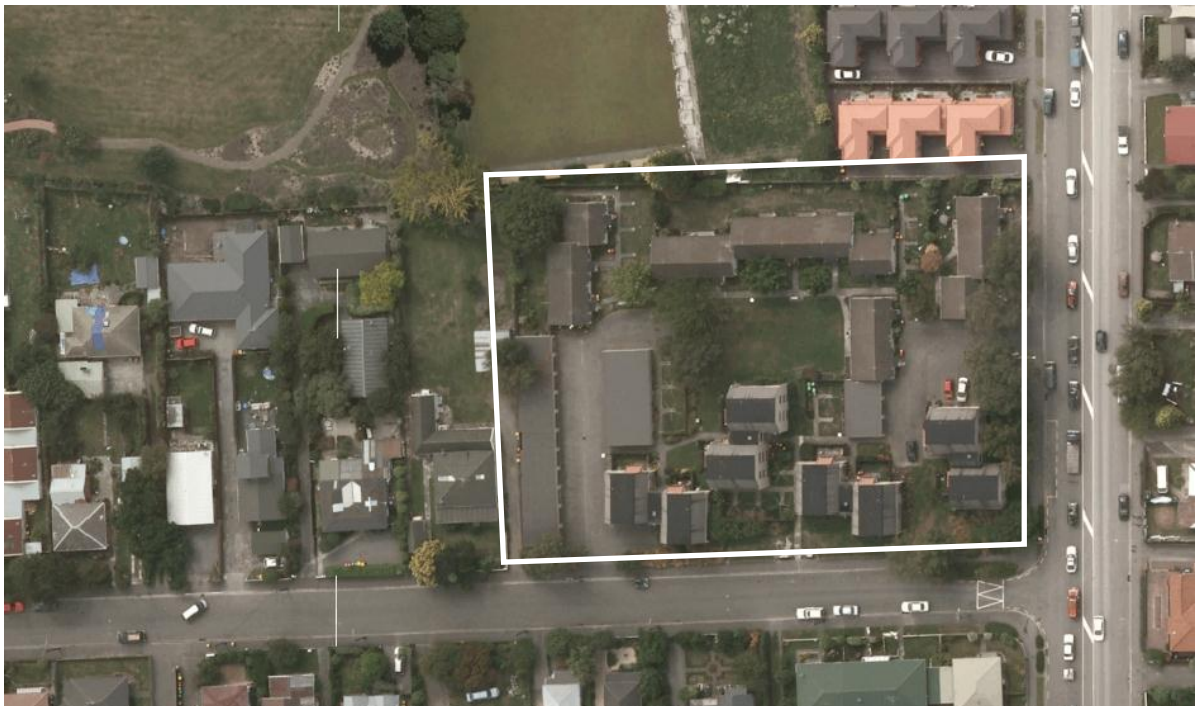
Figure 8.1 Post February 2011 Earthquake Aerial Photography³

Aerial photography taken following the 22 February 2011 earthquake shows no signs of liquefaction outside the building footprints or adjacent to the site, as shown in Figure 8.1.

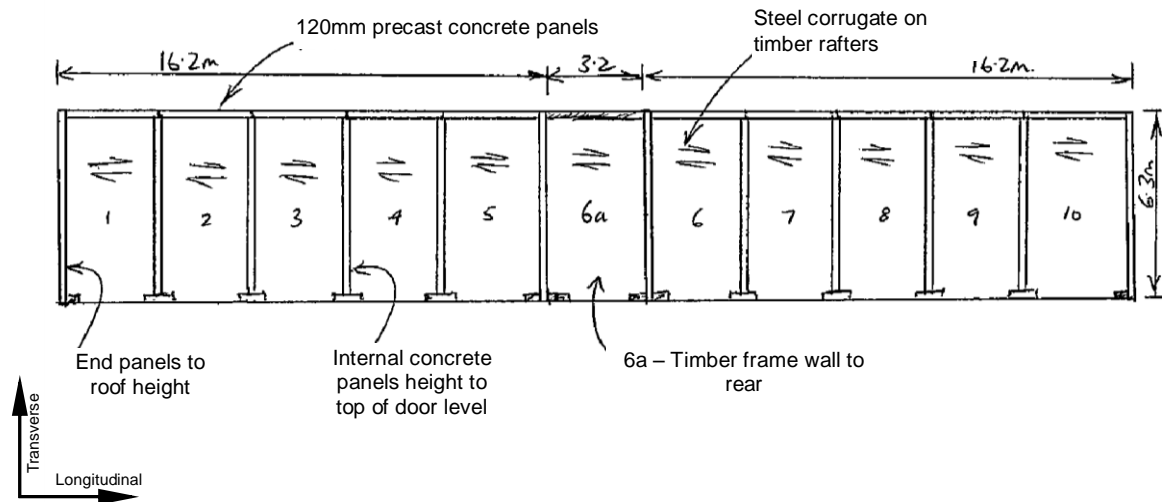
Figure 9.1 Layout of Structure.

The critical structural element was found to be the partition wall for loading in the longitudinal direction. This element was found to have a %NBS of 55% NBS. The undesirable support conditions for the partition walls, whereby no support above ground level on the entrance line is provided, is the reason for the poor performance of these elements.

All structural elements except the partition elements have been found to have a %NBS greater than 100%. The partition walls were found to have a %NBS of 55% given the minimal support provided to the elements.

Currently the partition walls achieve a %NBS of 55%. No further action is required under the building code, however given that the structure is Earthquake Risk, development of strengthening concepts is recommended.

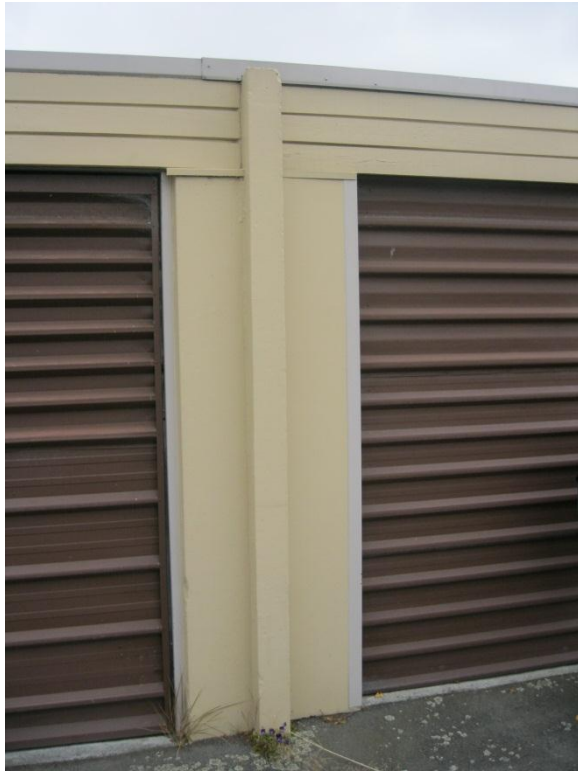
Photo 3. Minimal piers along garage door elevation.

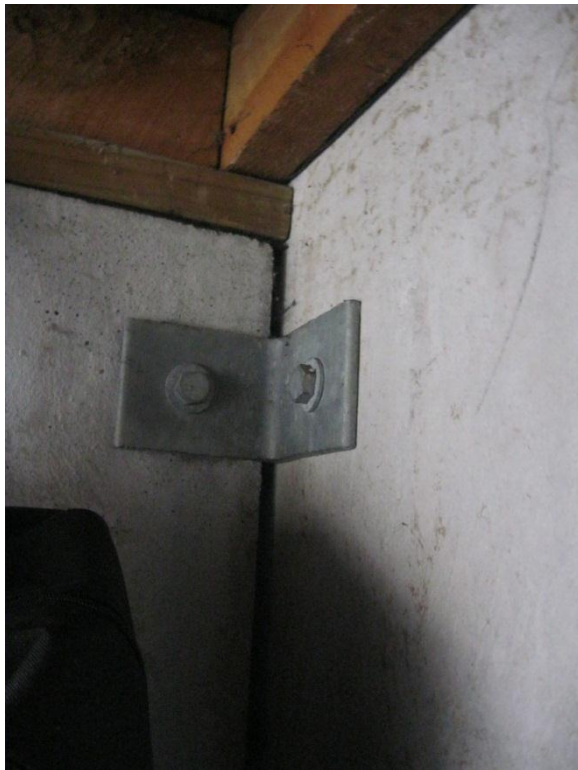
The connection of wall panels was checked. The expansion bolts used to connect the cleat angles to each wall was found to be the controlling capacity of the connection. The bolt connection was checked for both conditions of shear or tension.

Photo 4. Cleat connection between rear and partition walls.

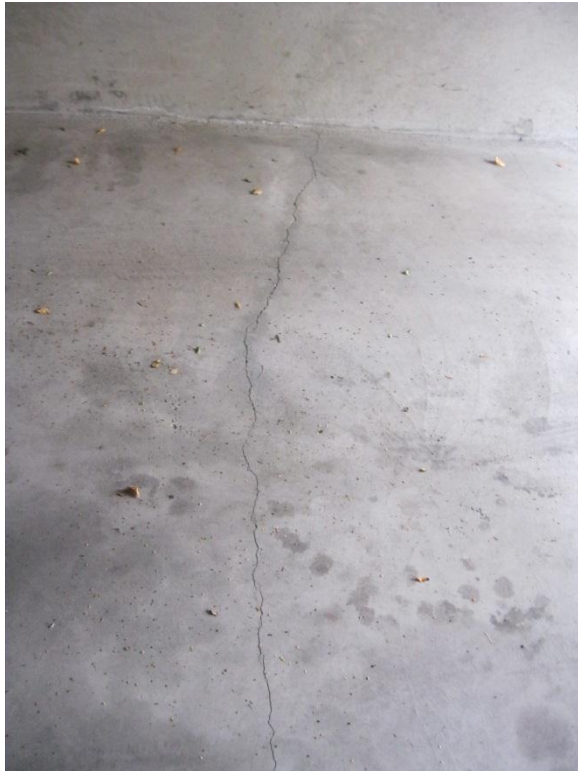
There were no residual displacements identified in the structure. Minor cracking was identified in the reinforced concrete floor slab and precast concrete wall panels, however it is unclear whether this damage is earthquake related. The cracking will not affect structural performance of the elements.

Photo 5. Minor cracking in reinforced concrete ground slab.
