Haast Courts-Block J - Garages 11 - 15
BU 0792-010 EQ2
Detailed Engineering Evaluation
Quantitative Report
Version FINAL

43 Haast Street, Linwood

Christchurch City Council

Date
20th December 2012

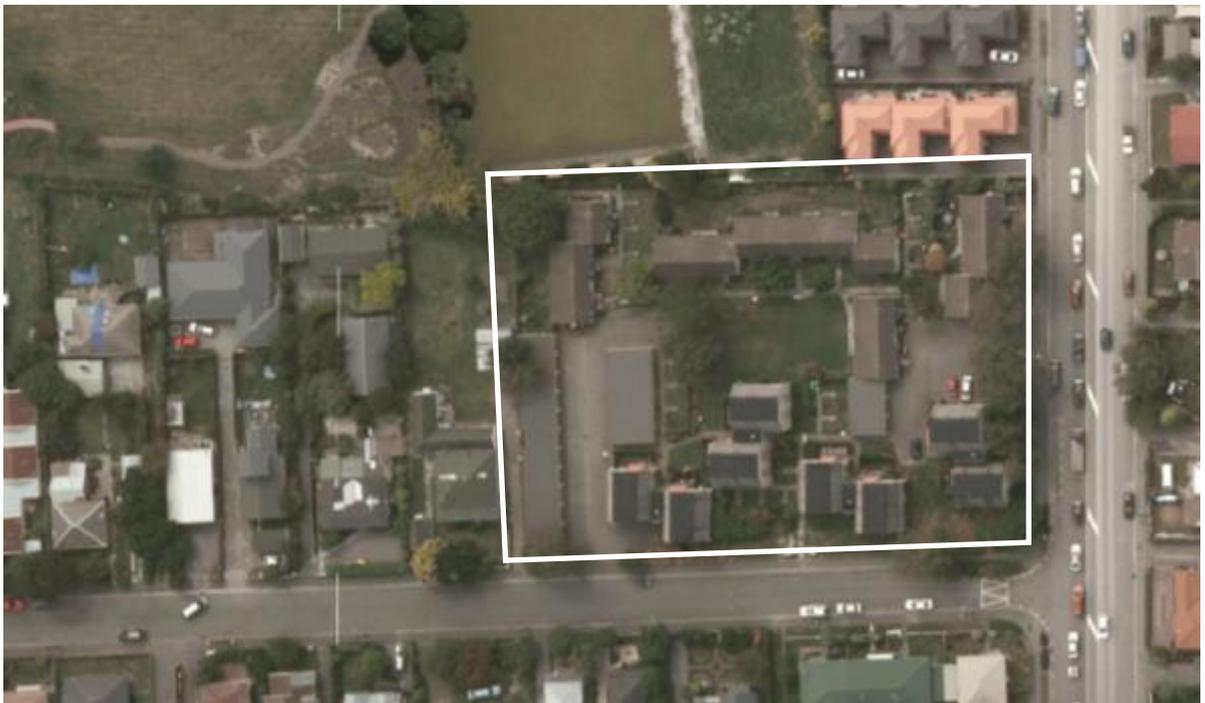
Figure 8.1 Post February 2011 Earthquake Aerial Photography³

Aerial photography taken following the 22 February 2011 earthquake shows no signs of liquefaction outside the building footprints or adjacent to the site, as shown in Figure 8.1.

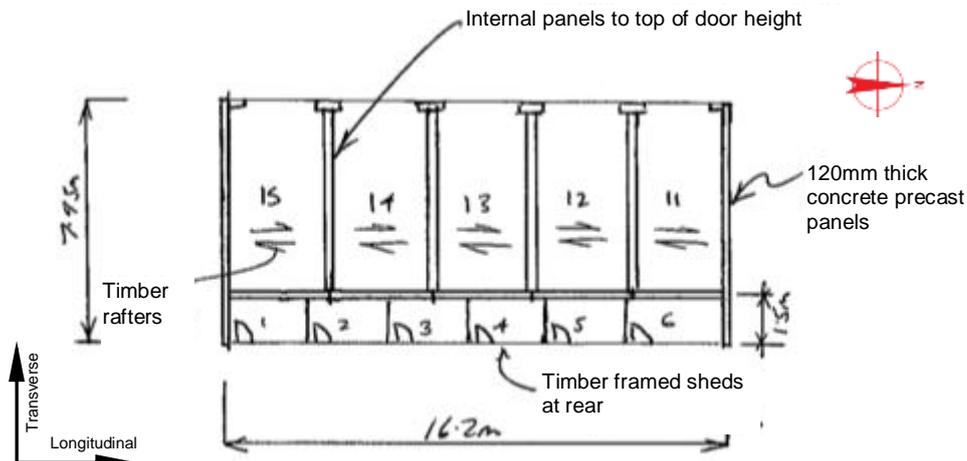
Figure 9.1 Layout of Structure.

The critical structural element was found to be the partition wall for loading in the longitudinal direction. This element was found to have a %NBS of 55% NBS. The undesirable support conditions for the partition walls, whereby no support above ground level on the entrance line is provided, is the reason for the poor performance of these elements.

All structural elements except the partition elements have been found to have a %NBS greater than 100%. The partition walls were found to have a %NBS of 55% given the minimal support provided to the elements.

Currently the partition walls achieve a %NBS of 55%. No further action is required to comply with the building code, however given that the building is earthquake risk, the development of strengthening concepts is recommended.

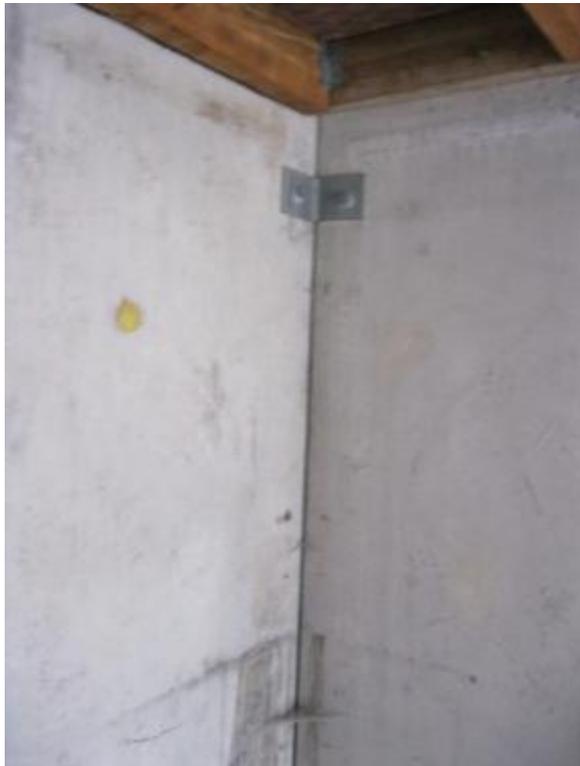
The connection of wall panels was checked. The expansion bolts used to connect the cleat angles to each wall was found to be the controlling capacity of the connection. The bolt connection was checked for both conditions of shear or tension.

Photo 4. Cleat connection between rear and partition walls.

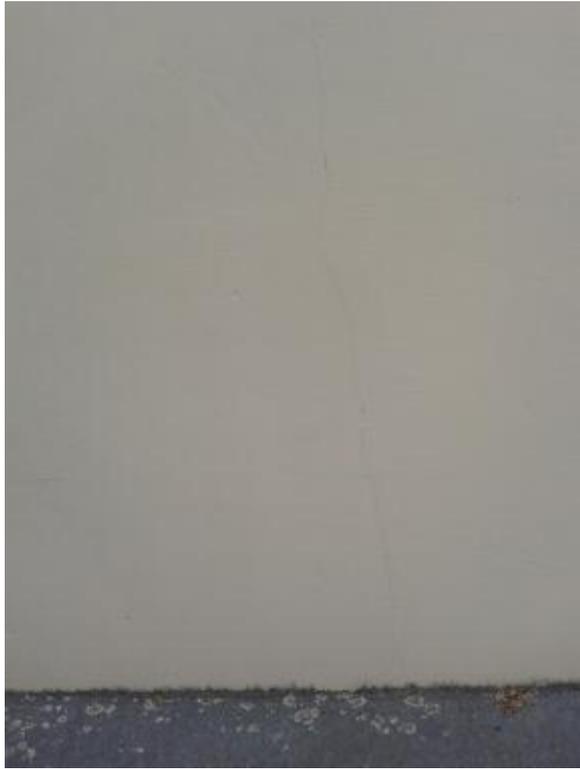
There were no residual displacements identified in the structure. Minor cracking was identified in the reinforced concrete floor slab and precast concrete wall panels, however it is unclear whether this damage is earthquake related. The cracking will not affect structural performance of the elements.

Photo 5. Hairline crack in the gable end wall.

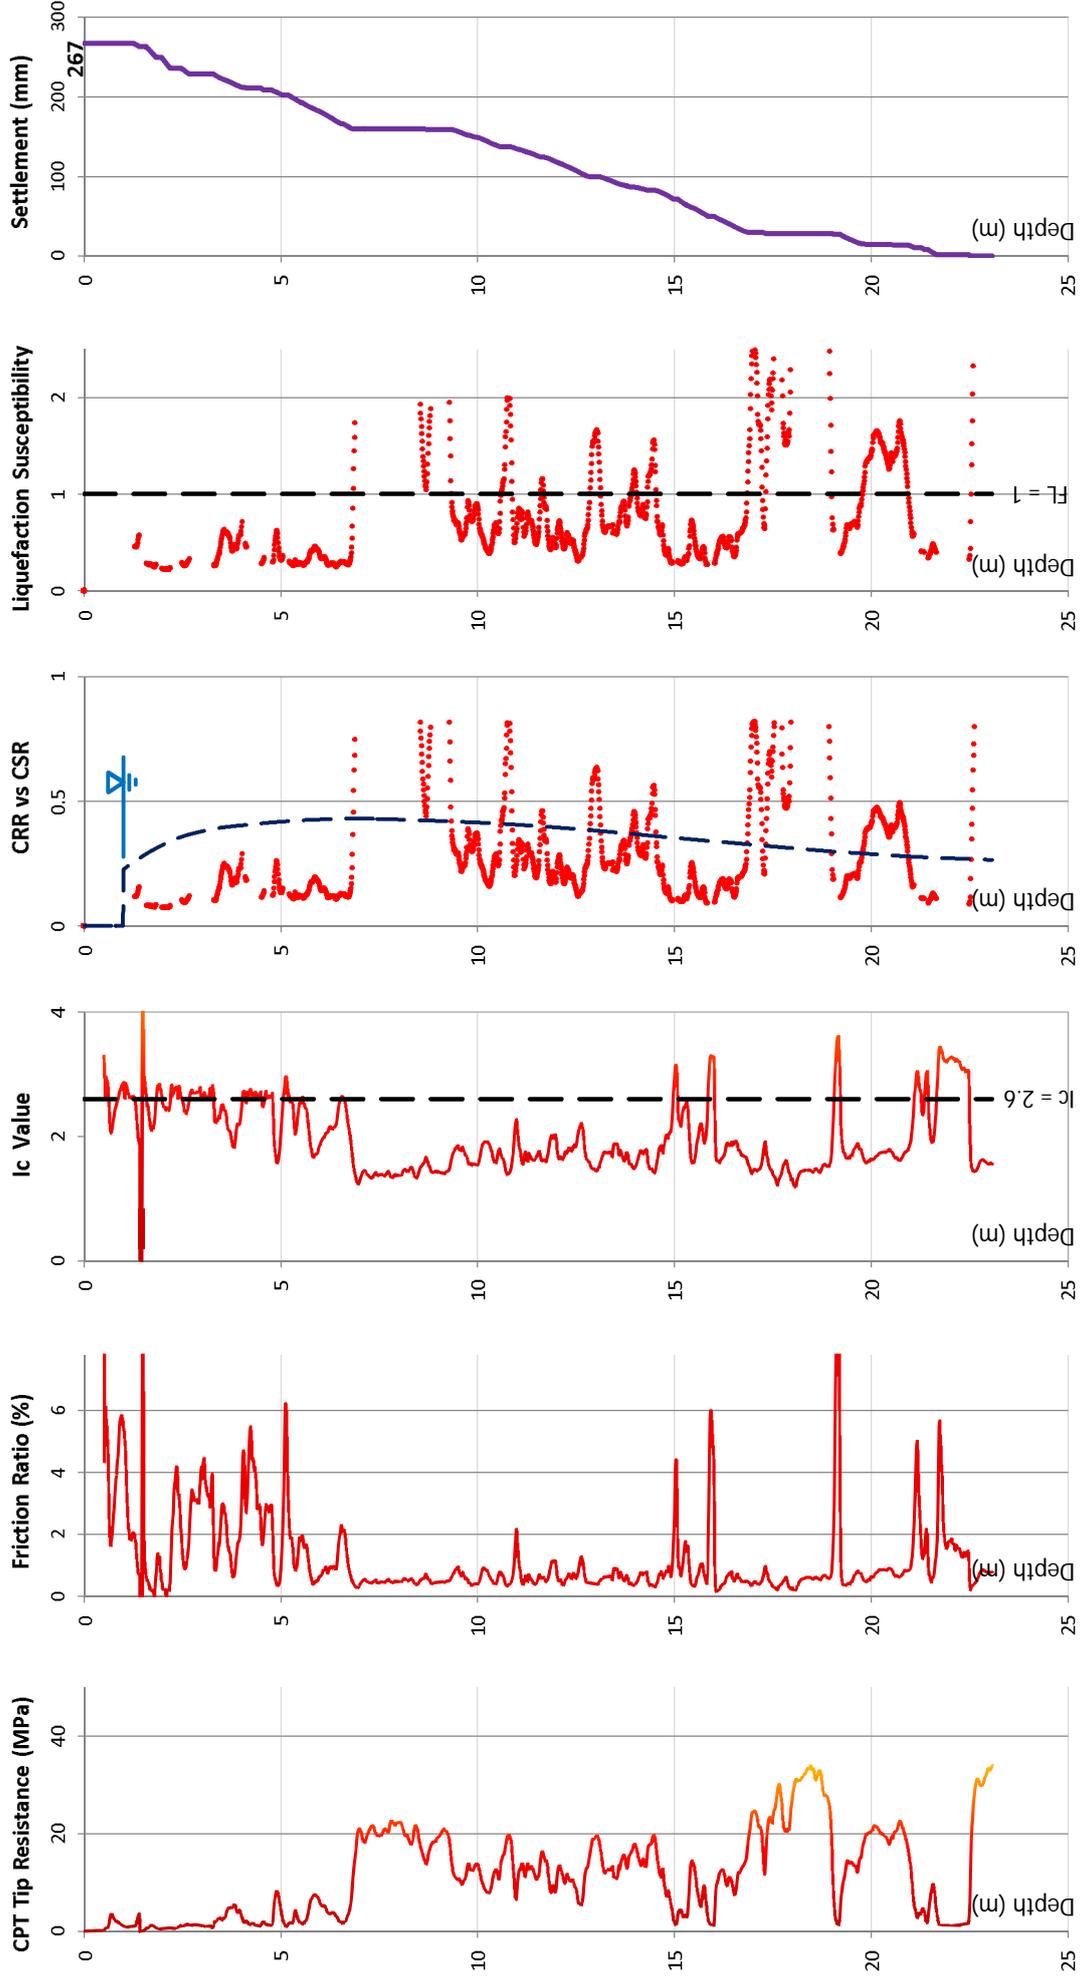
LOCATION : CPT 1
 PROJECT : Haast Courts - 149 Stanmore Road
 JOB NO : 51 30596 41
 TEST DATE : 28 Jun 2012
 SHEET : 1
 CALCULATED BY : HNN
 CHECKED BY :
 DATE : 4 Jul 2012

Settlement estimates for the CPT points are between 150mm and 270mm for ULS conditions.

PGA (a_{max}): 0.35 g
 EQ Magnitude: 7.5
 Groundwater Level (m bgl): 1.0
 Atmospheric Pressure (kPa): 101
 Bore depth (m): 23.07
 Test data step (m): 0.01
 Total Estimated Settlement (mm): **267**

- The soil class of **D** (in accordance with NZS 1170.5:2004) recommended in Section 8 of the Qualitative DEE/IEP is still believed to be appropriate; and,
- Any rebuilt foundations (or proposed new structures) be undertaken in accordance with DBH's guidelines for **TC3** land, due to the high levels of estimated settlement.

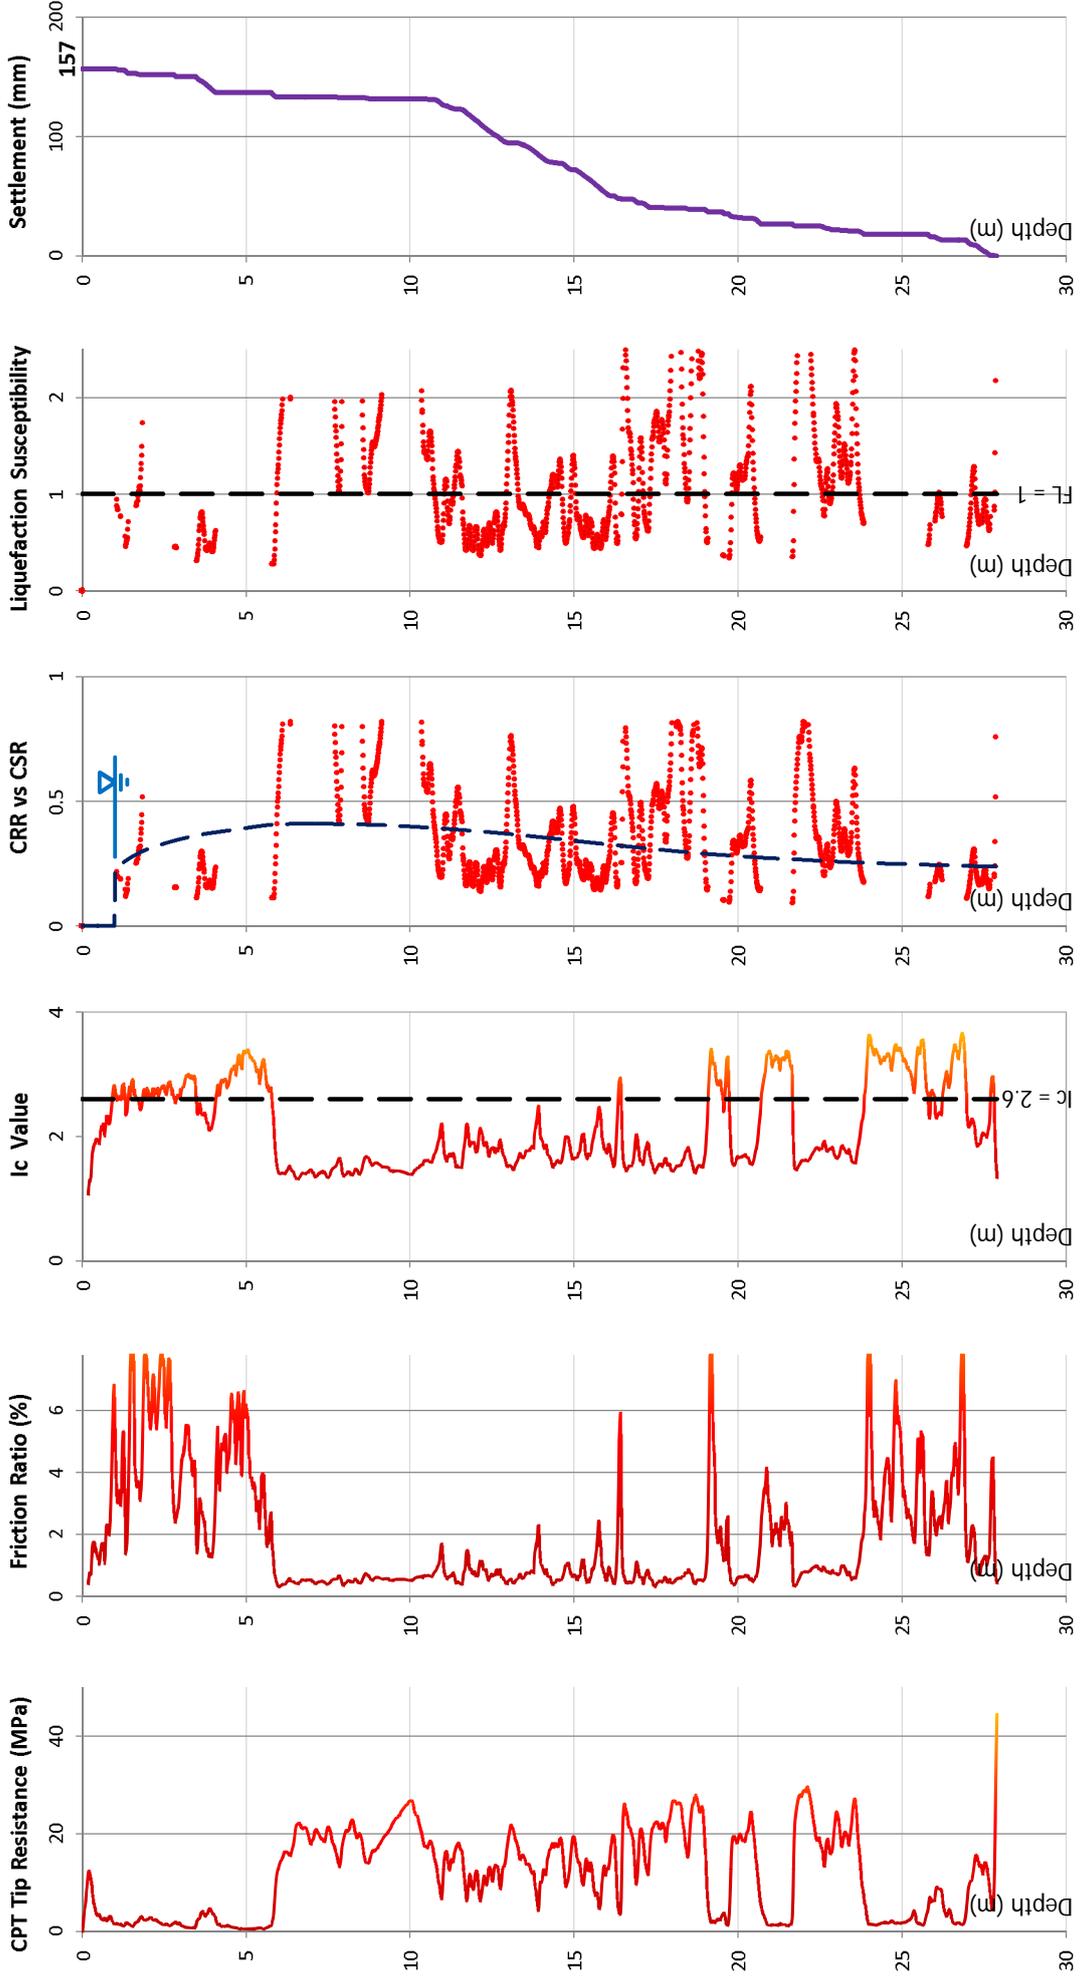
LOCATION : CPT 2
 PROJECT : Haast Courts - 149 Stanmore Road
 JOB NO : 51 30596 41
 TEST DATE : 28 Jun 2012
 SHEET : 2
 CALCULATED : HNN
 CHECKED BY :
 DATE : 4 Jul 2012

PGA (a_{max}): 0.35 g
 EQ Magnitude: 7.5
 Groundwater Level (m bgl): 1.0
 Atmospheric Pressure (kPa): 101
 Bore depth (m): 27.89
 Test data step (m): 0.01
 Total Estimated Settlement (mm): **157**
