Haast Courts-Block K - Garages 16 - 18
BU 0792-011 EQ2
Detailed Engineering Evaluation
Quantitative Report
Version FINAL

43 Haast Street, Linwood

Christchurch City Council

Date
20th December 2012

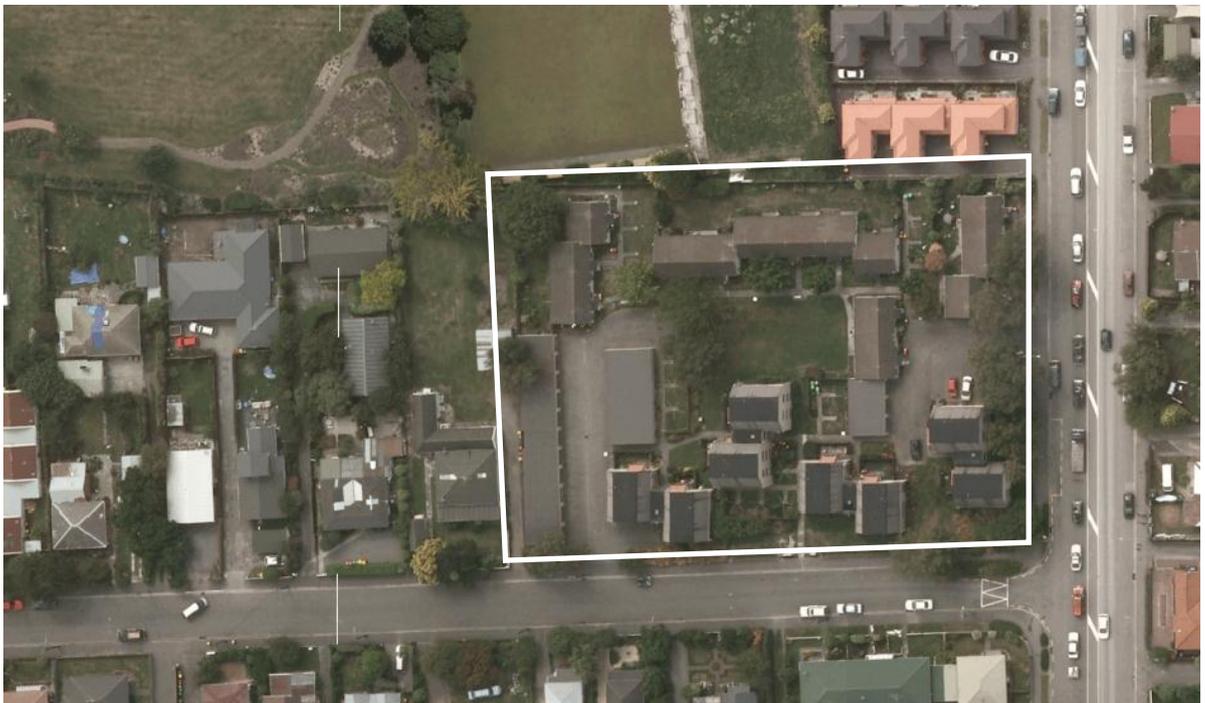
Figure 8.1 Post February 2011 Earthquake Aerial Photography³

Aerial photography taken following the 22 February 2011 earthquake shows no signs of liquefaction outside the building footprints or adjacent to the site, as shown in Figure 8.1.

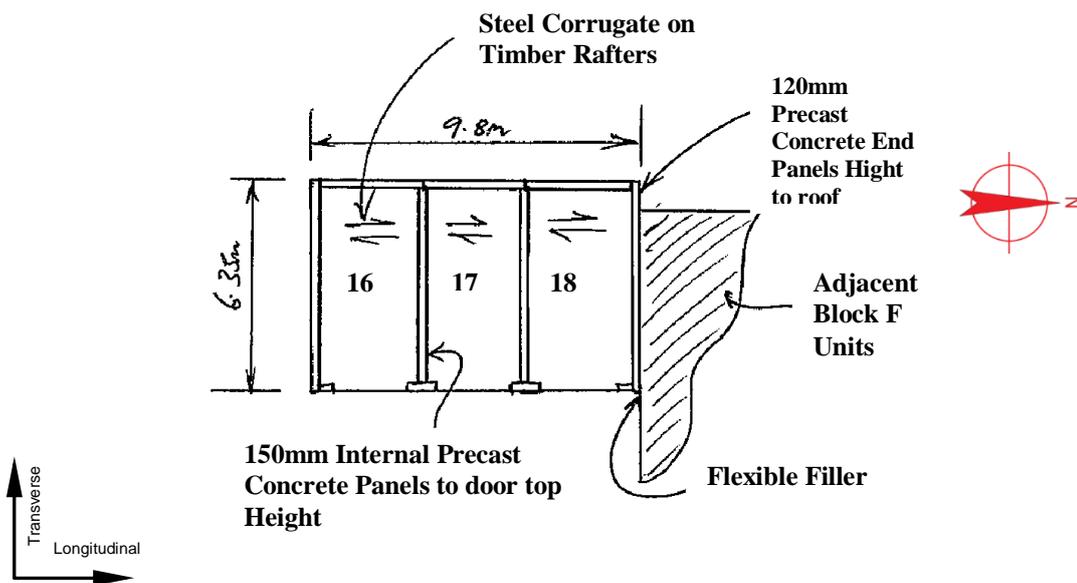
Figure 9.1 Layout of Structure.

The critical structural element was found to be the partition wall for loading in the longitudinal direction. This element was found to have a %NBS of 55% NBS. The undesirable support conditions for the partition walls, whereby no support above ground level on the entrance line is provided, is the reason for the poor performance of these elements.

All structural elements except the partition elements have been found to have a %NBS greater than 100%. The partition walls were found to have a %NBS of 55% given the minimal support provided to the elements.

Currently the partition walls achieve a %NBS of 55%. No further action is required under the building code, however given that the structure is Earthquake Risk, strengthening concepts are recommended.

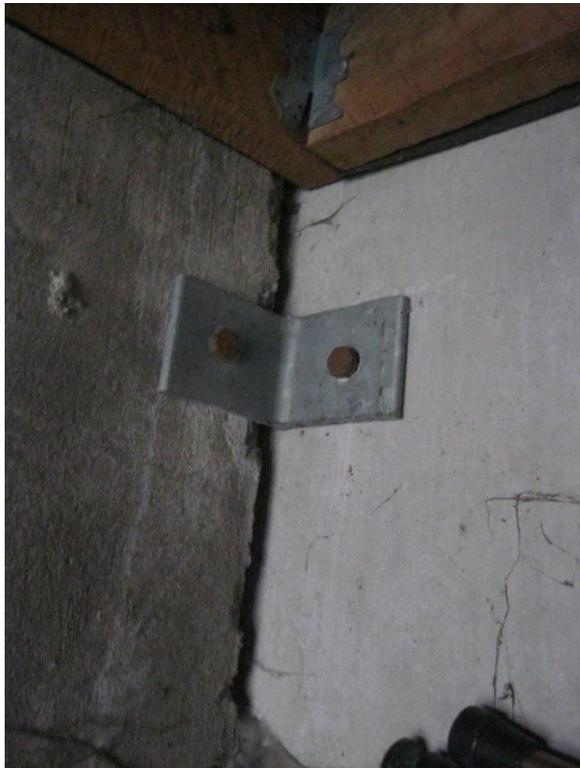
The connection of wall panels was checked. The expansion bolts used to connect the cleat angles to each wall was found to be the controlling capacity of the connection. The bolt connection was checked for both conditions of shear or tension.

Photo 4. Cleat connection between rear and partition walls.

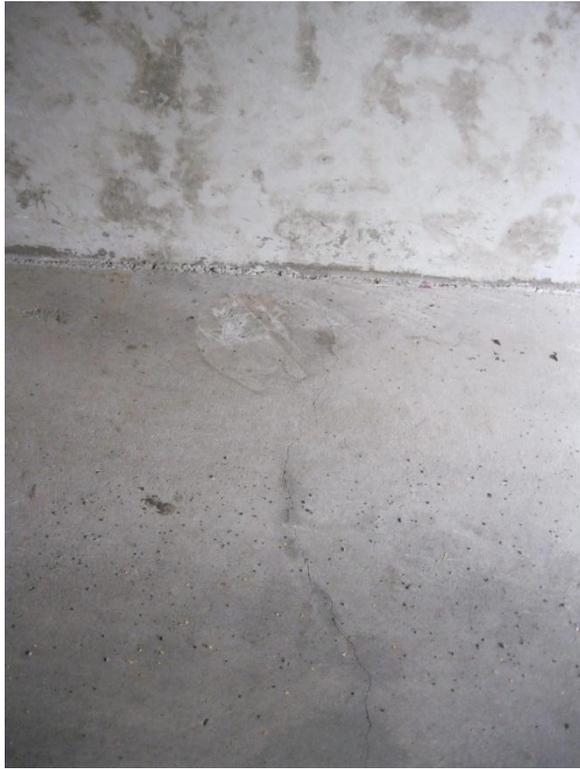
There were no residual displacements identified in the structure. Minor cracking was identified in the reinforced concrete floor slab and precast concrete wall panels, however it is unclear whether this damage is earthquake related. The cracking will not affect structural performance of the elements.

Photo 5. Minor cracking in reinforced concrete ground slab.

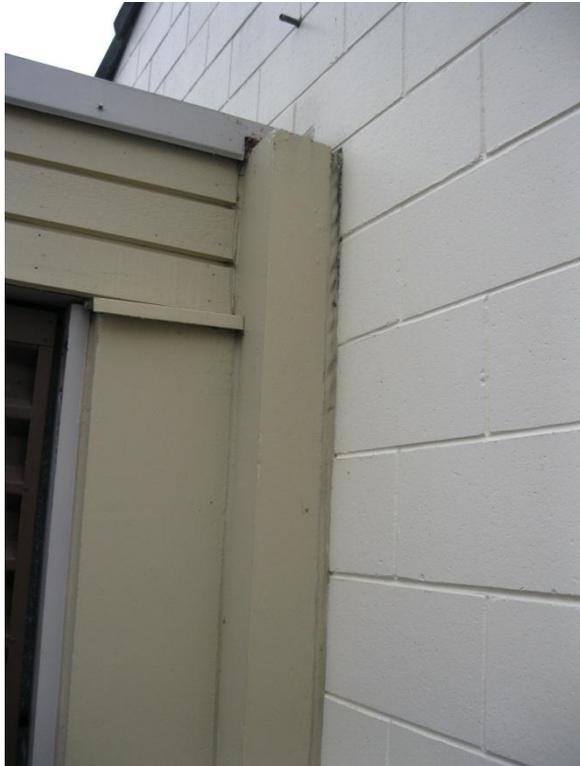
Photo 6. Flexible Filler between garage and gable wall of Block F.
