CHRISTCHURCH CITY COUNCIL  
PRK\_1190\_BLDG\_017 EQ2  
North Hagley 3 Bay Garage  
Hagley Park, Christchurch Central

QUALITATIVE ASSESSMENT REPORT  
FINAL

- Rev B
- 24 September 2013

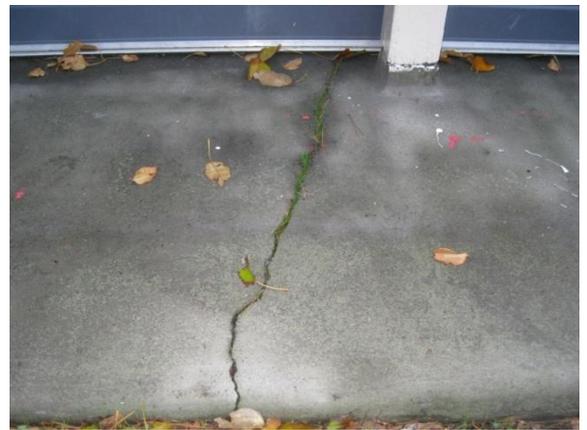
- 1) Horizontal hairline cracking of the paintwork on the rendered concrete block walls. This damage is non-structural, therefore a repair recommendation will not be provided.
- 2) Existing impact damage was noted on wall corners, but this is not earthquake-related damage.
- 3) Cracking of the concrete ground slab to the north of the building was noted (up to 10mm wide). This is believed to be due to gradual settlement as greater earthquake damage to the structure would be expected if the concrete ground slab had a 10mm wide crack as a result of earthquake damage (refer to Photo 10).

Photo 10: Cracking of concrete ground slab in front of entrance on north side.

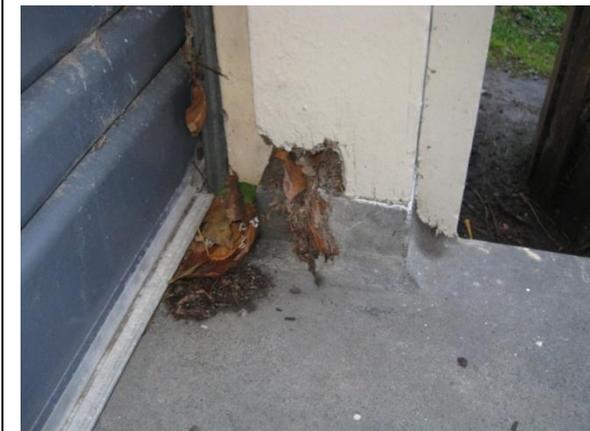
Photo 11: Existing impact damage to timber column embedded into concrete wall on north side.

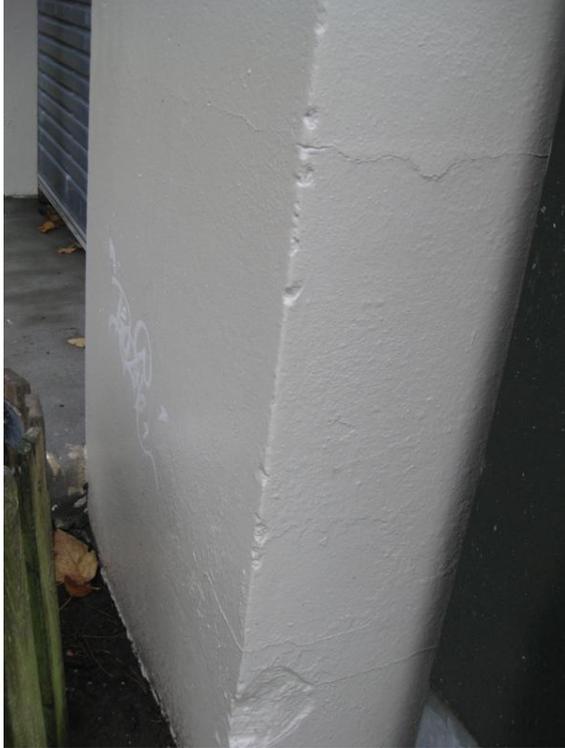
Photo 13: Hairline cracking in concrete wall on northwest corner (typical).

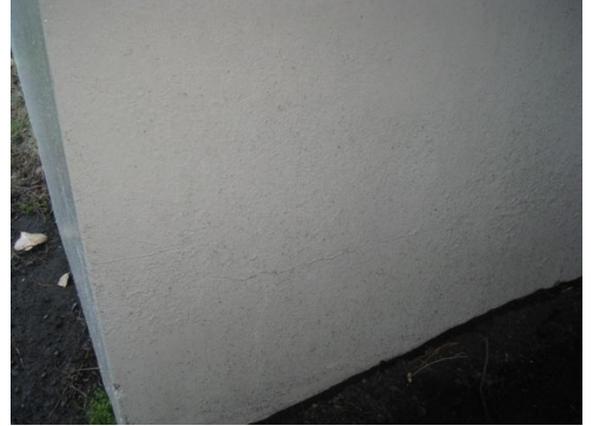
Photo 14: Hairline cracking in concrete wall on southwest corner (typical).

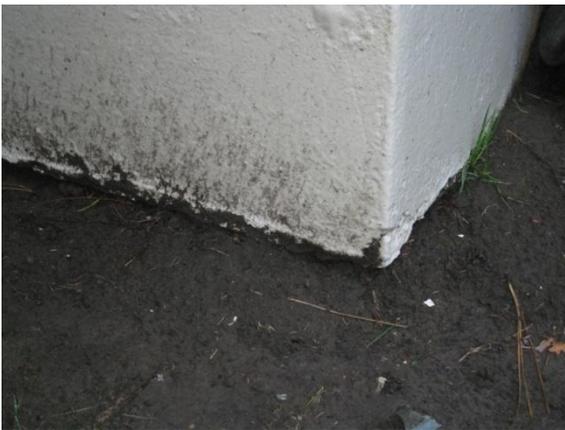
Photo 15: Underside of concrete footing exposed on northwest corner.

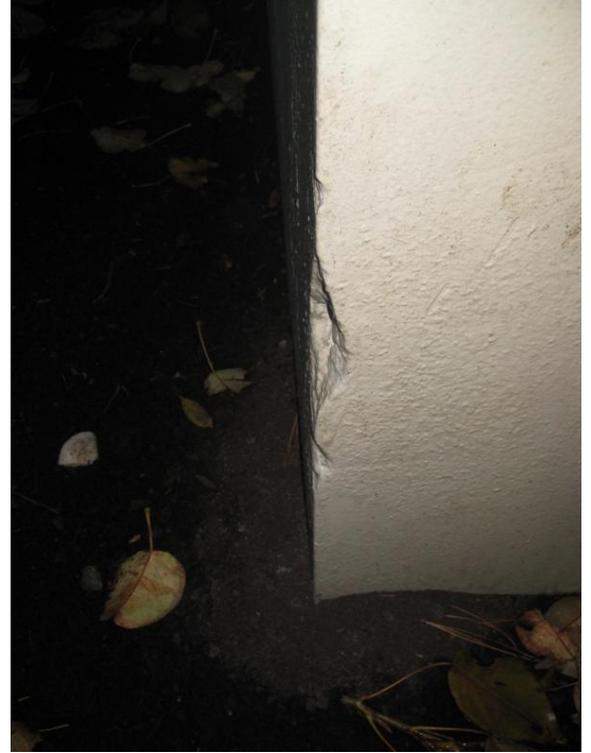
Photo 18: Existing impact damage on southeast corner (typical).

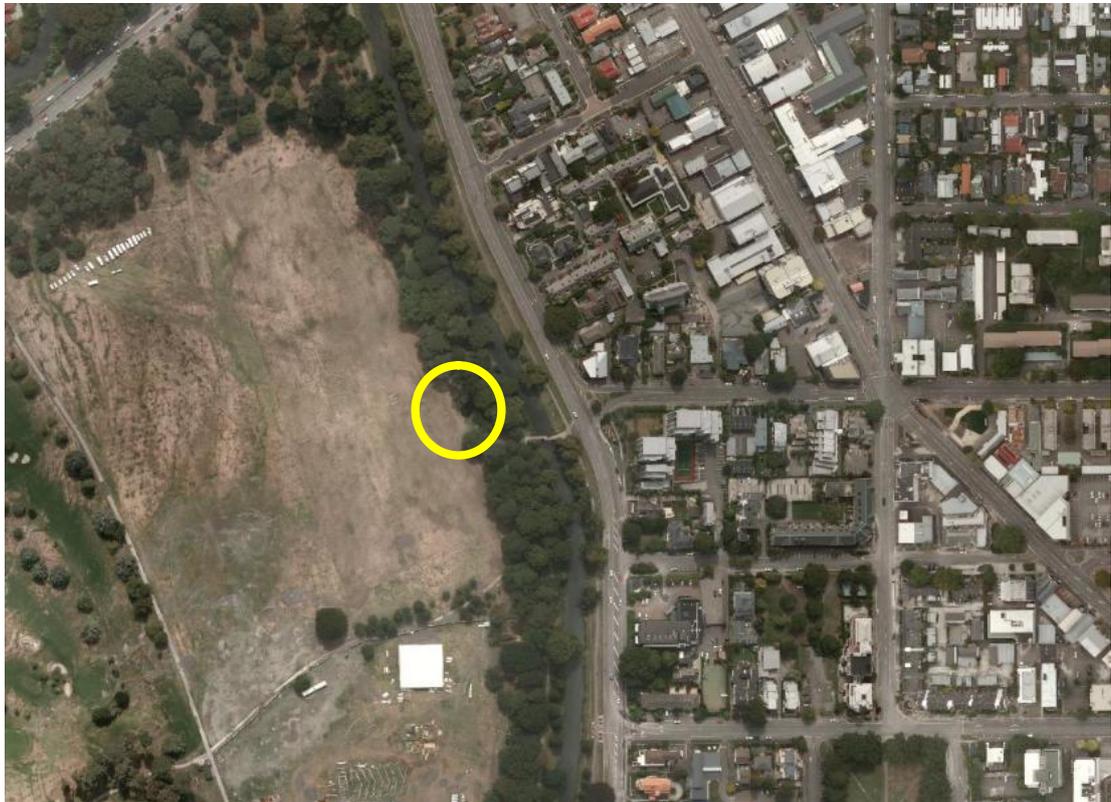
- **Figure 5 - Aerial photography from 24 Feb 2011 (<http://viewers.geospatial.govt.nz/>)**

Figure 5 above, shows no significant ejected material immediately around the site but eject material can be clearly seen approximately 100m away to the southwest and to the east of the structure.

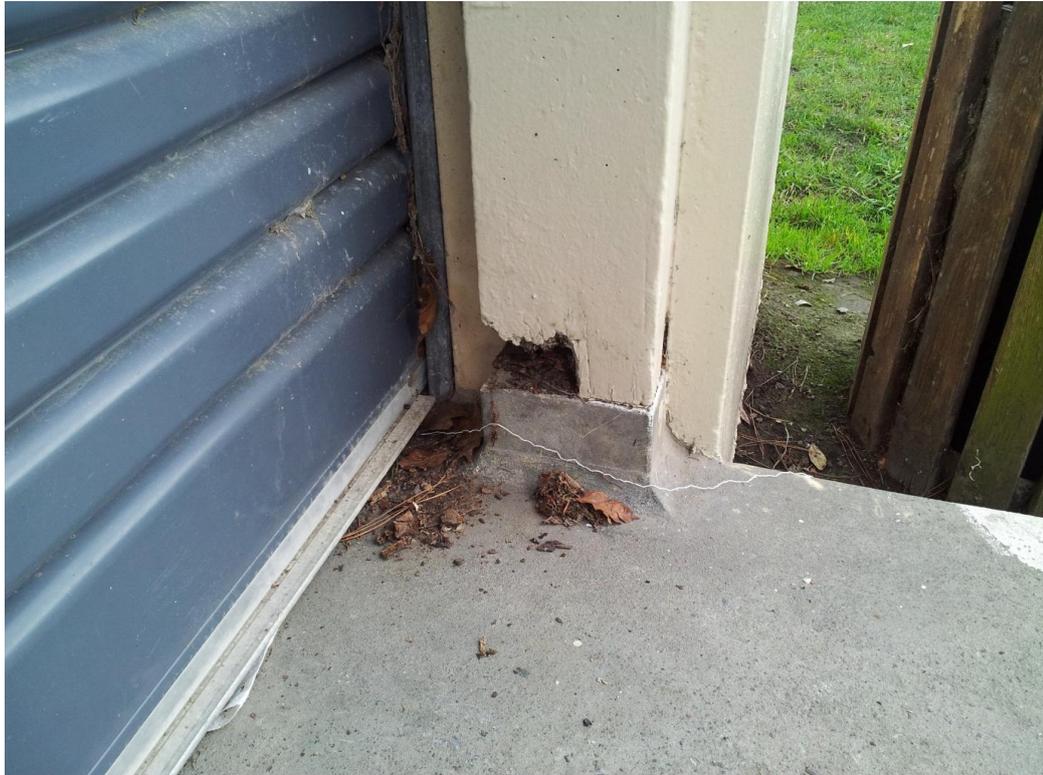
■ **Figure 8 Observed impact damage to timber column on the northern side**
