# **Hagley Park North Pavilion**

**North Hagley Park, Christchurch**

## **Detailed Engineering Evaluation**

### **Quantitative Assessment Report**

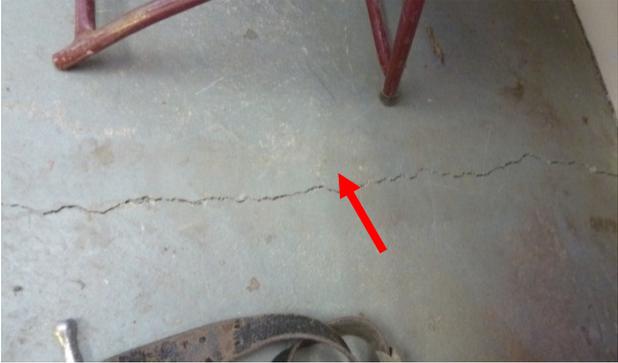
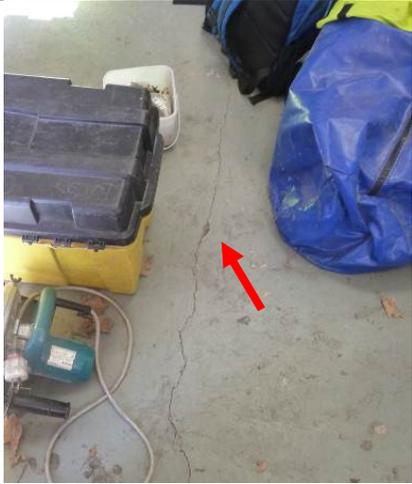
Cracking up to 3mm wide is observed to the internal ground bearing slab at several locations. The cracking tends to be in the transverse direction which suggests that they could be originally due to shrinkage but aggravated by the earthquake shaking. See Photo 2 in Appendix 1.

2.	Cracking to ground bearing slab at several locations

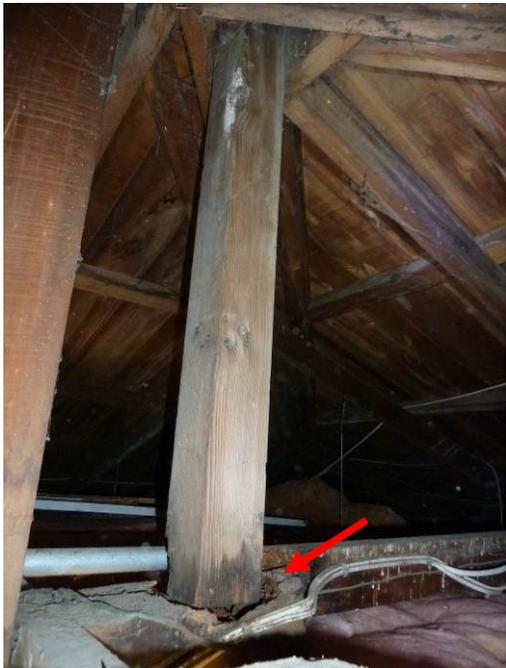
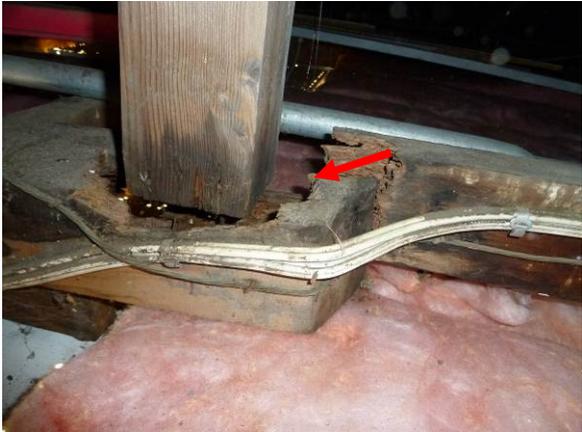
There does not appear to be any earthquake damage to the roof framing. However, it is observed that the base of the timber post near the west end of the hipped roof appears to have rotted due to water leakage from the roofing. The post's supporting beam is also severely damaged and does not appear to bear any roof load.

The current roof load is likely to be redistributed to other primary and secondary support members. There is also electrical cable running adjacent to the water damaged area. See Photo 3 in Appendix 1.

<p>3.</p>	<p>Damage to roof timber post and beam due to water leakage</p>

- d) Pre-earthquake damage within the roof timber framing needs to be re-assessed. In particular, the rotted timber post and beam and the repair made to the bottom chord of the truss should be assessed by a structural engineer.

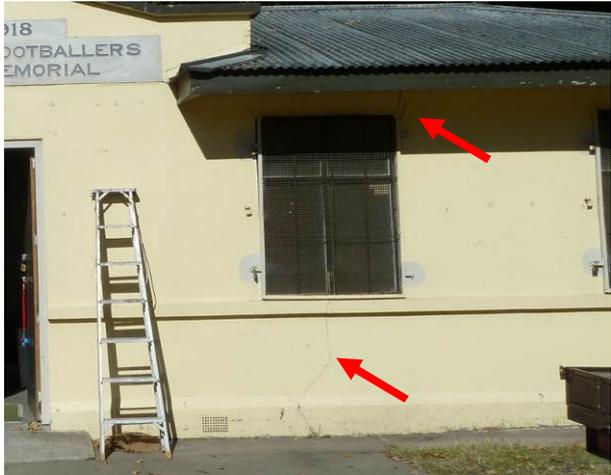
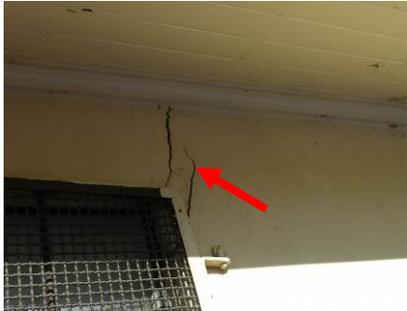
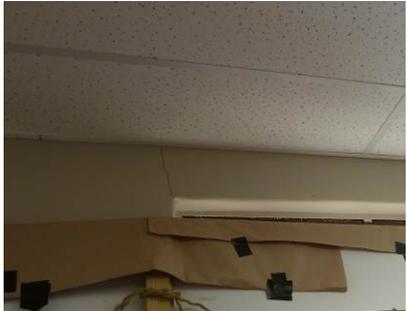
There are minor diagonal cracks of up to 1mm wide which appear mostly at the top corners of window and door openings. However, there is a moderate crack of up to 5mm wide which extends diagonally from the top corner of the window to the west of the front entrance. The crack appears on both sides of the wall creating a weather gap. See Photo 4 in Appendix 1.

<p>4.</p>	<p>Diagonal cracking to window opening west of front entrance</p>          <p>Crack appears to both sides of wall</p>

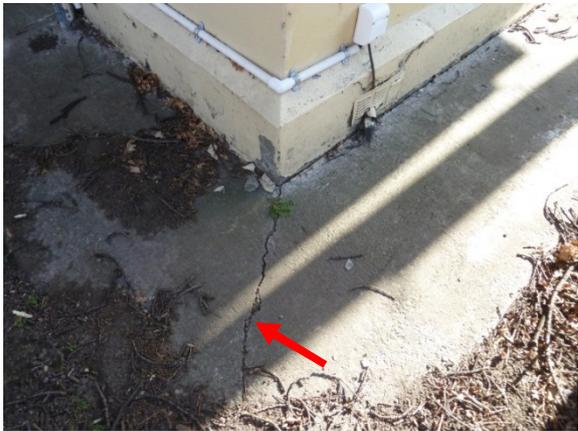
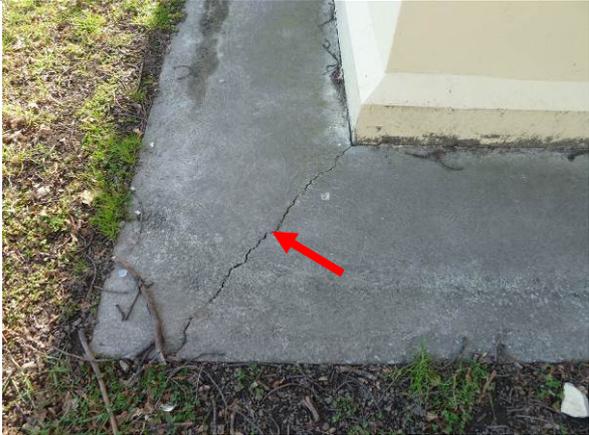
The external perimeter ground bearing concrete apron slab appears to have cracked at several locations especially at the corners. There is also minor separation of the apron from the perimeter RC wall. See Photo 5 in Appendix 1.

<p>5.</p>	<p>Cracking to perimeter concrete apron</p>

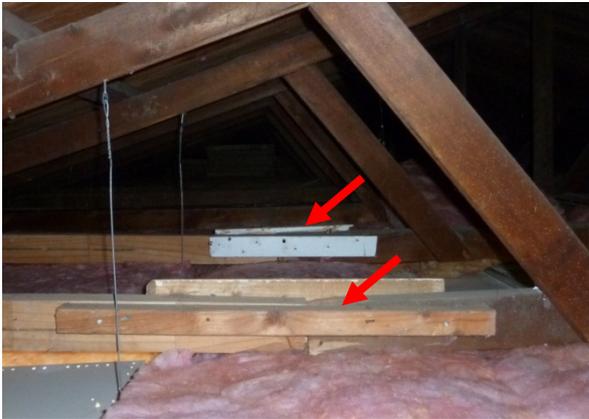
There had been some repairs made to the roof timber framing prior to the Canterbury earthquake. It is noted that some of the repairs do not appear to be engineered solutions and will need to be reviewed, in particular the joining of bottom chords of the roof framing. See Photo 6 in Appendix 1.

6.	Pre-earthquake nominal repairs to bottom chords of roof trusses

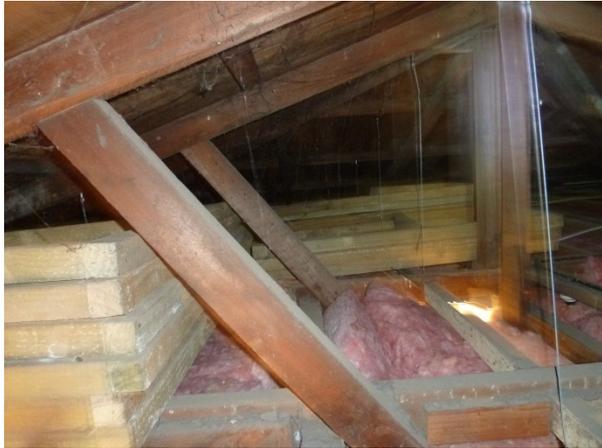
There are also stacks of prefabricated timber frames stored within the roof space at the northeast corner of the ceiling. See Photo 7 in Appendix 1. The roof truss is unlikely to be designed to support such heavy loading. There is also a risk of the timber frames becoming fall hazard in the event of strong earthquake shaking.

7.	Prefabricated timber frames stored within roof space

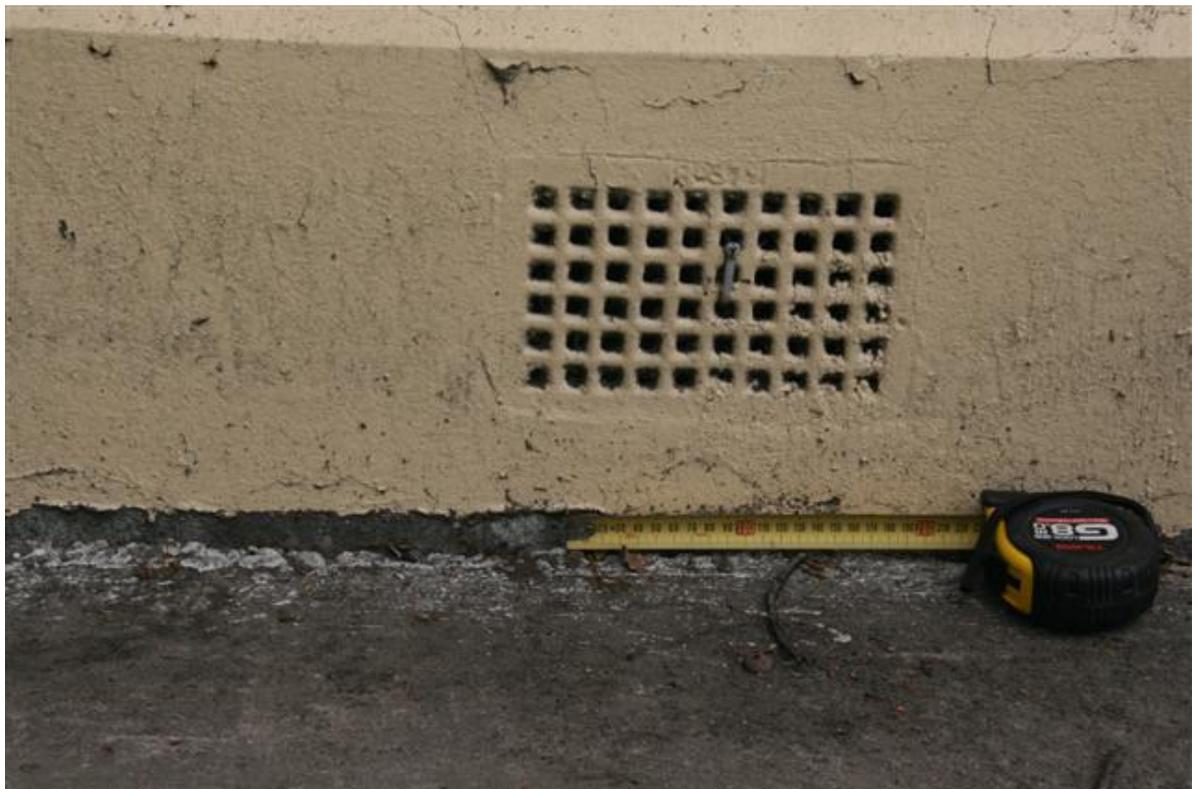
**Photo 2: The concrete footpath on the east elevation has settled approximately 20mm.**

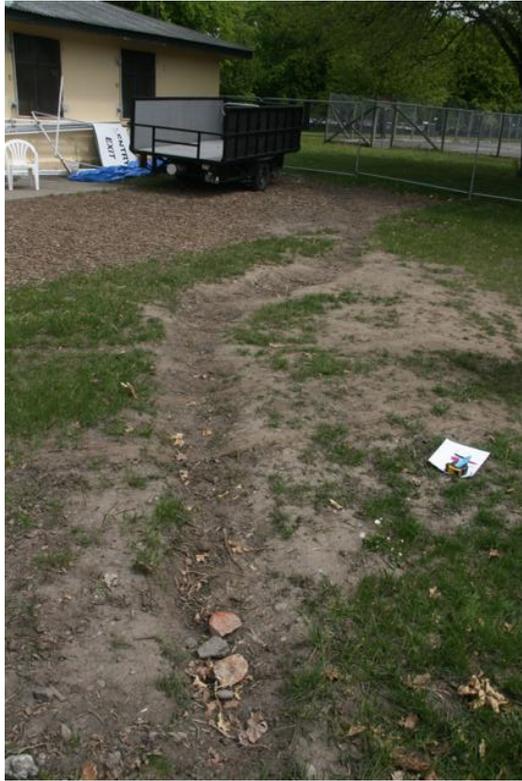
**Photo 3: The ground surrounding the water pipe has settled by approximately 50mm.**

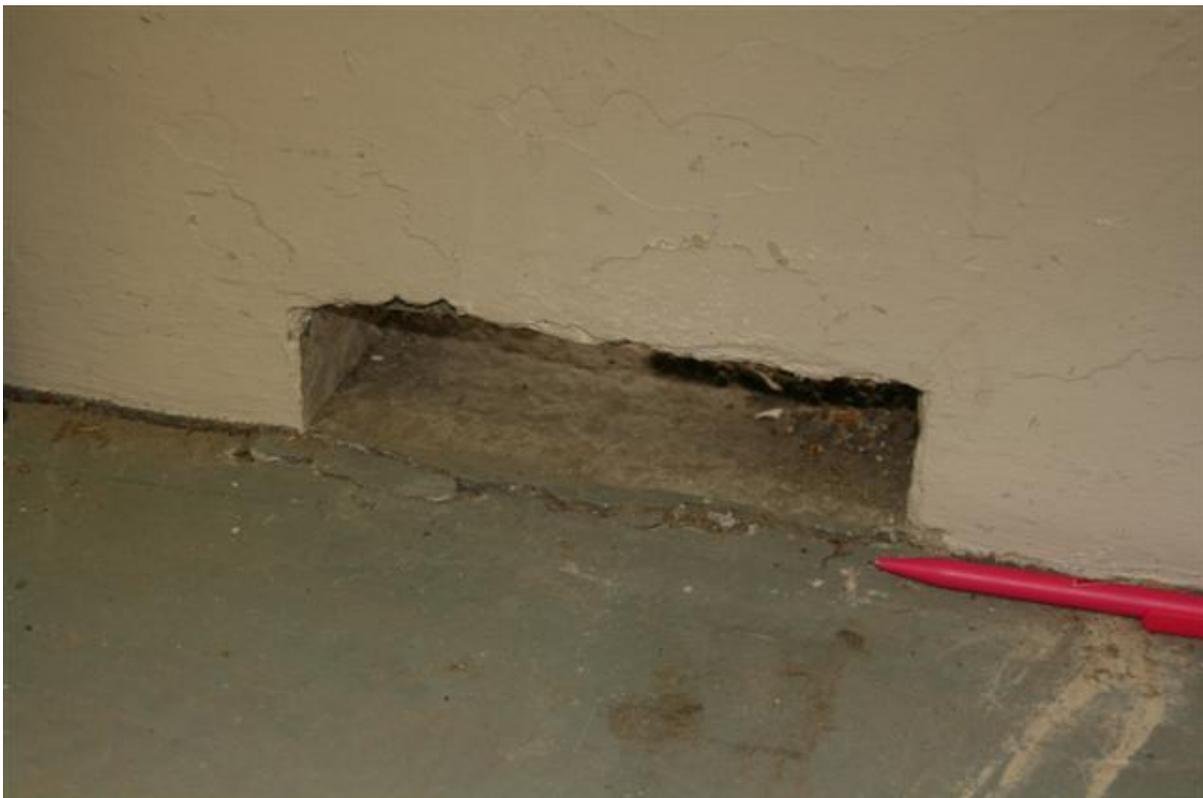
**Photo 4 : The floor slab has settled approximately 5mm.**

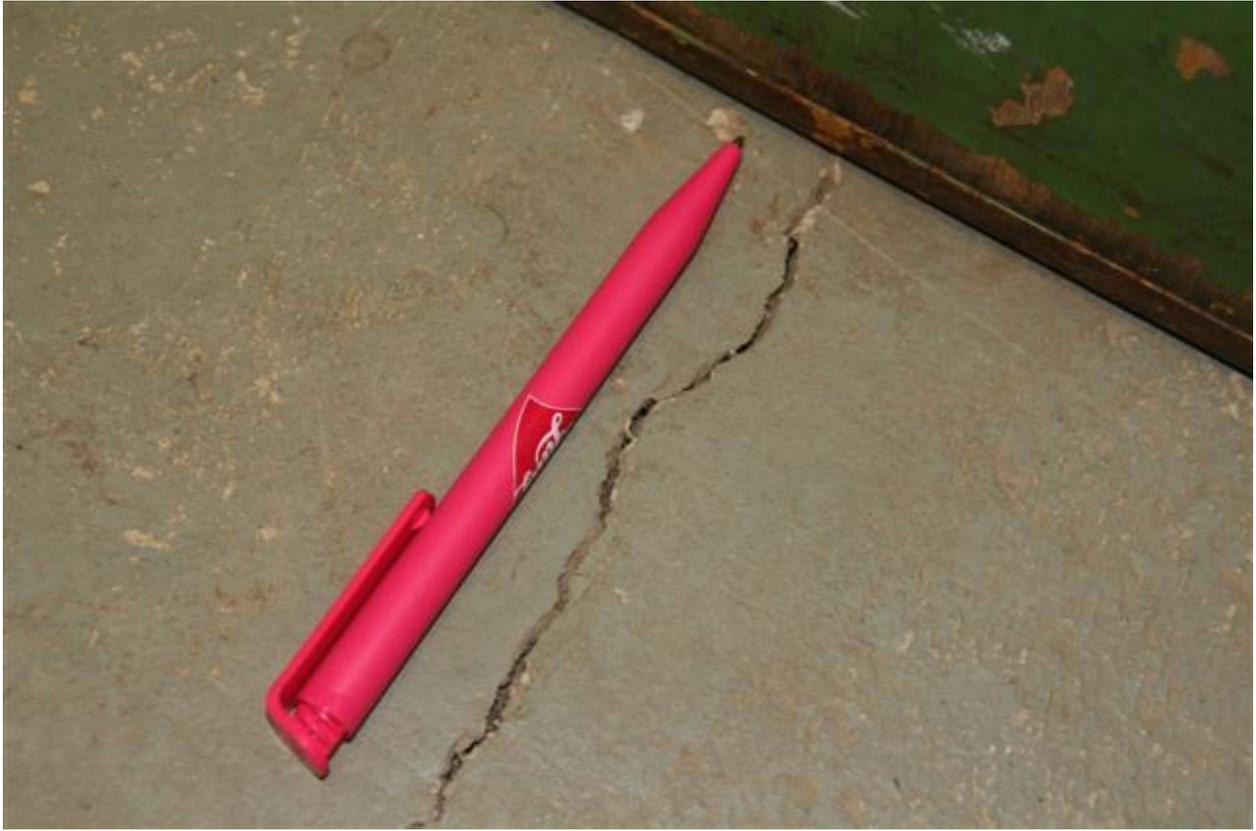
**Photo 5: Internal floor crack that is approximately 2mm wide.**
