**Hagley Park South Garage
and Soil Shed**

PRK 1507 BLDG 005 EQ2

Detailed Engineering Evaluation

Quantitative Assessment Report

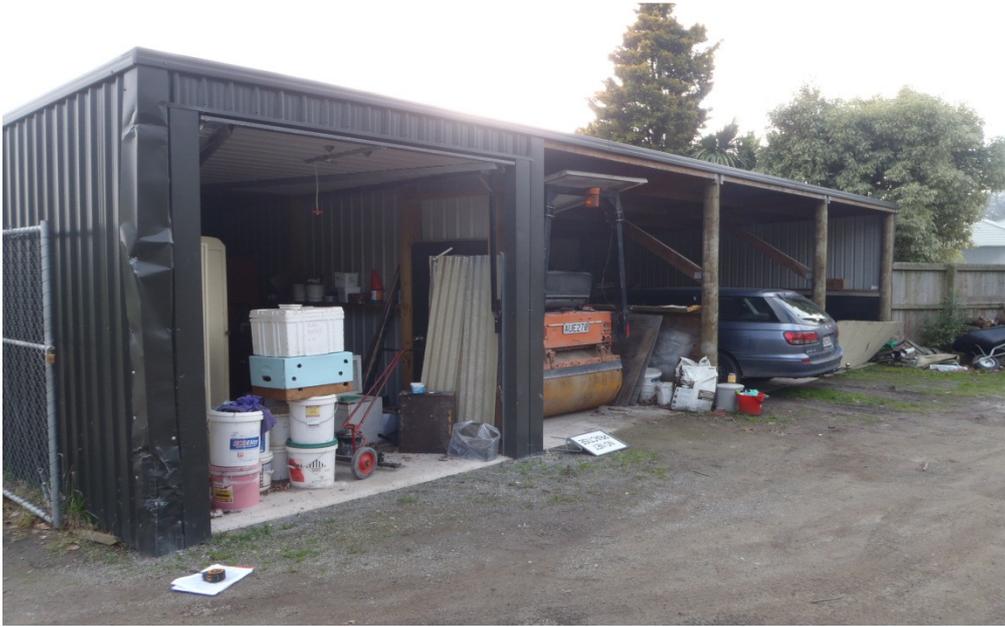
Photo 1: Front View of Building

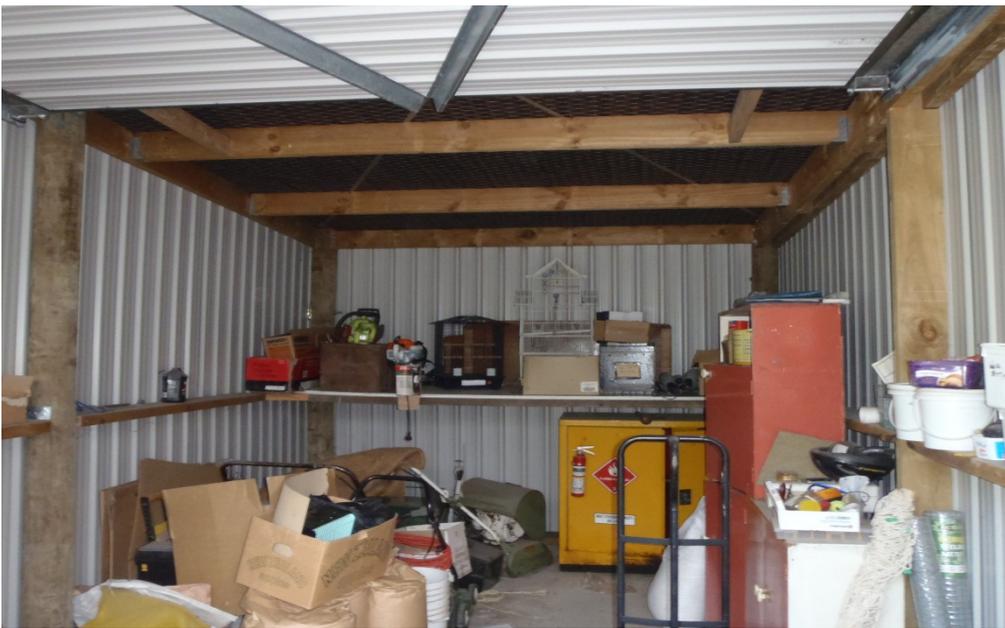
Photo 2: View of Soil Shed Area

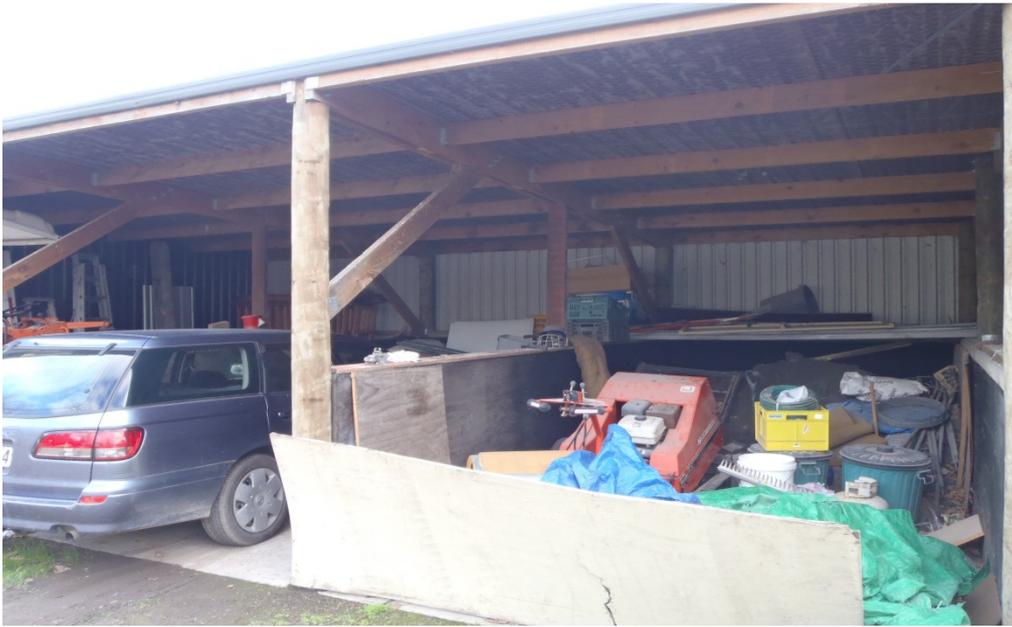
Photo 3: View of Garage Area

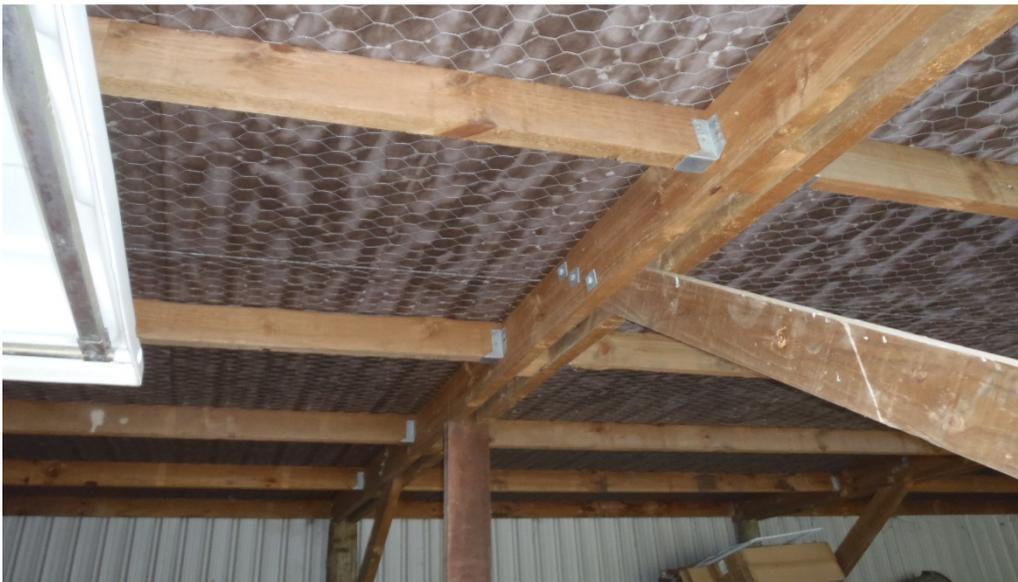
Photo 4: View of Roof Detail
