# Halswell Aquatic Centre, Main Building Complex Detailed Engineering Evaluation BU 1691-001 EQ2 Quantitative Report

**Prepared for Christchurch City Council (Client)**

**By Beca Carter Hollings & Ferner Ltd (Beca)**

4 October 2013

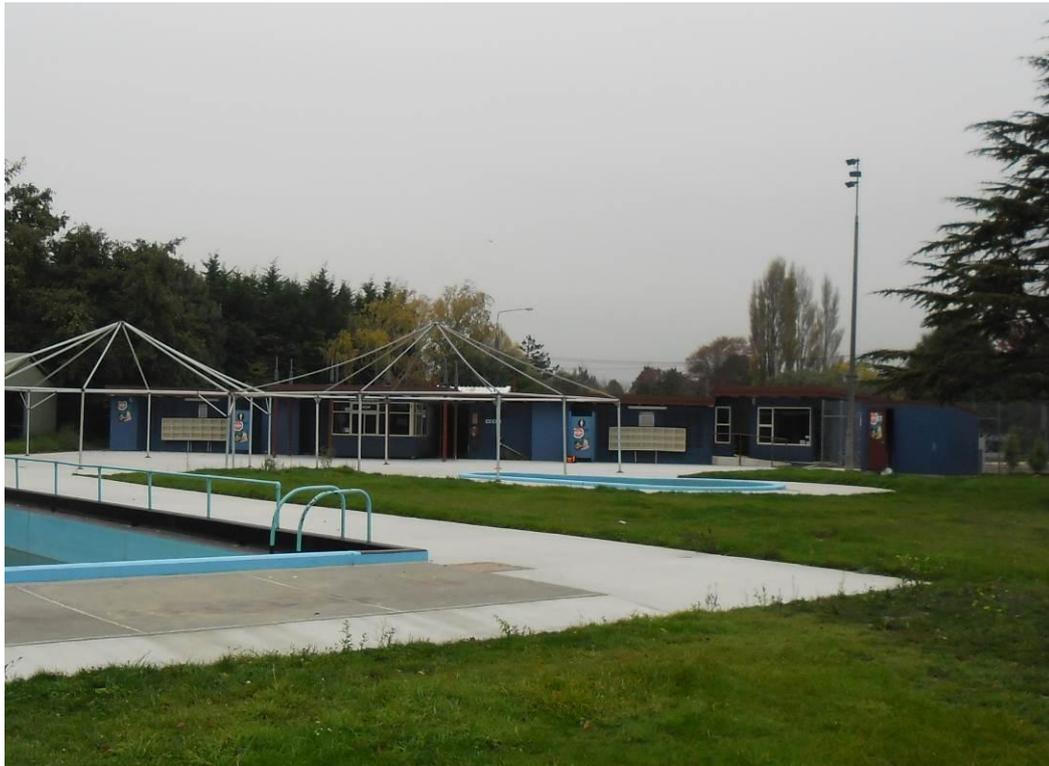
**Photo 1:** External view

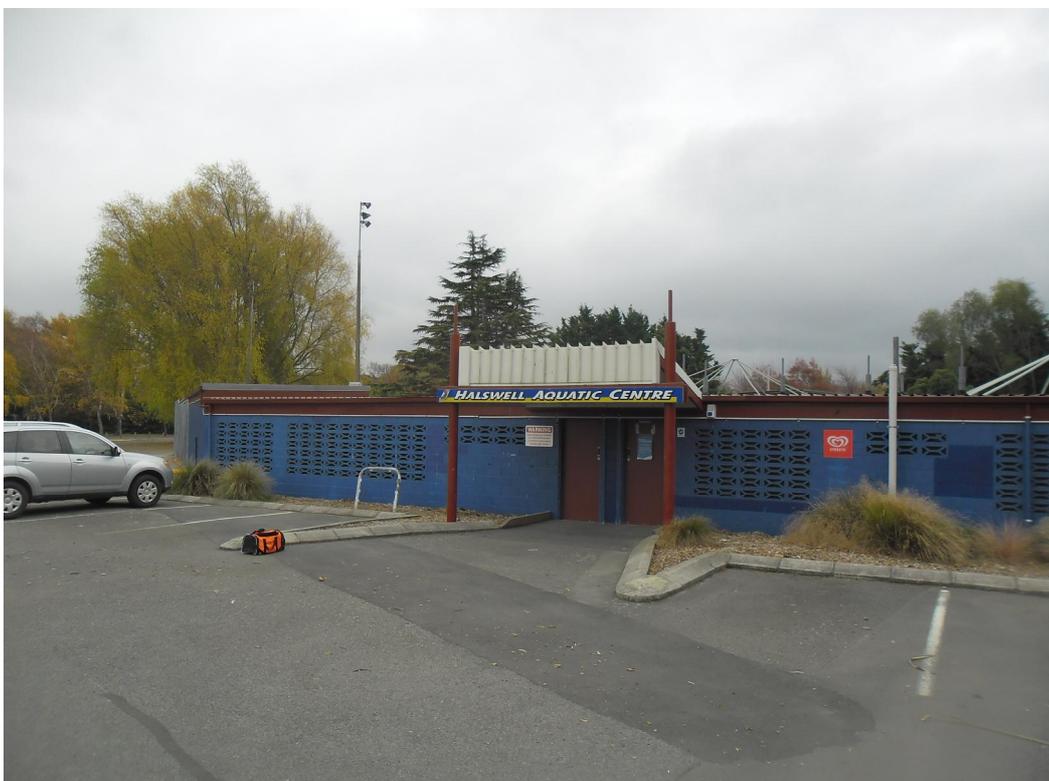
**Photo 2:** External view

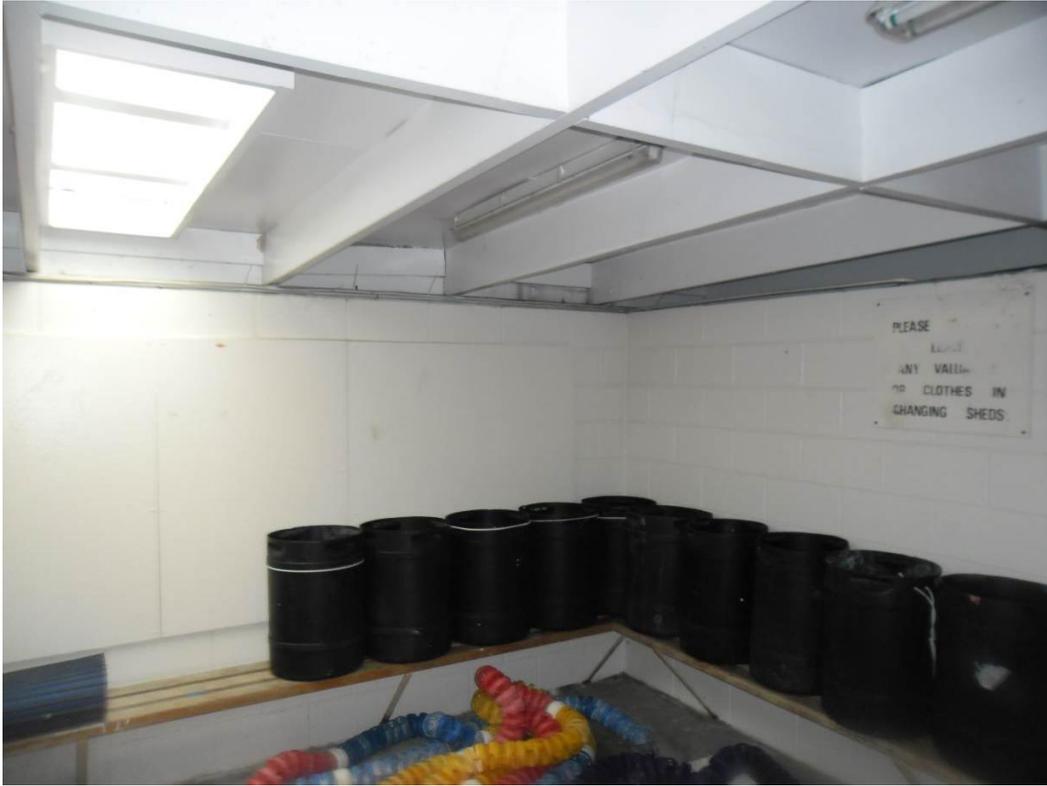
**Photo 3:** Internal view of changing room

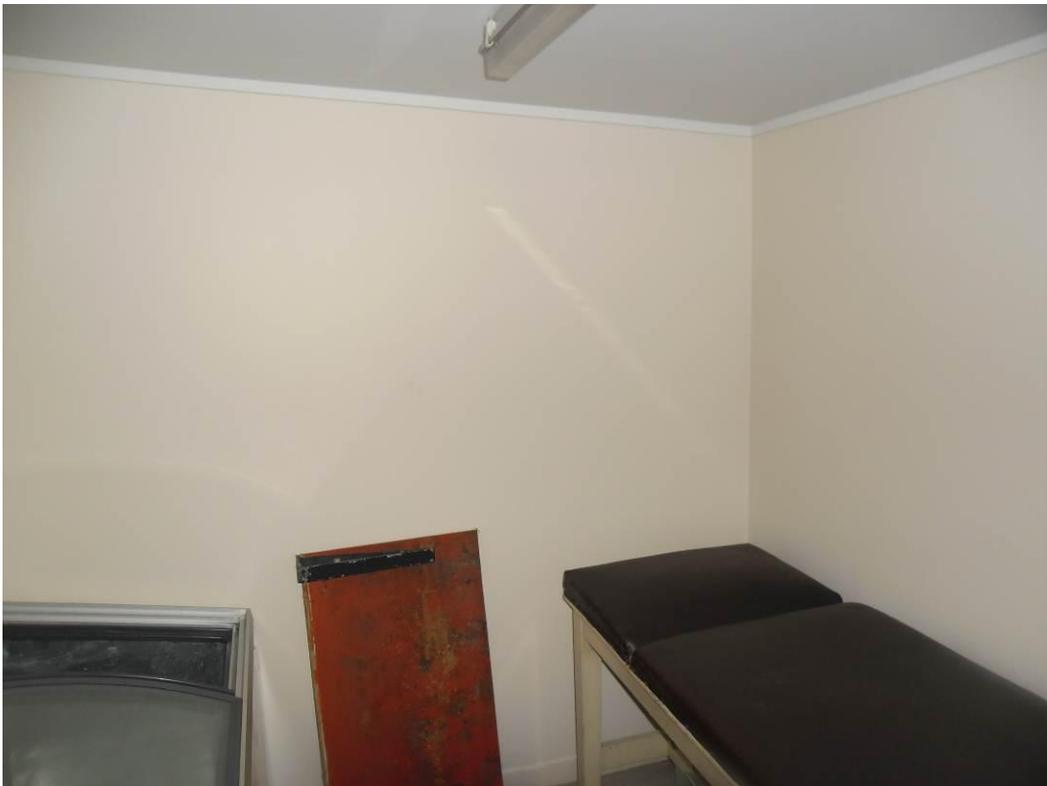
**Photo 4:** Internal view

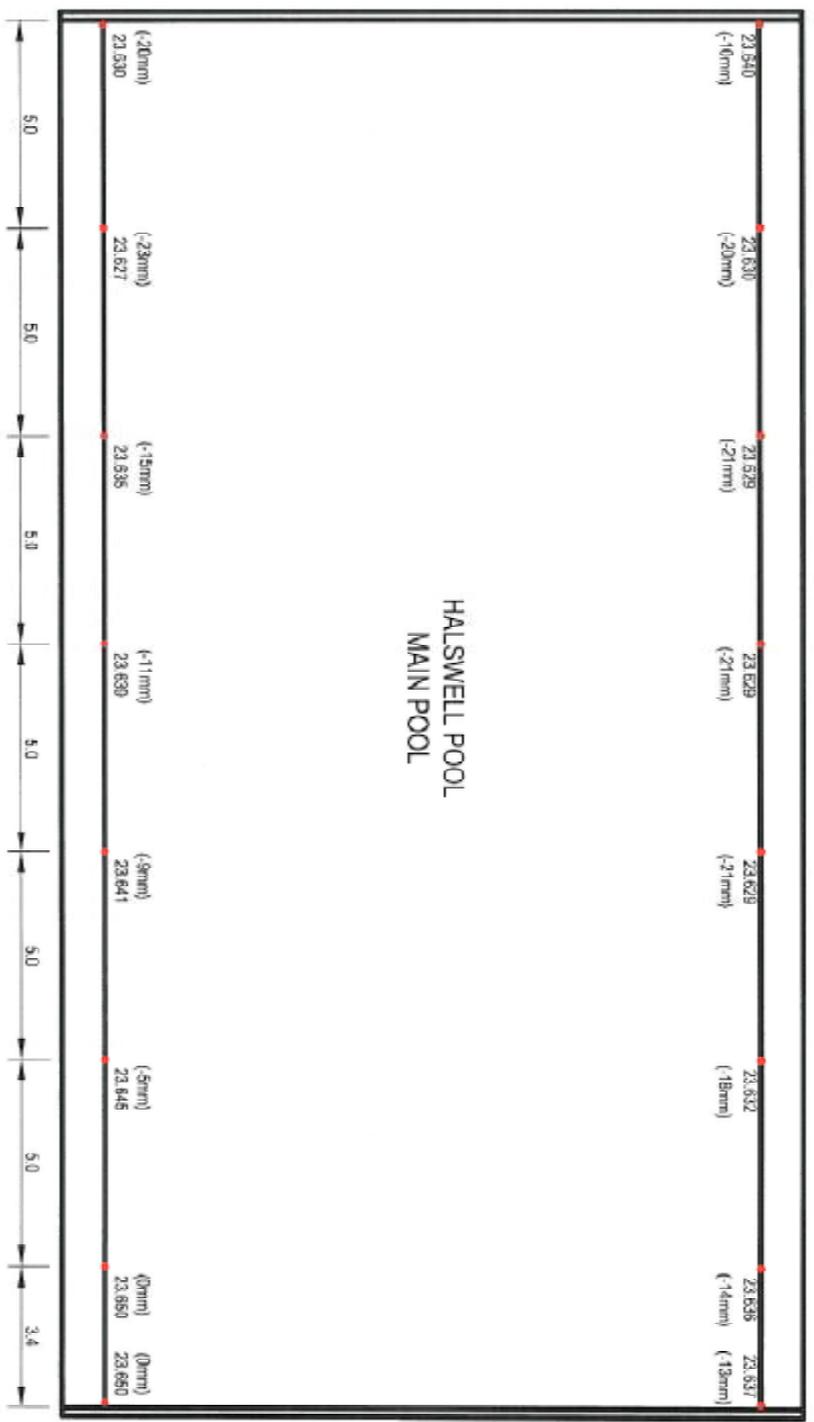
**HALSWELL POOL  
MAIN POOL**

A post-earthquake floor level survey indicates variations in floor levels, between high and low survey points of up to 67mm.

A level survey was carried out for the Halswell Aquatic Centre (refer to Appendix C). A global verticality survey may reveal movement that could be described as damage under insurance entitlement.

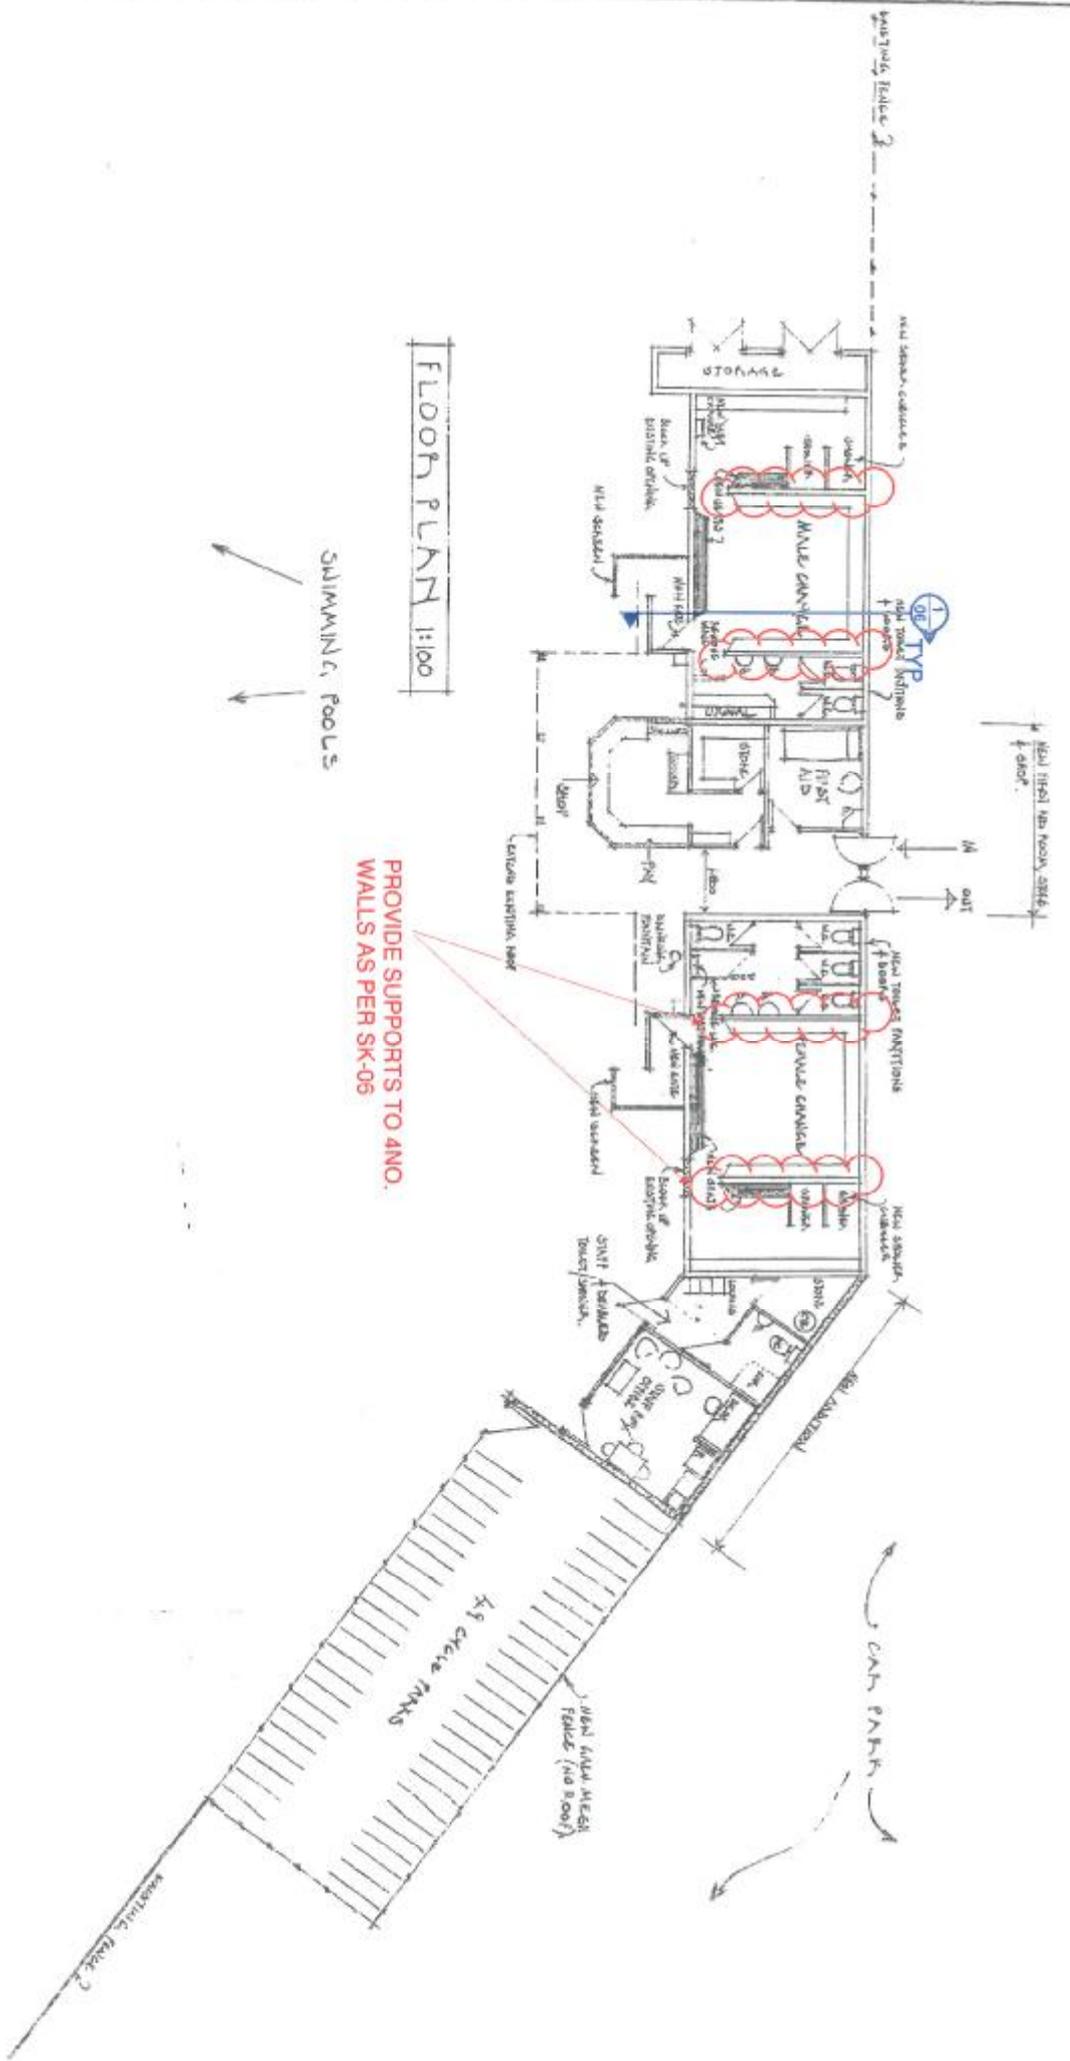
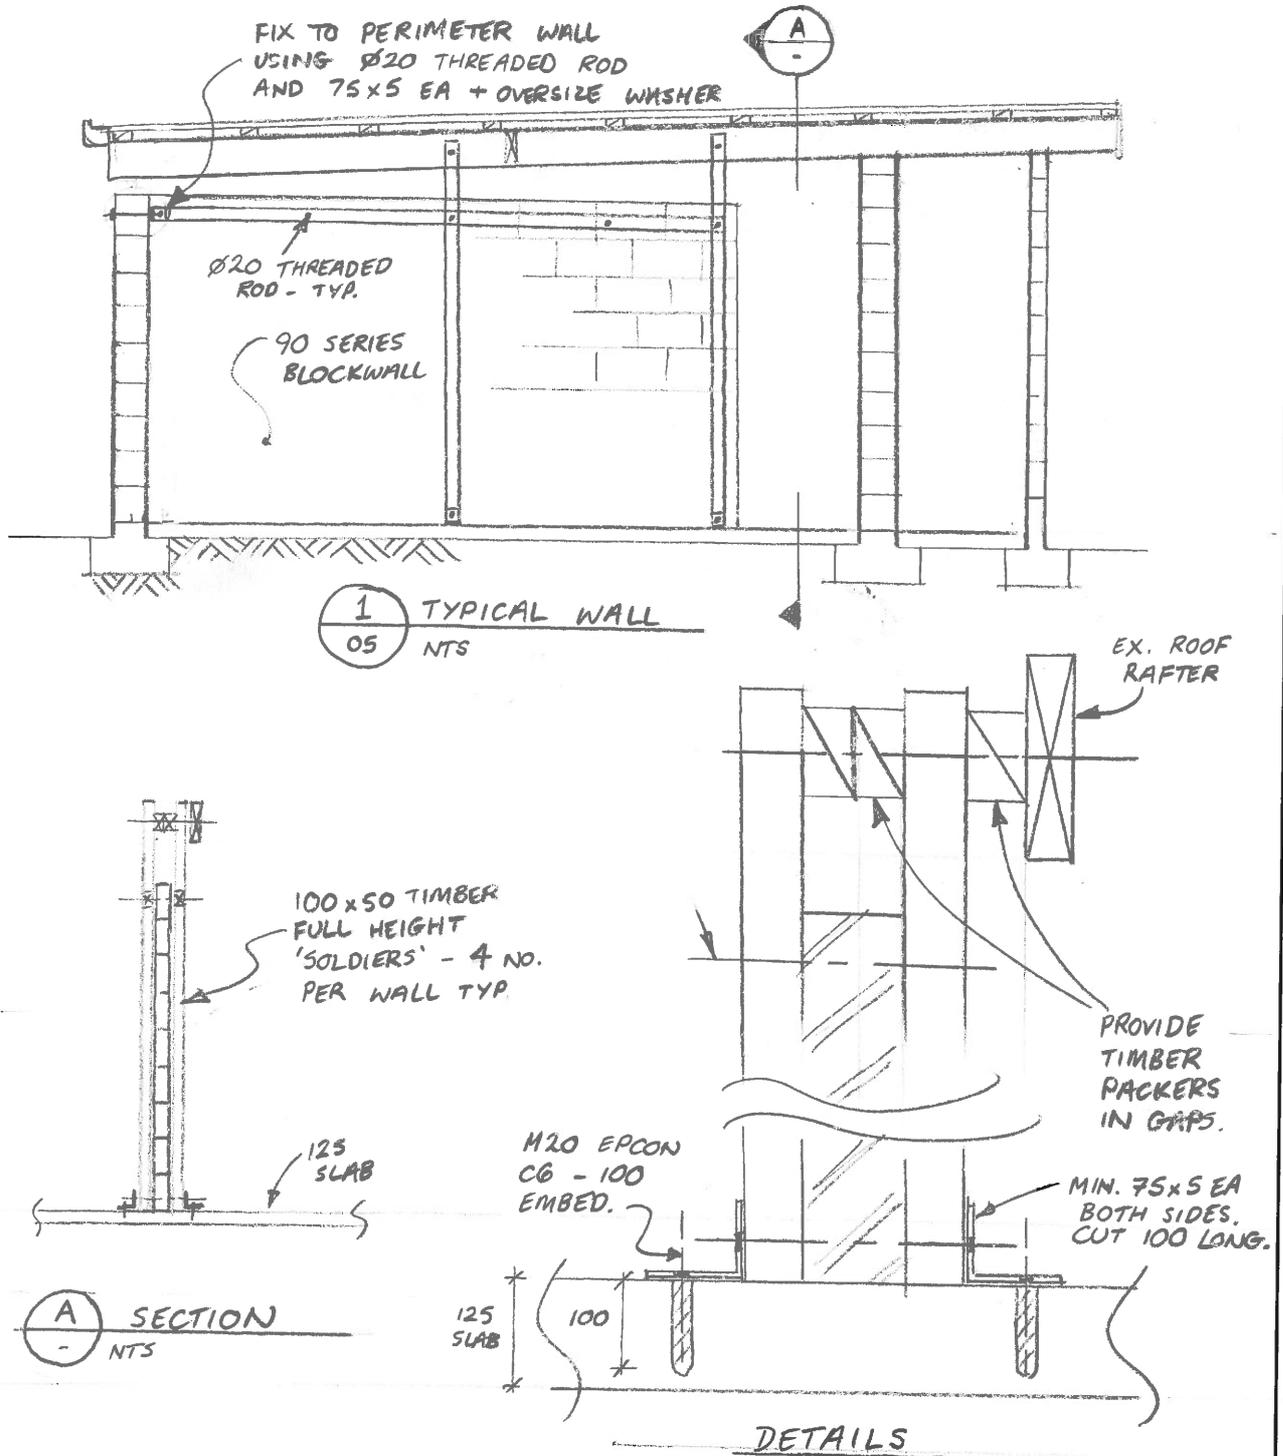
The internal block wall partitions have been identified as a potential collapse hazard, as the wall is reinforced at its ends only and does not span full height. However, calculations suggest that the lateral capacity of these elements is fairly high (89%NBS as indicated in Table 10.1 for Internal 90mm reinforced masonry block columns).

Temporary strengthening works have been developed for the internal block wall partitions. This is a precautionary measure as the walls pose a potential hazard based on observations of similar types of construction (refer to Appendix D for the temporary strengthening scheme). These temporary works have been completed prior to the issue of this report.

No repairs are required to reinstate the existing structural system. Localised temporary bracing has been added to some internal block walls as a precautionary measure to mitigate collapse hazards (see Appendix D).
