Hansen Park - Pavilion/Toilet
Qualitative Engineering Evaluation

Reference: 229616
Prepared for:
Christchurch City Council

Address: 1 Ombersley Terrace, Opawa

Revision:
Date: 23 September 2013

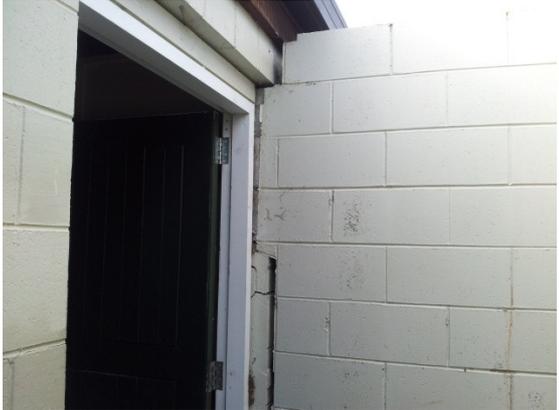
The Hansen Park - Pavilion/Toilet has performed well but has significant ground settlement issues. By visual inspection, the main structure does not appear to have settled but posts, paths and walls outside the main structure have settled. This has resulted in cracking around the northwest changing room entrance, the door jamming and the wall parting from the main structure. There is minor cracking in the slab at the entrances along the west wall. There is also parting and cracking of partition walls from the external walls. In the northeast corner a post has settled resulting in the deflection of the timber member connection.

7	Example of post settlement in northeast corner

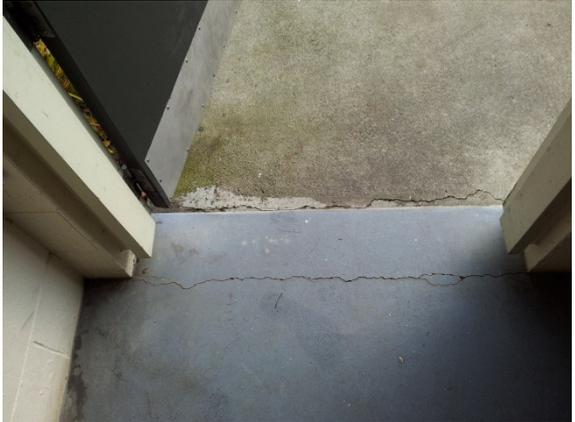
9	Separation of internal wall from external wall

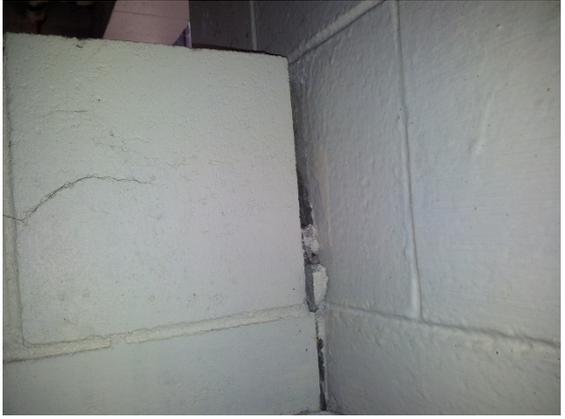
10	Internal view

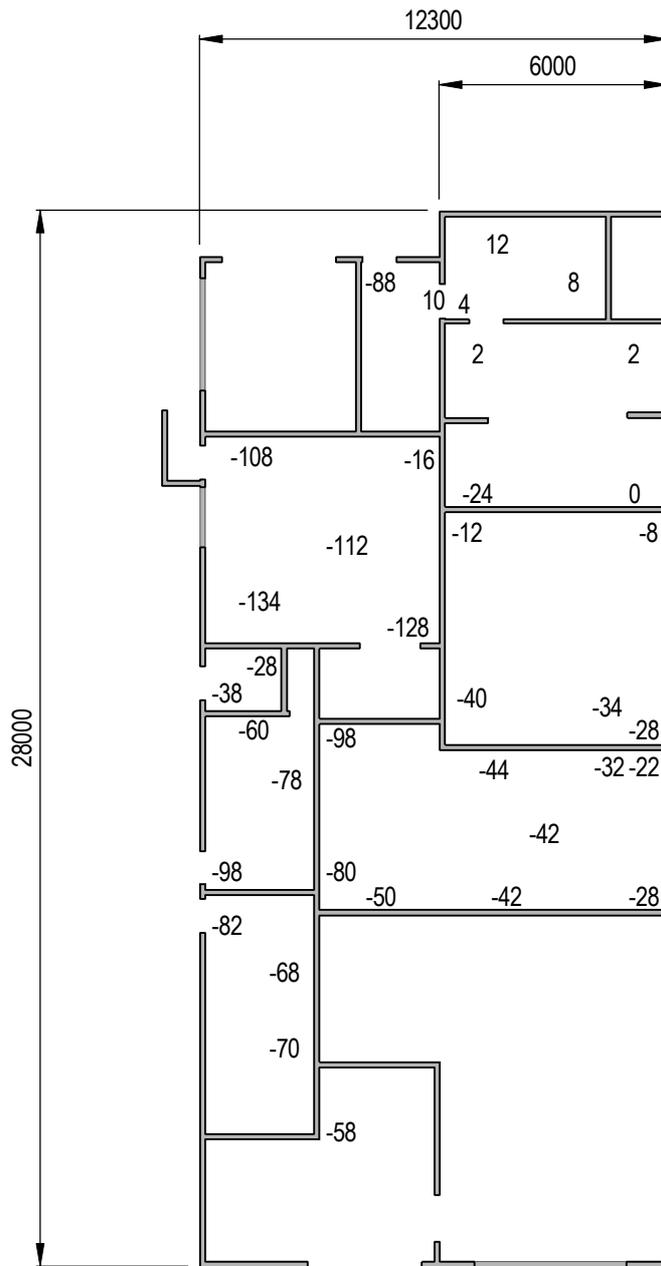
FLOOR LEVELS PLAN

The floor levels for the Hansen Park - Pavilion/Toilet were found to be outside the recommended tolerances with slopes over 0.5% in several locations and it has a maximum variation in floor levels of 134mm. However, the location where it showed the maximum variation is around the drainage area. Therefore, one of the factors for the floor level issue is due to construction.
