CHRISTCHURCH CITY COUNCIL
PRK_0339_BLDG_004 EQ2
Harewood Nursery – Pumphouse (x2)
239 Gardiners Road, Harewood

QUALITATIVE ASSESSMENT REPORT

- Rev B
- 23 November 2012

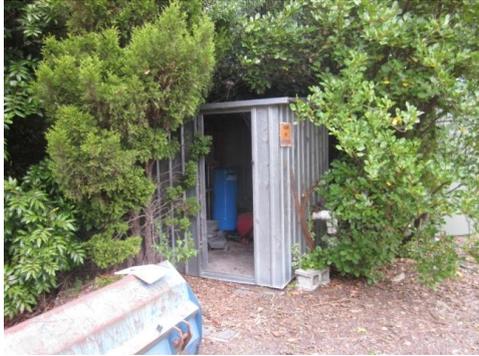
- 1) No external or internal damage was noted.
- 2) No visual evidence of settlement was noted at this site. Therefore a level survey is not required at this stage of assessment.

Photo 1: External View of First Pumphouse

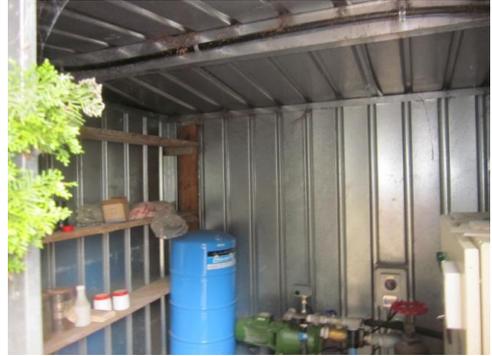
Photo 2: Internal View of Pumphouse

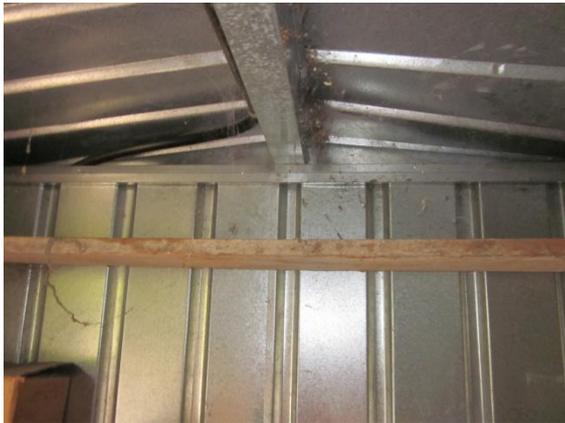
Photo 3: Roof Structure (Typical)

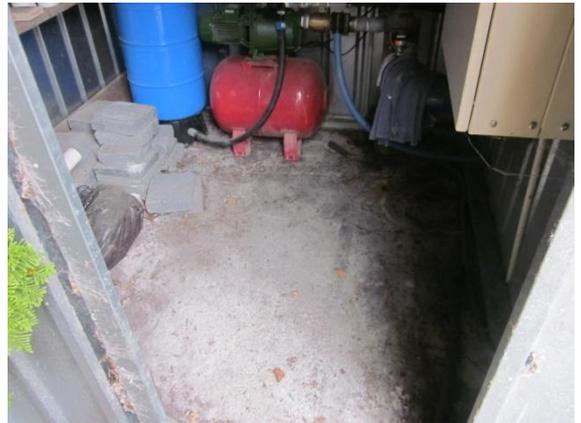
Photo 4: Concrete Floor Slab

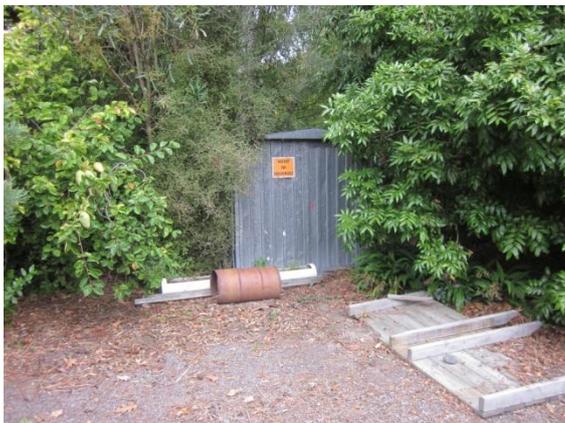
Photo 5: External View of Second Pumphouse

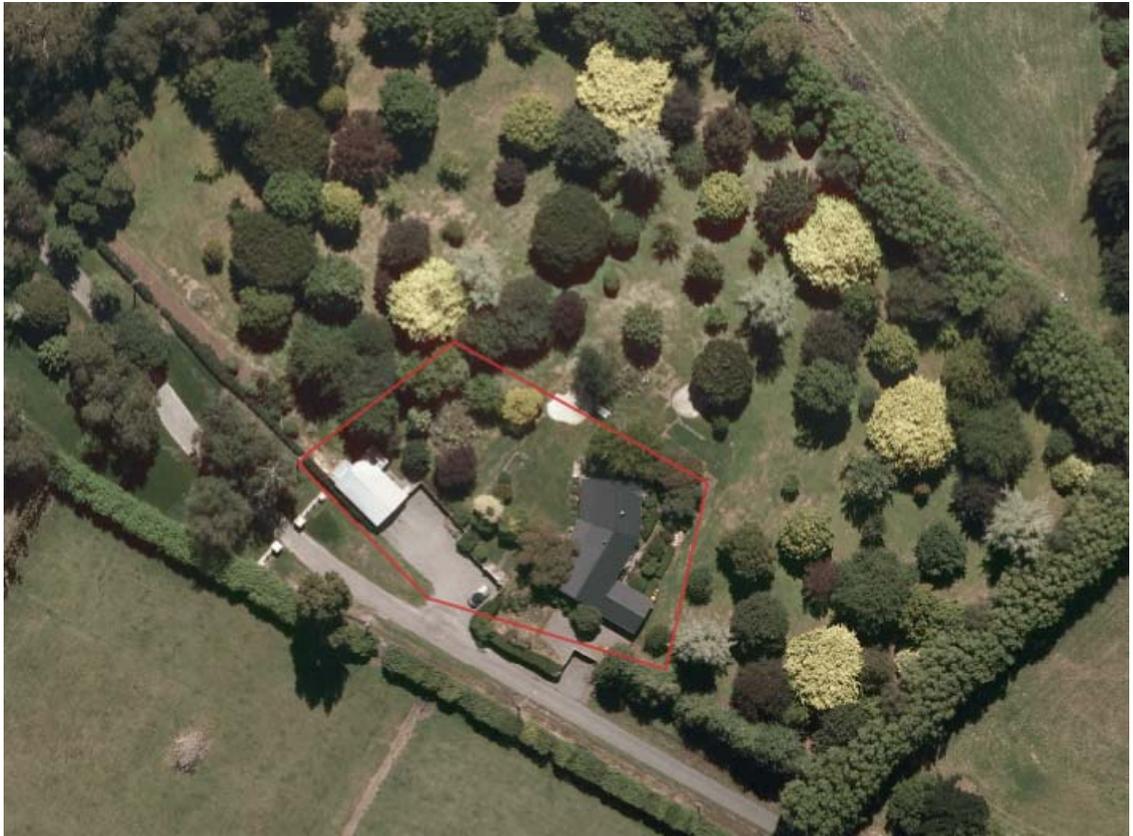
- **Figure 4 – Aerial photography from 24 Feb 2011 (<http://viewers.geospatial.govt.nz/>)**

Aerial photography shows relatively little damage to no damage after the 22 Feb 2011 event. There appears to be some ground disturbance shown in the bottom left hand corner of the aerial photograph, however this may not be related to the earthquakes, No liquefied material could be seen.

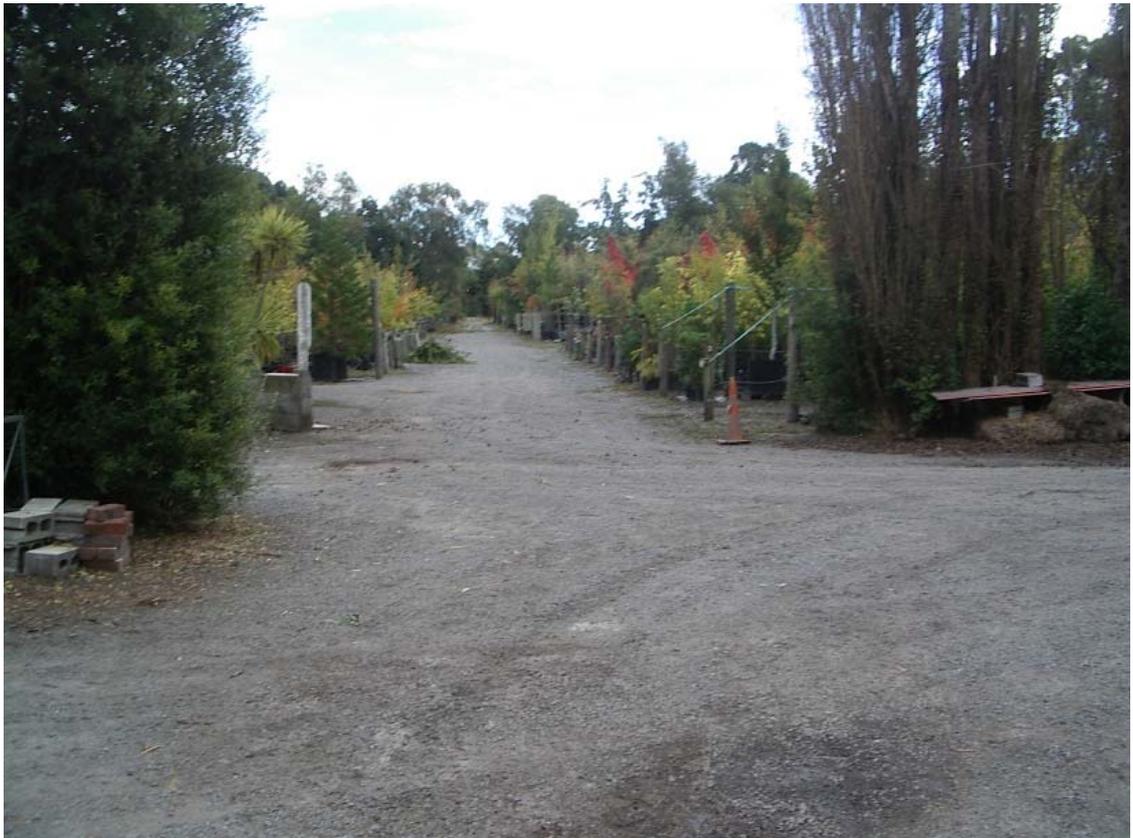
The amenity building was a brick and a metal roof construction. The vehicle shed was a portal frame building with metal sheet walls and a metal roof. The pump houses were metal sheds and the garage was a timber structure with a metal sheet roof. There was no obvious structural damage on any of the buildings. There were no signs of liquefaction on site, and no land damage was observed.

▪ **Figure 6 No visible liquefied material on the driveway**

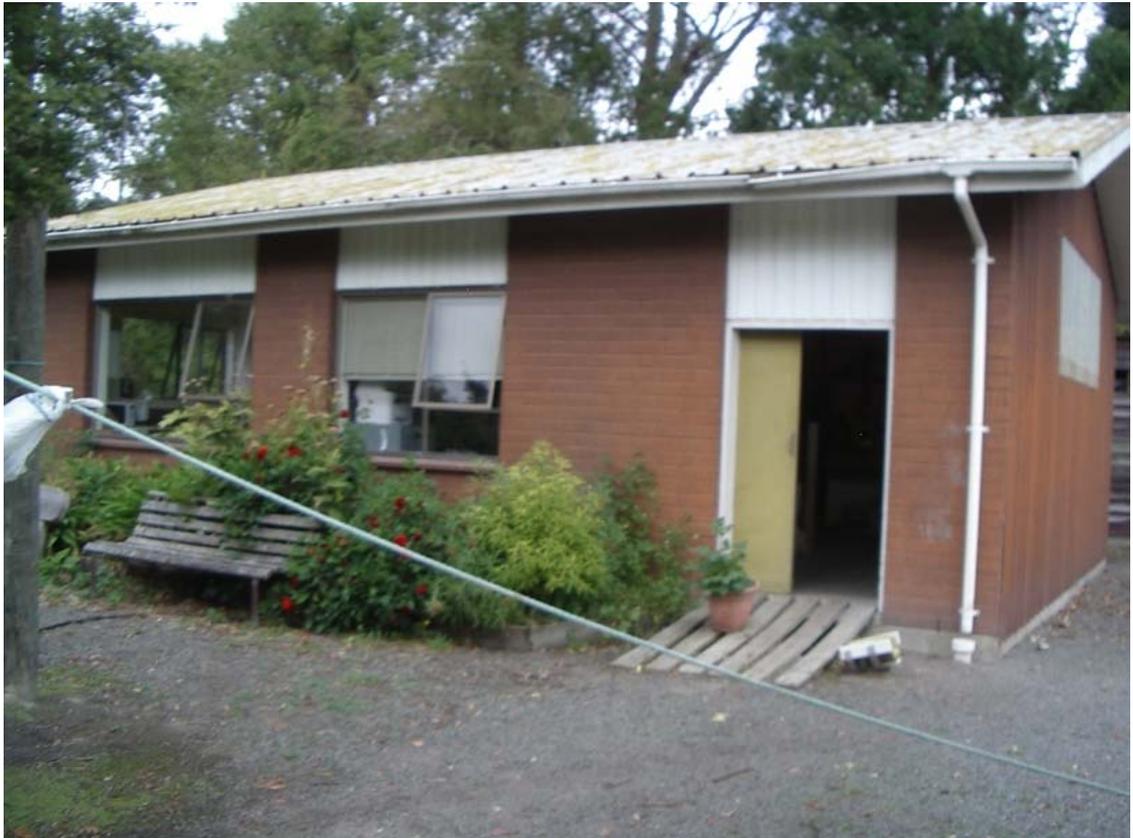
■ **Figure 7 No visible damage to the structure**
