Christchurch City Council
PRK_0339_BLDG_006 EQ2
Harewood Nursery Vehicle Shed
239 Gardiners Road, Harewood

QUANTITATIVE ASSESSMENT REPORT

- Rev B
- 12 March 2013

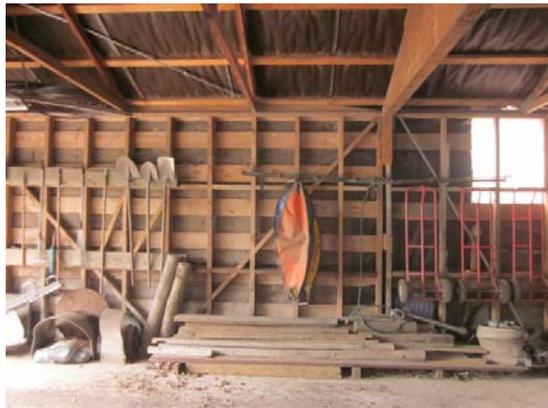
Photo 3: South Wall Bracing

Strengthening of the building should include the replacement of non seismic metal strap bracing or the addition of plywood sheathing to create ‘stiff corners’ of the building in combination with upgrading the roof bracing and/or lining.

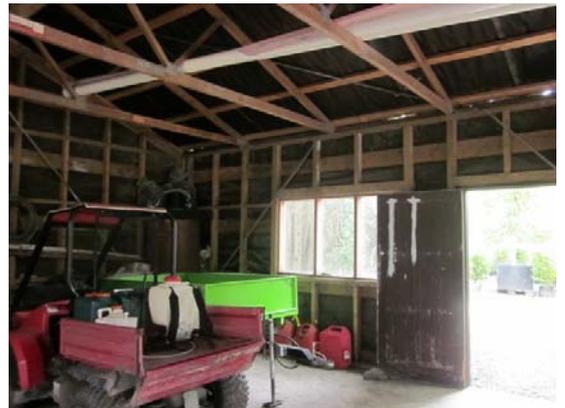
Photo 4: North Wall Bracing

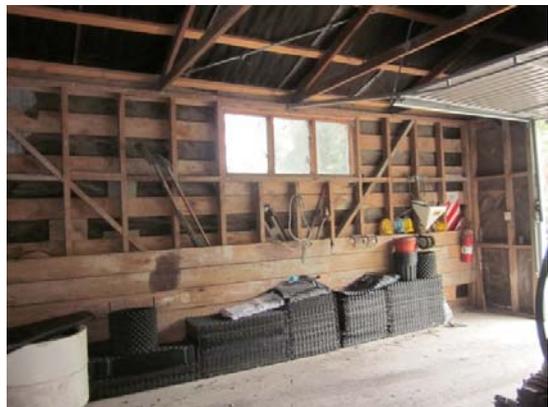
Photo 5: North Wall Bracing Continued

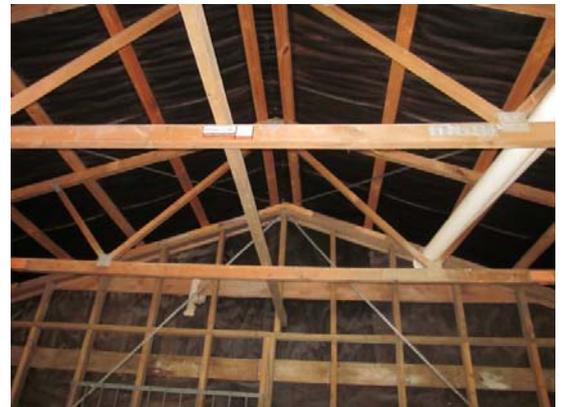
Photo 6: West Wall & Roof Bracing

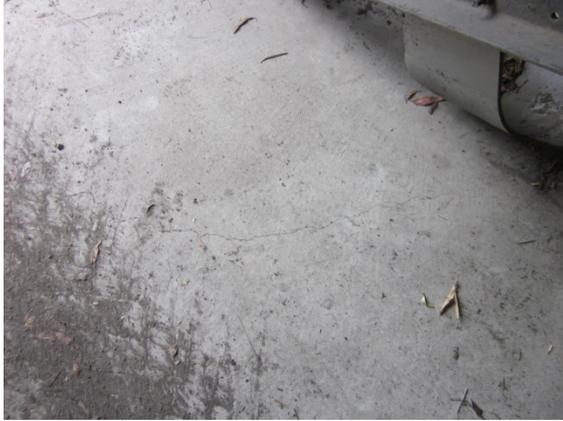
There is hairline cracking of the concrete foundation slab at the main entrance with no visual signs of local settlement.

- 1) No visual evidence of settlement was noted at this site. Therefore a level survey is not required at this stage of assessment.
- 2) Hairline cracking was present to the concrete slab near the main entrance of the building (PHOTO 7 & 8).

Photo 7: Hairline Cracking to Floor Slab – Near Main Entrance

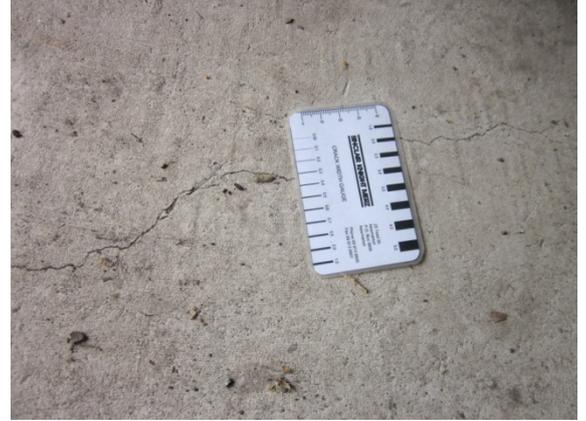
Photo 8: Close up of Photo 8

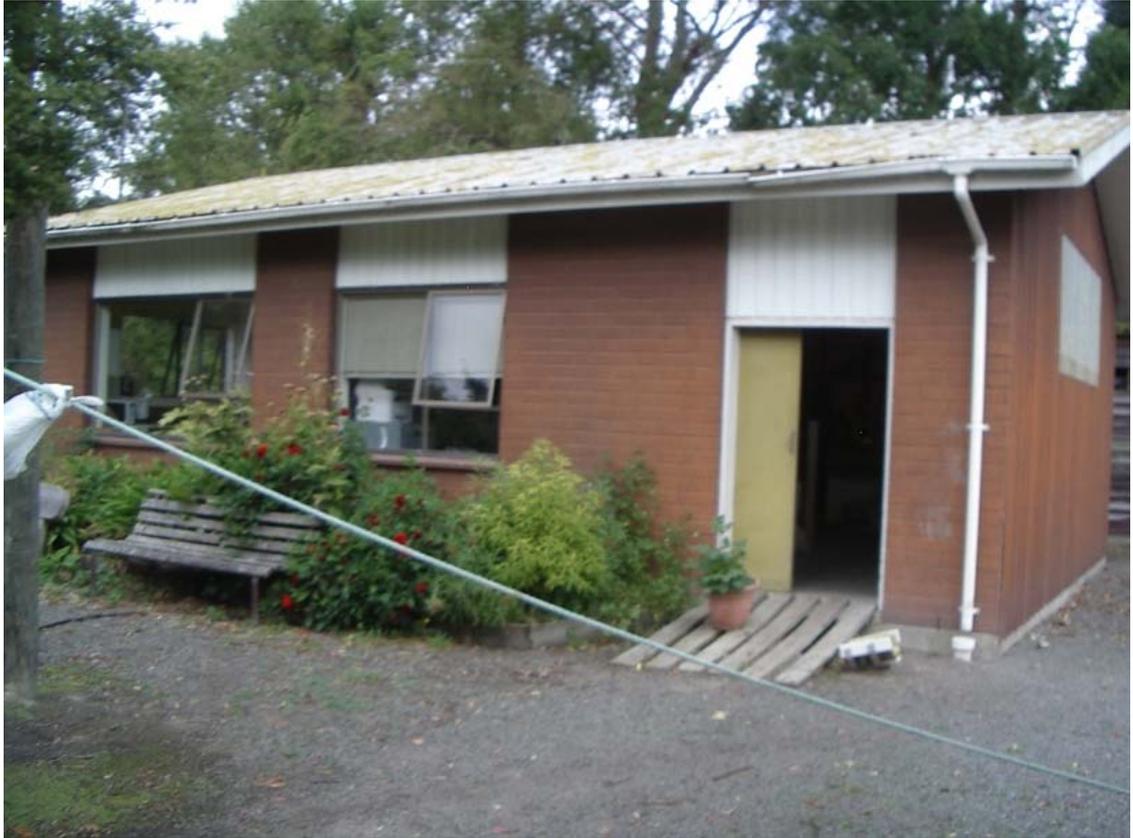
■ **Figure 7 No visible damage to the structure**
