**Hei Hei Community Centre**  
**BU 1559-001 EQ2**  
Detailed Engineering Evaluation  
Quantitative Report  
Version FINAL

16 Wycola Avenue, Hei Hei

Christchurch City Council

**Date**  
17/12/12

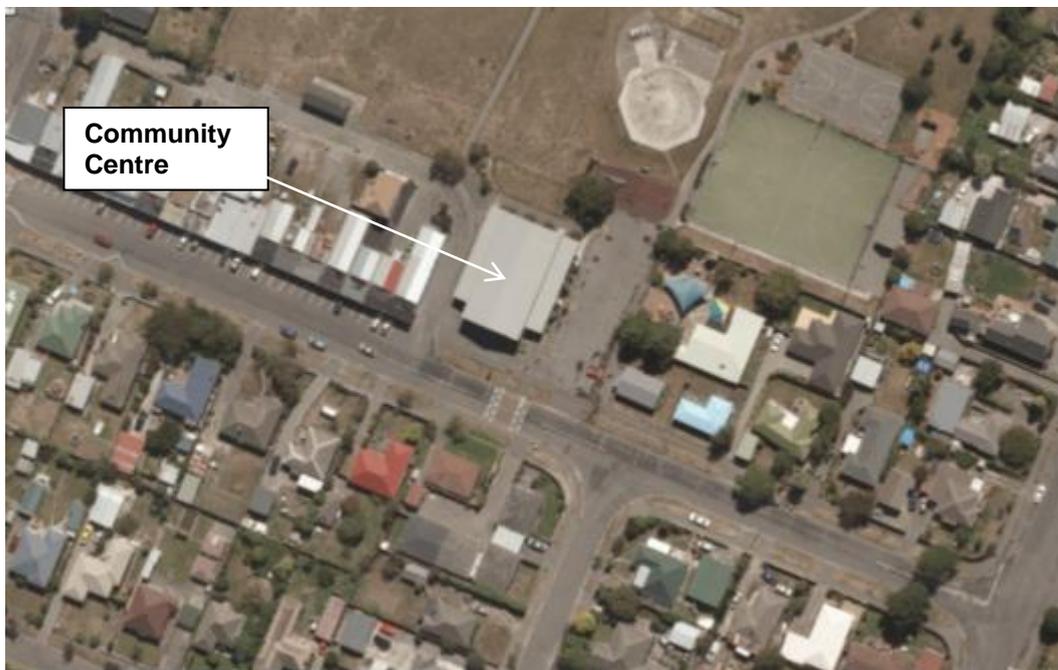
Figure 6 Post February 2011 Earthquake Aerial Photography <sup>2</sup>

Aerial photography taken following the 22 February 2011 earthquake (Figure 6) shows no signs of liquefaction outside the building footprint or adjacent to the site.

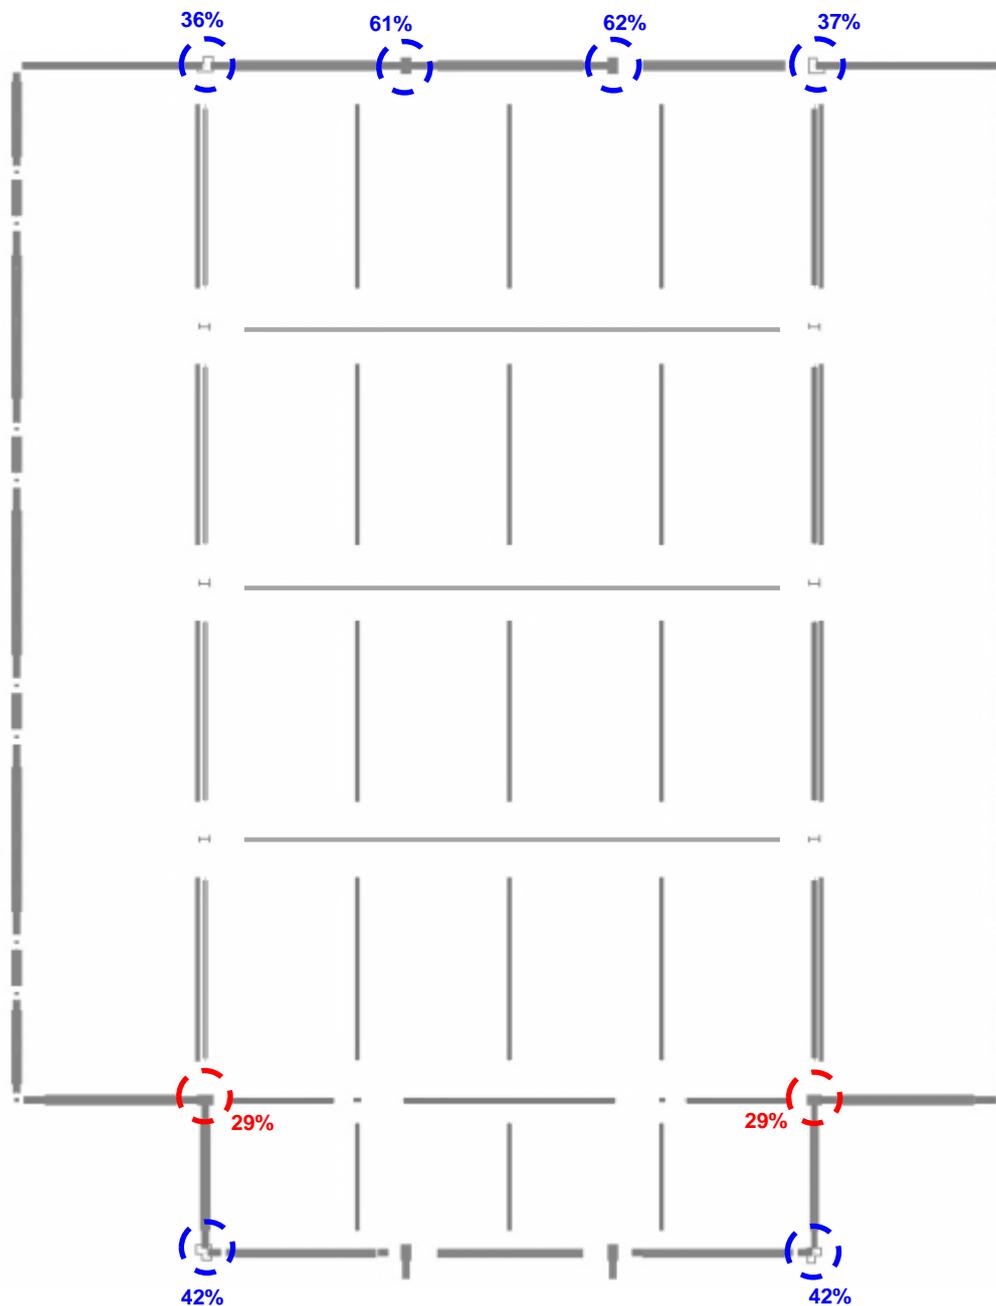
Two (2) reinforced concrete columns scored below 34% NBS with another six (6) scoring below 67% NBS.

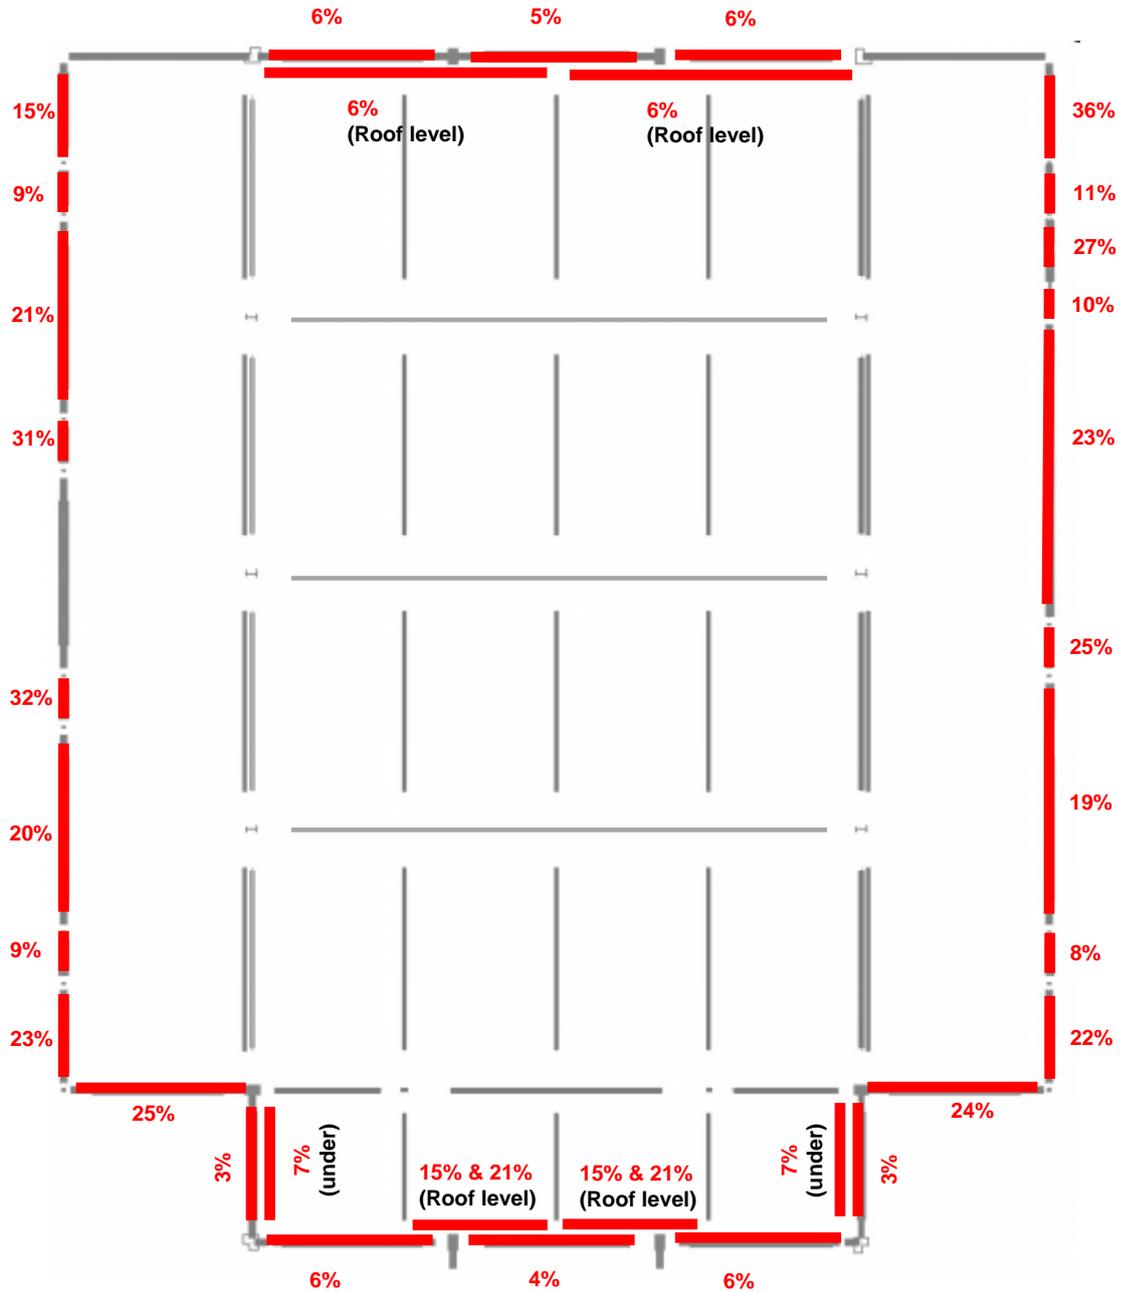
Nearly all RC beams/bond beams scored below 34% NBS and are highlighted in red.

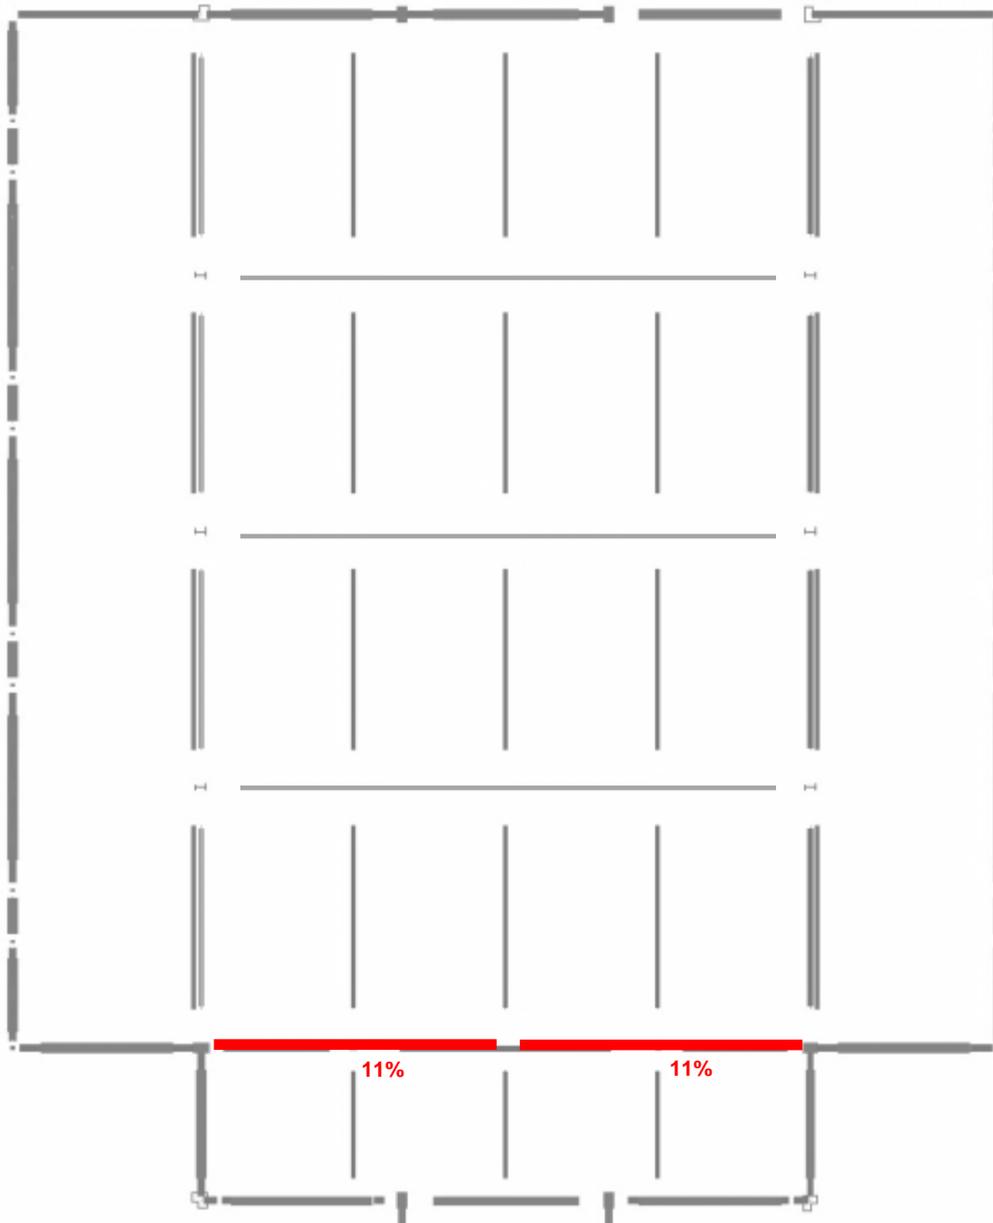
Two (2) steel rafters scored below 34% NBS and are highlighted in red below.

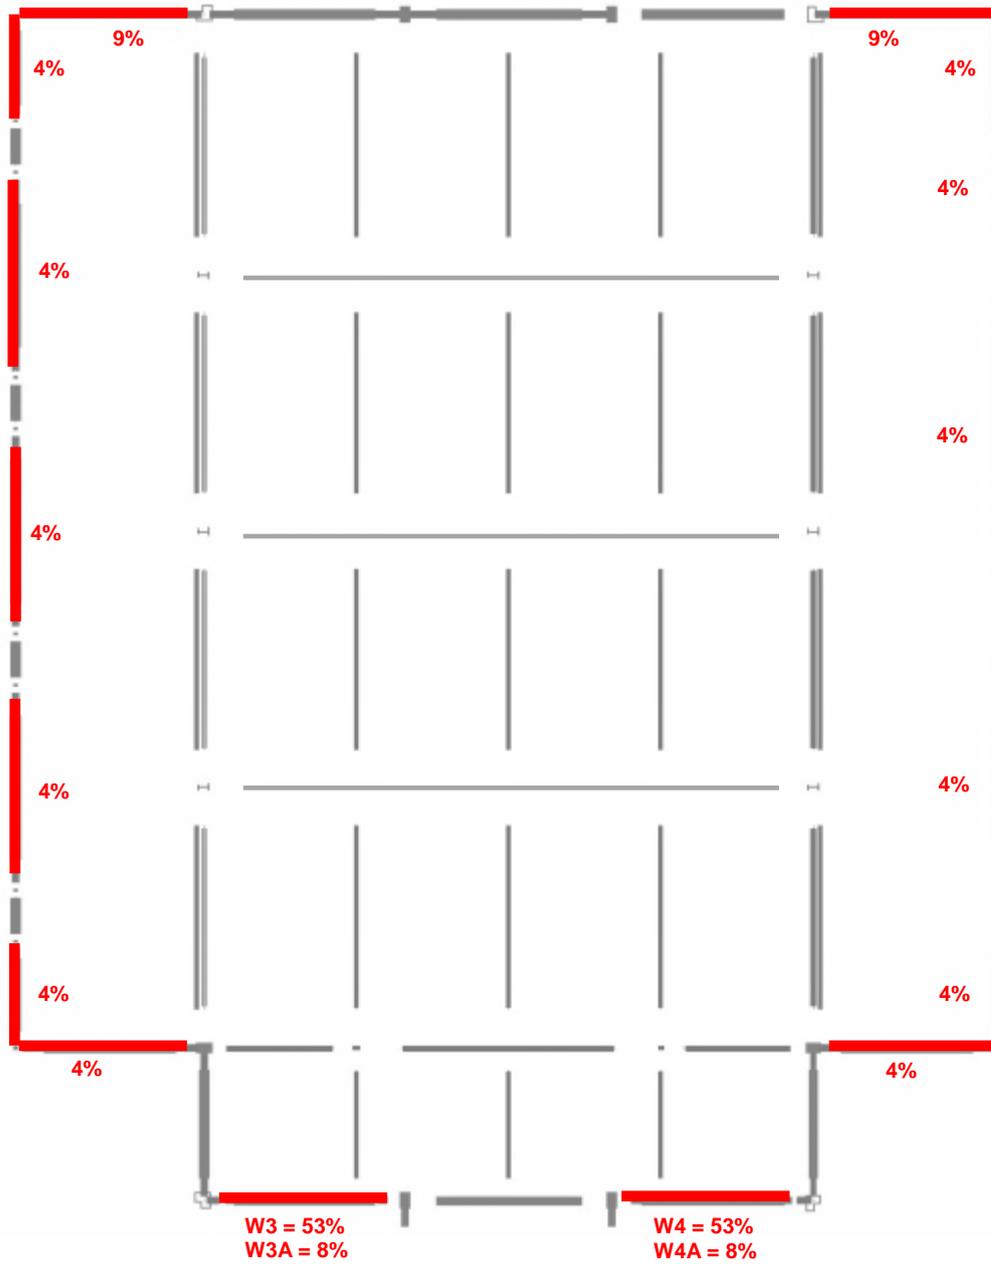
All unreinforced masonry walls scored below 34% NBS and are highlighted in red.

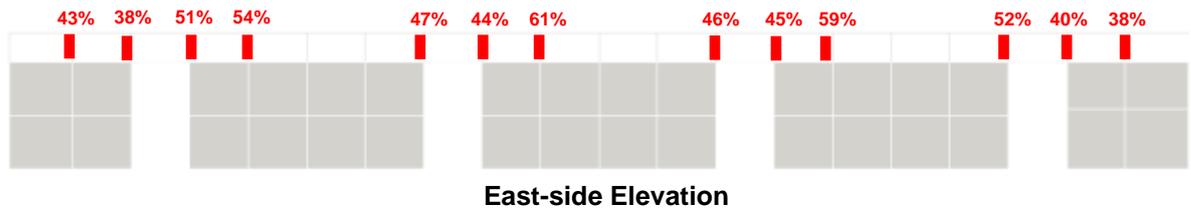
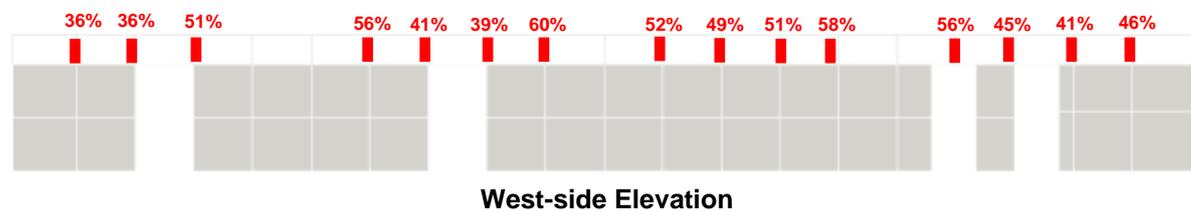
The timber stub posts all scored above 33% NBS. However, twenty-eight (28) timber stub posts scored below 67% NBS. These are shown in red below.

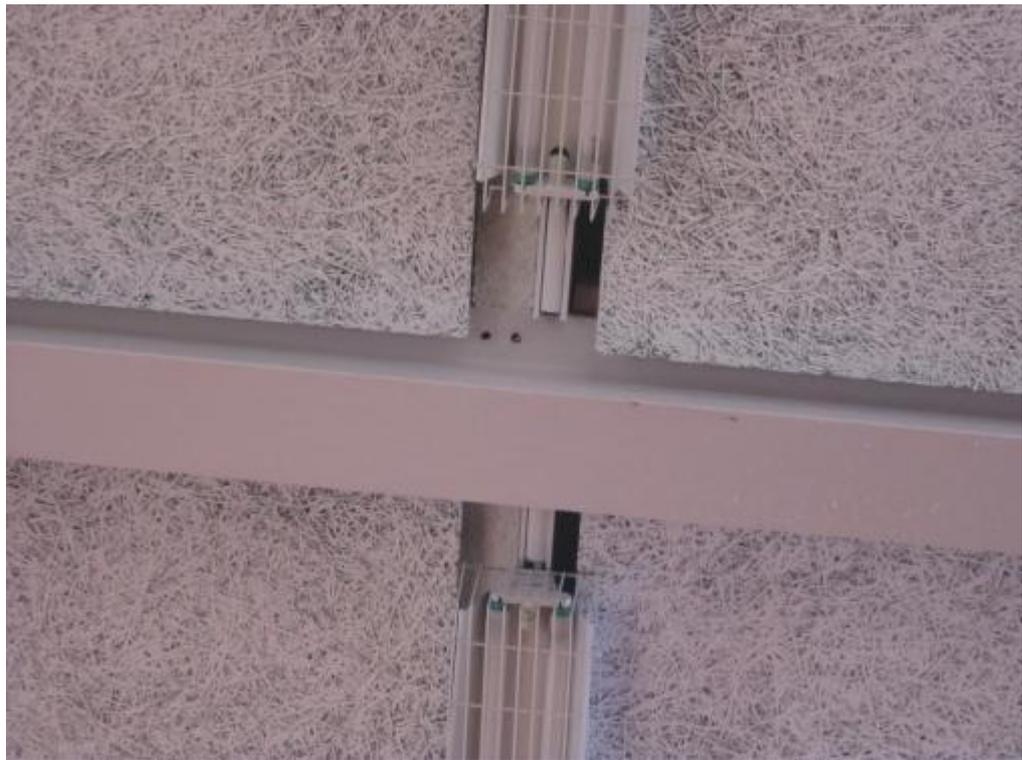
It was noted that bolts connecting the rolled steel joists (RSJ's) to the portal frames were missing (See Photograph 27). In addition, the connection between the RSJ's and the concrete frames at the front and rear of the building (See Photograph 23 and 24) could not be confirmed due to the presence of ceiling linings.

**Photograph 7: No bolts in connections between portal frame and RSJ's**

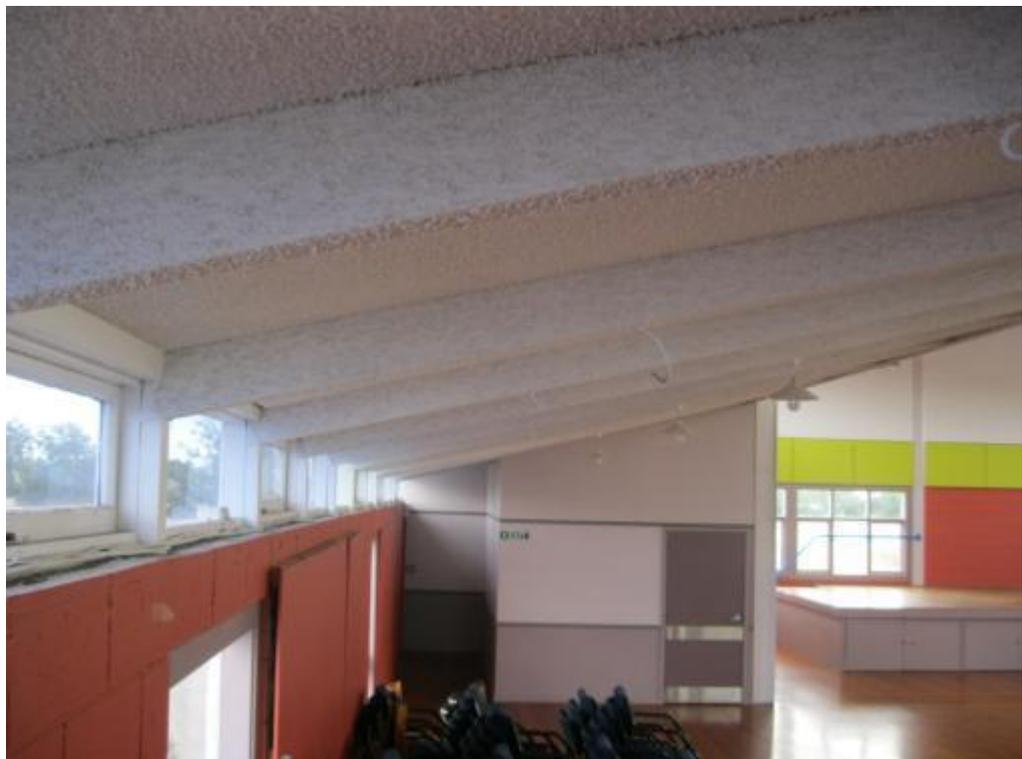
**Photograph 8: Ancillary building blockwork not directly connected into roof**

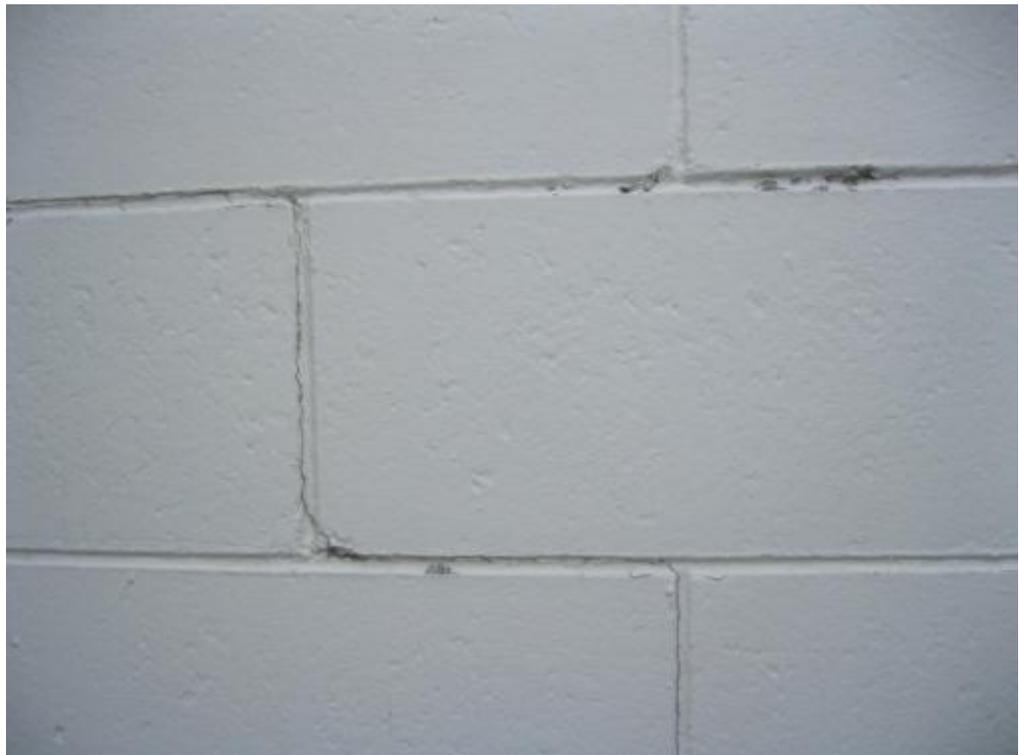
Cracking along blockwork mortar lines was noted in several locations around the building. These appear to be existing cracks that may have opened up slightly during the recent seismic activity. Observations on site indicate that blockwork walls are potentially of partial filled construction.

**Photograph 9: Minor cracking along mortar lines to concrete blockwork**

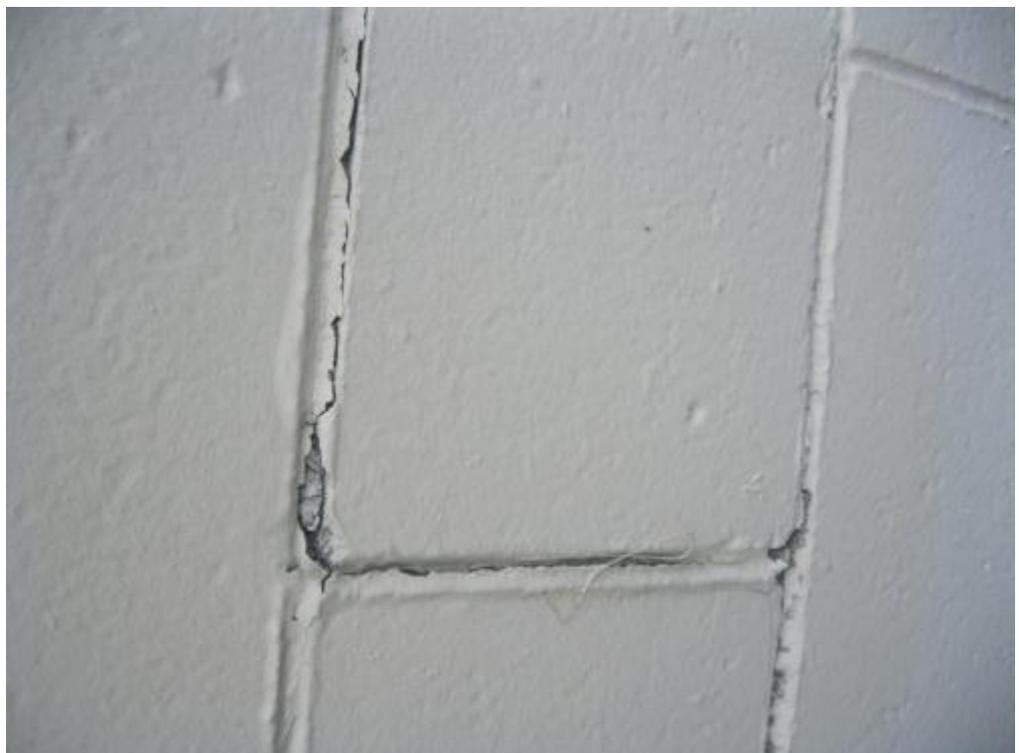
**Photograph 10: As above**

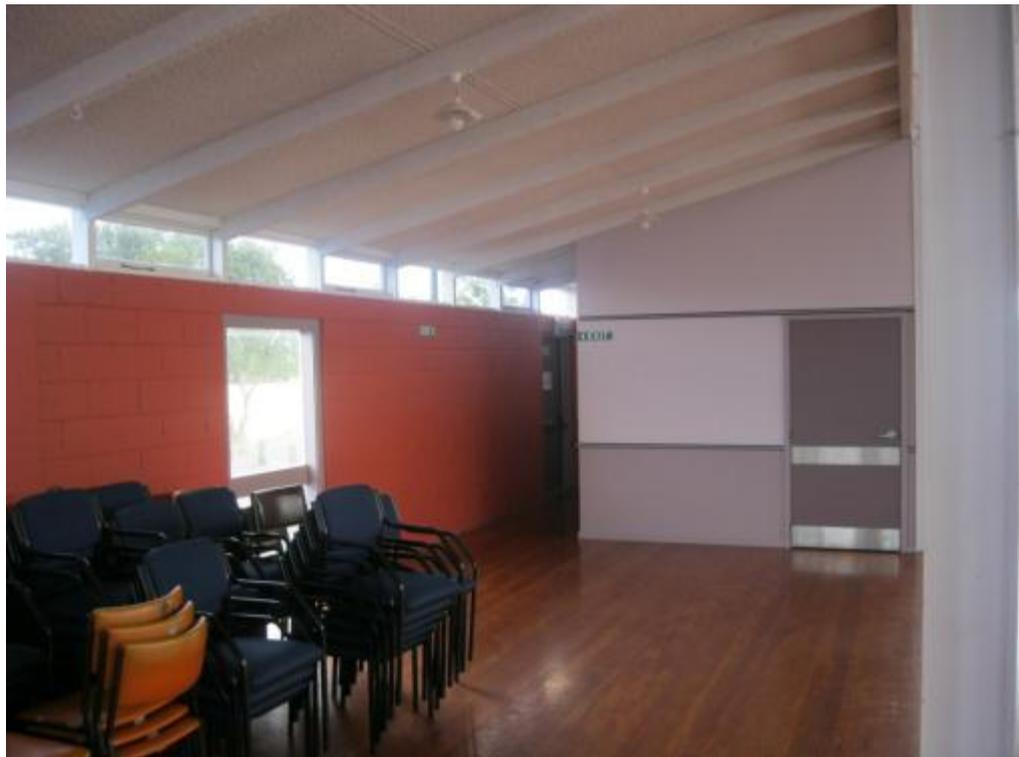
As discussed in Section 4.3, the exterior blockwork walls provide in-plane stability but the lack of adequate structural connection between the blockwork walls and roof structure is of concern. It is possible that the walls are tied to the suspended floor via a ribbon plate, though this was not observed on site. No damage was evident at the junction between the walls and floor.

**Photograph 11: Lack of adequate structural connection between the roof framing and exterior blockwork walls**

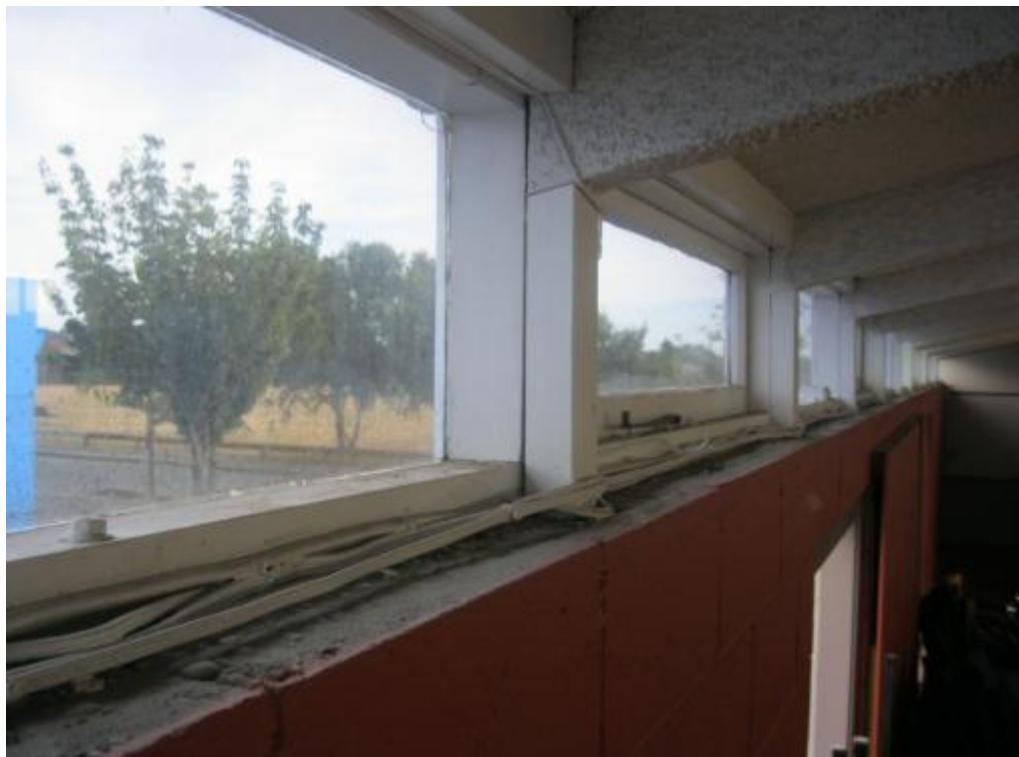
**Photograph 12: As above**

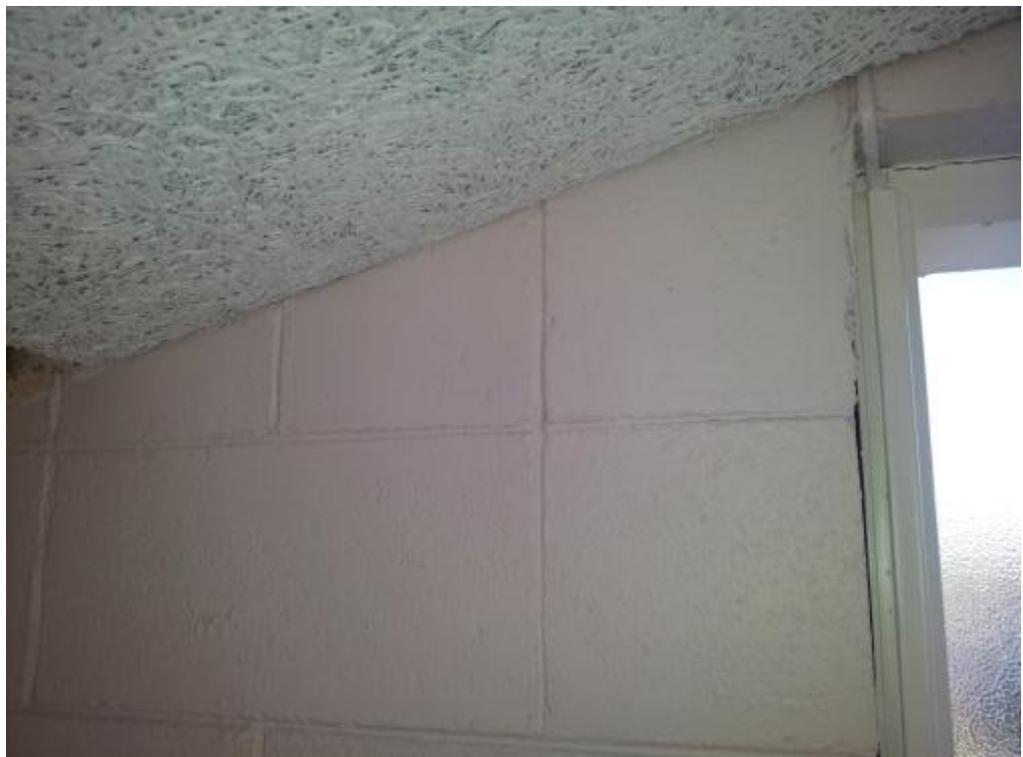
**Photograph 26: Minor cracking along mortar lines to exterior blockwork walls located at mezzanine floor area**

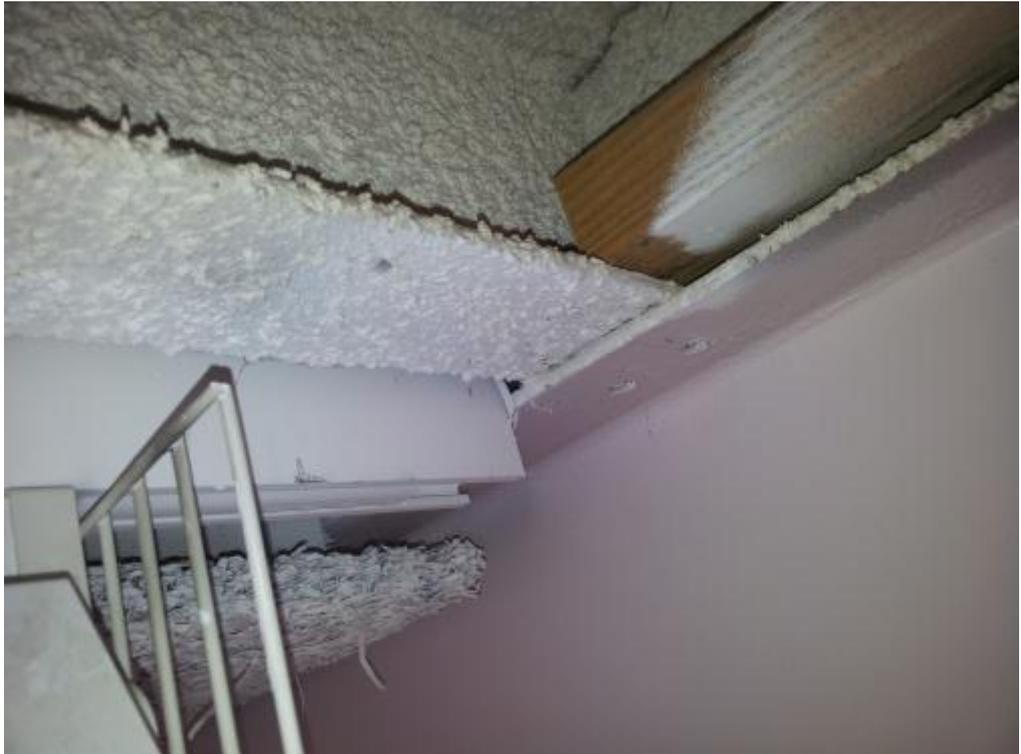
**Photograph 27: Opening up works on roof showing the connection between steel portal frame and RSJ's**
