Shed/Garage – Heritage Park
PRK 3659 BLDG 006
Detailed Engineering Evaluation
Qualitative Report
Version FINAL

12 Barclays Road, Little River

Christchurch City Council

Date
19th December 2013

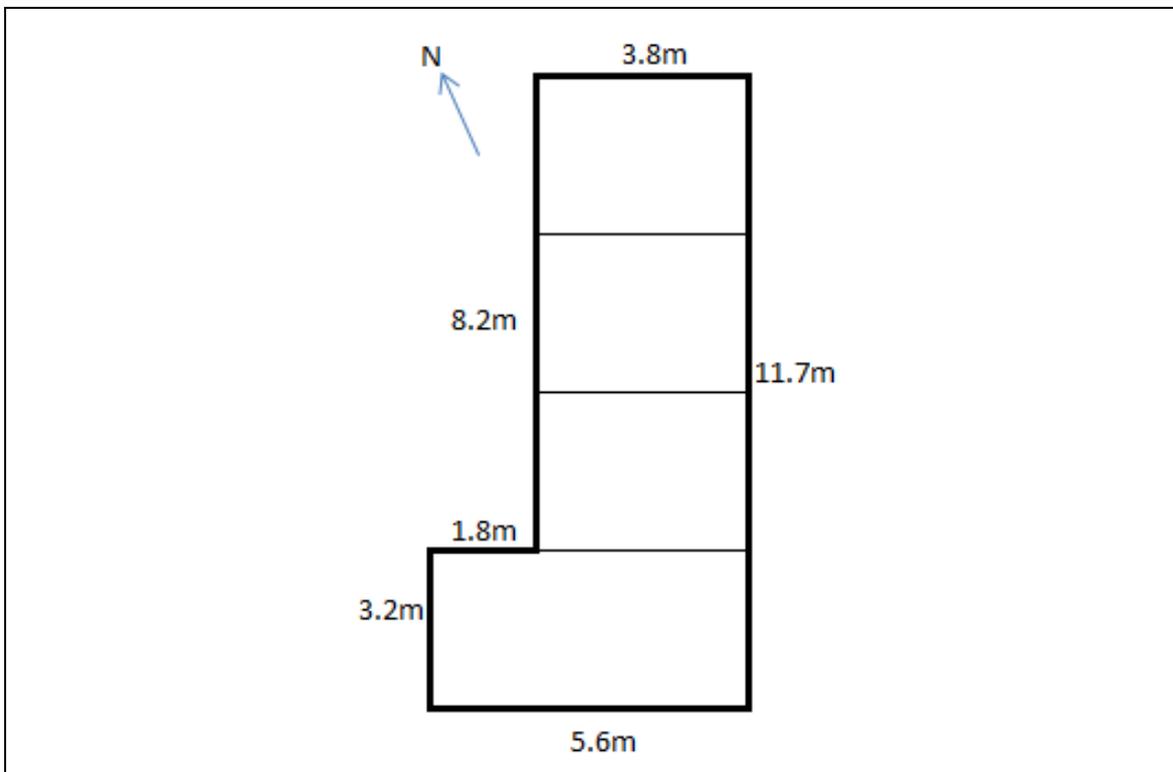
Figure 2 Plan Sketch Showing Key Structural Elements

Essentially the roof can be thought of as two parts. The first sits on the southern section of the building and has timber trusses supporting the cladding. The second is a timber bracing sloping downward toward the west; this roof is slightly shorter than the first but runs over the three northern sections. Both roofs are cladded with corrugated iron.

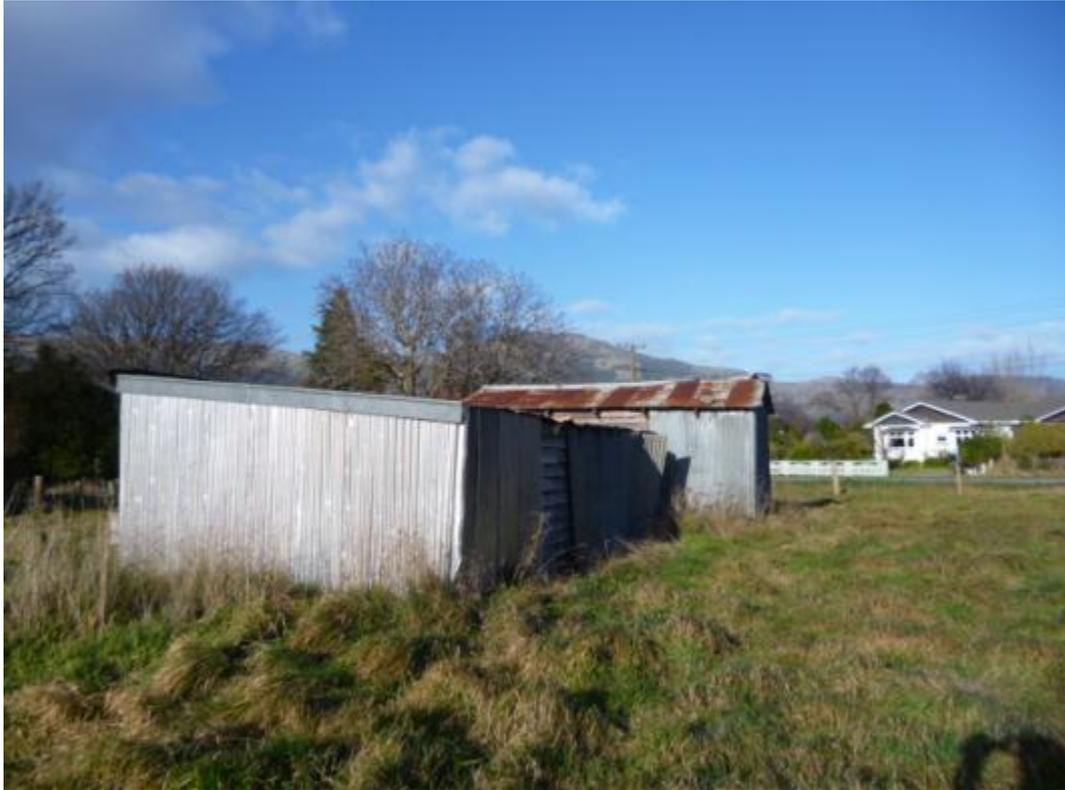
Photograph 1 North elevation.

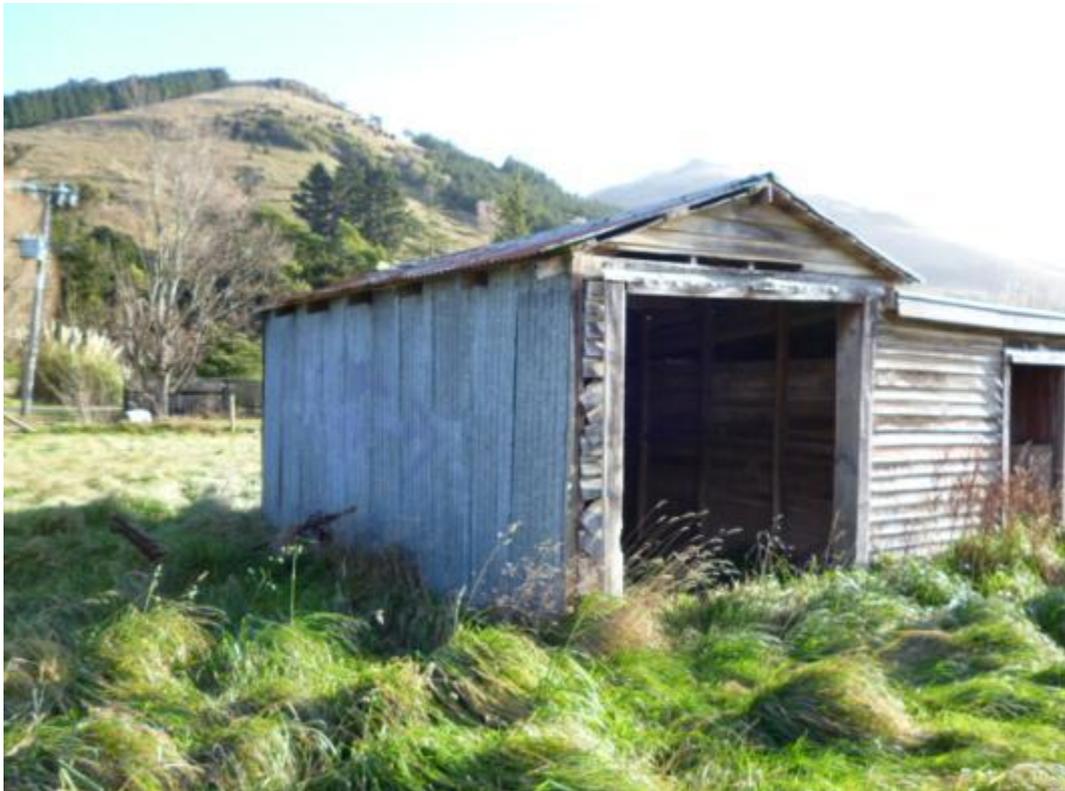
Photograph 2 Southern and Eastern elevations.

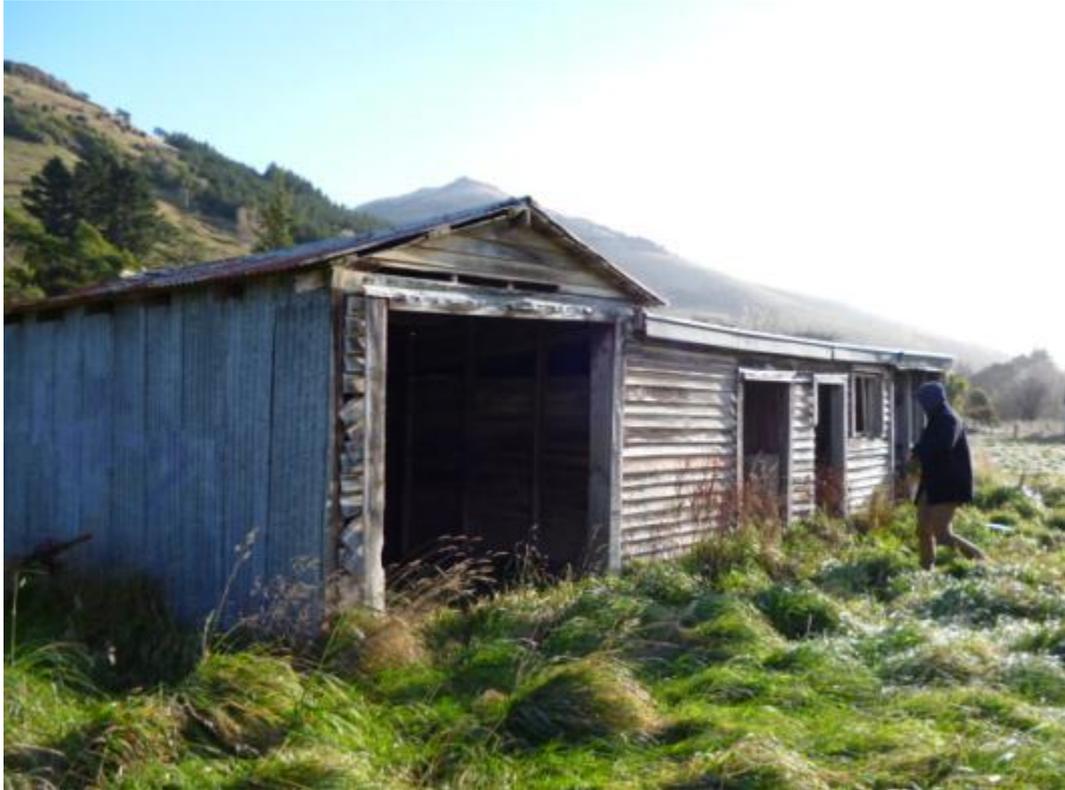
Photograph 3 East Elevation

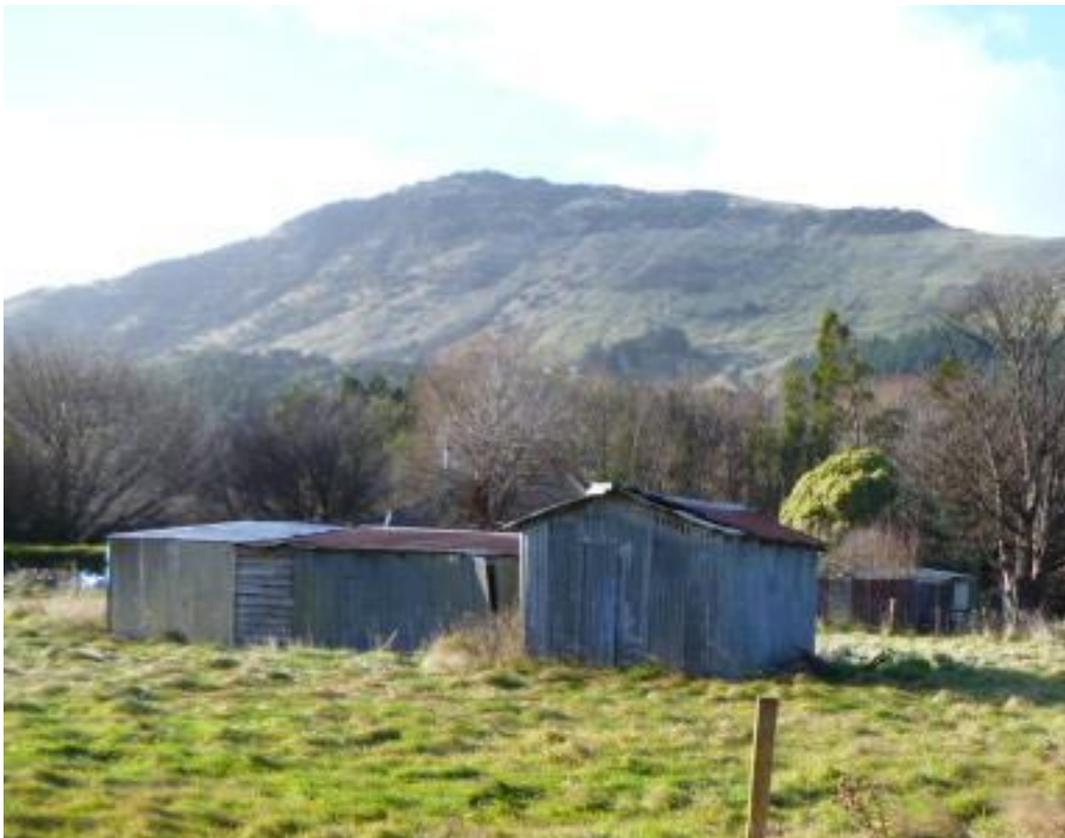
Photograph 4 West Elevation

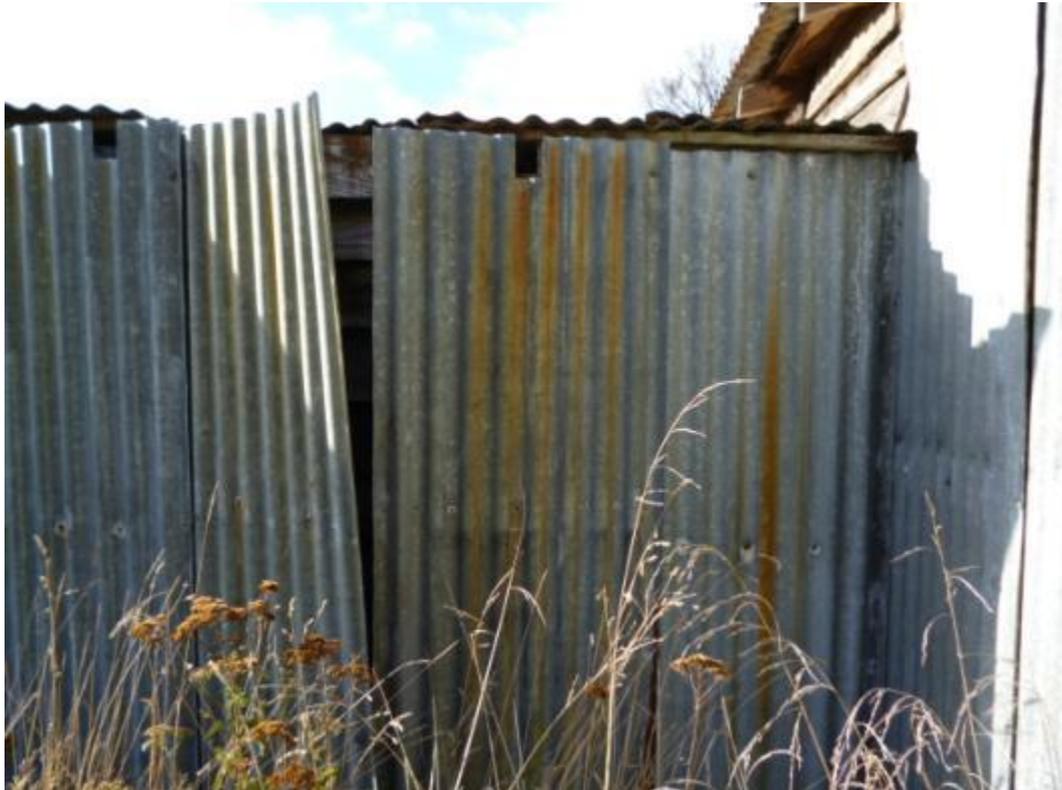
No residual displacements of the structure were noticed during our inspection of the building. There were loose sheets of corrugated iron; these were unlikely a result of seismic activity. However, the building is in particularly poor condition.

Photograph 5 Loose Corrugated Iron cladding/sheeting.

The recent seismic activity in Christchurch has caused no identifiable damage to the building, however the building is in particularly poor condition as a result of decay and Council may wish to consider demolition rather than any additional work on the structure.

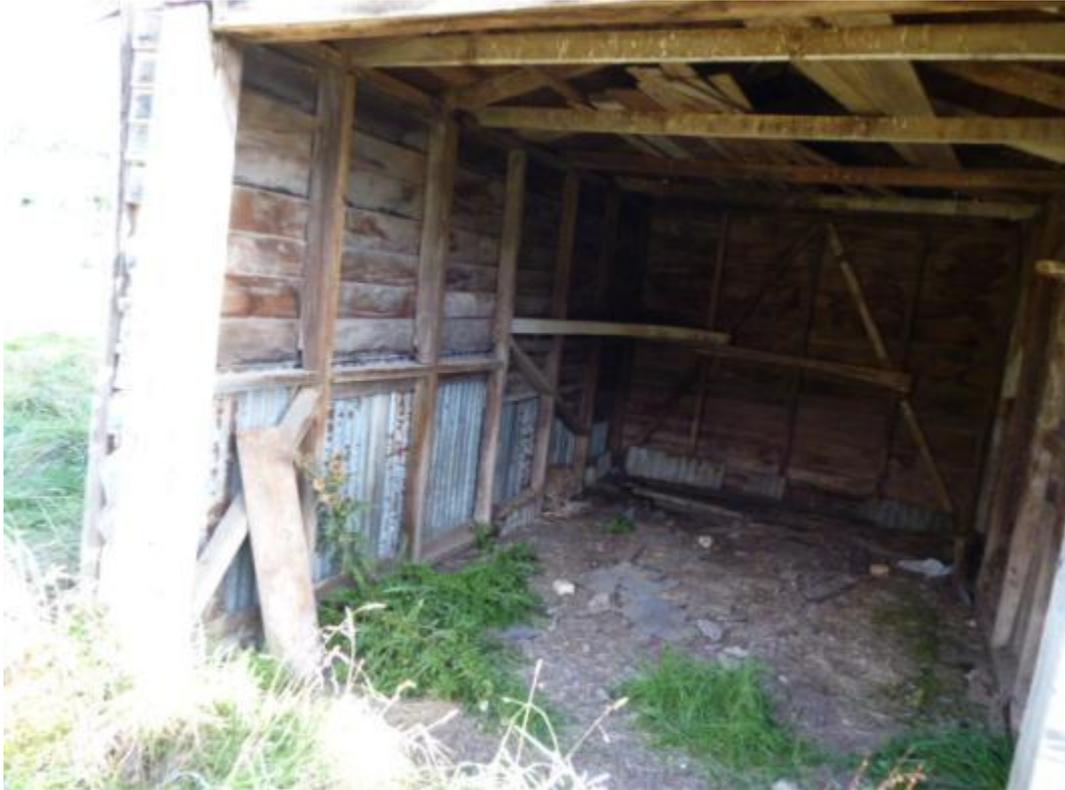
Photograph 7 Southern Section - Interior 1

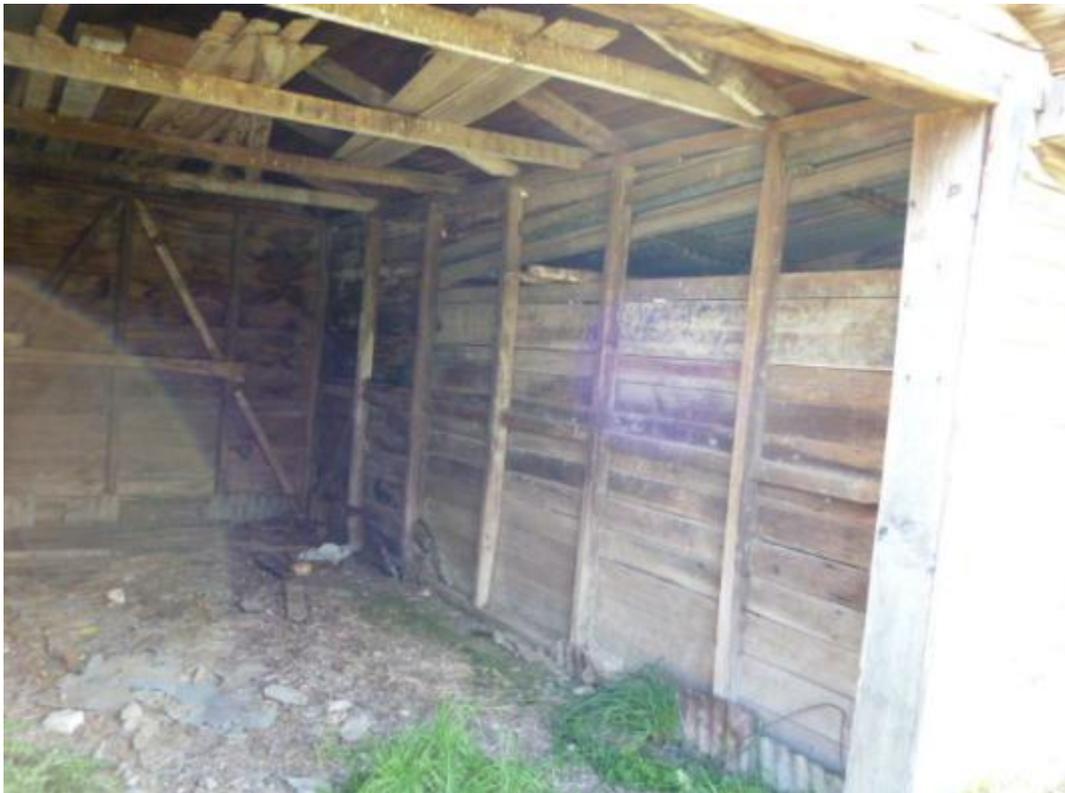
Photograph 8 Southern Section – Interior 2

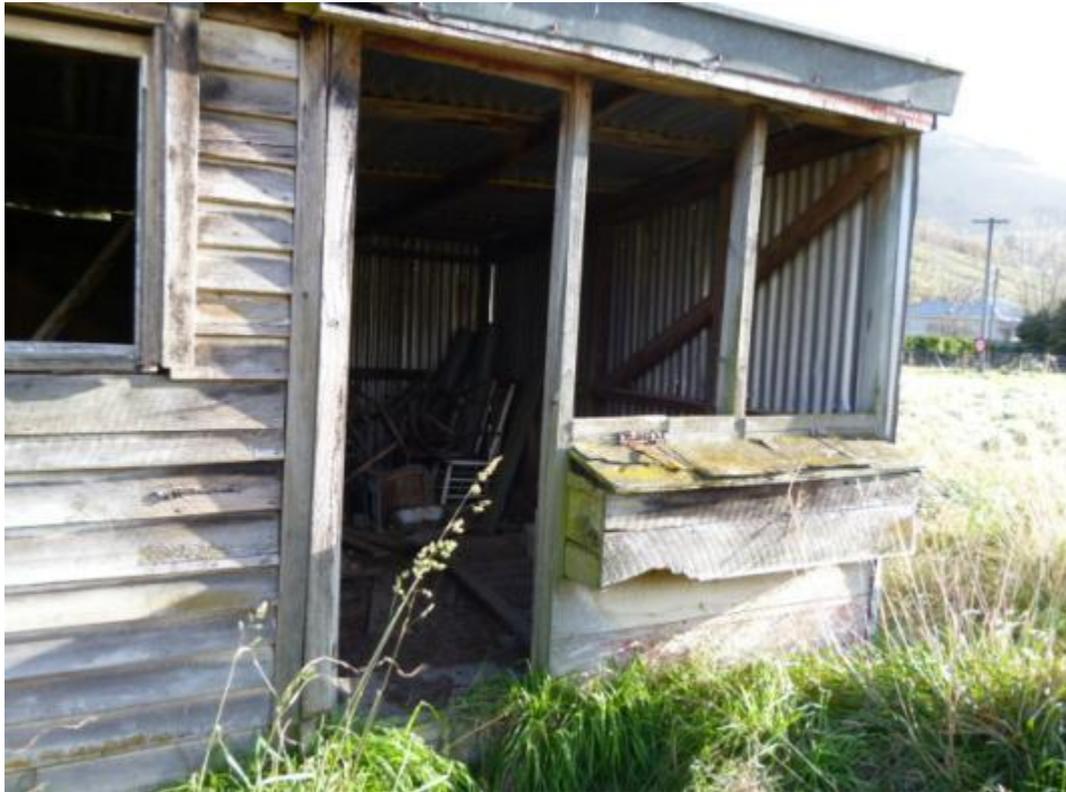
Photograph 9 Northern Section – Storage

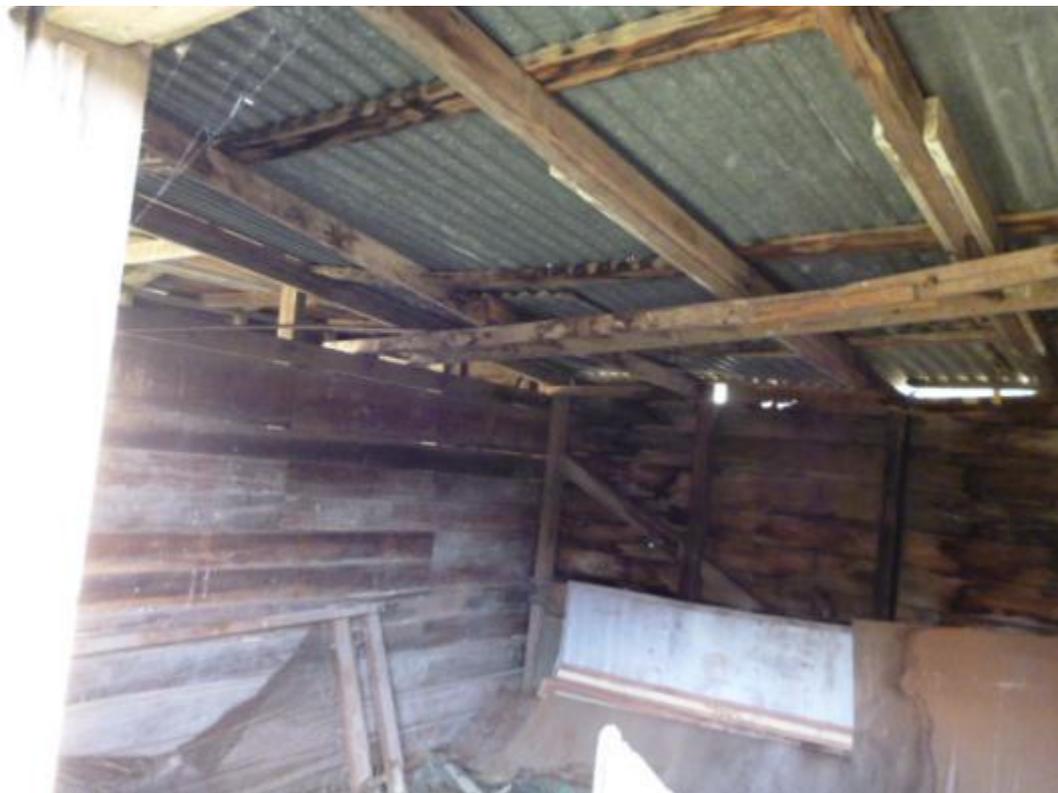
Photograph 10: Roof System - Northern Section

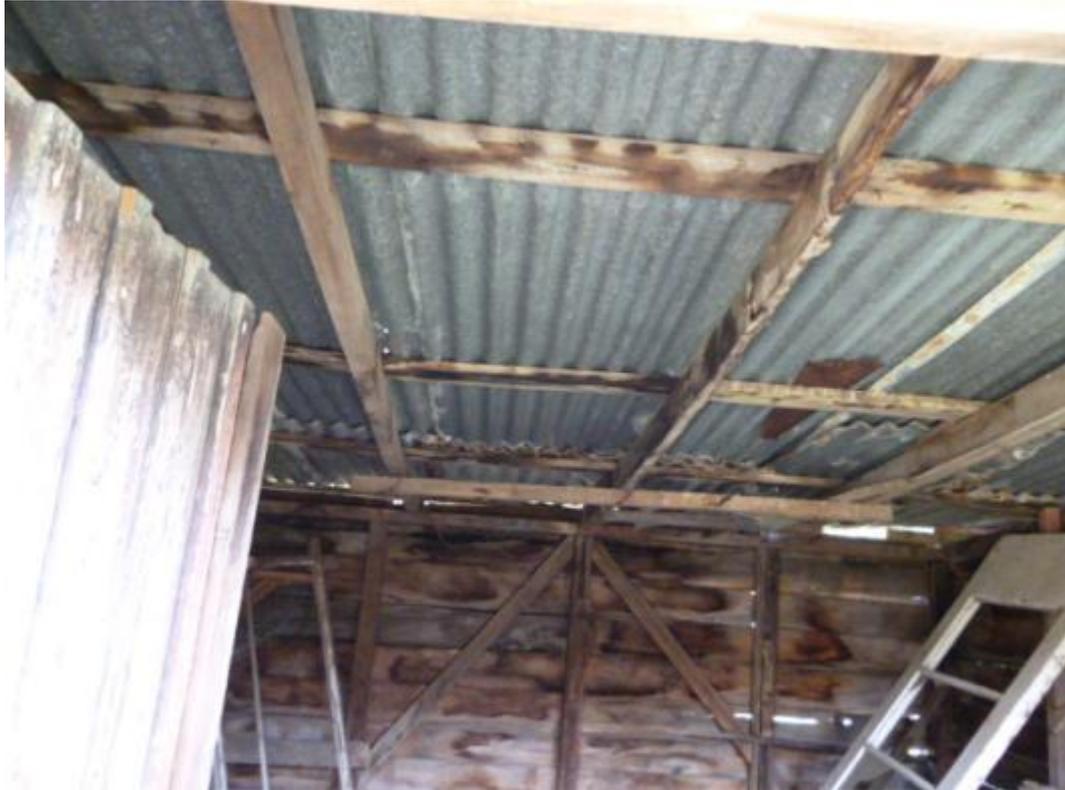
Photograph 11: Roof System - Northern Section

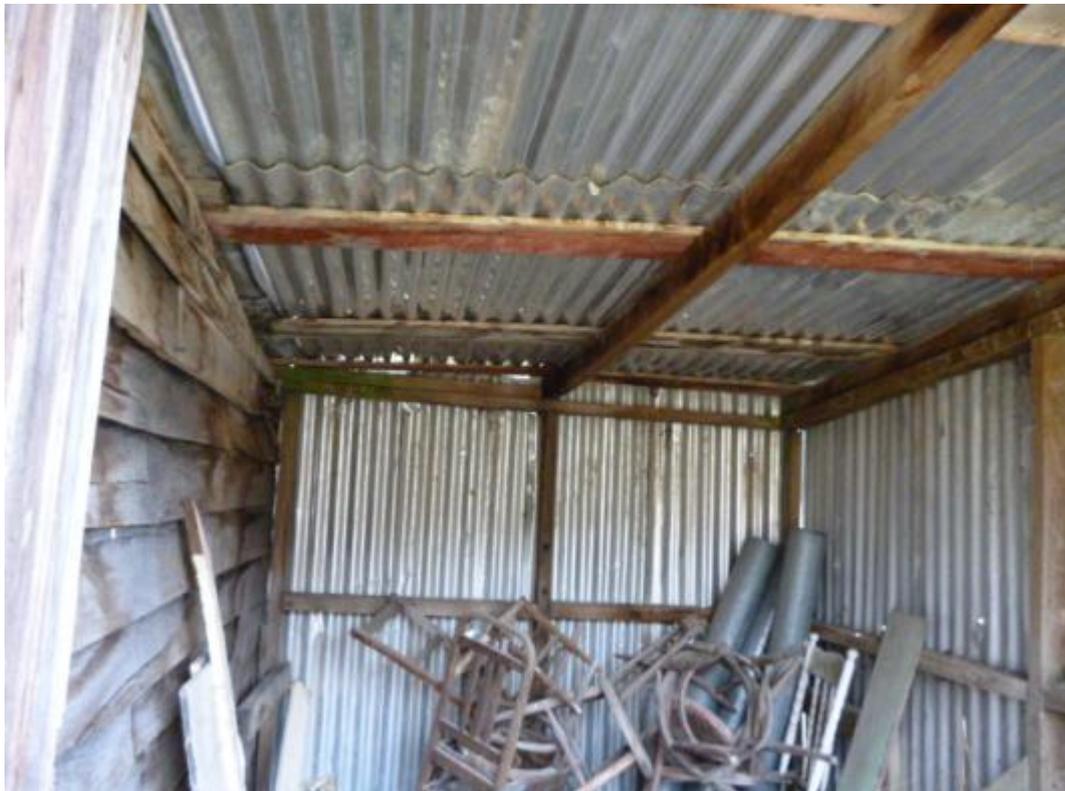
Photograph 12: Roof System - Northern Section
