Hornby Multicultural Centre Hall
Qualitative Engineering Evaluation

Reference: 227683
Prepared for:
Christchurch City Council

Functional Location ID: BU 2522 001 EQ2

Date: 19 October 2012

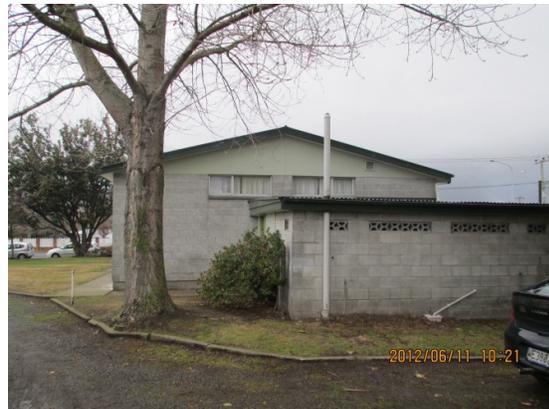
South western elevation of the Hornby Multicultural Centre Hall toilet block. The joint running through the centre of the toilet block highlights that the toilet block was constructed in two stages.

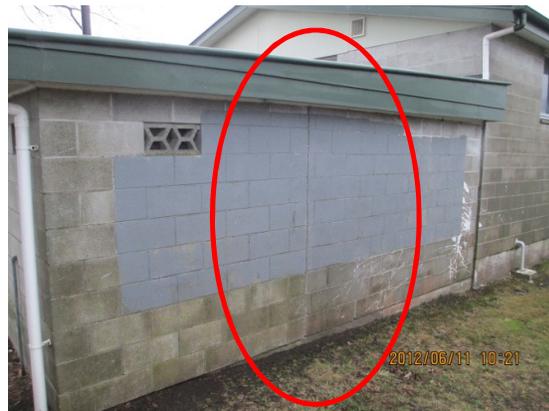
The floor levels for the Hornby Multicultural Centre Hall were generally found to be within the recommended tolerances with the exception of the toilet block area. Both the levels survey and visual assessment concur that the toilet block has settled in the north western corner. Nevertheless, the lack of damage seen to the superstructure and the absence of liquefaction boils in the vicinity suggests that the observed settlement is due to long term soil consolidation rather than seismic actions.

Close up of the crack in the toilet block, which increases in width up the wall indicating differential settlement.

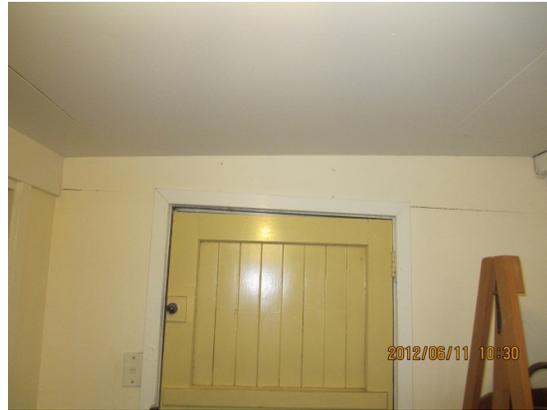
View from underneath the vents of the concrete perimeter foundation suggests that the concrete masonry walls are partially filled.

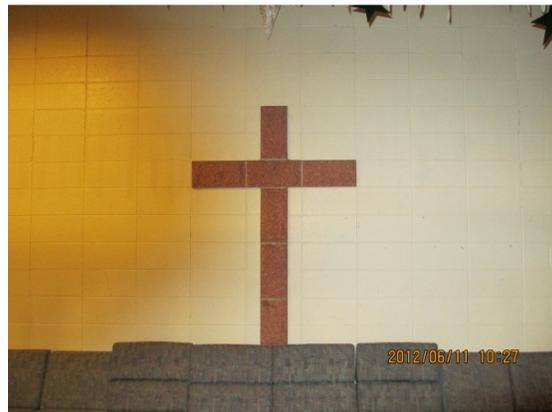
Cracking of the mortar joints in the south eastern gable wall.

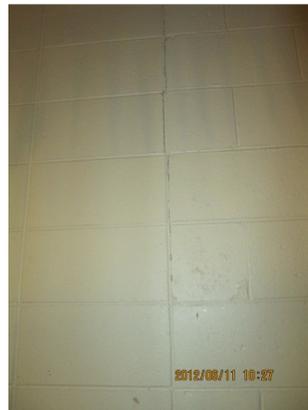
Cracking in the mortar joints of the south eastern side wall.

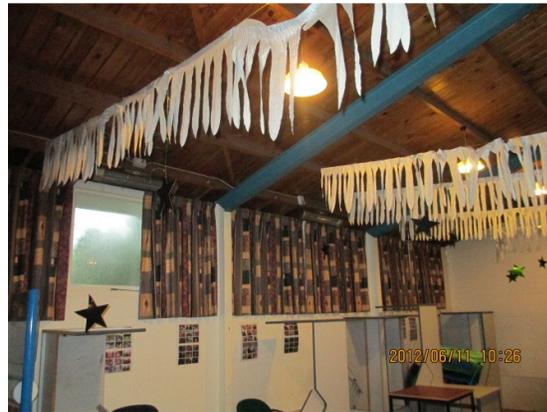
Close up of the interface between the timber sarking roof, the steel portal frame and the concrete masonry side wall.

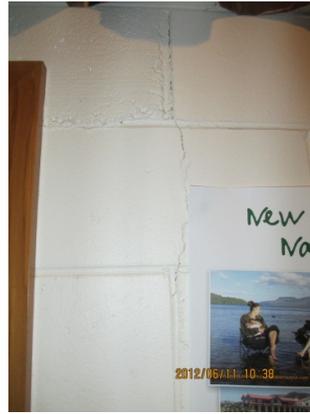
Cracking in the kitchen/toilet concrete masonry partition wall viewed from the toilet block.

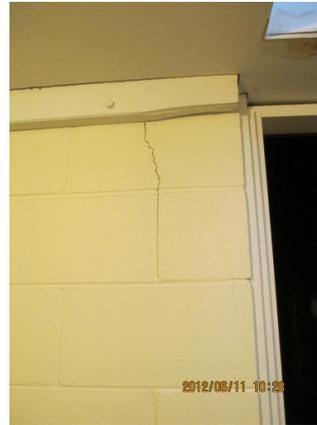
Top view of the toilet's concrete masonry partition walls.

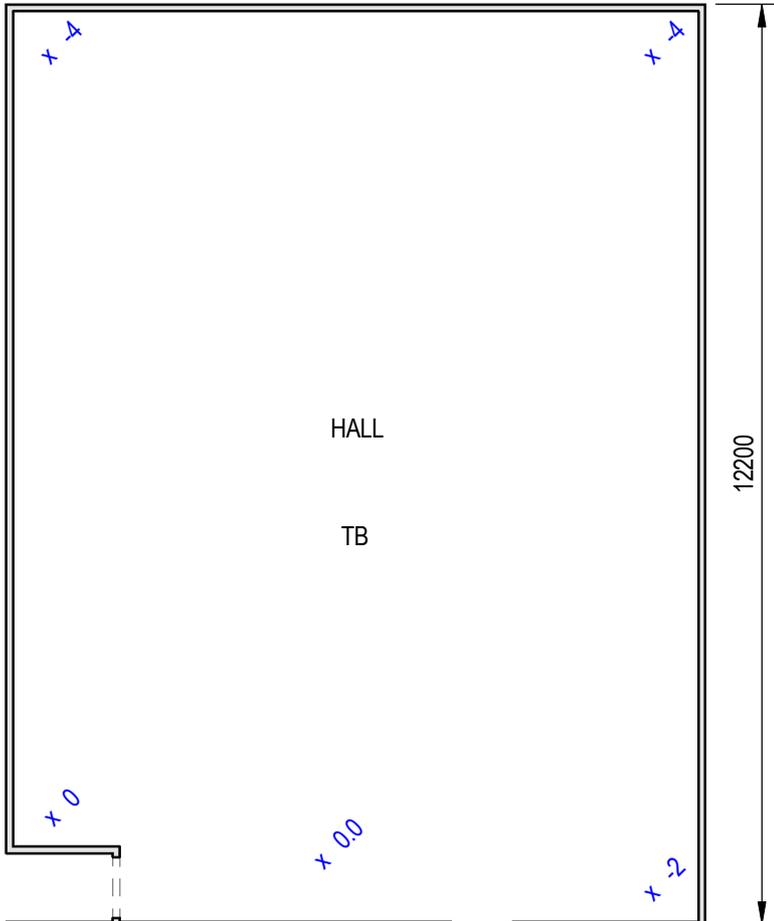
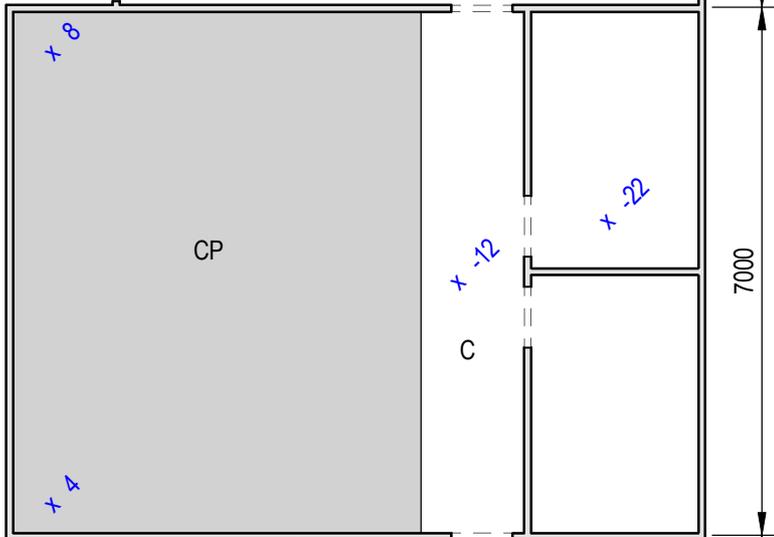
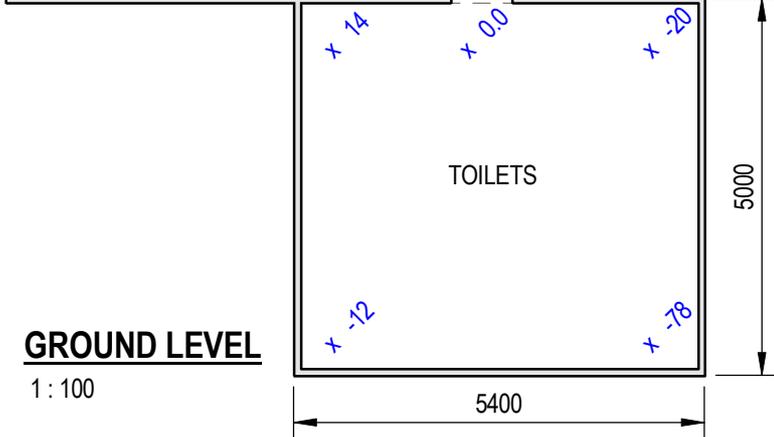
PROJECT
153 GIBERTHORPES RD, HEI HEI, CHRISTCHURCH
CCC HORNBY MULTICULTURAL CENTRE
TITLE
FLOOR LEVEL SURVEY

MAXIMUM VARIATION ACROSS GROUND LEVEL = 78mm
