Hornby OSCAR Early Learning Centre PRO 3052

**Detailed Engineering Evaluation
Quantitative Assessment Report**

Date: March 2013
Reference: 6-QC107.00
Status: Final

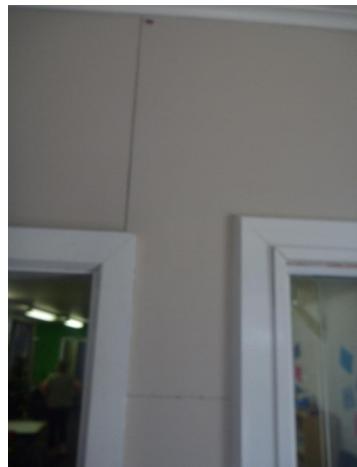
Some minor cracking was noted at various locations between plasterboard sheets forming the internal wall linings together with some horizontal cracking at the junction between the wall and ceiling linings.

Photo 10: Plasterboard crack at door head

Cosmetic work is required to infill the gaps noted between plasterboard sheets and repair the ceiling junctions with the wall linings. It may be prudent to verify if sufficient fixings between the plasterboard linings and timber panels have been provided.

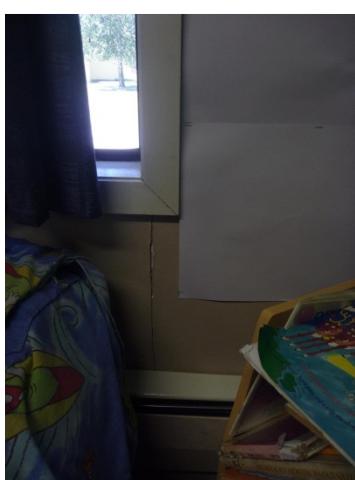
Photo 11: Plasterboard crack at spandrel

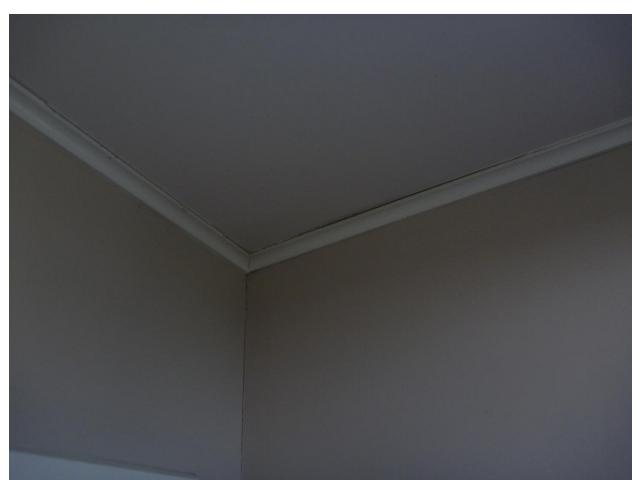
Photo 12: Movement at wall/ceiling junction
