Huggins Place Housing Complex PRO 0638

**Detailed Engineering Evaluation
Quantitative Assessment Report**

Huggins Place Housing Complex Quantitative Assessment Report

Date: February 2014
Reference: 6-QC361.00
Status: Final

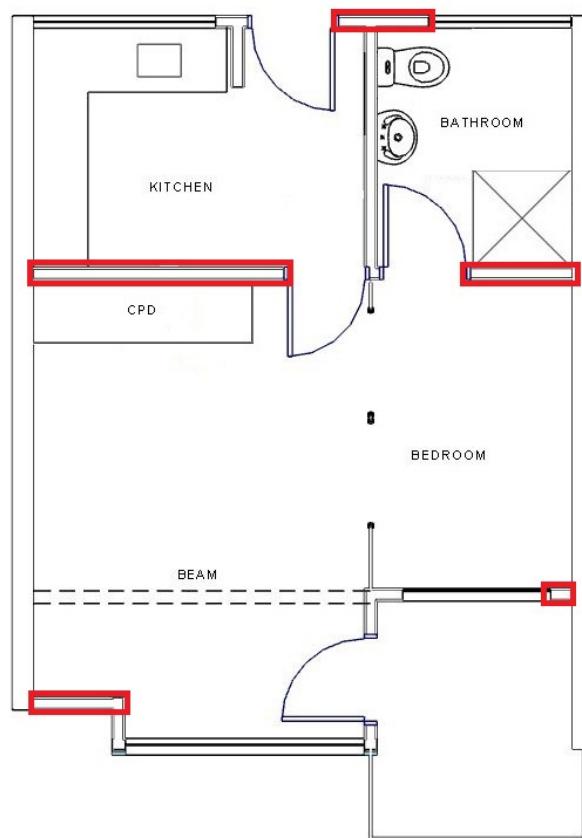
Figure 5: Walls used for bracing in the longitudinal direction.

Hand calculations were performed to determine seismic forces from the current building codes. These forces were applied globally to the structure and the capacities of the walls were calculated and used to estimate the %NBS. The walls, highlighted in Figure 5 and Figure 6, were used for bracing in their respective directions.

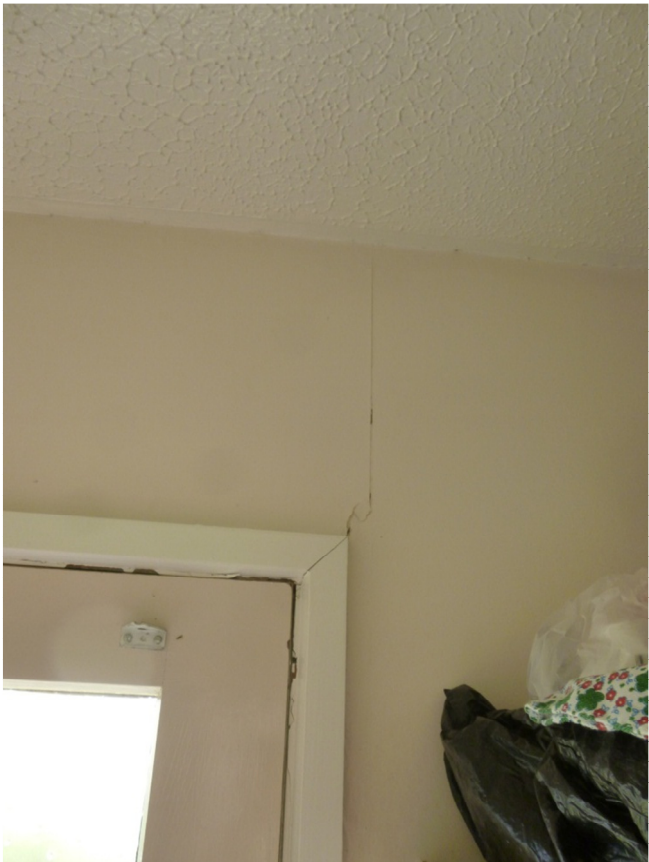
Plasterboard cracking was observed in all units typically above doorways, windows and at the roofline. Cracking of the ceiling diaphragm was also observed.

| 12. | Typical cracking above doorways | A photograph showing a vertical crack in the wall above a doorway. The ceiling is textured, and the wall is a light beige color. A doorway is visible on the left, and some items are on the right. |

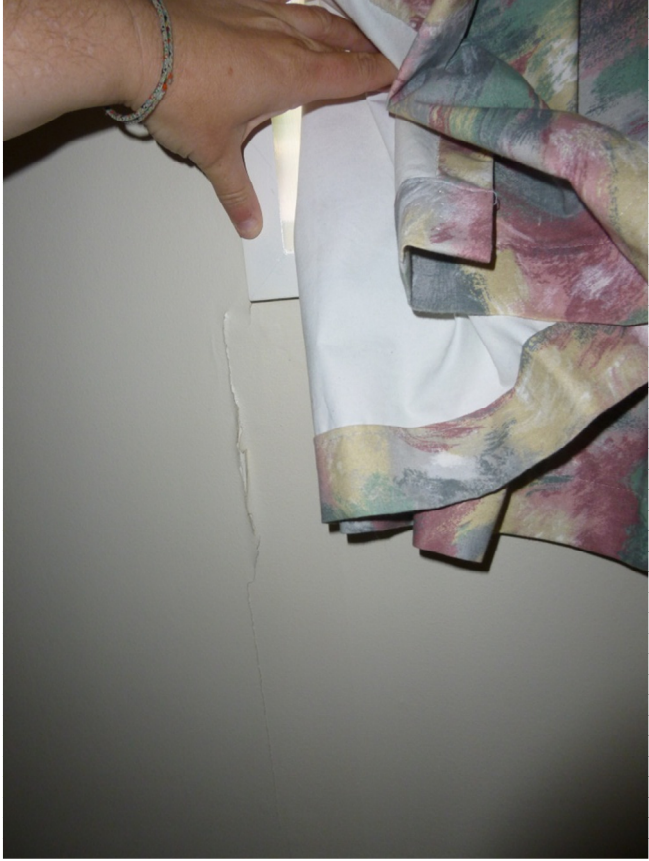
| 13. | Typical cracking around windows | A photograph showing a hand pointing to a crack in the wall around a window. The wall is light grey, and the window has a colorful, patterned curtain. |

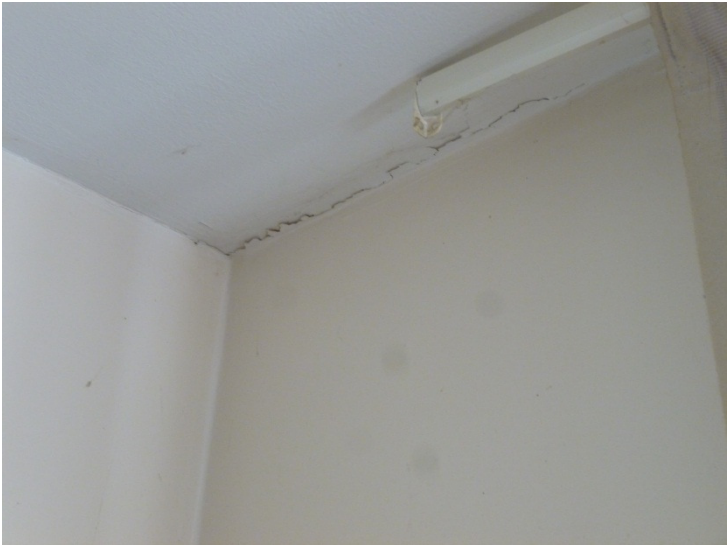
| 14. | Typical cracking at the roofline | A photograph showing the corner of a room where the ceiling meets the wall. There is a significant crack running along the roofline, and some peeling paint is visible on the wall. |

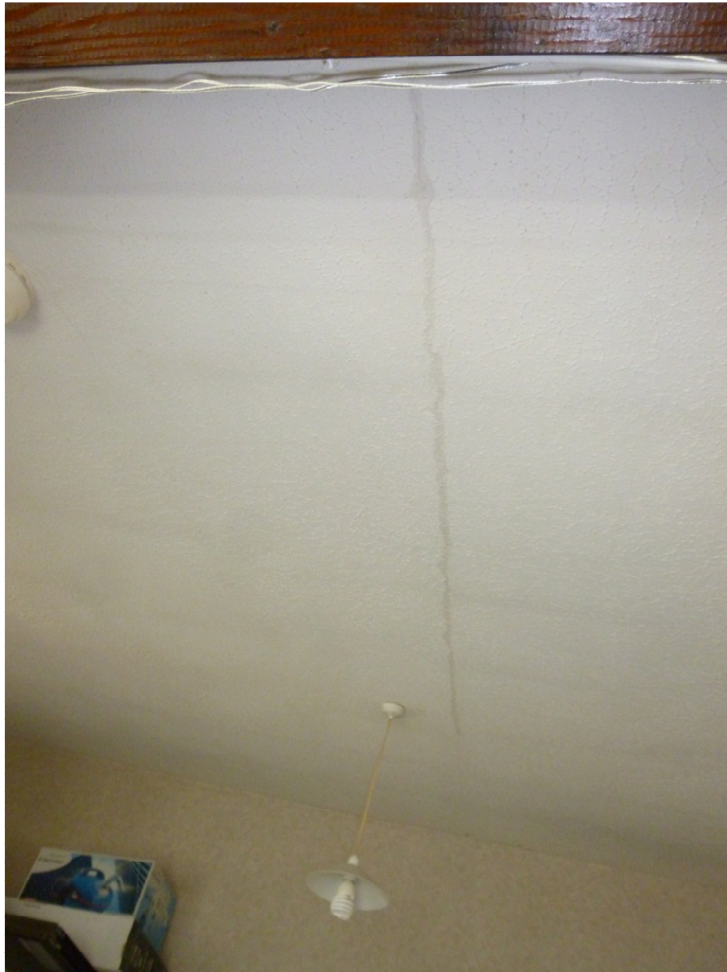
| 15. | Typical cracking of the ceiling diaphragm | A photograph showing a large, vertical crack running down the center of a white ceiling. A light fixture is visible on the ceiling, and a box is on the floor in the bottom left corner. |

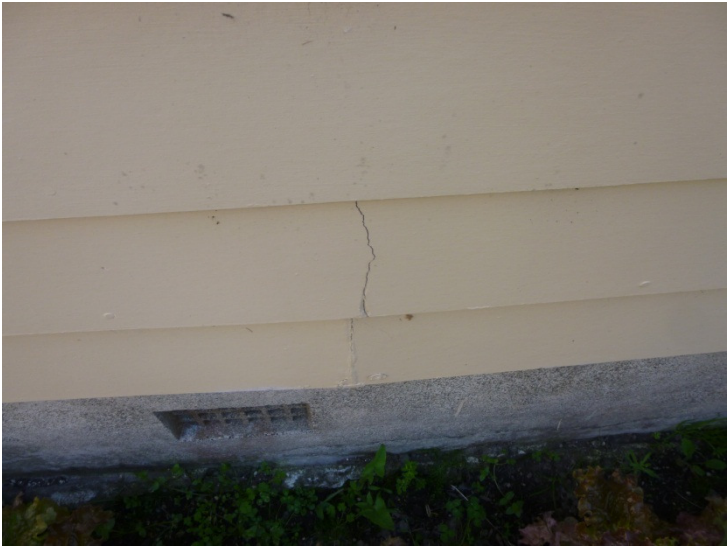
Cracking through the weatherboard veneer was observed at the ends of most blocks (photo 16). Hairline cracking of the concrete entrance patio was observed in all units. Minor splitting was observed between the weatherboard veneer and the firewall (photo 20).

| 16. | Cracking through the weatherboard veneer | A photograph showing a vertical crack running through a light-colored, horizontal weatherboard veneer on an exterior wall. Below the veneer, a concrete foundation is visible, and some green foliage is at the base of the wall. |

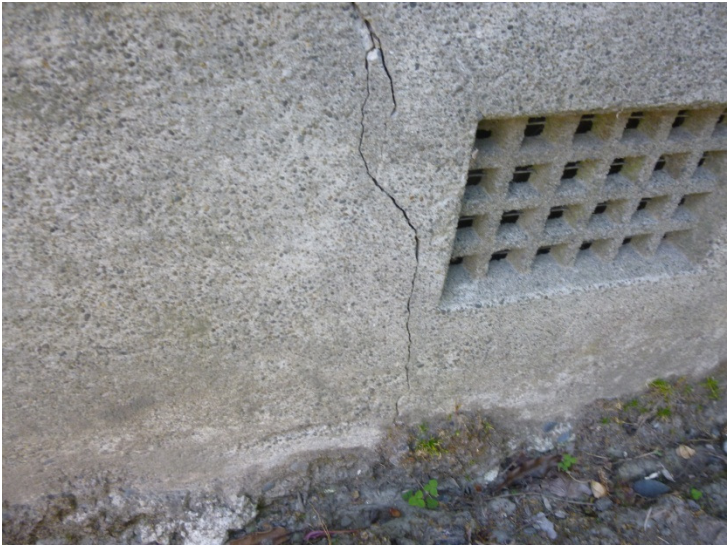
The concrete piles have settled differentially causing excessive floor slopes. There is moderate cracking to the concrete perimeter wall, this cracking was observed to extend through both the render and the concrete itself. Cracks greater than 3.5mm were observed in the new concrete perimeter wall of Blocks F and G (photo 22).

| 17. | Cracking of the concrete perimeter wall | A close-up photograph of a concrete perimeter wall. A vertical crack is visible on the left side of the wall. To the right, there is a rectangular section of the wall with a grid-like pattern, possibly a drainage or ventilation feature. The ground at the base of the wall is covered with some debris and small plants. |

- Strengthening schemes be developed to increase the seismic capacity of Blocks A – H to at least 67%NBS.
- Units be releveled as required.
- The concrete perimeter footings be repaired where cracking occurs.
- Additional weight in the roof space be removed, in particular, the concrete header tanks.
- Cosmetic repairs be undertaken as required.

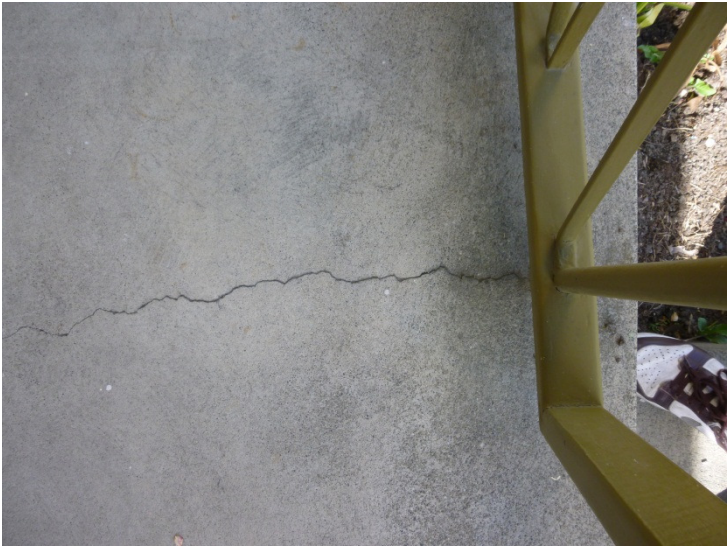
| 18. | Cracking of the concrete patio | A photograph of a concrete patio surface. A horizontal crack runs across the middle of the frame. On the right side, a portion of a yellow metal railing is visible, suggesting the patio is adjacent to a walkway or stairs. |

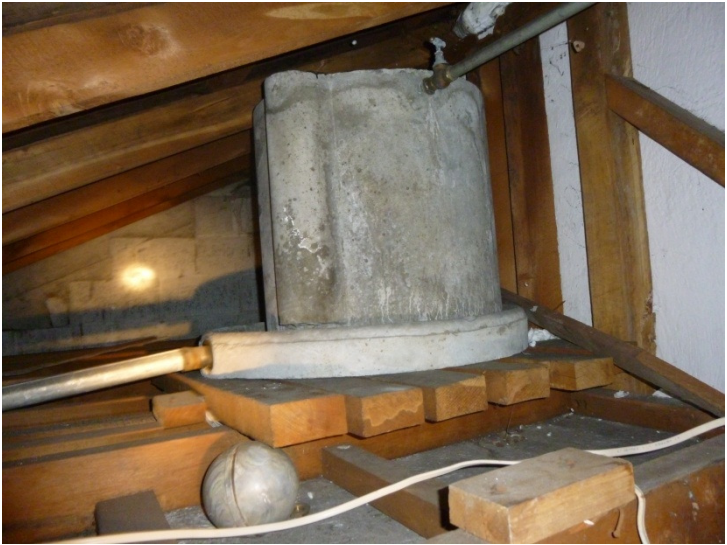
| 19. | Concrete water tank (Blocks A-E) | |

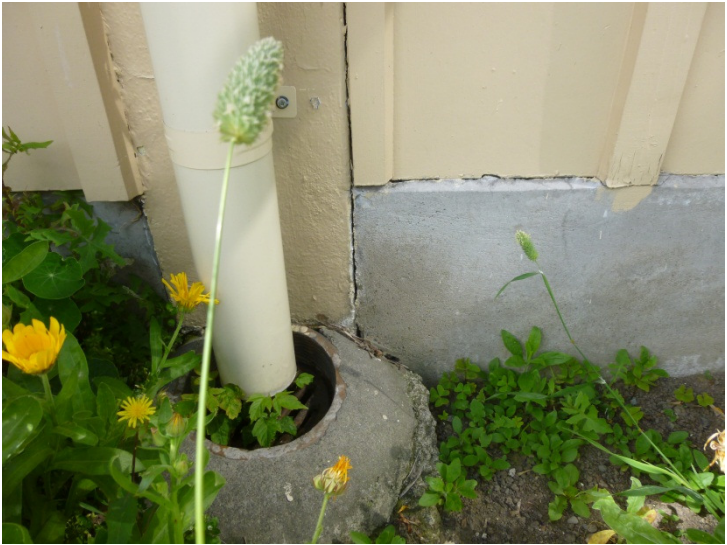
| 20. | Slight splitting of the veneer and firewall | |

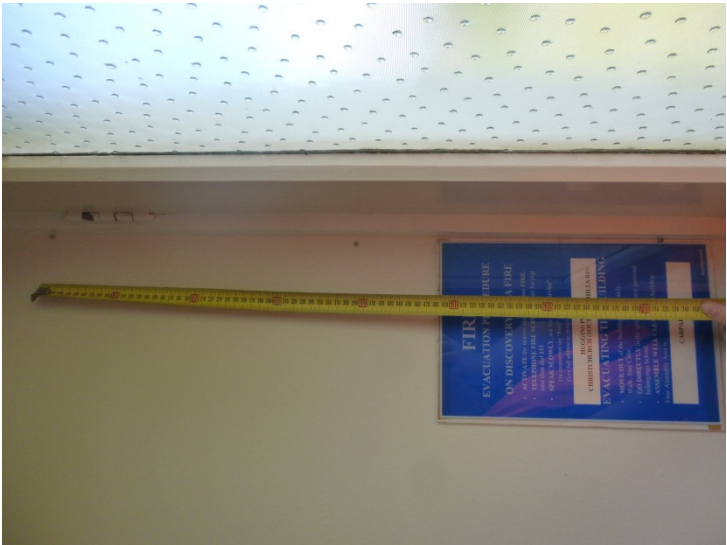
The internal lining nail spacings were measured on site to vary between 300-400mm.

| 21. | 400mm nail spacings | |

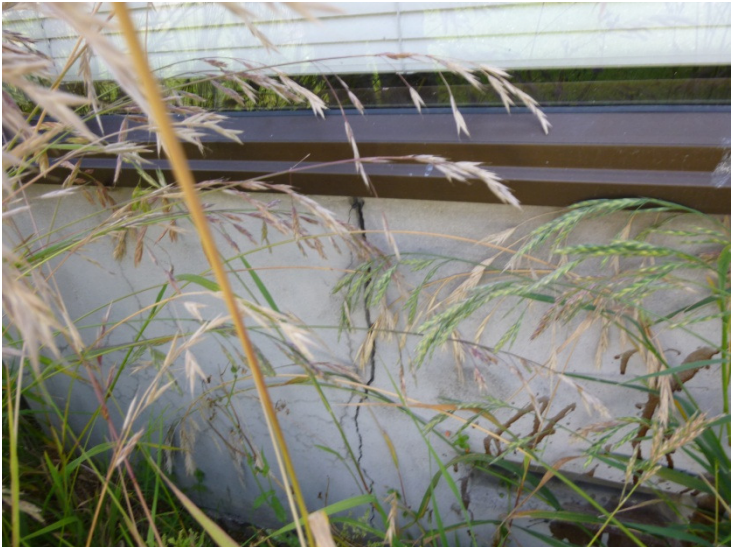
| 22. | Cracking of the extension perimeter wall of Blocks F and G (greater than 3.5mm) | |
