Jellie Park Recreation & Sport Centre
BU 0266-006 EQ2
Indoor and Outdoor Hydroslides
Detailed Engineering Evaluation
Quantitative Assessment Report

Jellie Park Recreation & Sport Centre Hydroslides Detailed Engineering Evaluation

Quantitative Assessment Report

Date: September 2012
Reference: 6-QUCCC.62
Status: Final

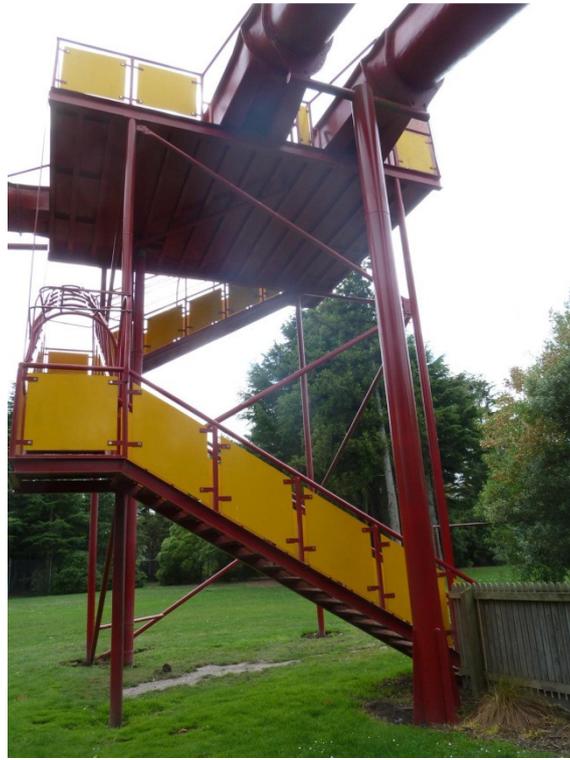
Figure 1 – Outdoor Hydroslide Platform Structure – Looking North

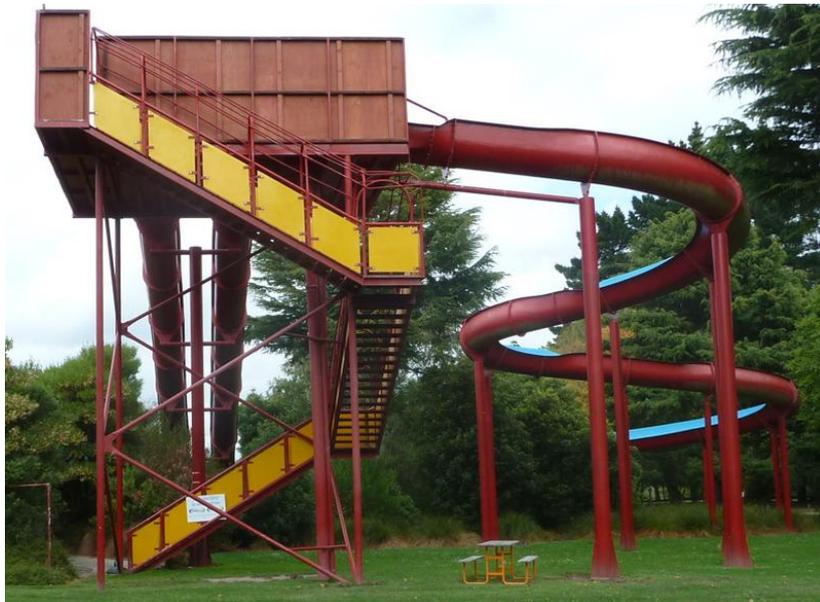
Figure 2 – Outdoor Hydroslide Platform Structure – Looking South

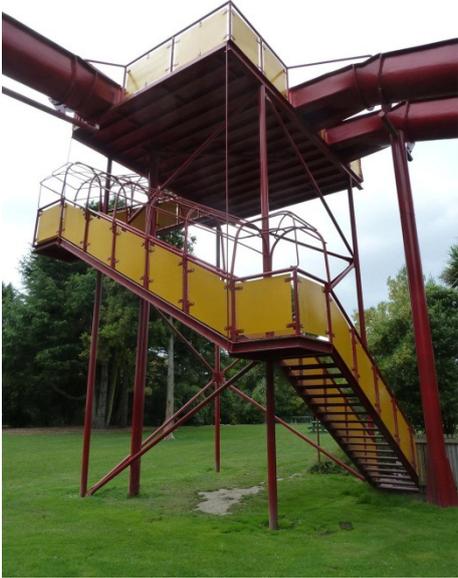
Figure 3 – Outdoor Hydroslide Platform Structure – Looking Northeast

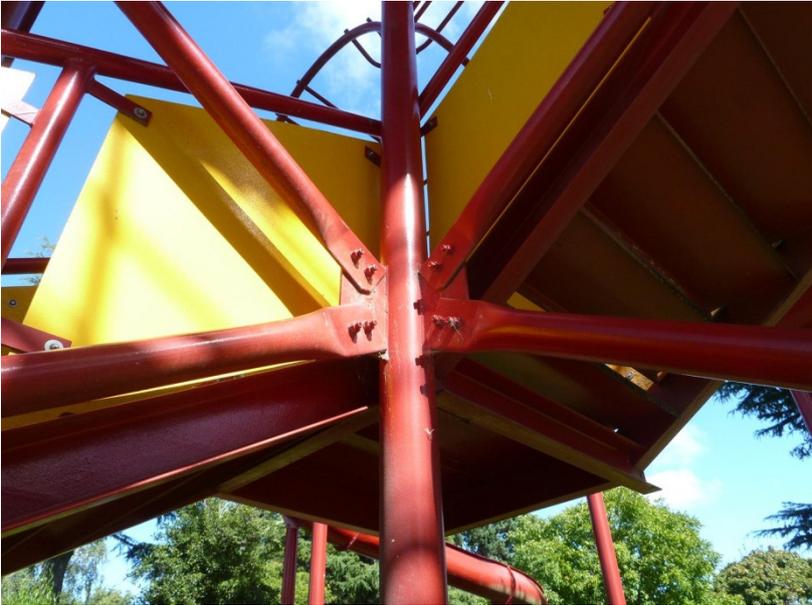
- b) **Outdoor Platform Pipe Bracing Connections** – Failure of these connections is a brittle failure mechanism, resulting in loss of lateral stability. A loss of lateral stability would lead to collapse of the platform.

Figure 4 – Typical Mid-Column Height Pipe Brace-to-Column Connection

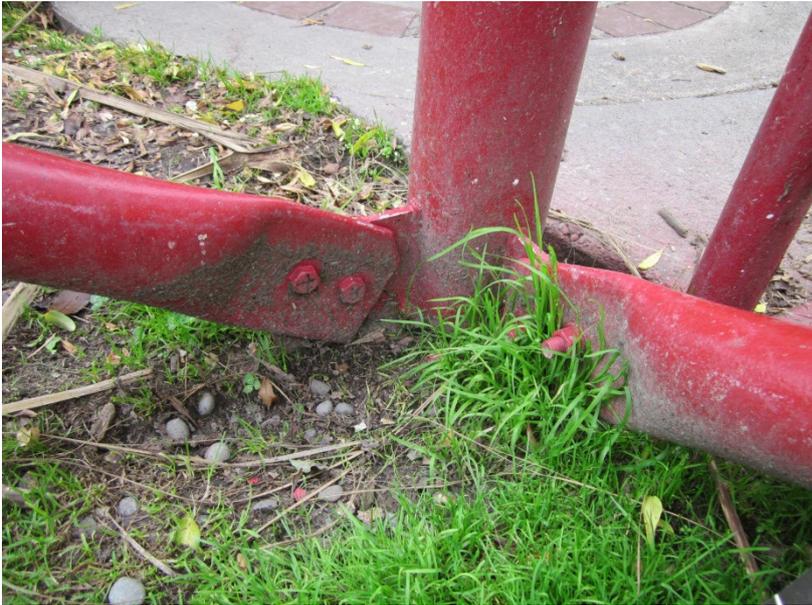
Figure 5 – Typical Pipe Brace-to-Column Connection at Platform Column Base

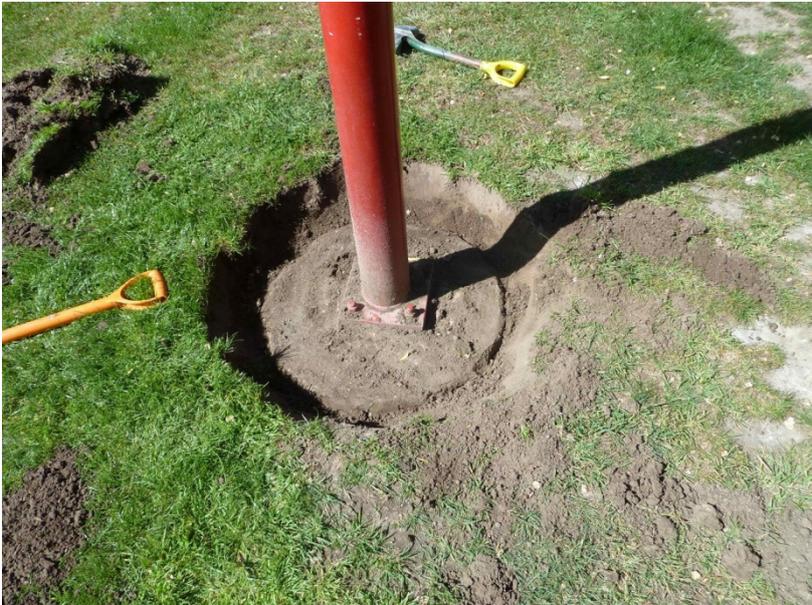
- c) **Uplift of Outdoor Platform Column Foundations** – Insufficient uplift capacity of the foundation would result in the rocking of the platform. In general, rocking of a structure is an energy dissipating mechanism and would increase the seismic performance of a structure. However, if there is too much rocking, the structure will not be able to right itself, resulting in a collapse of the structure.

- d) **Sliding of Outdoor Platform Column Foundations** – A foundation sliding failure of the piles, which are not tied together at ground level, would lead large column base displacements. Large column base displacements could lead to axial instability of the platform columns, leading to collapse of the platform.

Figure 6 – Platform Column Base Connection

- Based on the actual pipe brace wall thickness, the pipe braces may or may not need to be replaced. If the actual pipe brace wall thickness leads to a %NBS that is below 67% NBS, then the braces will need to be replaced.
- If the pipe braces require replacing, new brace connections at the columns will also be required.
- Since the platform foundations are insufficient for uplift and sliding, the existing foundations will need to be replaced with new foundations.

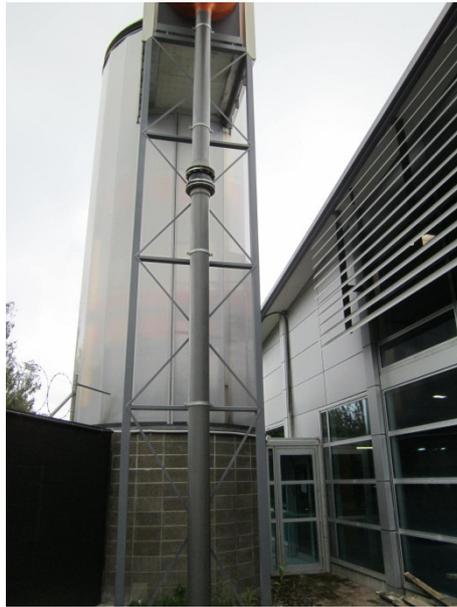
Figure 13 – Indoor Hydroslide Stair Tower and Braced Frame at Mouth of Slide

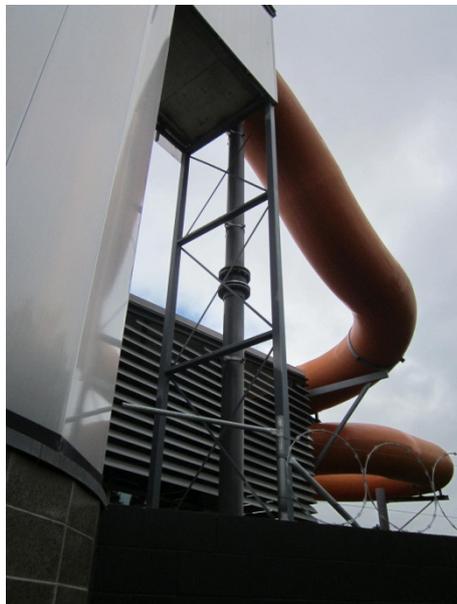
- e) **Uplift of Indoor Hydroslice Braced Frame Foundations** – Insufficient uplift capacity of the foundation would result in the rocking of the platform. In general, rocking of a structure is an energy dissipating mechanism and would increase the

- b) The seismic performance of the indoor hydroslide is governed by the uplift capacity of the foundations at the braced frame structure supporting the mouth of the slide. These foundations have a capacity of 35%NBS. The indoor hydroslide is therefore considered to be a moderate risk structure.

Figure 14 – Braced Frame Supporting Mouth of Slide and Stair Landing

- Since the foundation of the braced frame at the mouth of the slide is inadequate in uplift, the two existing isolated pad footings will need to be incorporated into a new footing system.

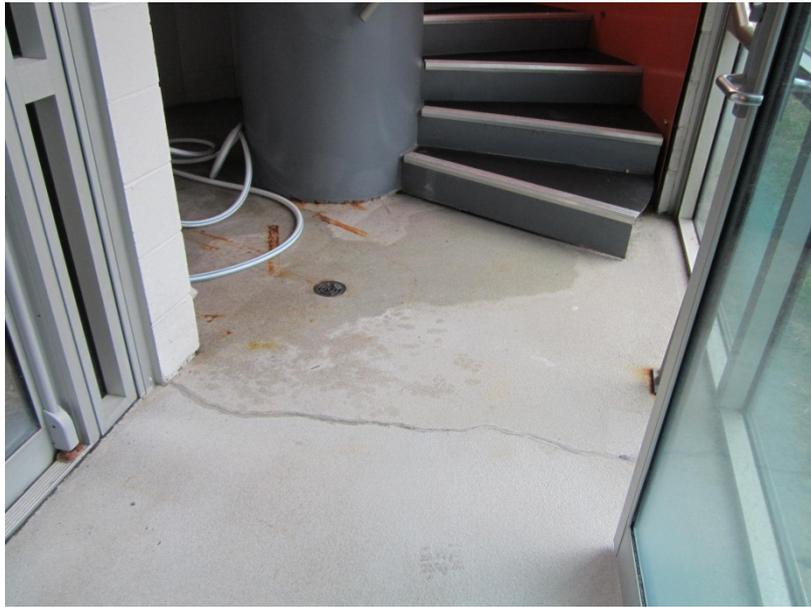
- Cracked slab on grade at the indoor hydroslide stair tower.

No structural damage was noted to the indoor hydroslide superstructure. There was cracking of the slab-on-grade that connects the new indoor pool to the indoor hydroslide stair tower. This cracking coincided with the edge of the hydroslide's stair tower foundation, leading to an assumption that the stair tower rocked during the earthquake.

Both structures appear to have generally performed well during the earthquake, with no apparent structural damage noted. The observed damage to the slab-on-grade between the indoor pool and indoor hydroslide stair tower is consistent with the stair tower rocking and the foundation cracking the slab as it rocks.

Figure 19 – Interior View of Stair Tower Base with Cracked Slab-on-grade (Evidence of Foundation Rocking)
