**Jellie Park
Recreation & Sport
Centre
PRO 0266-007**

**Detailed Engineering Evaluation
Quantitative Assessment Report**

Date: February 2014
Reference: 6-QUCCC.62
Status: Final V4

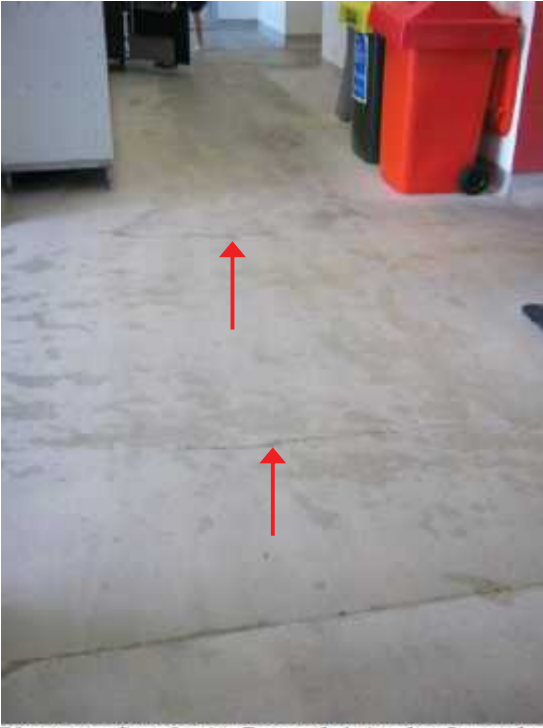
Photo 3: Cracks in floor slab in the foyer leading into the pool complex.

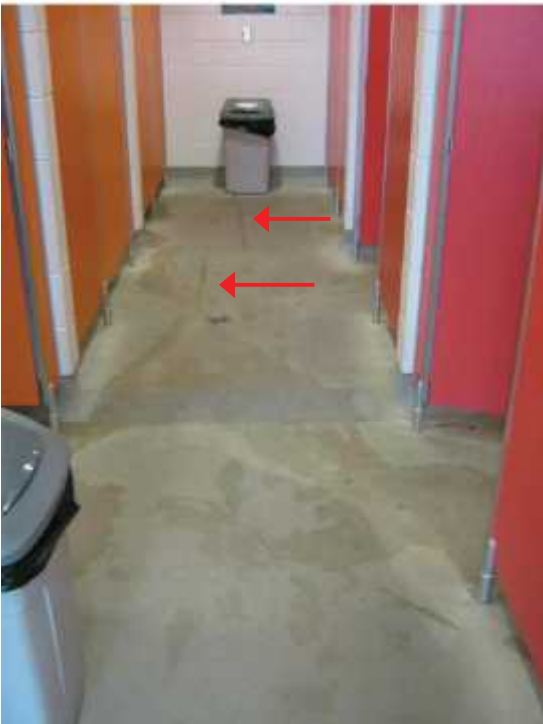
Photo 4: Cracks in floor slab in the Family Changing Rooms.

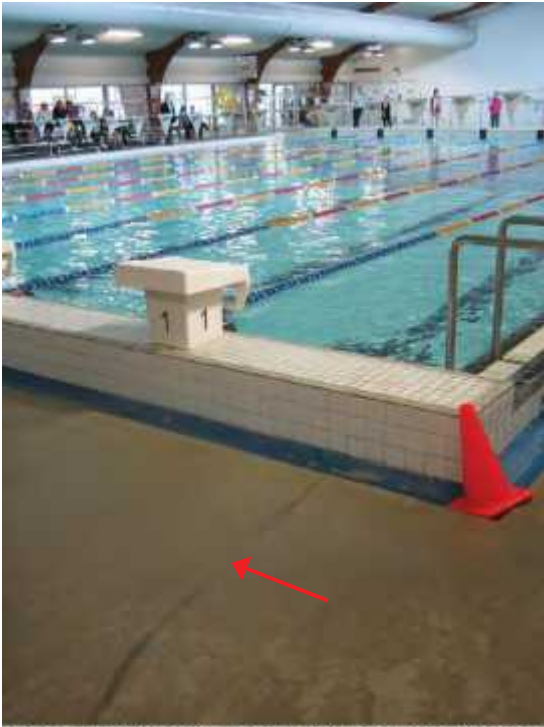
Photo 5: Crack in floor slab in the Old Pool Hall, looking north.

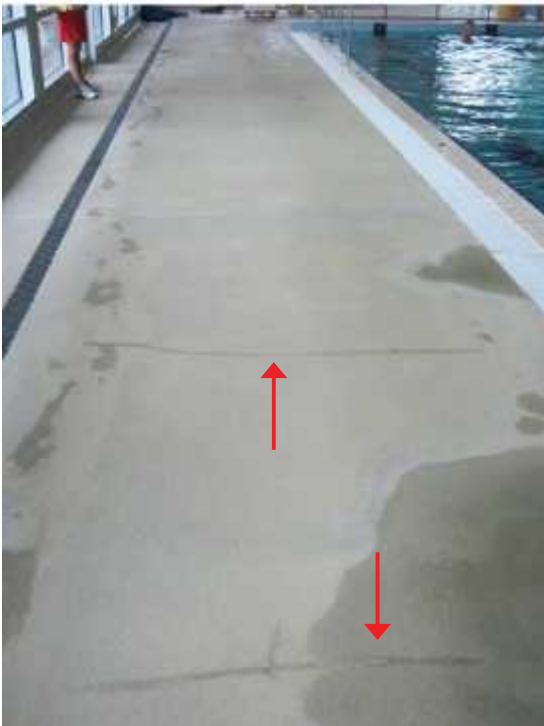
Photo 6: Cracks in floor slab in the New Pool Hall, looking north-east.

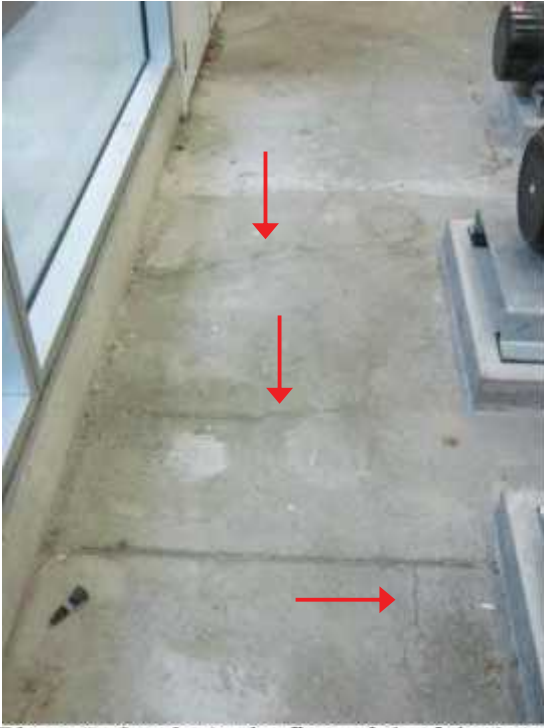
Photo 7: Cracks in the floor slab of the internal Plant Room 3.

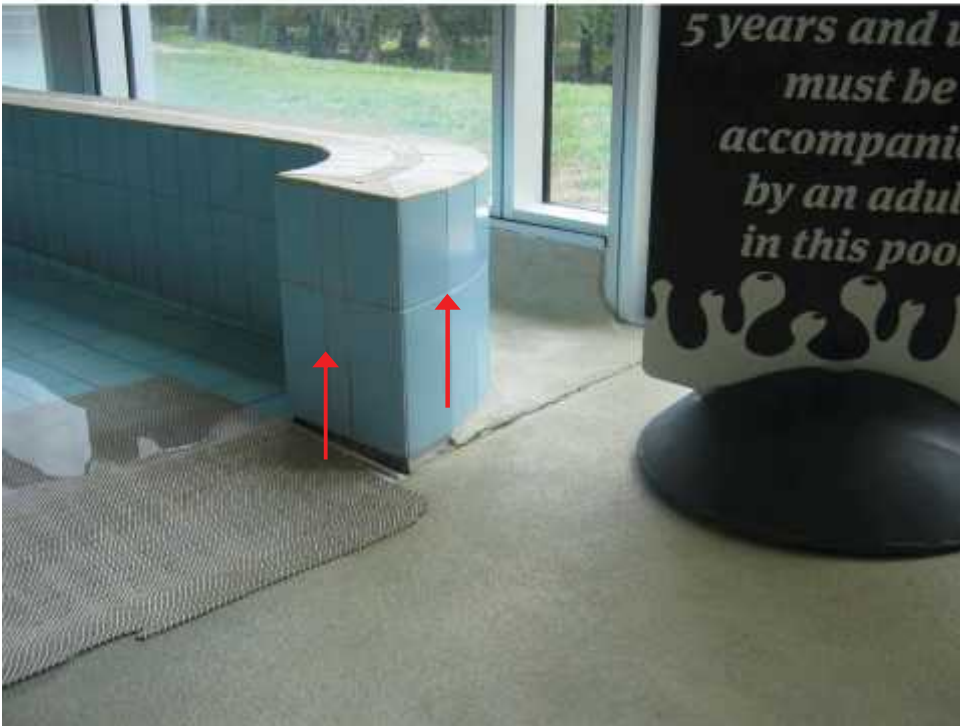
Photo 8: Possible settlement at the entrance to the Toddlers Pool, approximately 10mm to 15mm.

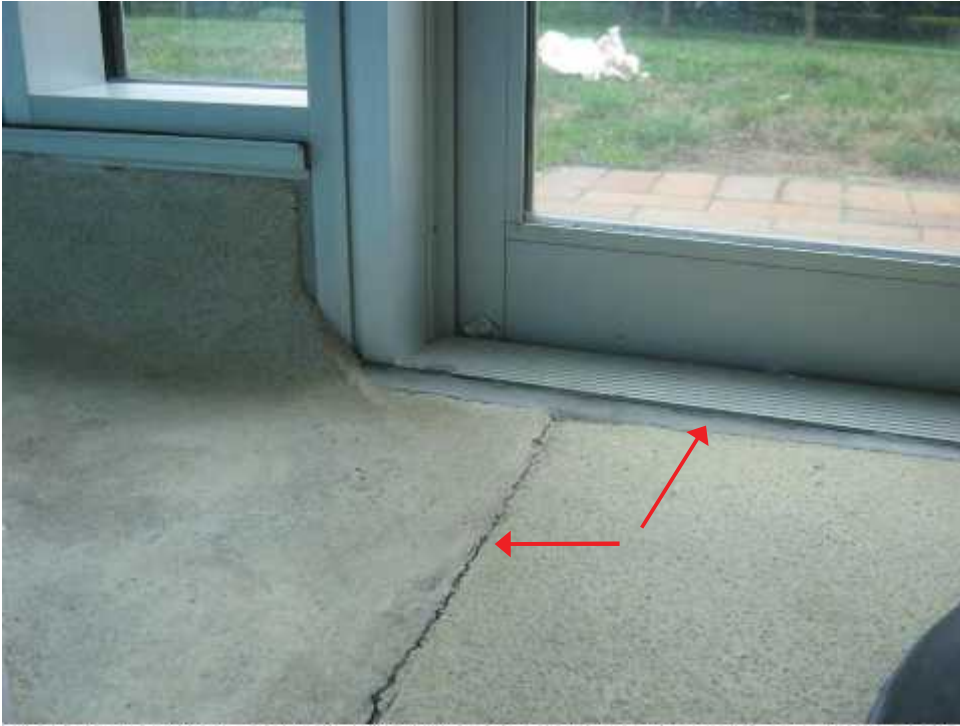
Photo 9: Possible settlement at the entrance to the Toddlers Pool. Note new seal at the base of external door frame.

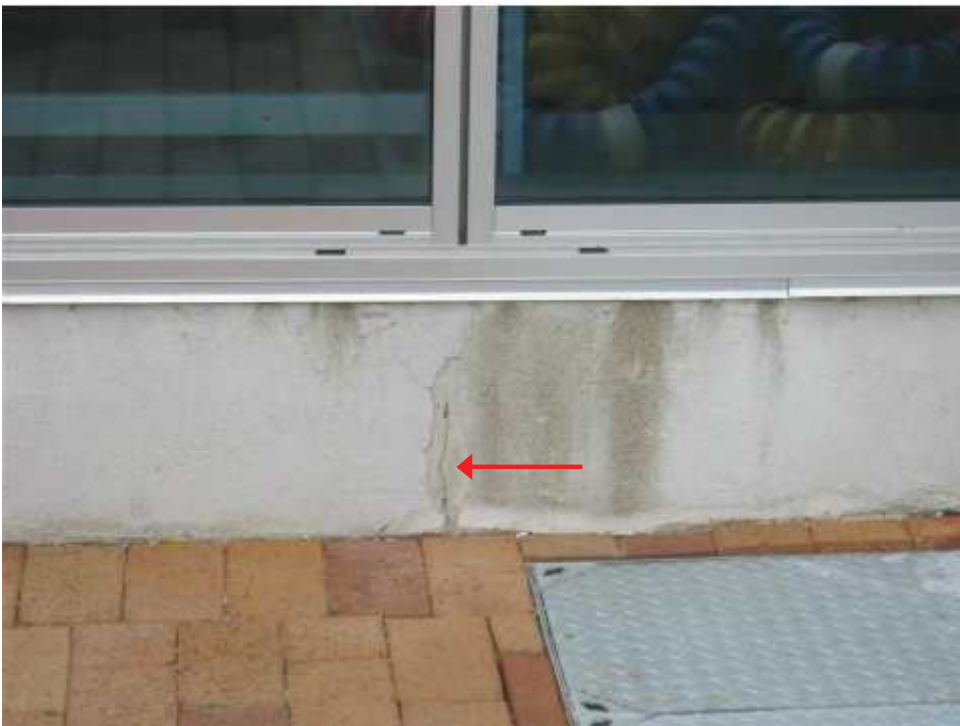
Photo 10: Cracking and spalling of concrete in the perimeter strip footing, north-west wall of the Spa Area.

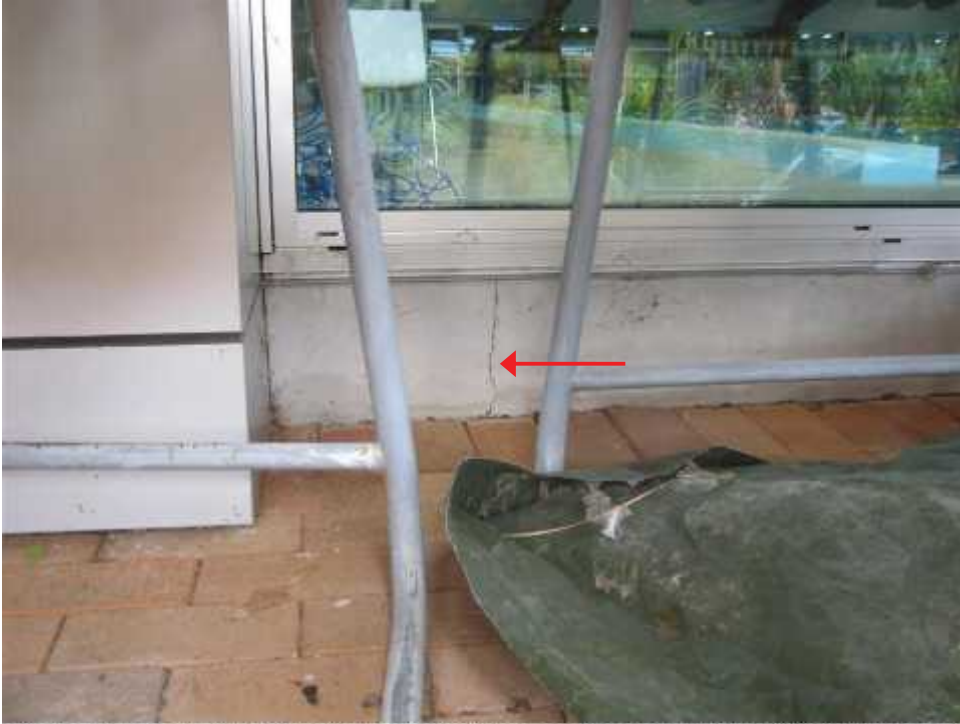
Photo 11: Crack in perimeter strip footing, north-west wall of the New Pool Hall.

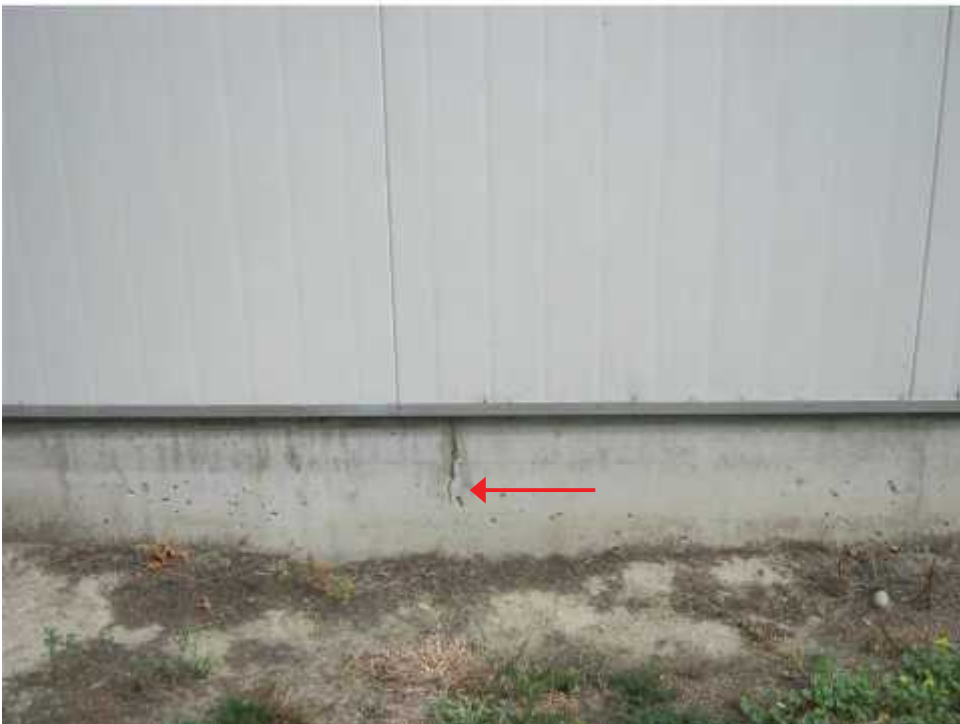
Photo 12: Crack in perimeter strip footing, northern side of Internal Plant Room 3.

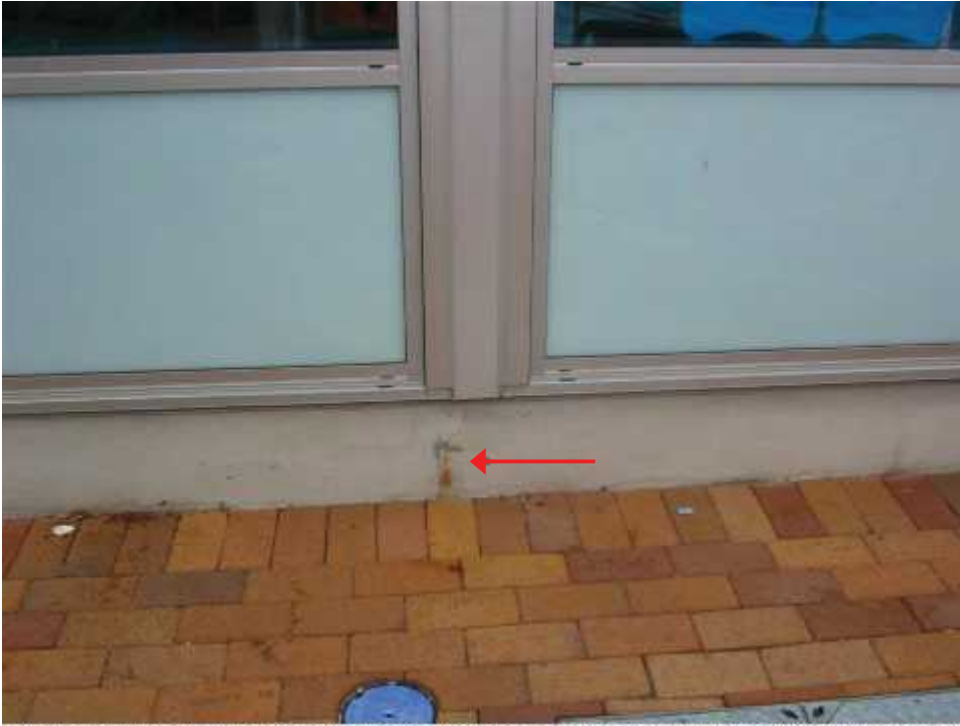
Photo 13: Crack in perimeter strip footing, north-west wall of the New Pool Hall.

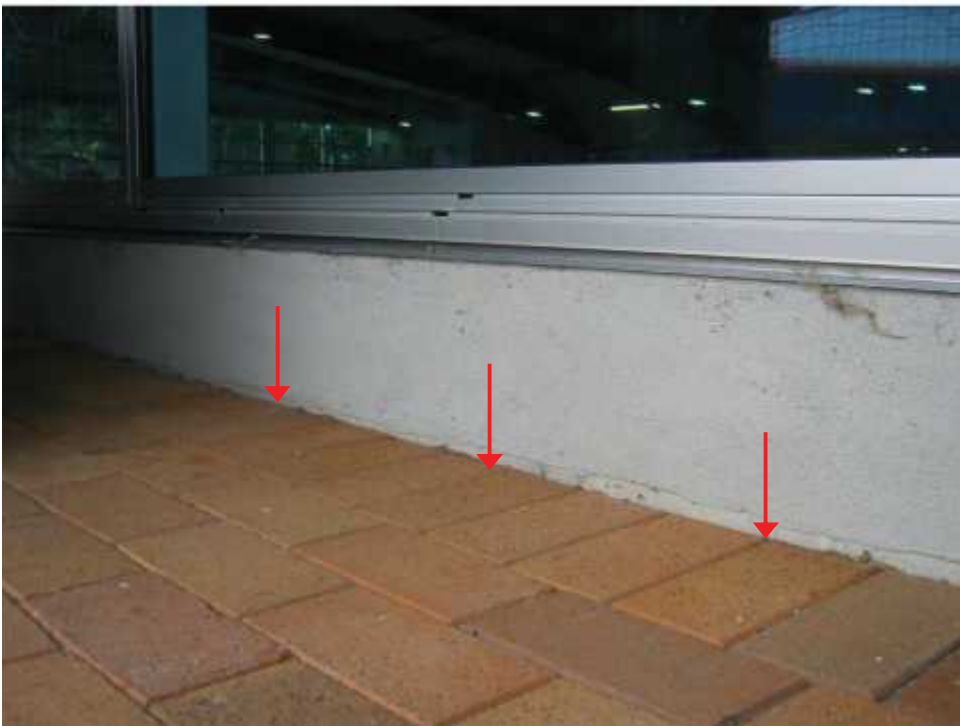
Photo 14: Horizontal crack in perimeter strip footing, north-west wall of the New Pool Hall.

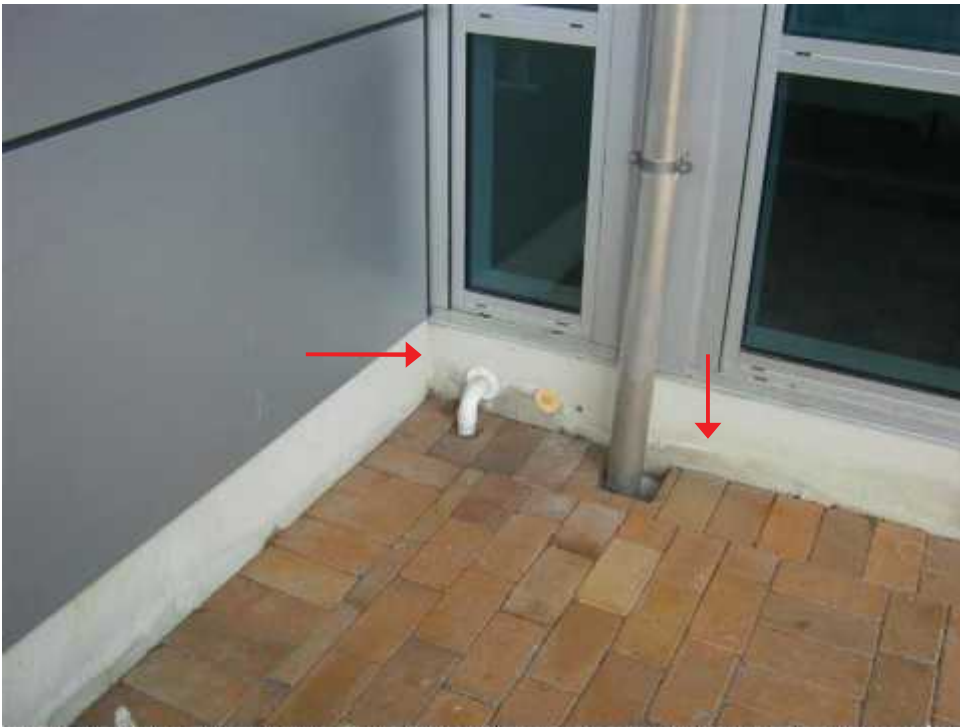
Photo 15: Minor vertical and horizontal cracking adjacent to the Gym and the Foyer, possible water damage.

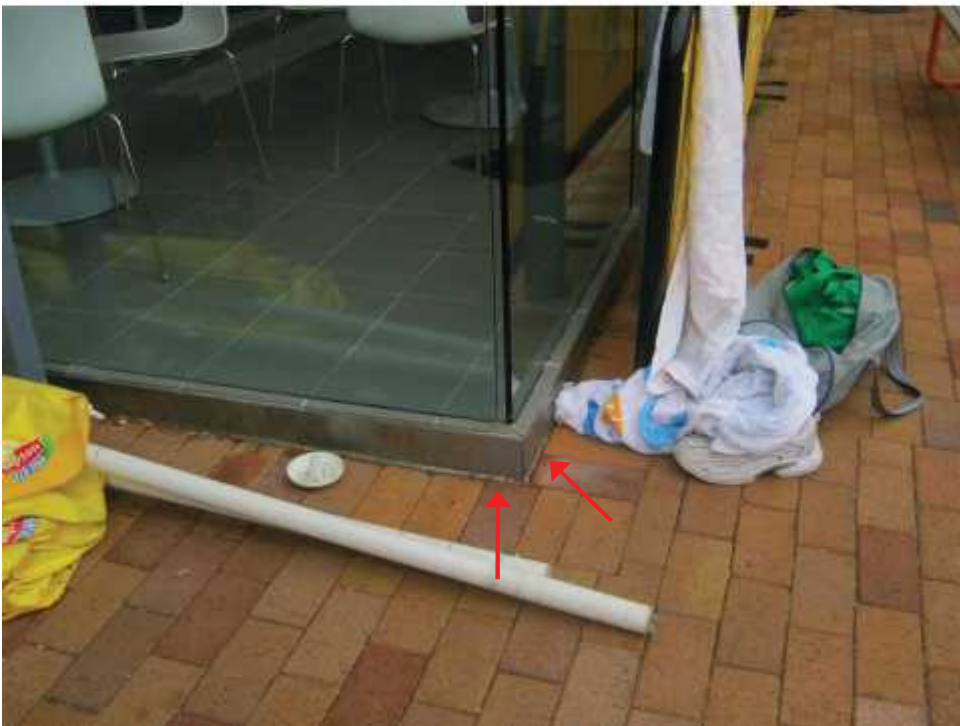
Photo 16: Minor settlement, approximately 10-15mm, between brick and tiled area outside of the cafe in the Foyer.

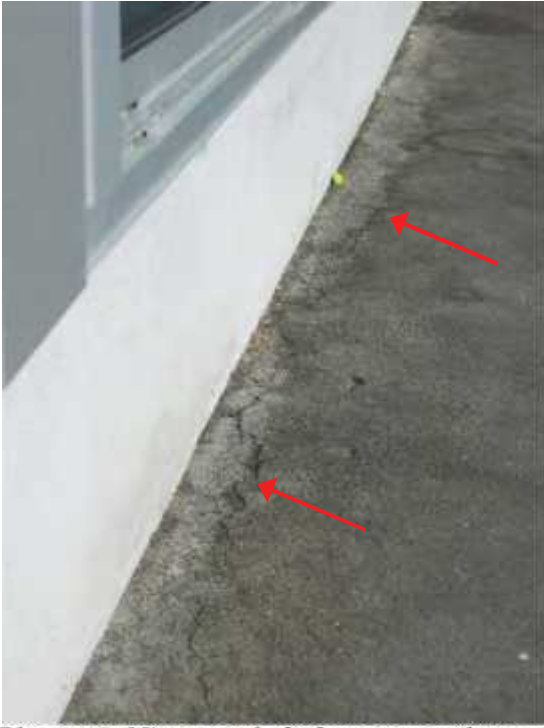
Photo 17: Minor asphalt damage on the north-west side of the Gym.

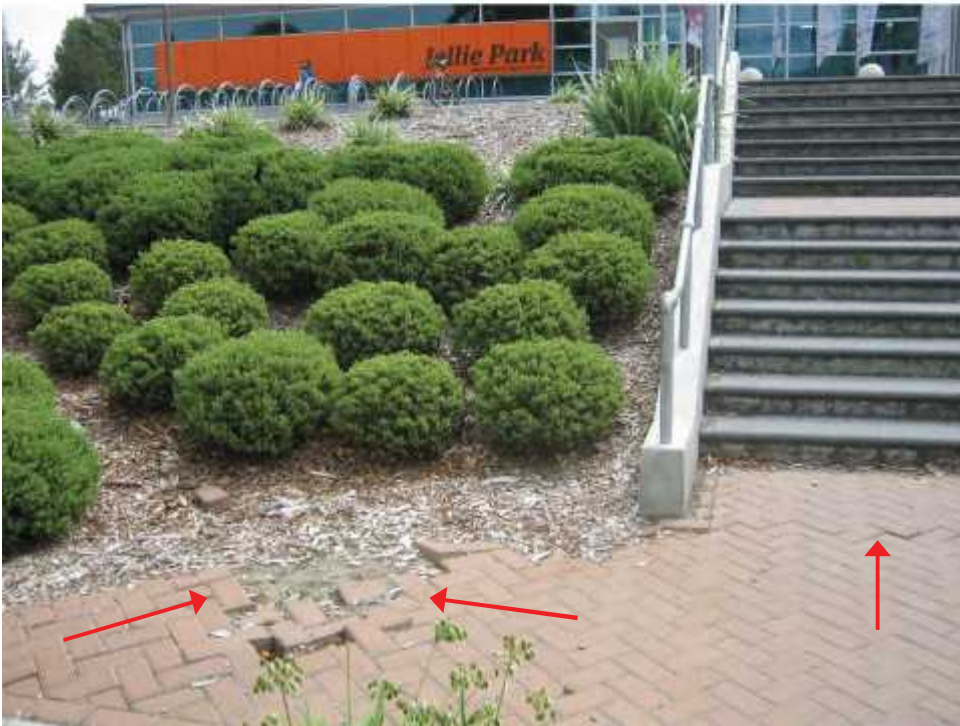
Photo 18: Sole location of liquefaction on site, 18m south-east of the main entrance to Jellie Park, less than 100mm of heave. Note the displacement of the bricks.

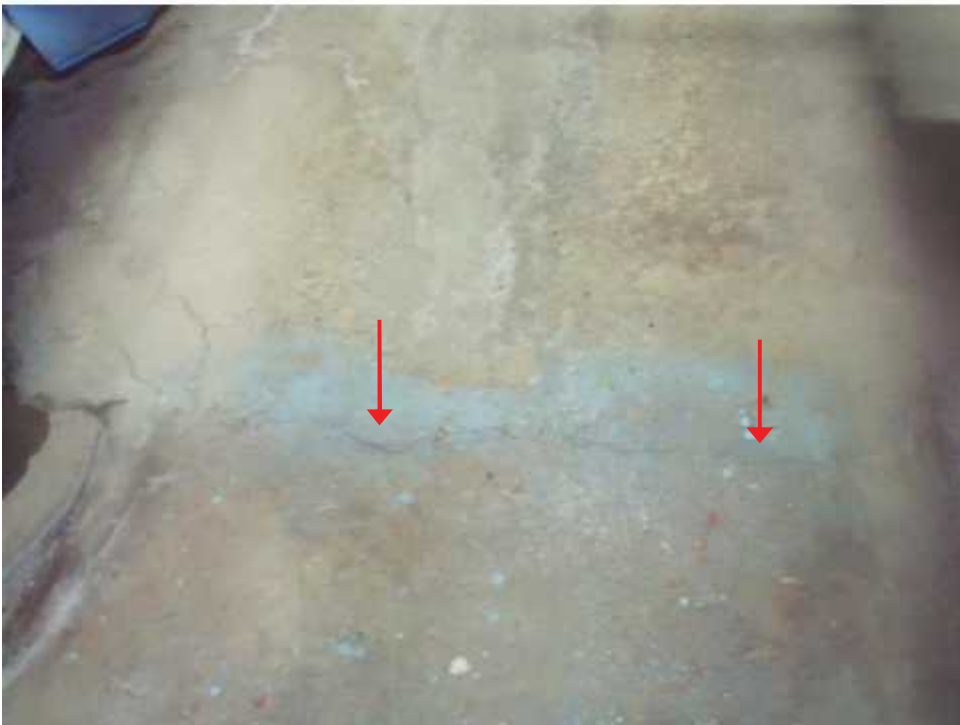
Photo 26: Minor crack (running north-west to south-east) in floor slab of Plant Room.

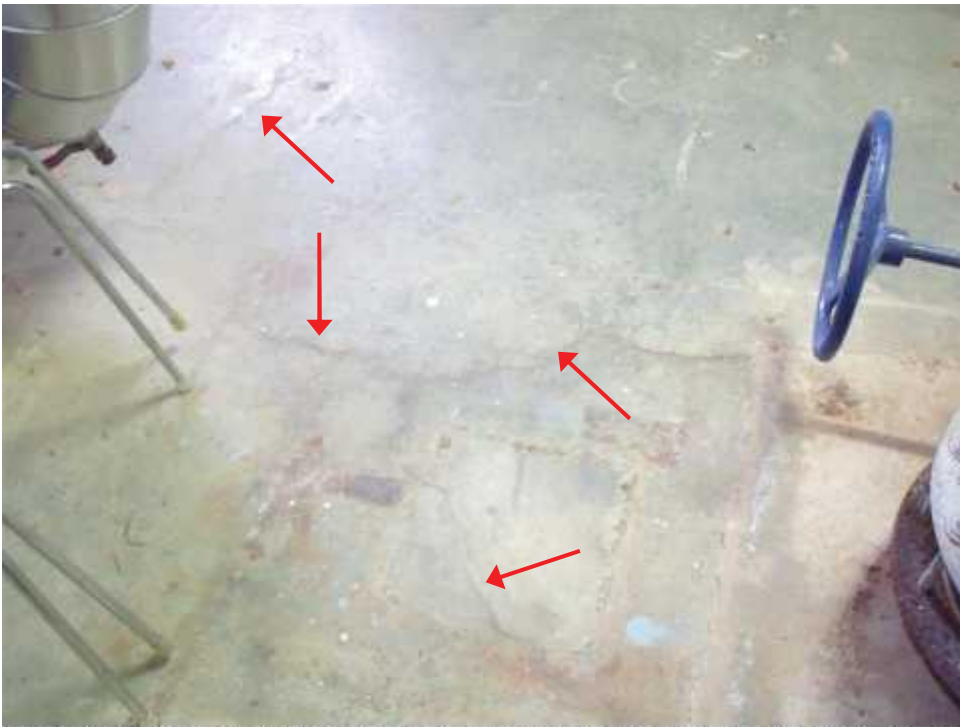
Photo 27: Minor crack (running north-west to south-east) in the floor slab of the Plant Room.

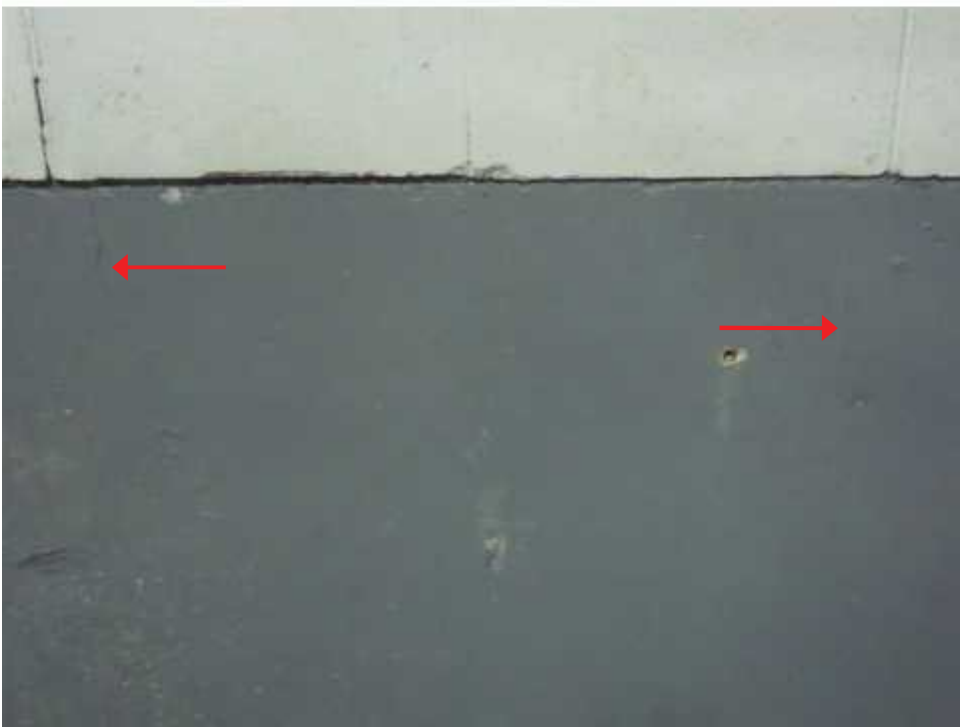
Photo 28: Minor cracking in the retaining section of the north-eastern wall.

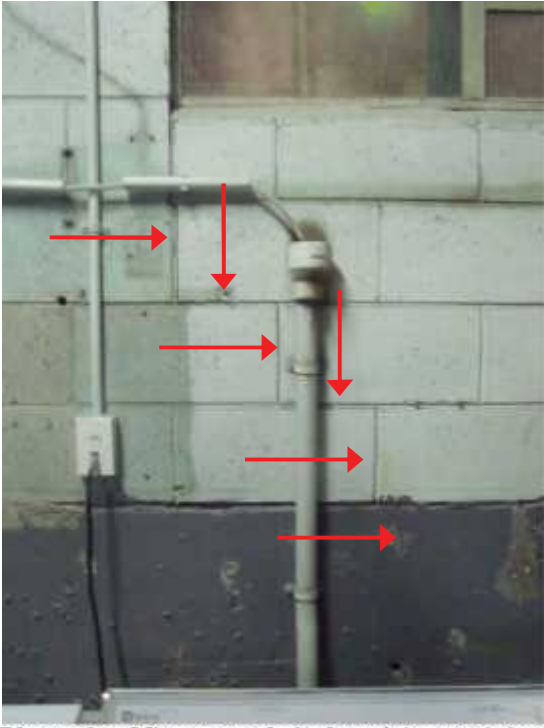
Photo 29: Minor crack (1-2mm) in retaining section of the south-eastern wall, note that it extends up through the block work.

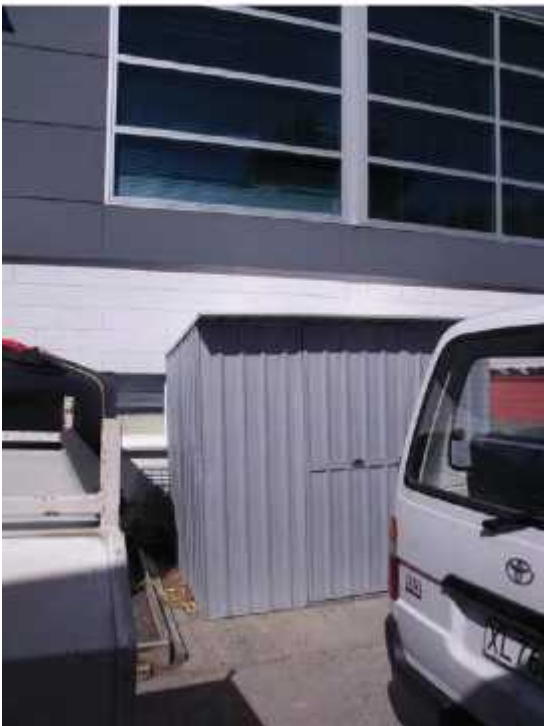
Photo 30: Shed on the north-western wall leaning towards the north-east.

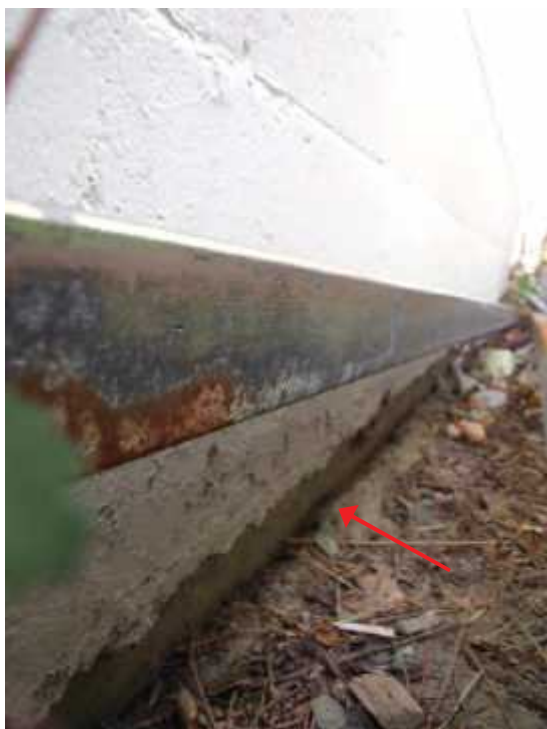
Photo 31: Possible settlement (20-30mm) of the asphalt on the north-western side of the Plant Room.
