Pavilion Toilets - Jellie Park
PRK 0266 BLDG 002
Detailed Engineering Evaluation
Qualitative Report
Version FINAL

Christchurch City Council

Date
17th May 2013

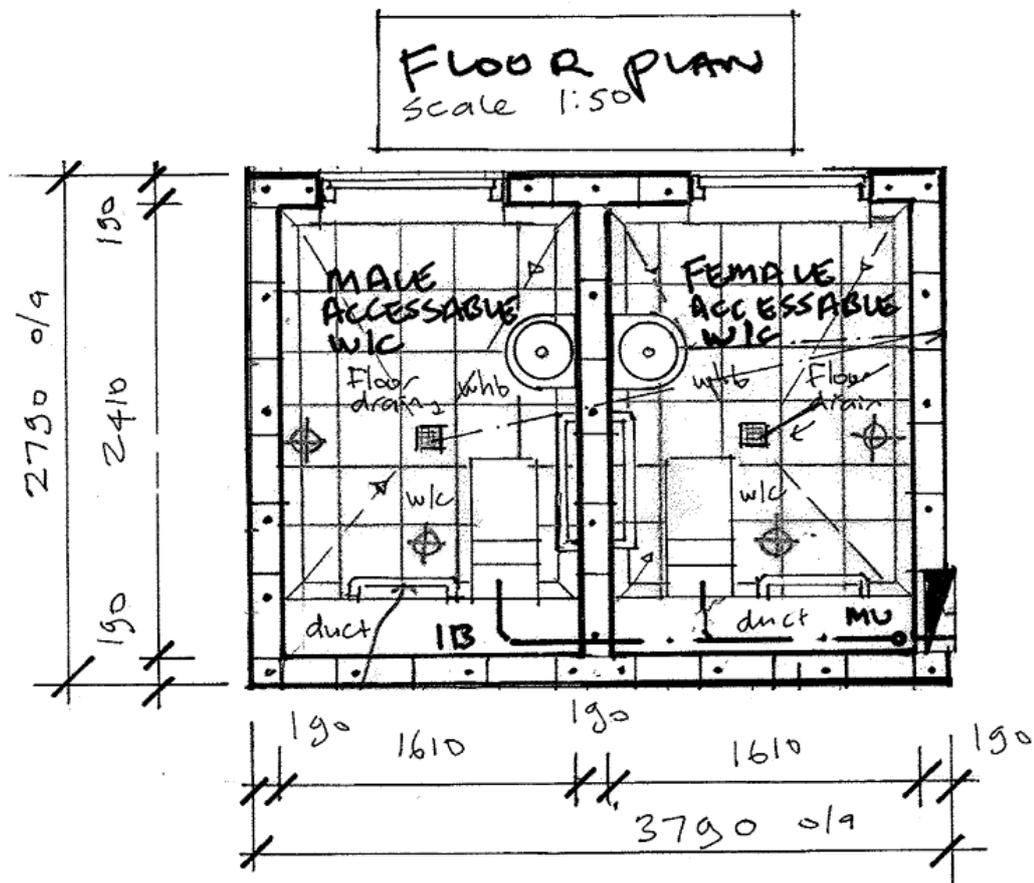
Figure 2 Plan Sketch Showing Key Structural Elements

There is an imbalance of stiffness when considering lateral loading in the transverse direction. The back face has two walls spanning the width of the toilet where the front face has two openings for doors (See Figure 2). This imbalance of stiffness has the potential to cause torsional effects; however, due to the size and nature of this structure these potential torsional effects have not been considered a critical structural weakness.

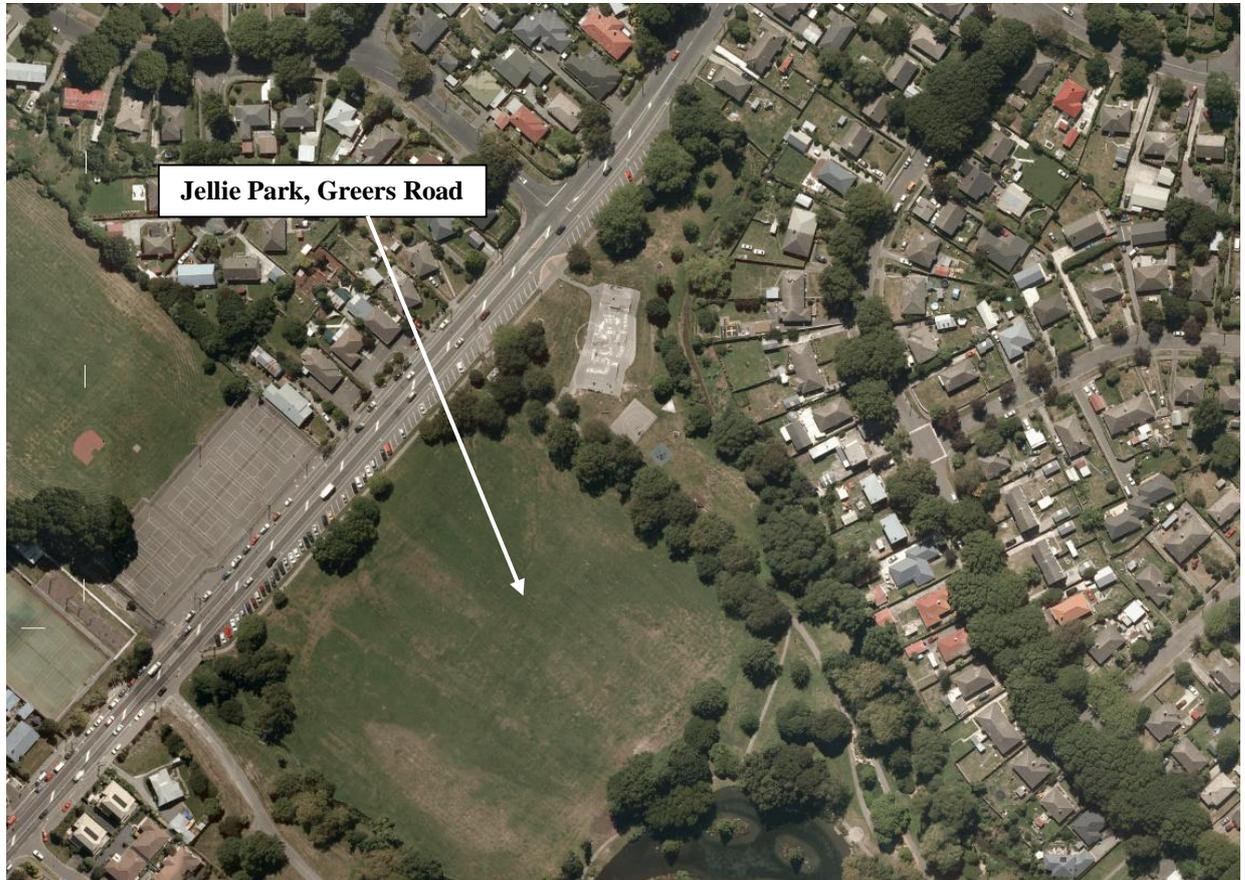
Figure 3 Post February 2011 Earthquake Aerial Photography ²

Aerial photography taken following the 22 February 2011 earthquake shows no signs of liquefaction outside the building footprint or adjacent to the site, as shown in **Figure 3**.

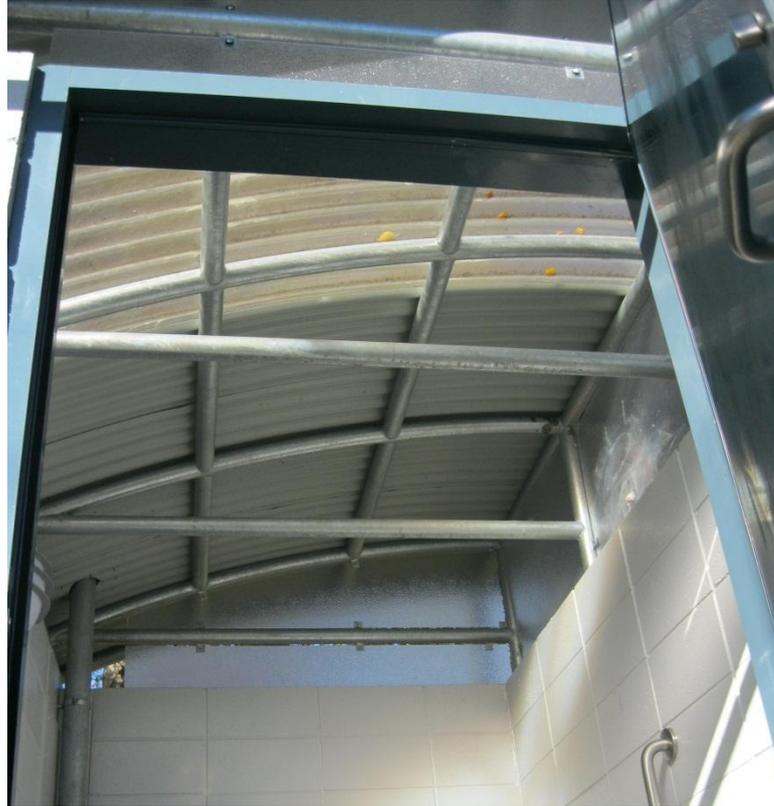
Photograph 3 Roof Structure (from inside)

Rigid connections between the roof trusses, wall plates and timber purlins form a rigid braced diaphragm.
