**Jennifer-Manor-
Torquay
Housing Complex
PRO 0571**

**Detailed Engineering Evaluation
Quantitative Assessment Report**

Date: January 2014
Reference: 6-QC364.00
Status: Final

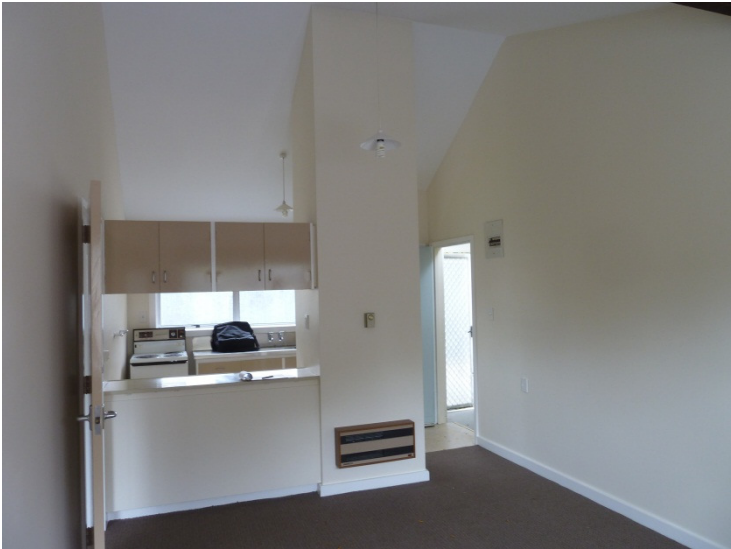
6.	Typical interior

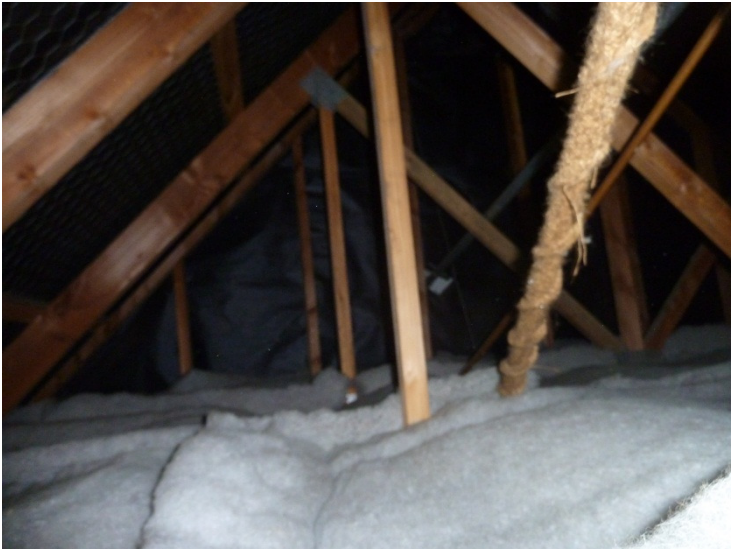
14.	Typical roof void

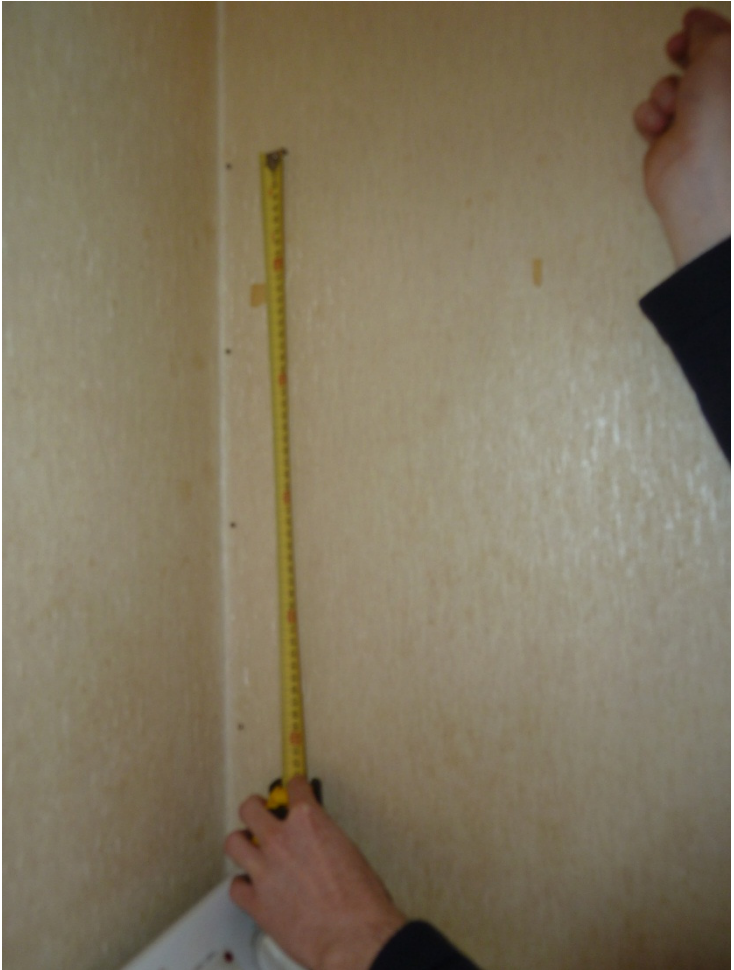
Stepped cracking of the block veneer was observed on some units (photo 17). Vertical cracking was observed at the point where the block veneers overlap with concrete block firewalls (photo 18). A block was also observed to be sitting loosely in place on Unit 13 (photo 16).

15.	Typical wall fixing spacings (200mm)

- Strengthening schemes be developed to increase the seismic capacity of Blocks A - D to at least 67%NBS.
- Veneer at height (gable ends) have the veneer ties checked.
- Cosmetic repairs be undertaken as required.

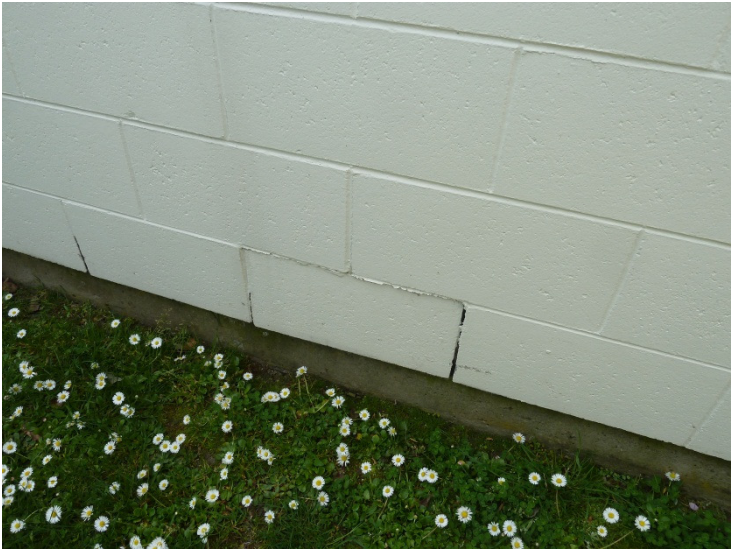
16.	Block veneer is loosely sitting in place on Unit 13

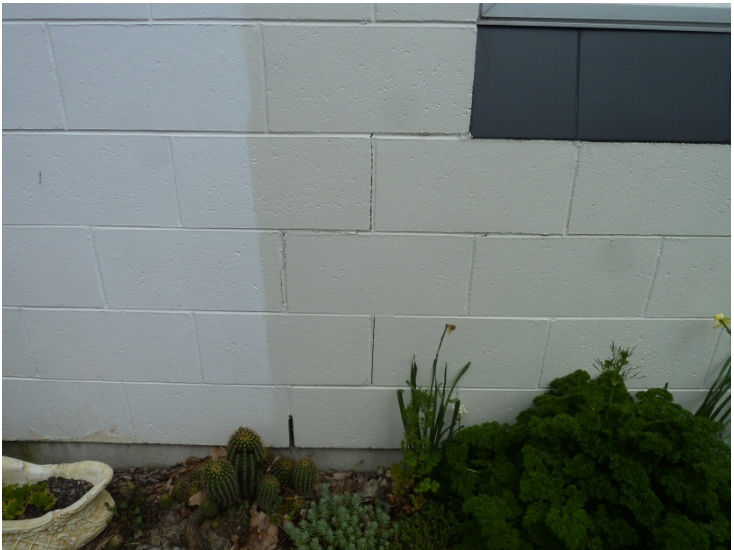
17.	Typical stepped cracking of blockwork

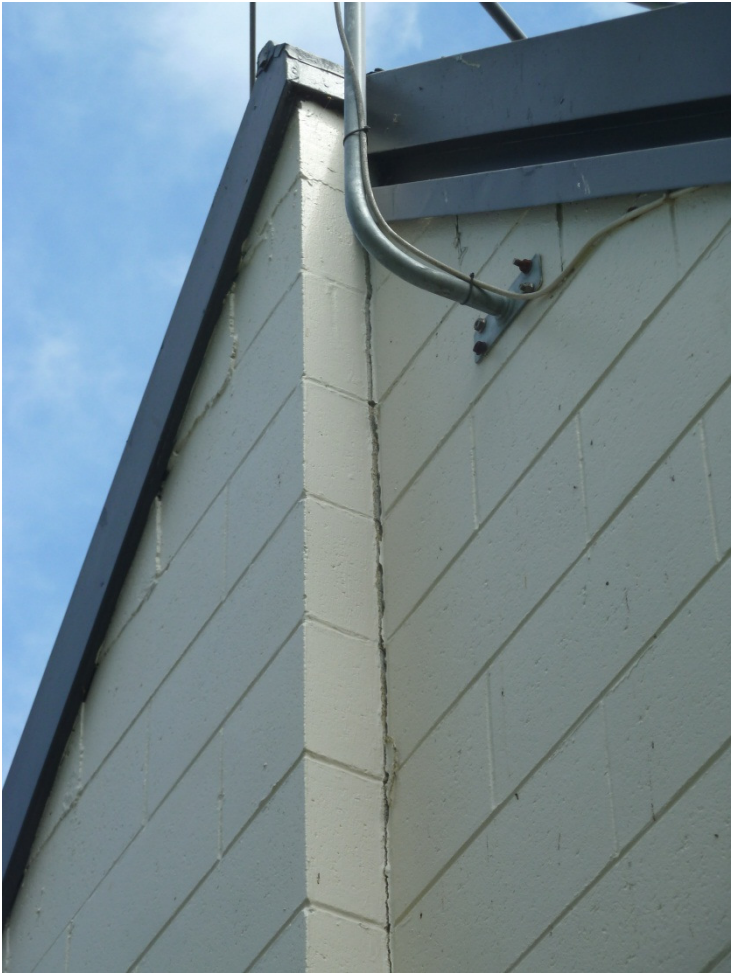
Foundation damage is particularly evident in Unit 13 and 14. Unit 14 has a noticeable rise in the floor slab around the bedroom door area.

18.	Unit 10-11: Minor separation between overlapping firewalls/veneers

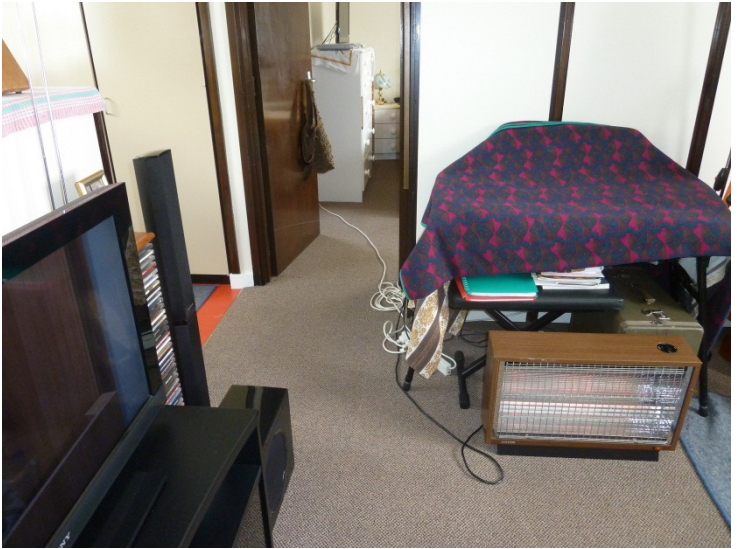
Minimal cracking of plasterboard ceiling diaphragms and wall linings was observed in the units (photo 20). This form of damage is common throughout the units.

19.	Unit 13: Variation in concrete slab height

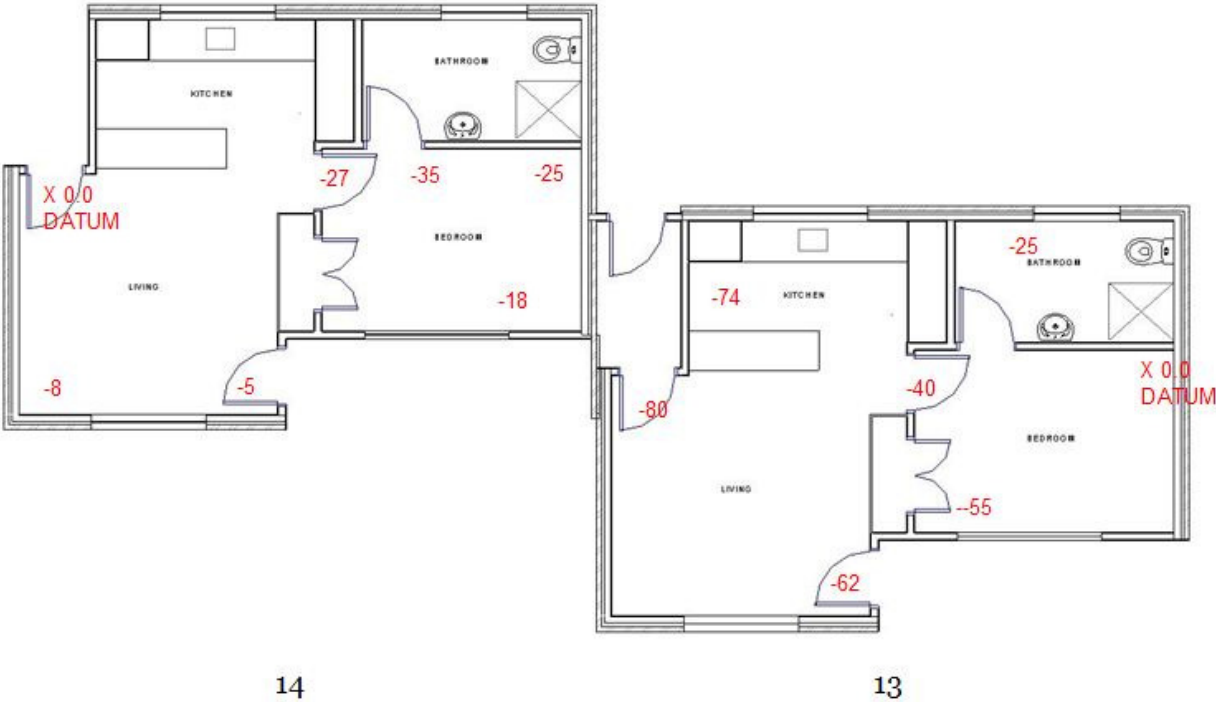
JENNIFER, MANOR, TORQUAY: UNITS 13 & 14

A full level survey was not deemed to be necessary at Jennifer-Manor-Torquay as it is located in a TC2 zone. Properties in TC2 zones suffered moderate damage due to liquefaction and/or settlement. In lieu of a full level survey, a laser level was placed in each unit so that differentials in vertical levels could be measured at the extreme ends of the unit. These values could then be used to determine the floor slope of the entire unit. For this site, the maximum slope in a unit was 11 mm/m, which exceeds the 5mm/m limitation imposed by MBIE guidelines.

Block	Unit No.	Comment	Maximum Fall*
A	1	Pass	
	2	Pass	
B	3	Pass	
	4	Pass	
C	5	Pass	
	6	Pass	
D	7	Pass	
	8	Pass	
E	9	Pass	
F	10	Pass	
	11	Pass	
G	12	Pass	
H	13	Fail	8 mm/m
	14	Fail	11 mm/m
