**Jura Courts
Housing Complex
PRO 0840**

**Detailed Engineering Evaluation
Quantitative Assessment Report**

**30 Jura Courts, Linwood, Christchurch
8062**

Mary Ann Halliday Senior Structural Engineer	Date: November 2013 Reference: 6-QC365.00 Status: Final

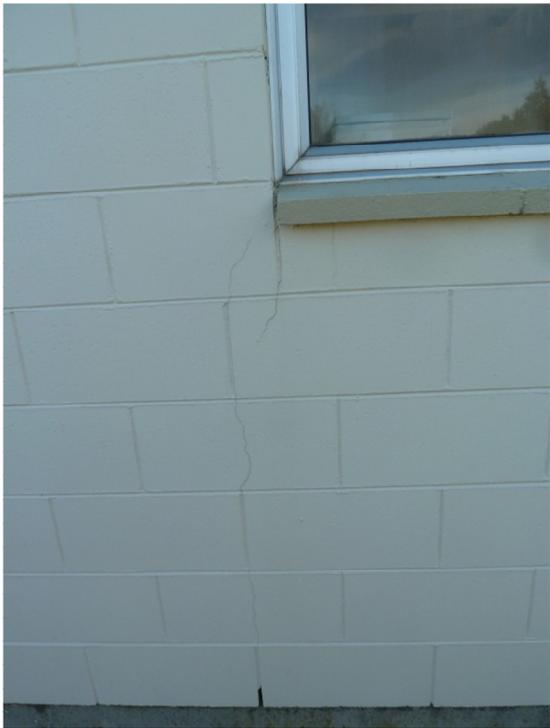
6	Cracking of block veneer.

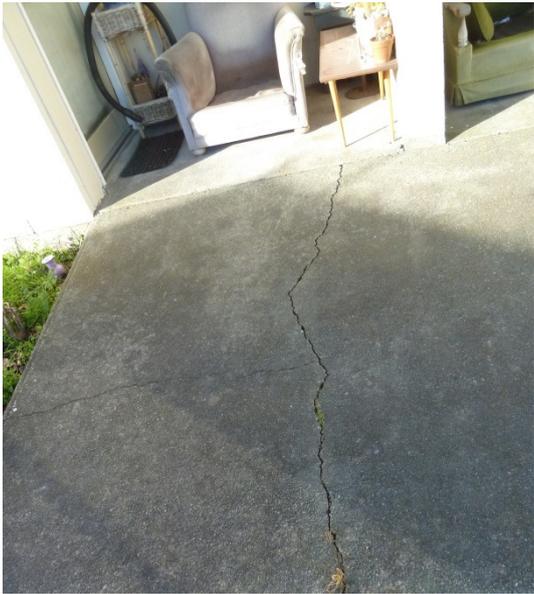
A photograph showing a vertical crack in the white block veneer of a building's exterior wall. The crack runs vertically through several courses of blocks. A window is visible in the upper right corner of the image.
7	Cracking of exterior paving.

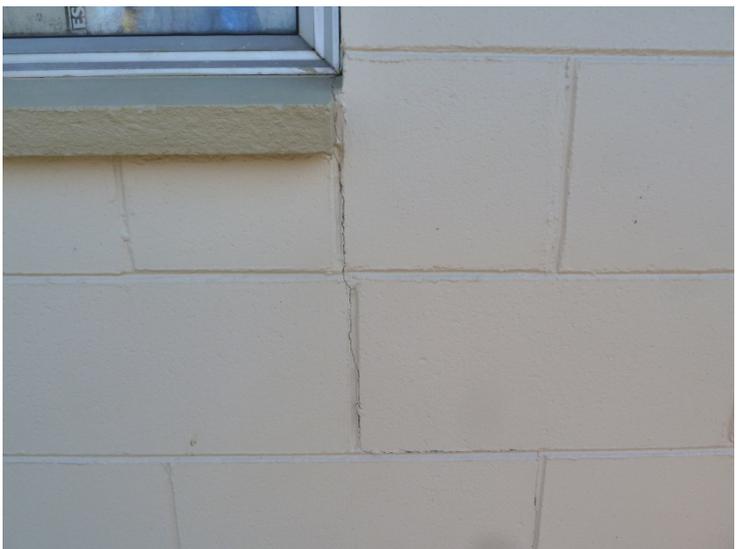
Stepped cracking of the mortar joints and through the block veneer exterior cladding was observed on some units (photo 8-10). This form of damage is not widespread.

8	Cracking of block veneer.

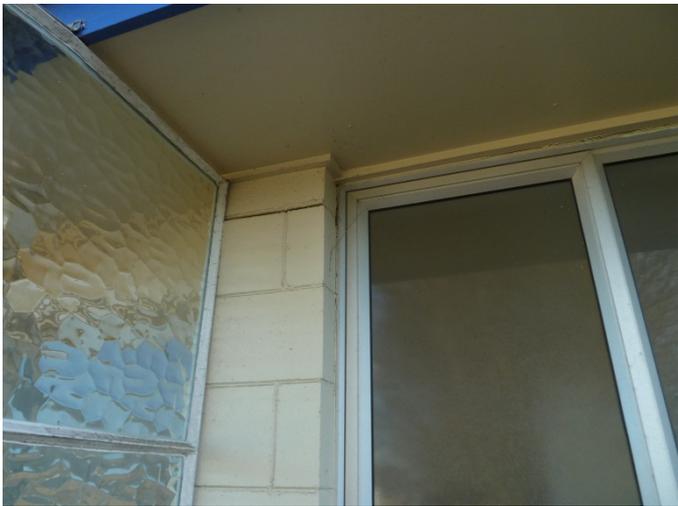
9	Cracking of block veneer along horizontal mortar joint.

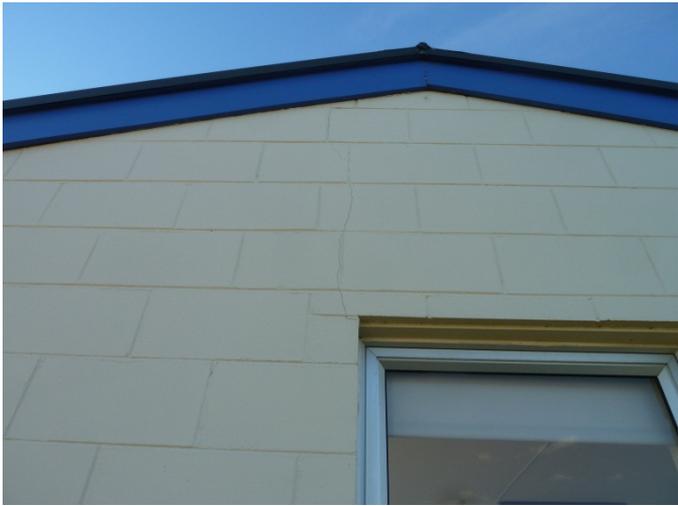
10	Cracking of block veneer.

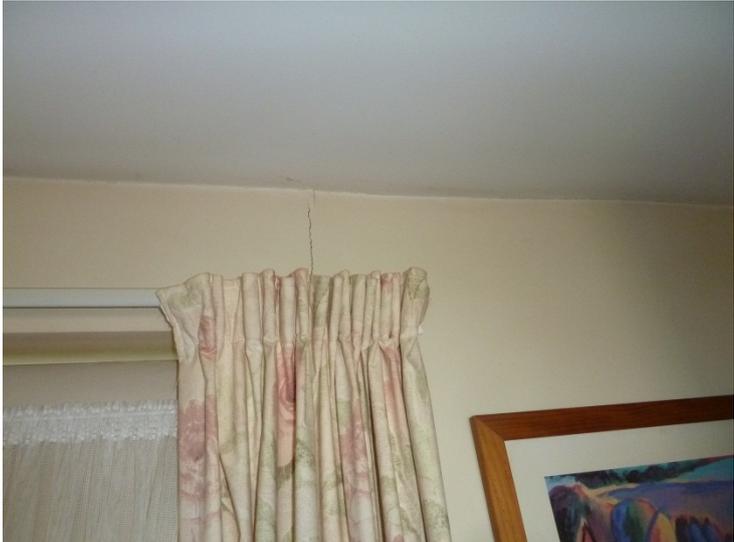
Minimal cracking of plasterboard ceiling diaphragms and wall linings was observed in the units. This form of damage is not widespread throughout the units.

A photograph of a roof cavity showing a fire wall. The wall is constructed from grey concrete blocks and runs across the width of the cavity. Wooden trusses are visible above and below the wall. Pink insulation is on the floor, and a black mesh netting is at the top.
13	Typical cracking of wall lining.

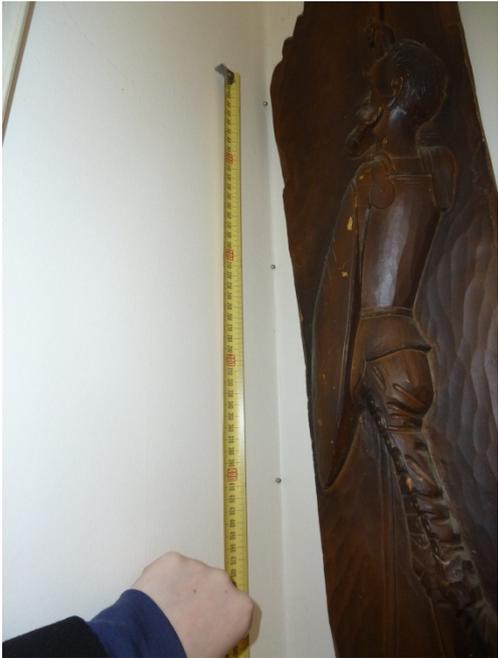
14	Typical Plasterboard Nail Spacing (200mm).

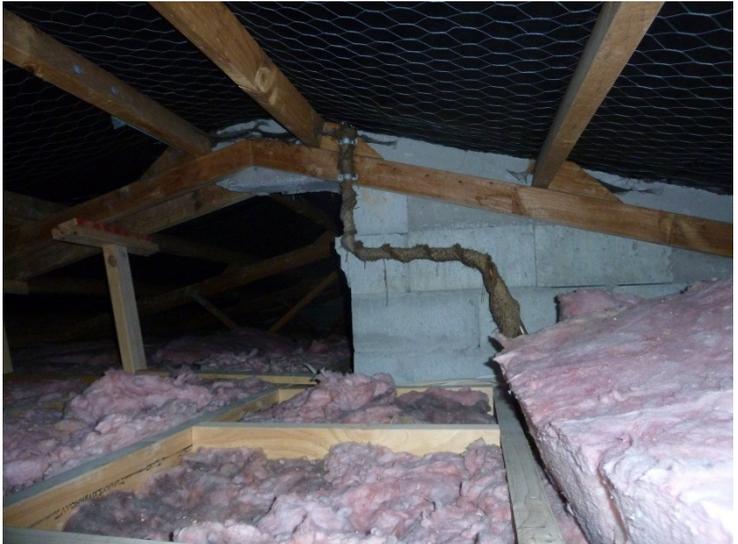
19	Partially removed fire wall.

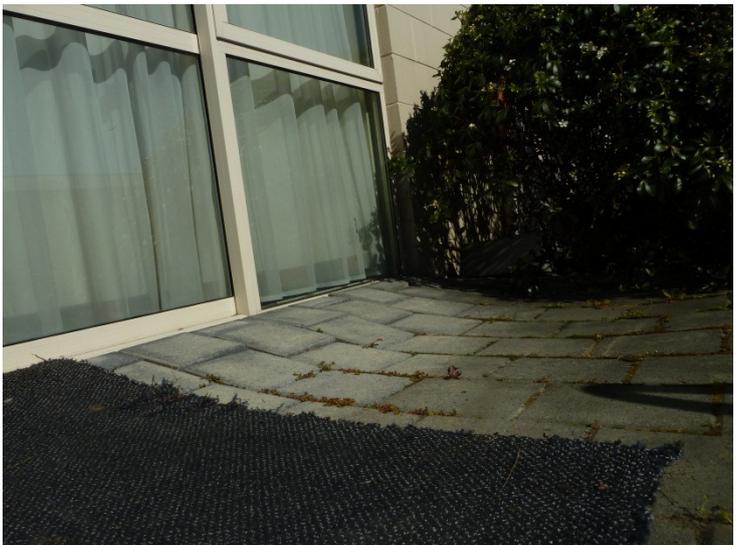
21	Evidence of settlement outside residents lounge.

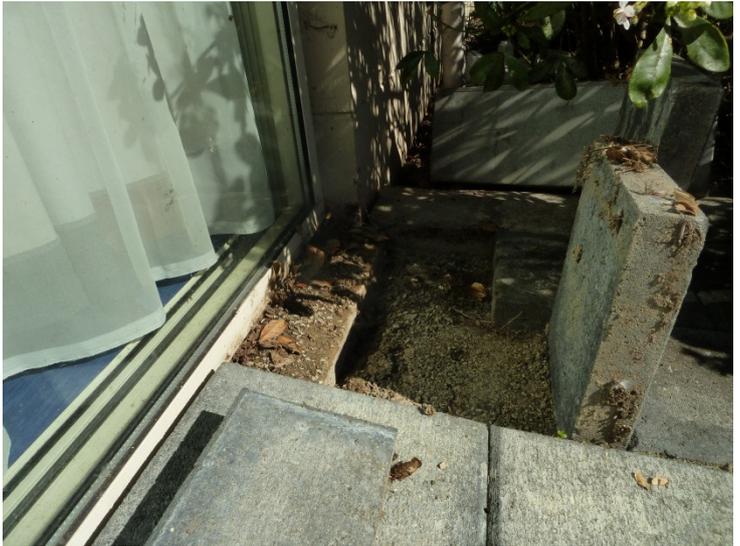
22	Evidence of settlement outside residents lounge.
