**Ka Wahine Trust  
Halfway House  
PRO 2538**

**Detailed Engineering Evaluation  
Quantitative Assessment Report**

**18 McGregors Road, Bromley,**

Date: March 2014  
Reference: 6-QC366.00  
Status: Final

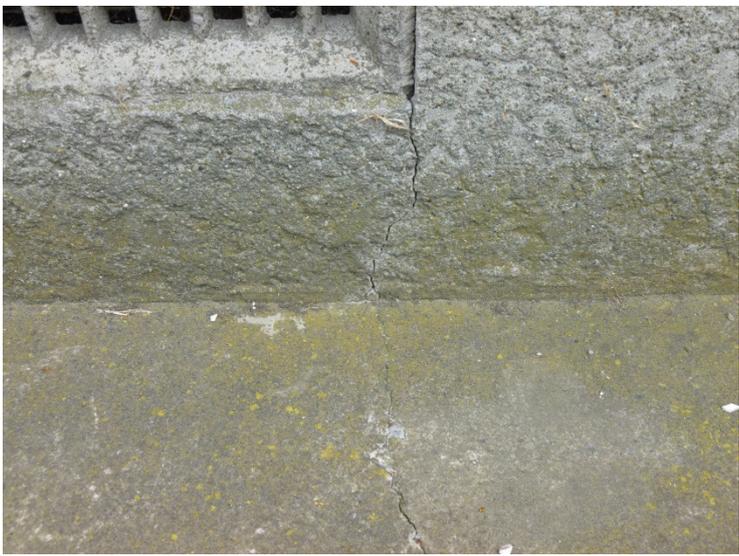
Some cracking was observed in the perimeter footing of the house (photo 4).

A close-up photograph of a concrete foundation wall. A prominent vertical crack runs down the center of the wall. The concrete is grey and shows signs of weathering and moss growth.
<p>5.</p>	<p>House: Cracking in brick veneer at back of house</p>

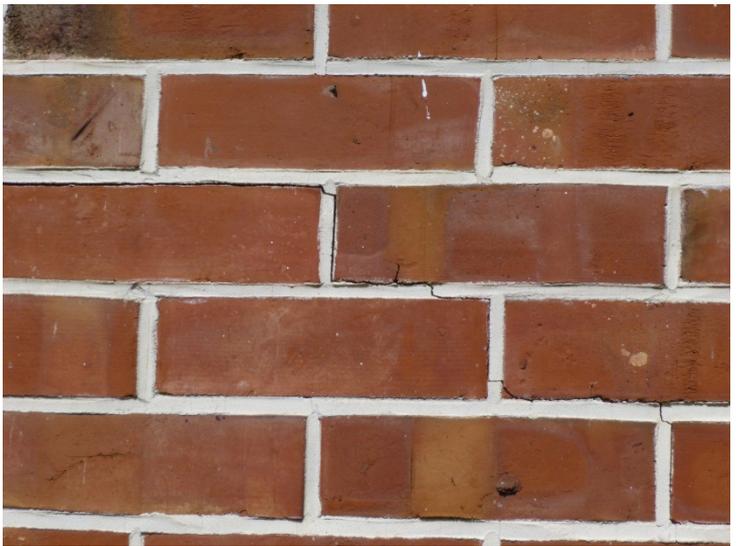
Step cracking and mortar cracking was observed in the brick veneer of the house (photos 5 and 6).

A close-up photograph of a brick wall. The bricks are reddish-brown with white mortar joints. There are several visible cracks in the mortar joints and the bricks themselves, indicating structural damage.

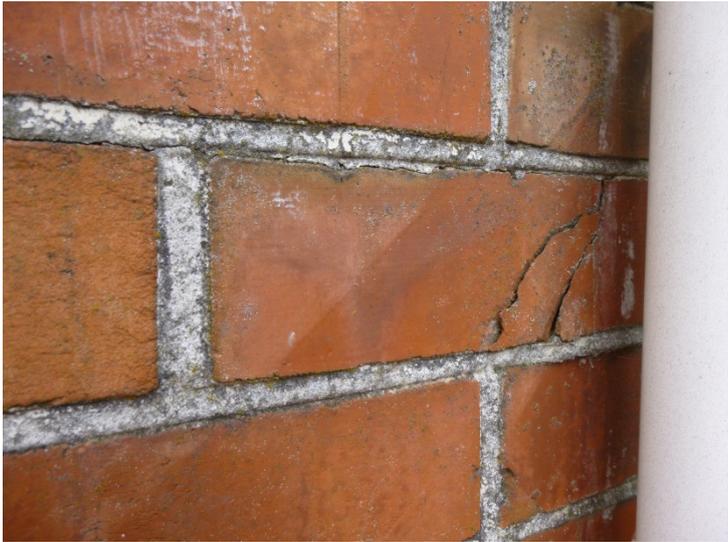
6.	House: Cracking of brick veneer at front of house

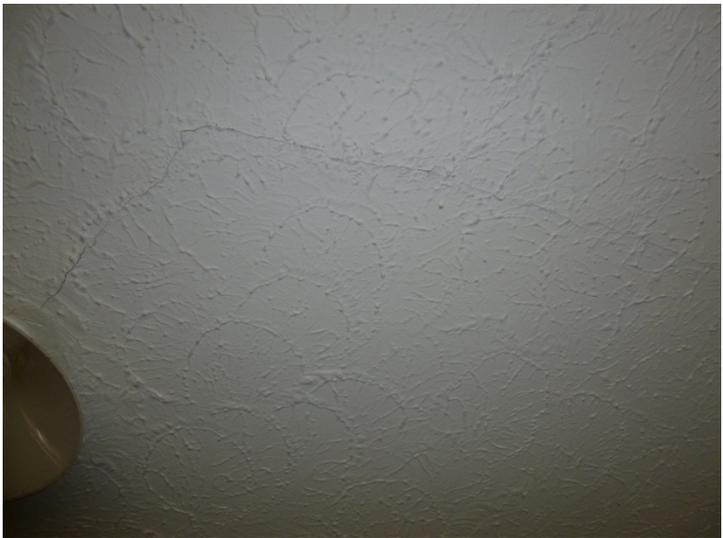
Hairline cracking of the ceiling diaphragms and wall linings was commonly observed. This was predominantly observed to run from the corners of windows, doors and through ceiling lights (photos 7 and 8). In some cases it was observed that the wall lining had bulged without actually cracking (photo 9). More severe cracking was noted in the wall above the fire place in the lounge (photo 10). Emergency remediation of the ceilings in the lounge and one bedroom had been conducted by fixing Gib board to the ceiling (photos 11 and 12).

7.	House: Typical cracking in ceiling diaphragm

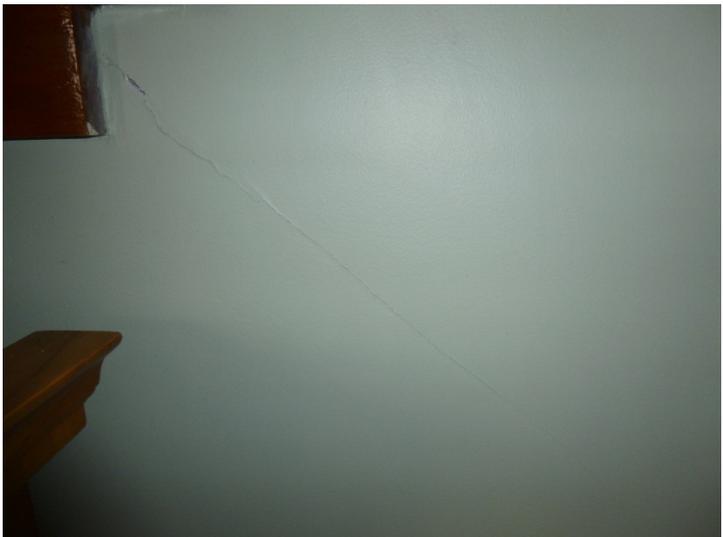
8.	House: Typical cracking in wall

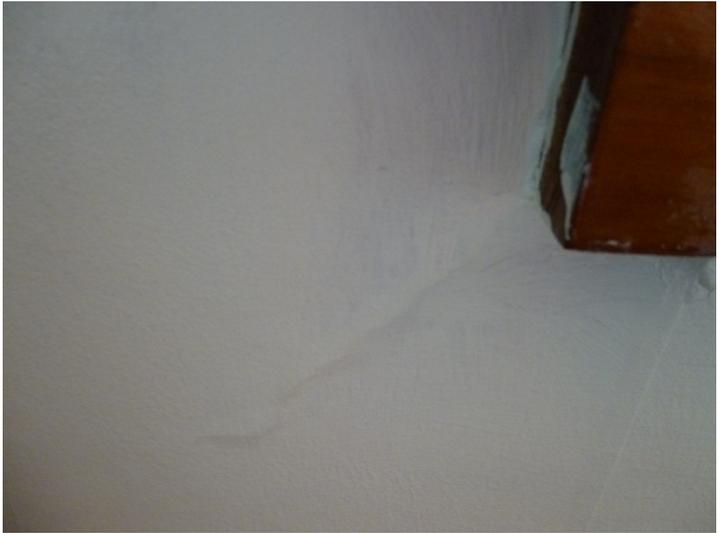
9.	House: Typical bulging in wall lining

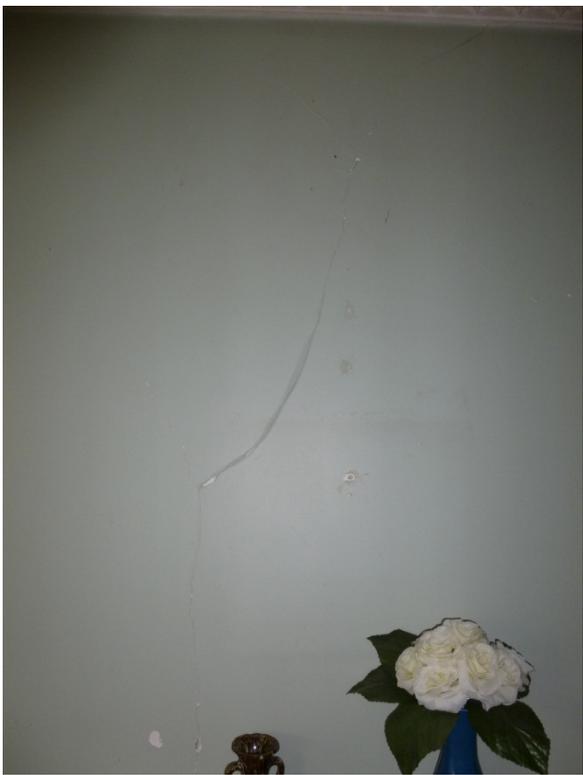
A photograph showing a close-up of a light-colored wall. The wall surface exhibits a distinct bulging or unevenness, particularly towards the right side of the frame. A portion of a dark wooden object, possibly a door or window frame, is visible in the upper right corner.
10.	House: Cracking in wall above fire place

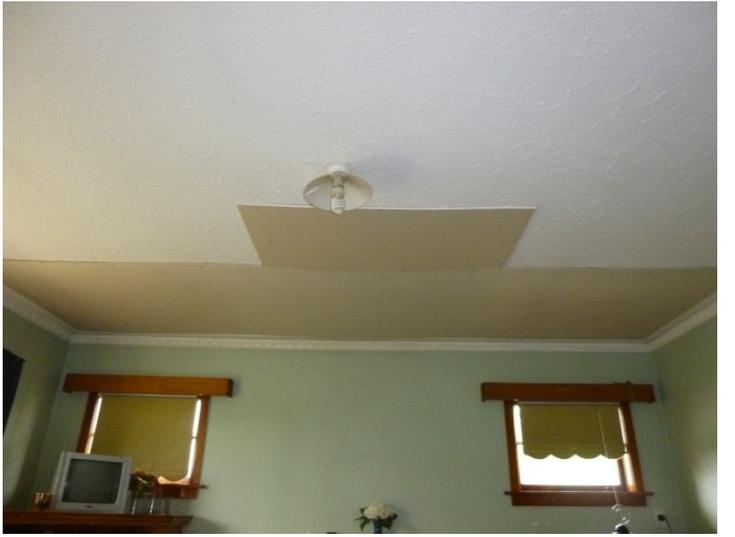
<p>11.</p>	<p>House: Ceiling remediation in lounge</p>

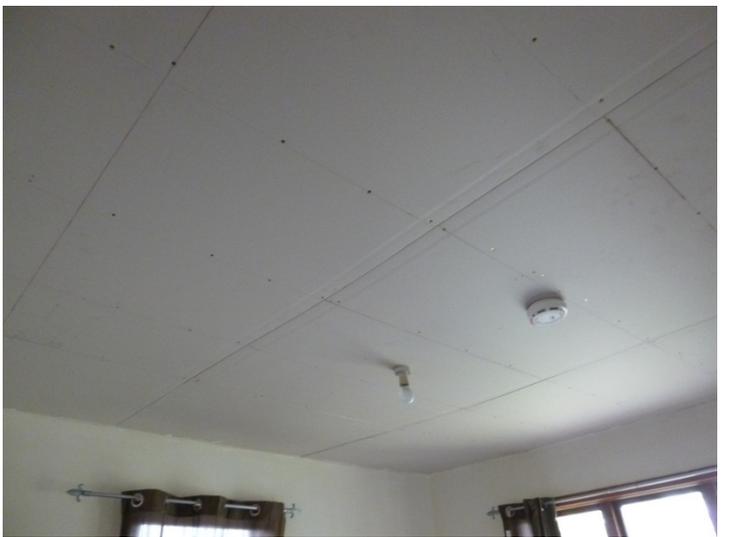
<p>12.</p>	<p>House: Ceiling remediation in bedroom</p>

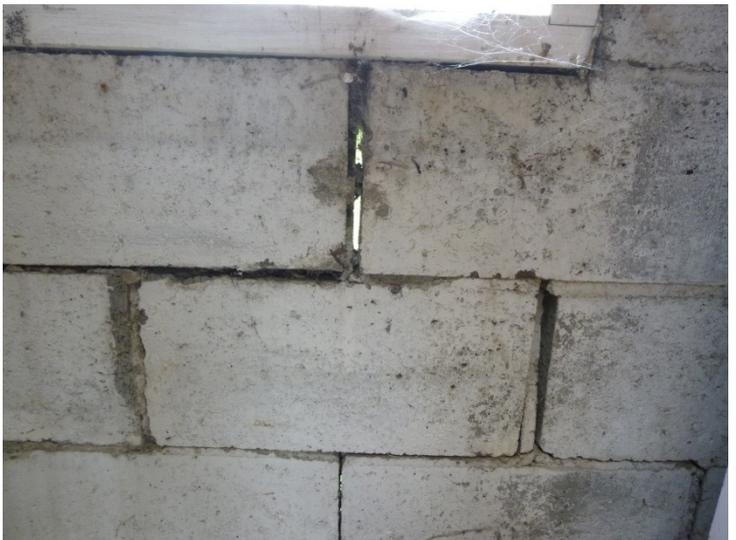
The garage suffered severe damage to structural elements including significant cracking of the concrete block wall. This damage is expected as the concrete block walls are believed to be unreinforced.

Severe cracking in the block-work of the garage was observed (photo 16).

The garage appeared to have performed poorly, as would be expected for unreinforced concrete masonry buildings. Severe structural damage has occurred which is typical of the type and age of construction.

<p>16.</p>	<p>Cracking in garage</p>

- Cosmetic repairs be undertaken as required.
- The concrete block garage be strengthened or replaced.
