# **Kyle Park Toilets**

## **PRK 1577 BLDG 002 EQ2**

**Detailed Engineering Evaluation**

**Quantitative Assessment Report**

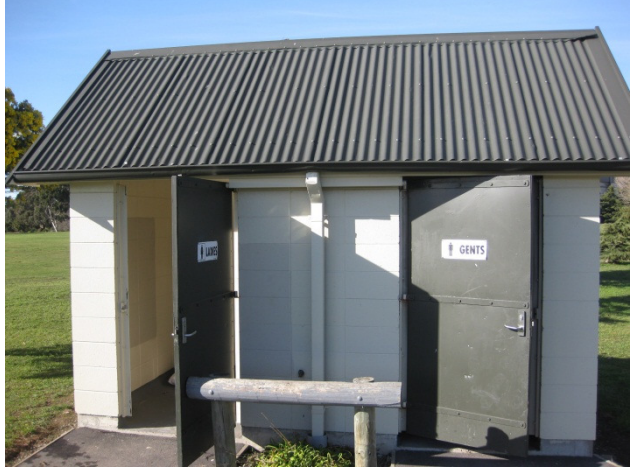
Site Name		
No.	Item description	Photo
General		
1.	<b>Northern view of building</b>

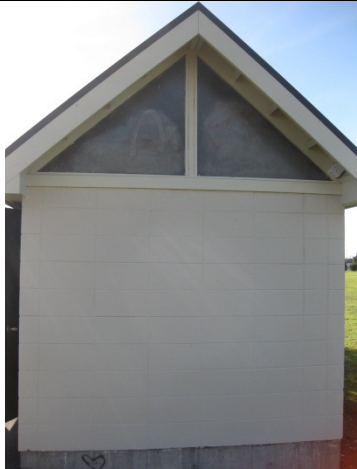
2.	<b>Eastern view of building</b>

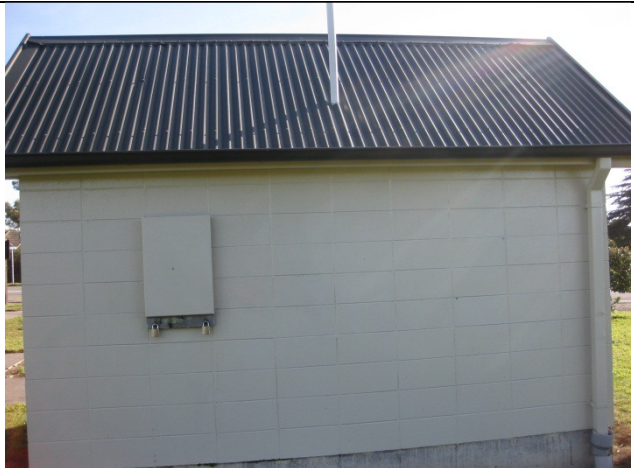
3.	<b>Southern view of building</b>

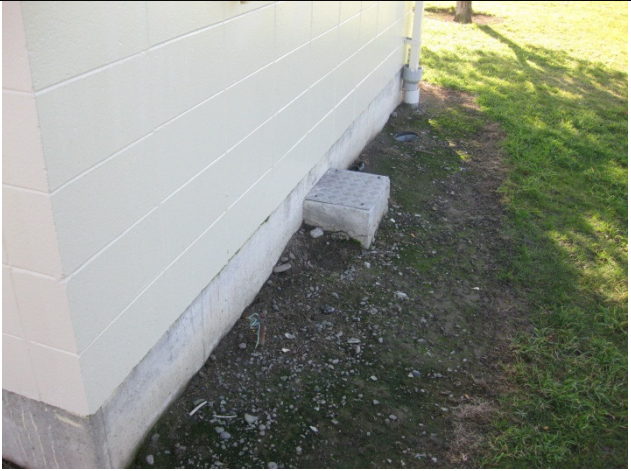
4.	<b>Slab on ground foundations</b>

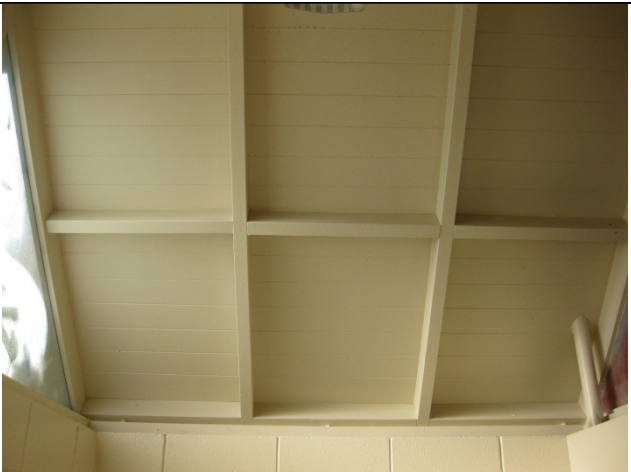
5.	<b>Timber framed roof (sarking - no ceiling)</b>

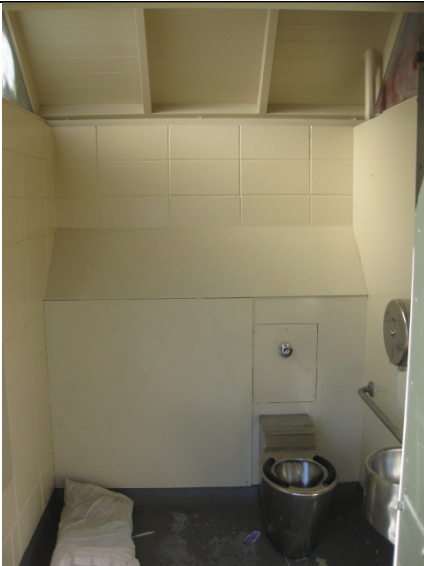
6.	<b>Internal walls (ladies)</b>

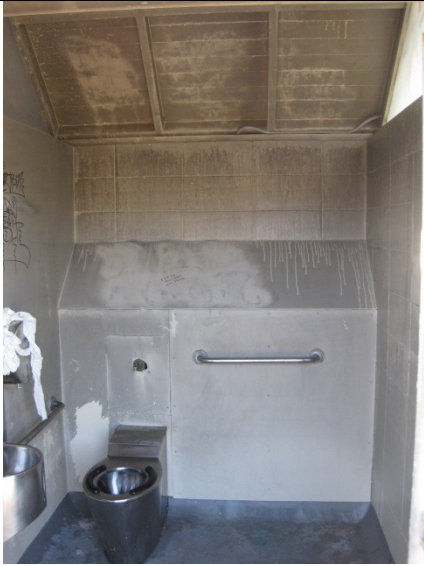
7.	<b>Internal walls (gents)</b>

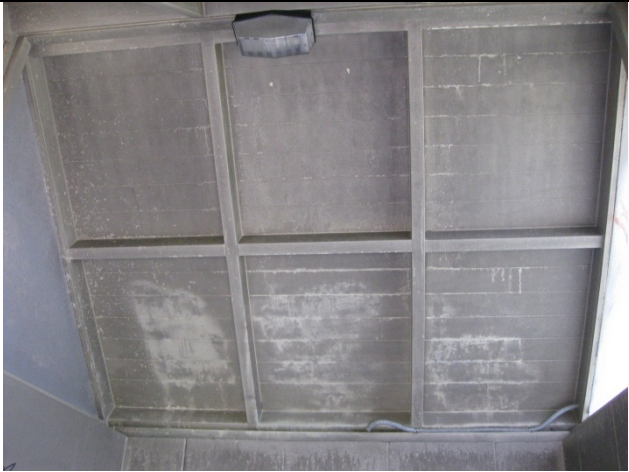
8.	<b>Timber framed roof (sarking - no ceiling)</b>
