Pavilion/Toilet – Le Bons Bay Domain
PRK 3596 BLDG 003 EQ2
Detailed Engineering Evaluation
Quantitative Report
Version FINAL

16B Rue de la Mer, Le Bons Bay

Christchurch City Council

Date
17 September 2013

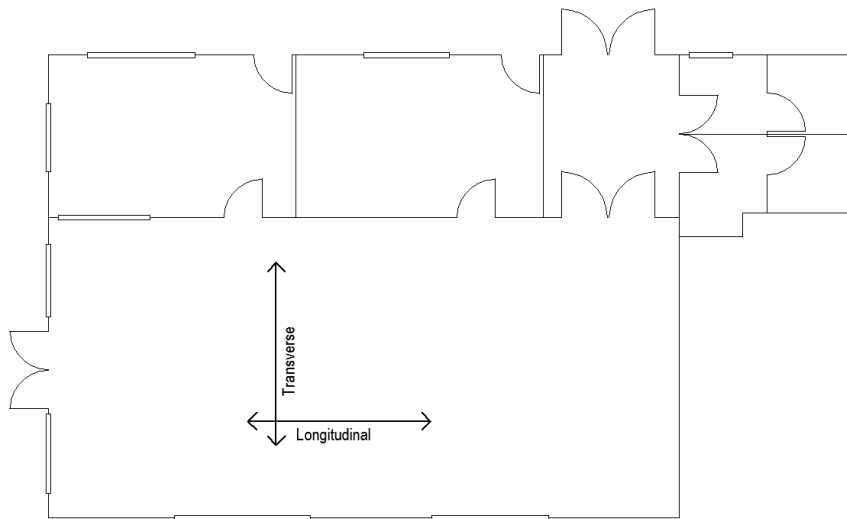
Figure 9-1 Plan showing orthogonal directions.

Direction	% NBS
Longitudinal Direction	54%
Transverse Direction	55%

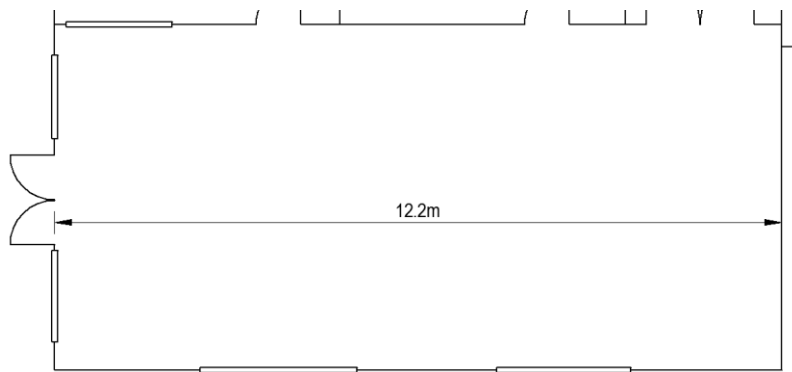
Figure 9-2 Bracing Line Spacing

In addition to the bracing capacity check, other NZS3604:2011 requirements were checked. In accordance with NZS3604:2011, bracing lines shall be at no greater than 6m centres. As shown in Figure 9-2 there is a distance of 12.2m between bracing lines for the mono-pitch hall portion of the structure. This large distance between bracing lines results in higher demand on the roof diaphragm. The building has been assessed as having a New Building Standard of 49% in this regard.

No further action is required, however given the low score achieved, the development of strengthening schemes to a minimum of 67% NBS is recommended.

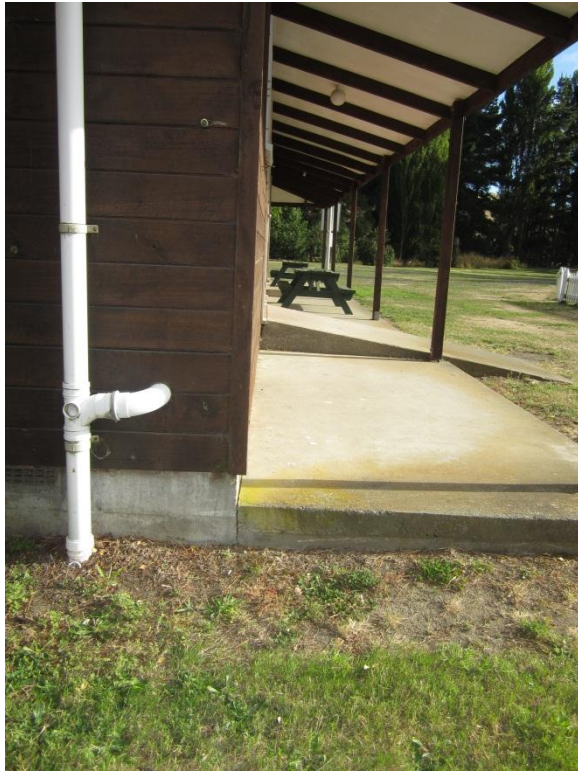
Photo 3. Veranda on the Eastern Elevation.

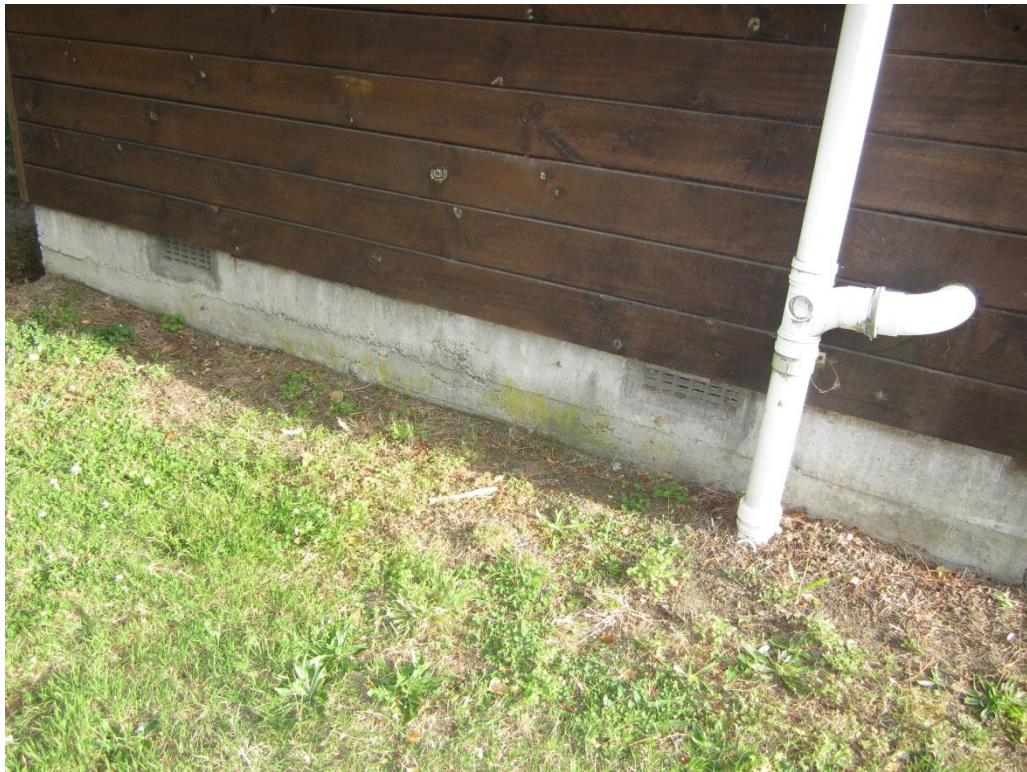
Photo 4. Concrete perimeter strip footing with weather boards above.

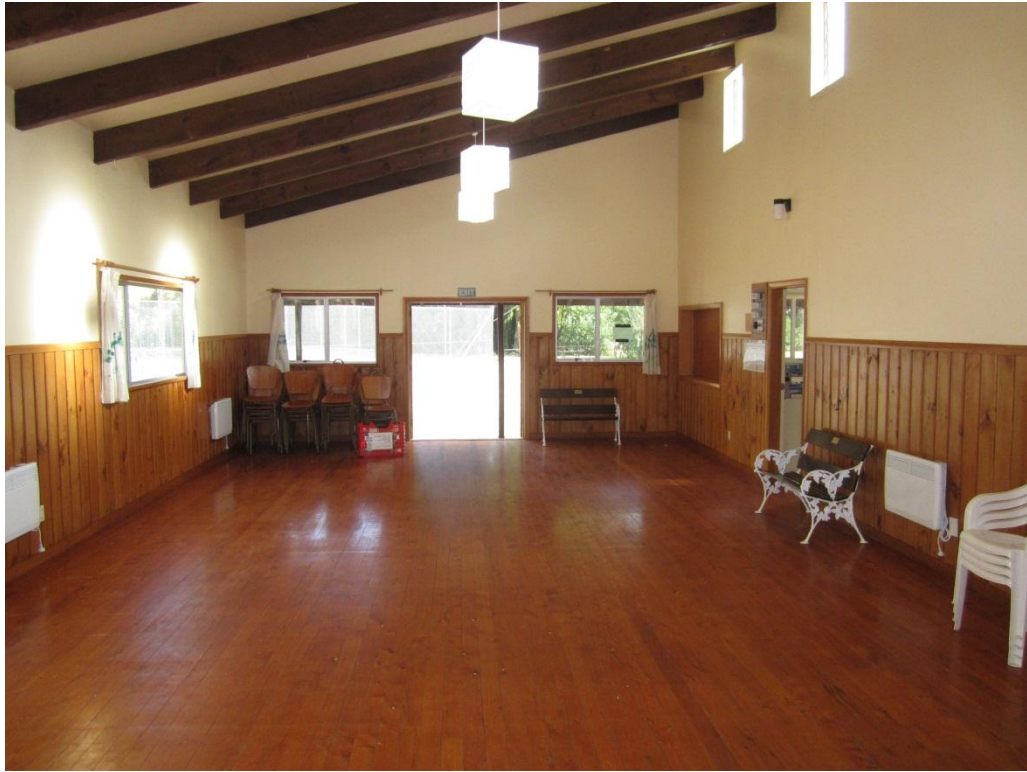
Photo 5. Internal view of the hall portion.

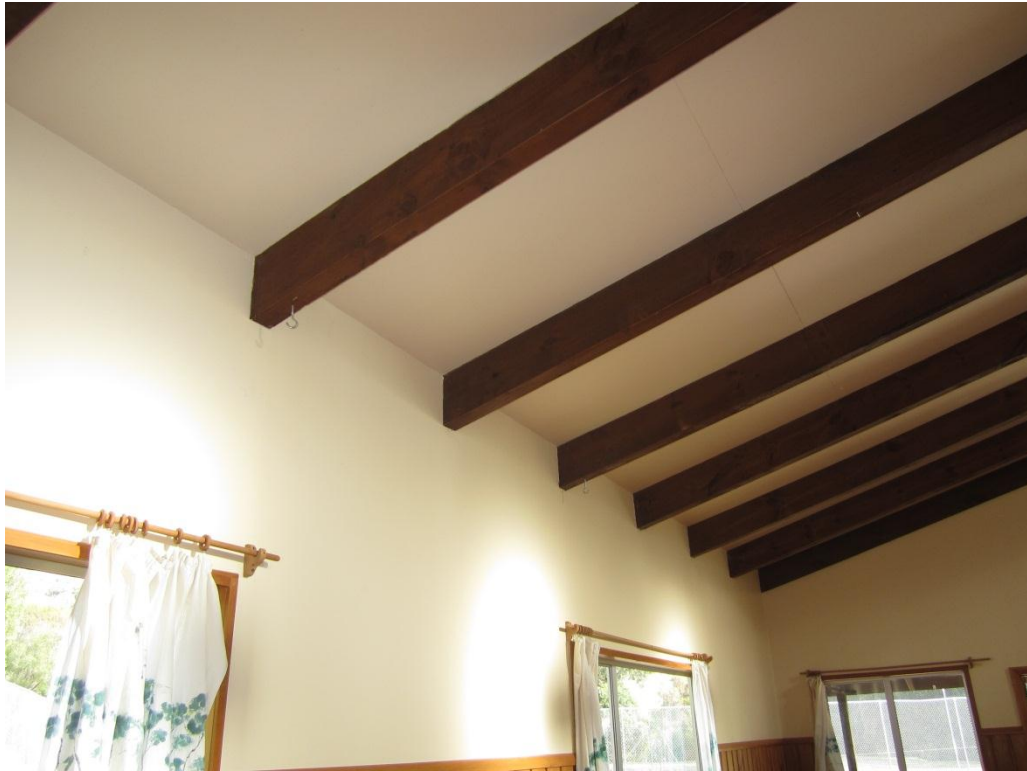
Photo 6. Timber rafters supporting roof structure.

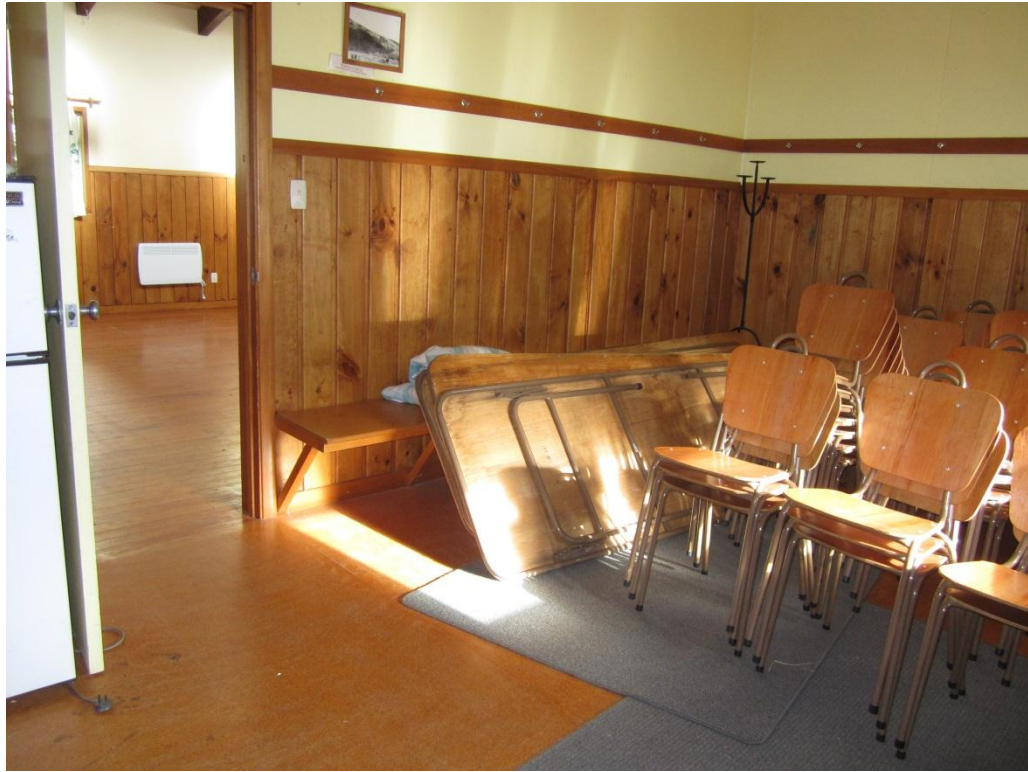
Photo 7. Timber board lining with plasterboard above.
