CHRISTCHURCH CITY COUNCIL
PRK_0227_BLDG_002
Linwood Nursery – Garage
320 Linwood Ave, Linwood

QUALITATIVE ASSESSMENT REPORT
FINAL

- Rev E
- 06 December 2013

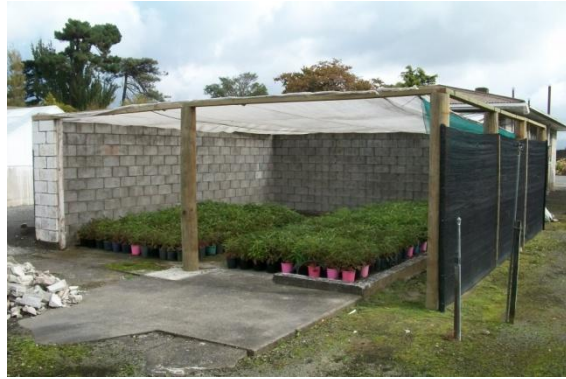
Photo 1: The garage structure looking west

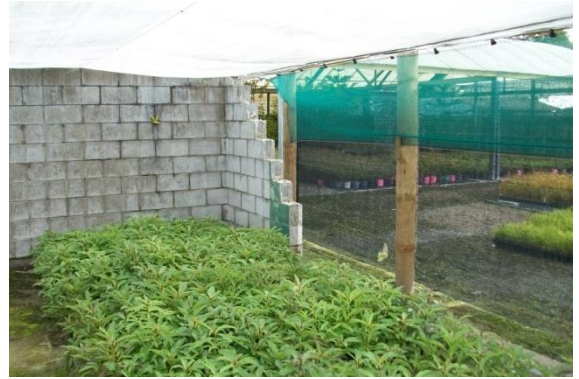
- The northern wall was weakened in the September 2010 and February 2011 earthquakes, underwent out of plane displacement in heavy snow fall during the following winter and was demolished after being deemed a risk
- The remaining block walls have minor existing stepped cracks

Photo 2: The north wall of the structure which has been demolished

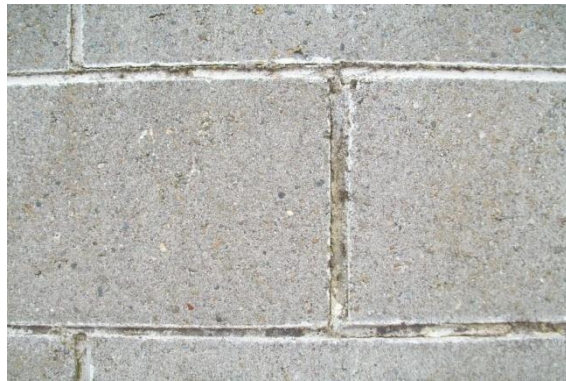
Stepped cracking up to 0.8mm in width was found throughout the masonry walls. No other damage was observed in the structure

There is a risk of further movement and increased cracking due to subsequent aftershocks or settlement.

Photo 3: Typical stepped cracking in the block walls

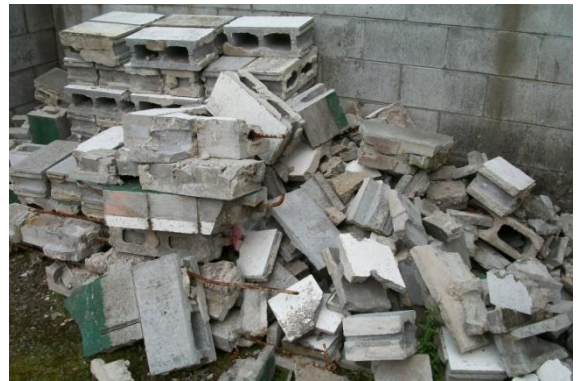
Photo 4: Rubble from the demolished wall showing partially filled and reinforced walls with poor compaction
