Linwood Park Pavilion  
Qualitative Engineering Evaluation

Functional Location ID: PRK 0835 BLDG 002

Address: 252 Linwood Ave

**Date:** 28 June 2013

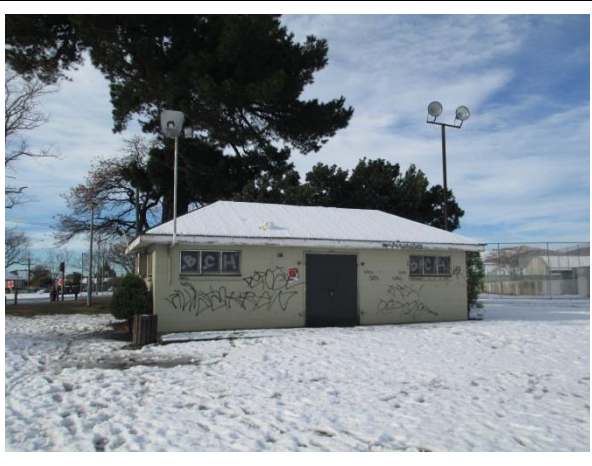
| <p>Building western elevation.</p> | |

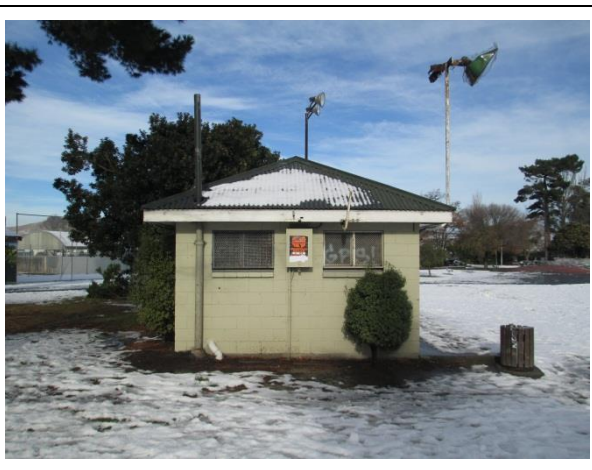
| <p>Building northern elevation.</p> | |

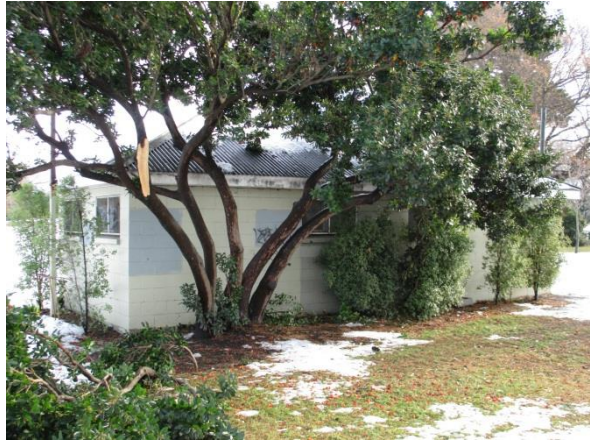
Building eastern elevation.

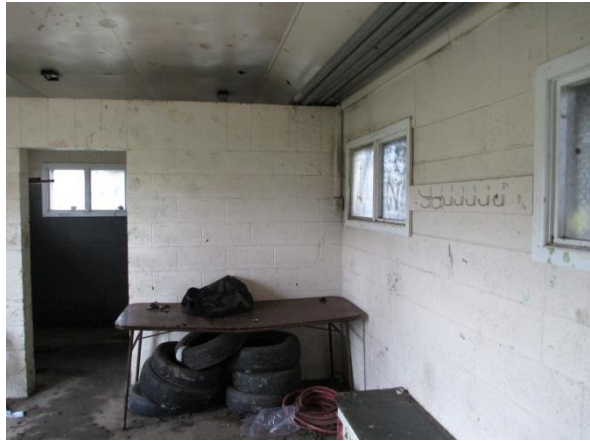
Building internal view.

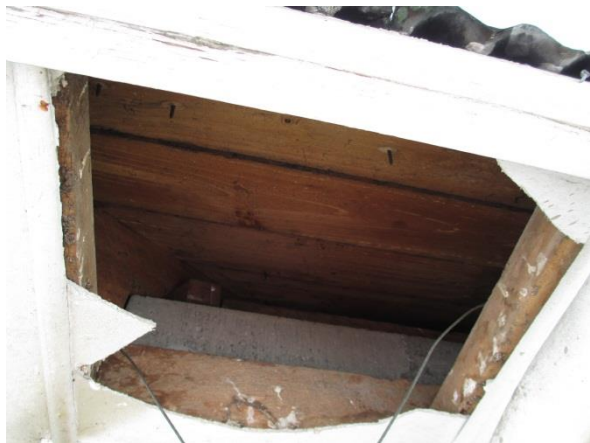
Roof timber sarking.

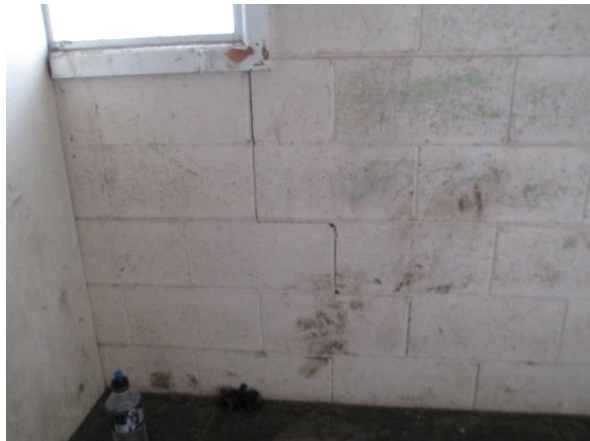
- Minor step cracking in the blockwork under one of the windows. This is only visible from the inside of the building.

There was only minor damage noted to the Linwood Park Pavilion. The damage observed is due to the deformation of the building during the recent earthquakes.

Minor step cracking in the blockwork under one of the windows

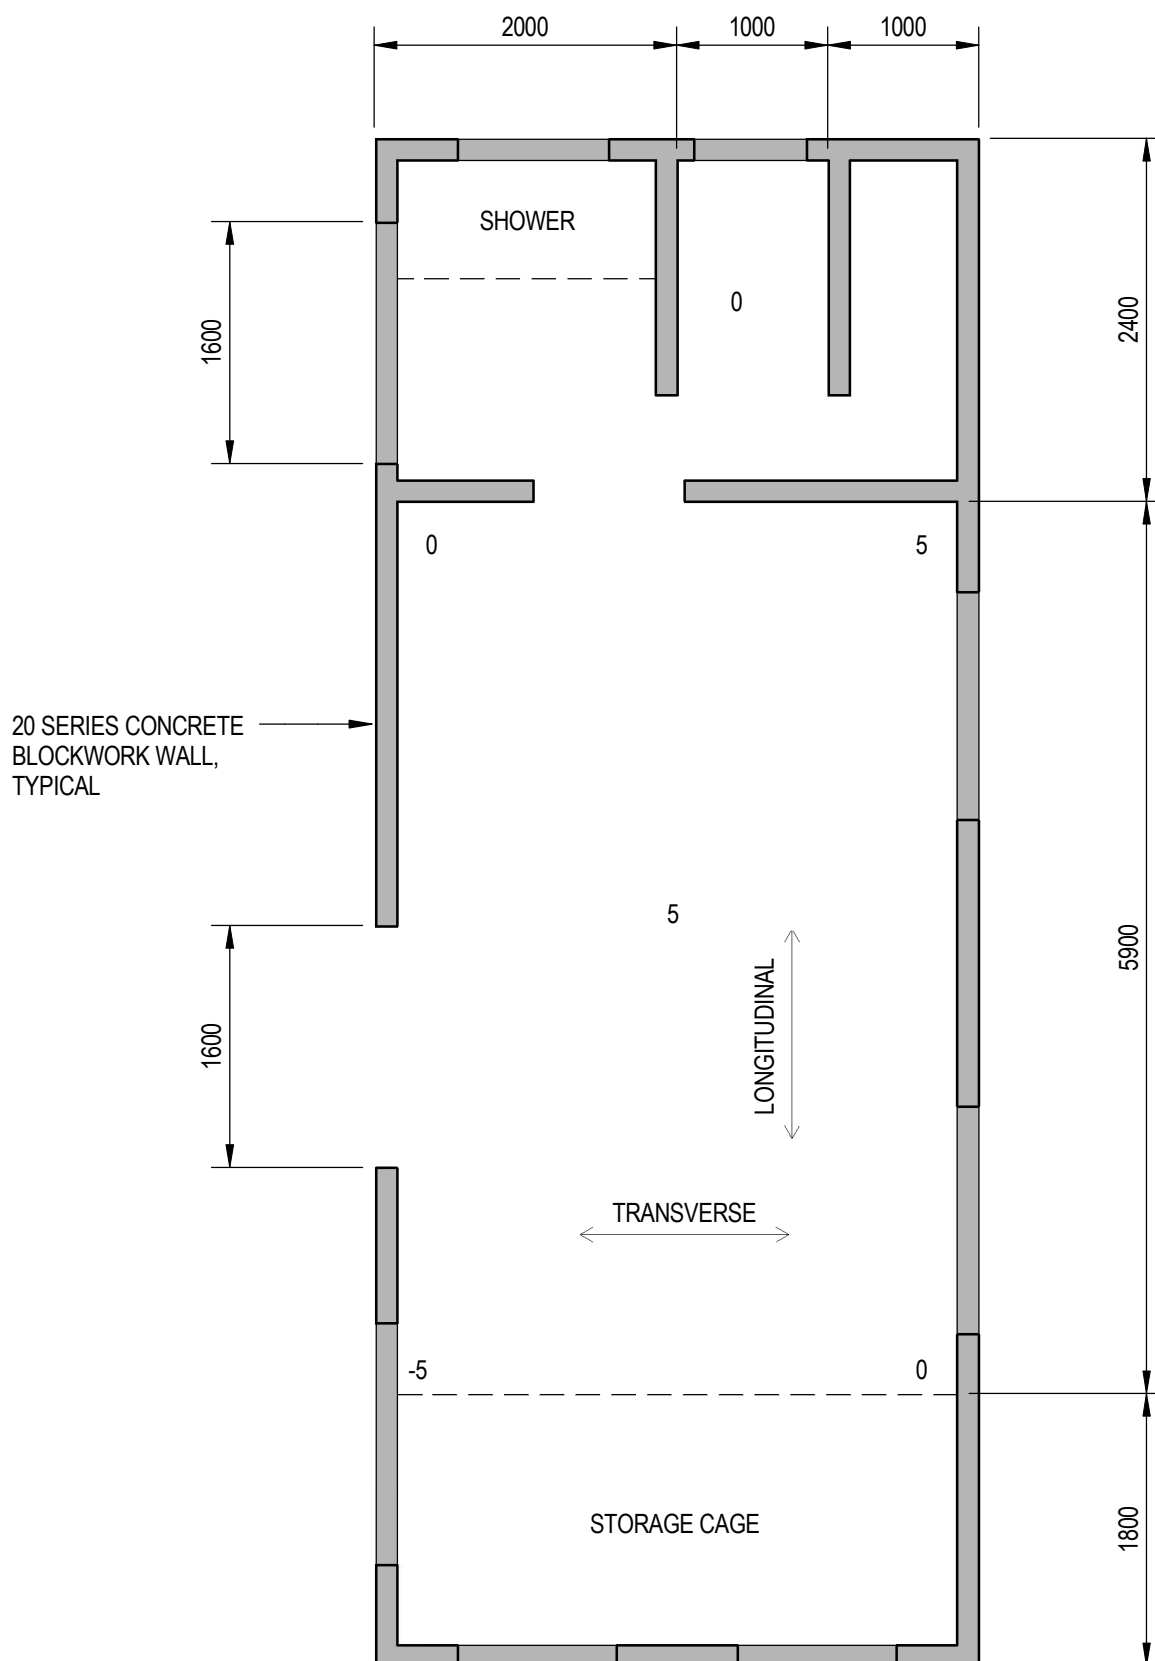
## FLOOR LEVELS PLAN

The floor levels for the Linwood Park Pavilion were found to be within acceptable tolerances.
