Linwood Park Pavilion and Toilets
Qualitative Engineering Evaluation

Reference: 229189
Prepared for:
Christchurch City Council

Functional Location ID: PRK 0835 BLDG 001 EQ2

Revision: 2
Date: 14 December 2012

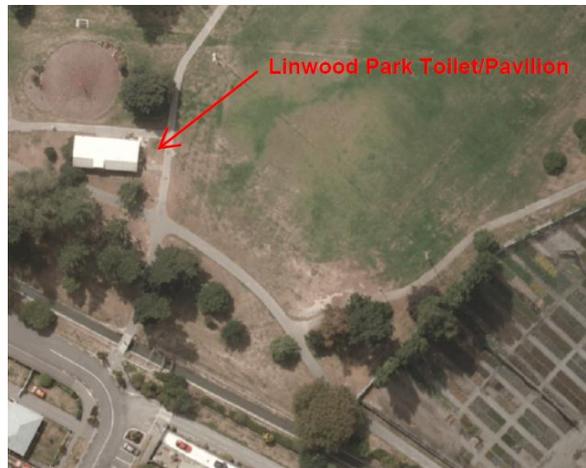
Northern elevation of Linwood Park Pavilion and Toilets.

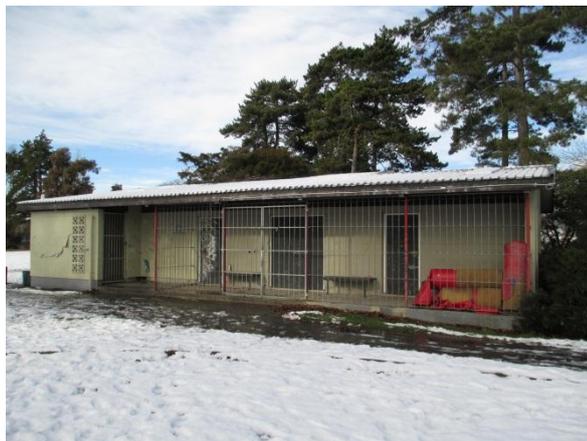
Eastern elevation of Linwood Park Pavilion and Toilets

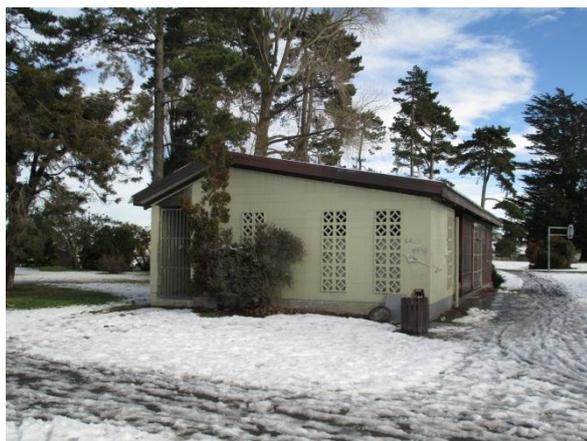
Southern elevation Linwood Park Pavilion and Toilets.

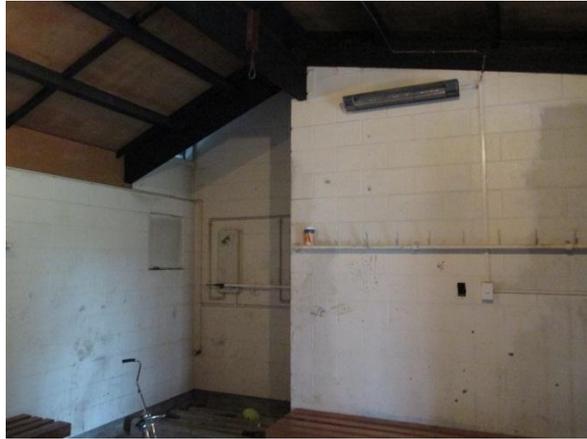
Internal view Linwood Park Pavilion and Toilets.

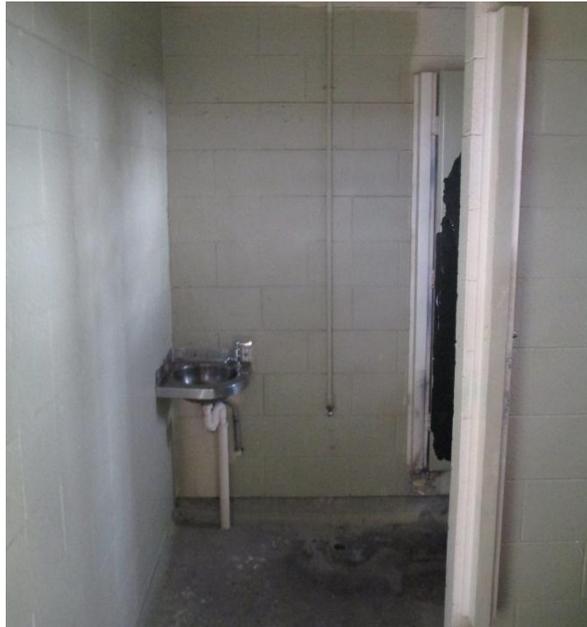
Internal view Linwood Park Pavilion and Toilets.

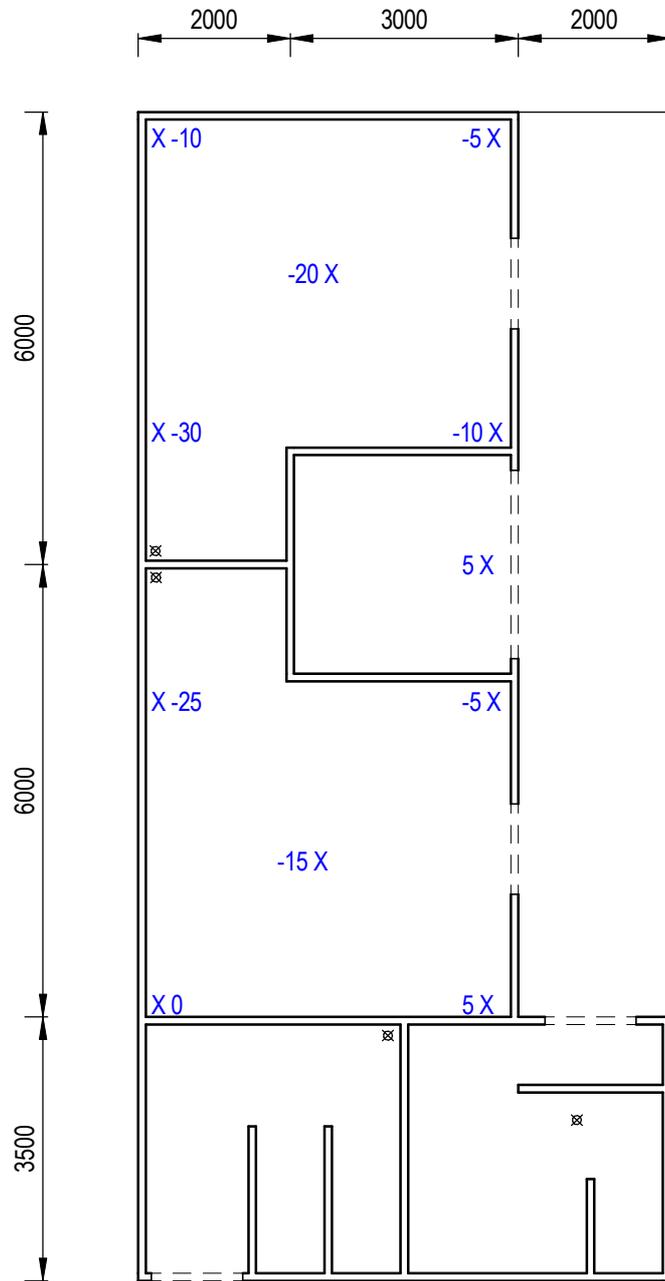
PROJECT
LINWOOD PARK PAVILION/TOILET
TITLE
LEVEL SURVEY

We undertook a floor levels survey to establish the amount of settlement that has occurred. The results of the survey are presented on the attached drawings in Appendix A. All of the levels were taken on top of the existing floor coverings which will have introduced some variation.

The floor levels for the Linwood Park Pavilion and Toilets were found to be within acceptable tolerances. The variances in floor levels noted have been provided for drainage purposes.
