**Little River Cemetery
Community Building
PRK 3668 BLDG 001 EQ2**

Detailed Engineering Evaluation

Quantitative Assessment Report

32 Upper Church Rd, Little River, Canterbury

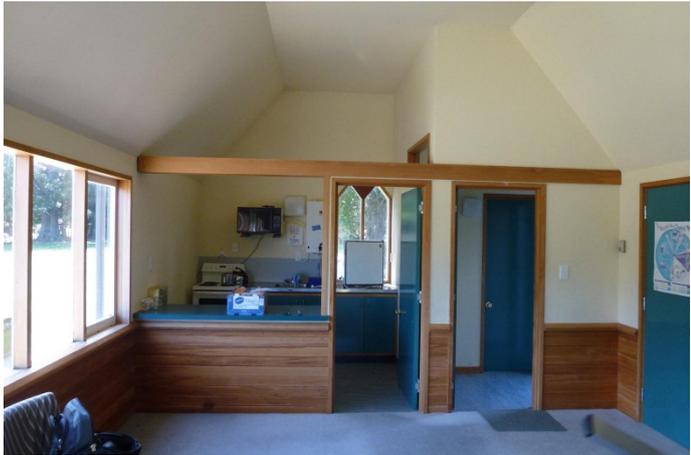
<p>3.</p>	<p>Northern end wall and kitchen (refer beam over kitchen)</p>

There appears to be separation of the timber encasing and the wall to the roof beam spanning over the kitchen at the northern end of the building, likely to be caused by longitudinal shrinkage. A closer inspection should be undertaken to ensure that the beam remains fully connected to the wall and that only the timber encasing has pulled away. This damage is not considered to be the result of the recent seismic activity.

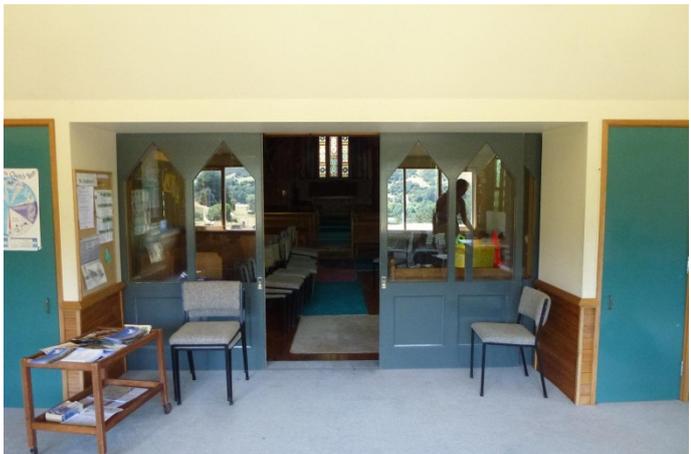
There is a noticeable sag in the ceiling section over the passageway to the adjoining church. This damage is not believed to be as a result of the recent seismic activity.

A photograph showing the northern end wall and kitchen area. The room features a vaulted ceiling, light-colored walls, and wood-paneled lower walls. A wooden counter with a blue top runs along the wall. To the left, there are large windows. In the center, there is a doorway leading to another room. A blue door is visible on the right side.
<p>4.</p>	<p>Passageway to church</p>

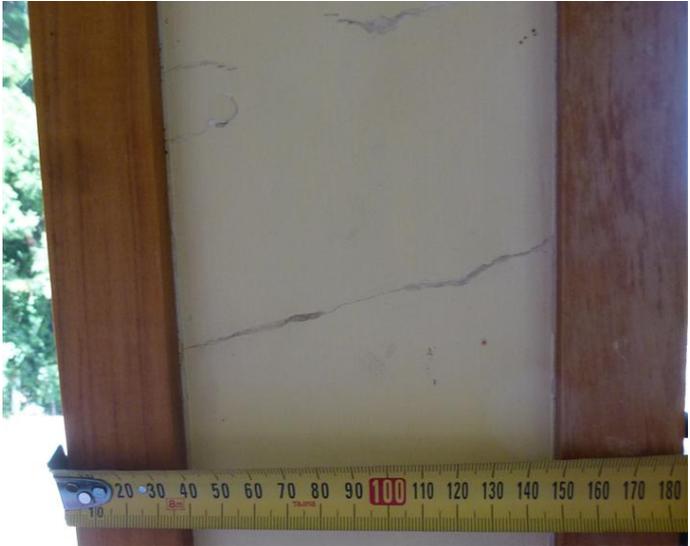
There are numerous instances of minor cracking in the internal wall lining. These are likely the result of excessive wall deflections caused by the seismic activity since September 2010. However these will not significantly impact the performance of the building in future seismic events.

A photograph showing the interior of a room. On the right, there is a large window with a decorative, multi-paned glass section at the top. A sofa covered in a striped cloth is positioned in front of the window. To the left, there is a wooden table and some equipment on a desk.
<p>7.</p>	<p>Gib board cracks between glazing frames</p>

- (a) If improved performance is required then install hold-down connections between the timber bearers and piles in accordance with NZS 3604.
- (b) Repair wall lining cracks.

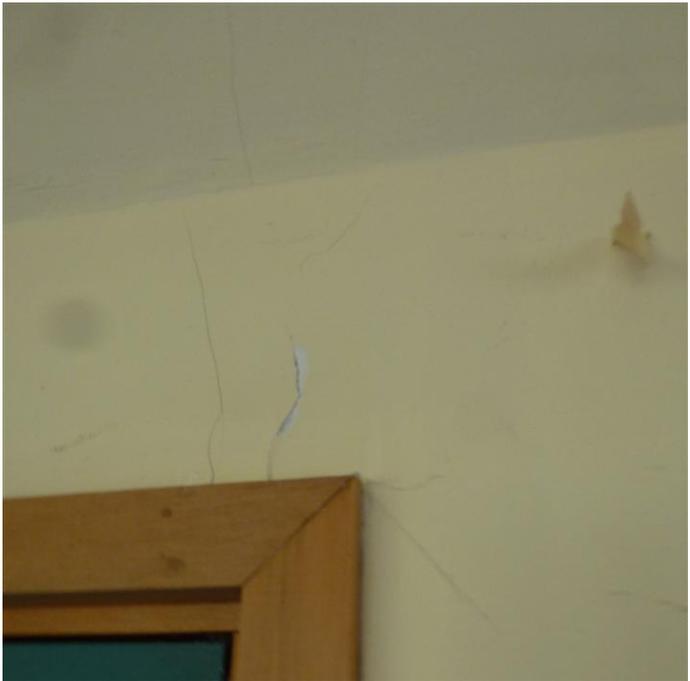
A close-up photograph of a wall. A horizontal crack runs across the wall between two vertical wooden frames. A yellow measuring tape is placed at the bottom of the image for scale, showing the crack is approximately 100 cm long.
<p>8.</p>	<p>Gib board cracks around door frame</p>

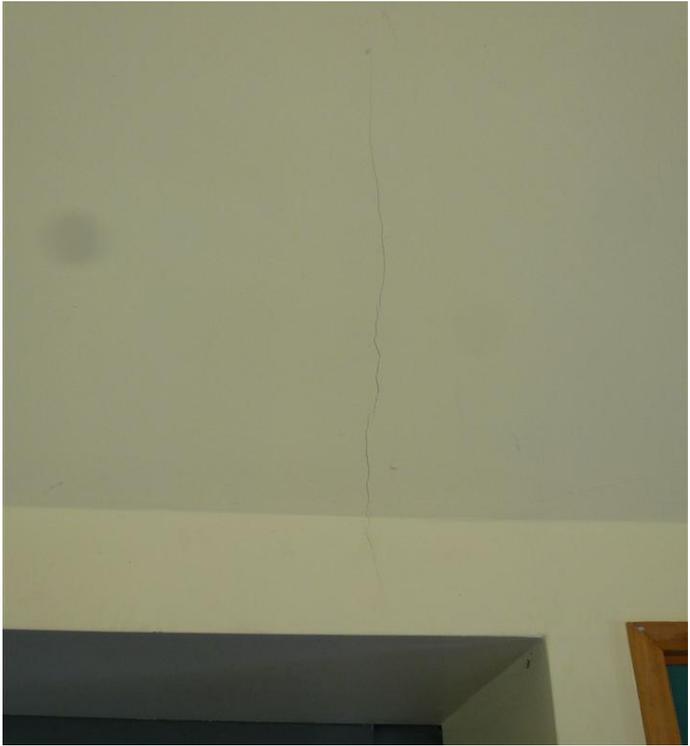
<p>9.</p>	<p>Gib board cracks over passageway</p>

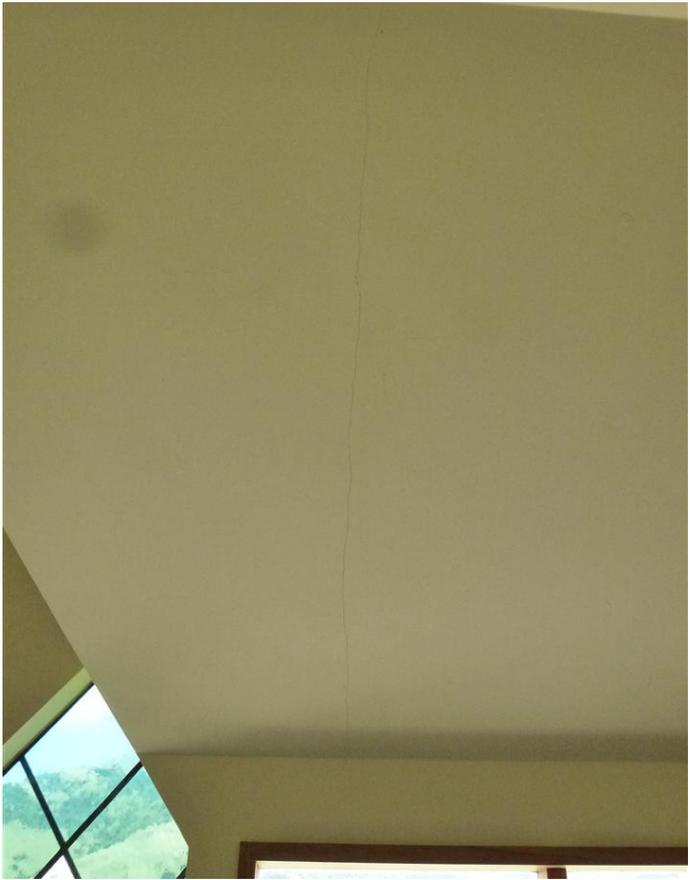
A photograph showing a vertical crack in a white wall. The crack runs from the top of the frame down to a horizontal ledge or passageway. The wall is otherwise plain and white.
<p>10.</p>	<p>Gib board cracks over window frames in western wall</p>

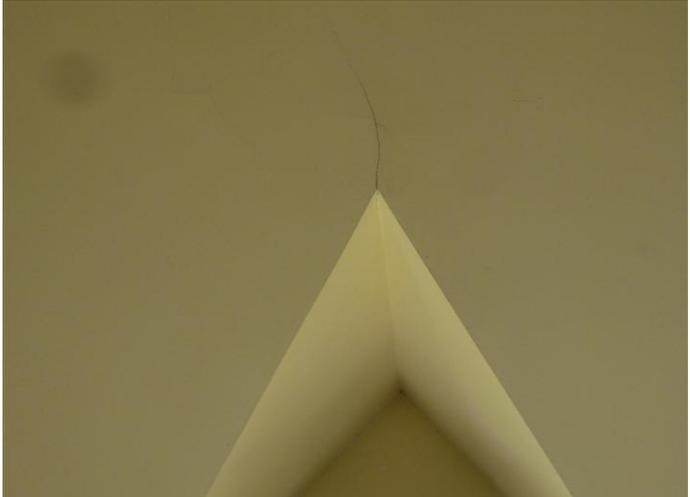
11.	Gib board cracks over window frames in western wall

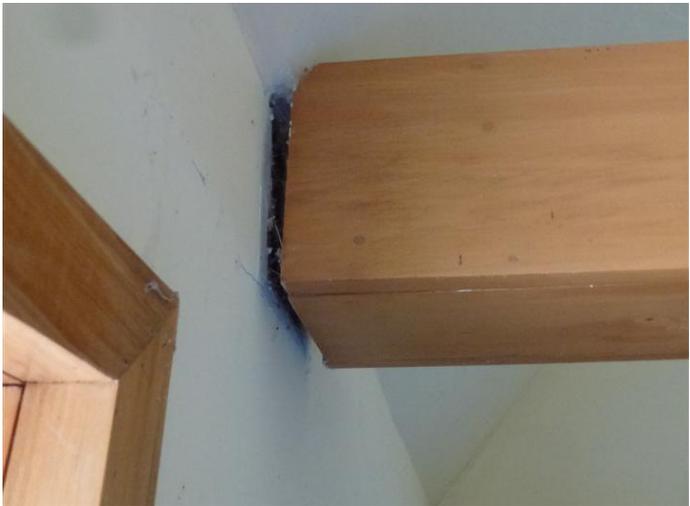
12.	Separation of lining around beam from western wall in kitchen

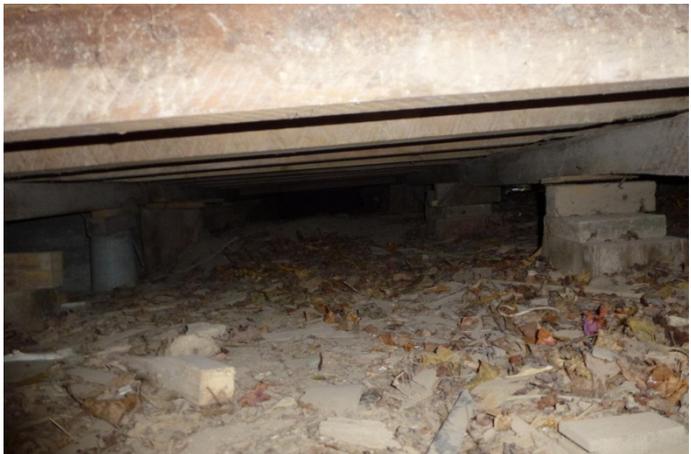
Visual inspection shows that there is no significant connection between bearers and the supporting piles. No indications of failure were observed, but a lack of hold down fixings is not in accordance with current design codes.

16.	Sub-floor supports – mix of timber or concrete piles and timber blocking

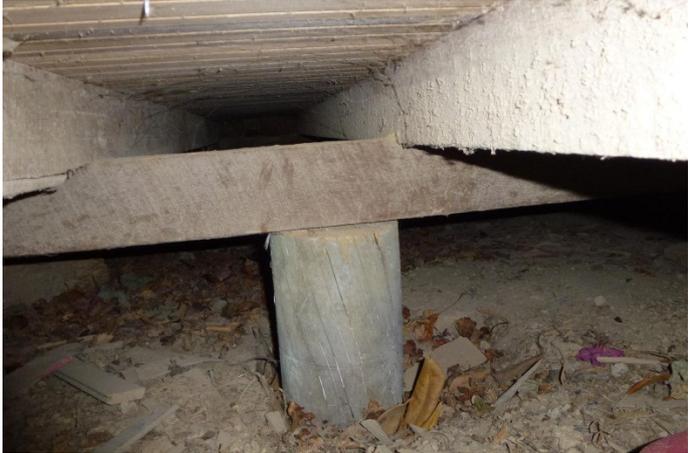
This building has been assessed to have a seismic capacity of 84% NBS, limited by lack of footing tie down, and therefore is not classed as an earthquake prone building. The key seismic strength deficiency is the lack of tie-down of floor bearers to footings.

17.	Joist-bearer-pile. Note: No apparent tie-down between any members
