Little River Community Facilities
Qualitative Engineering Evaluation

Reference: 228600
Prepared for:
Christchurch City Council

Address: 40 Western Valley Road

Date: 28 June 2013

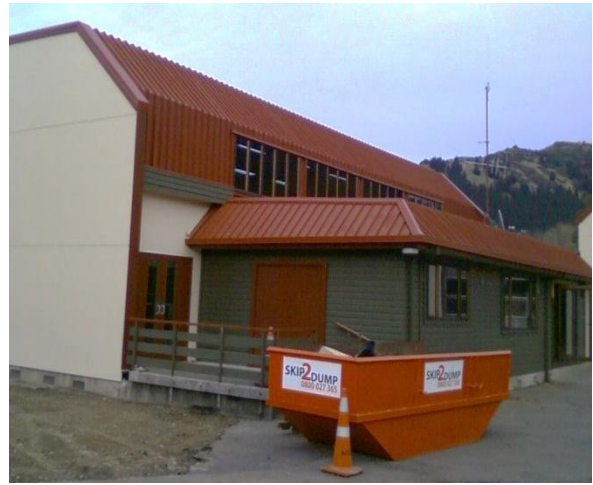
Building north-eastern elevation.

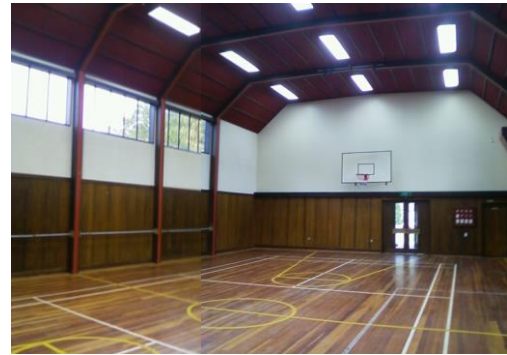
Building internal view.

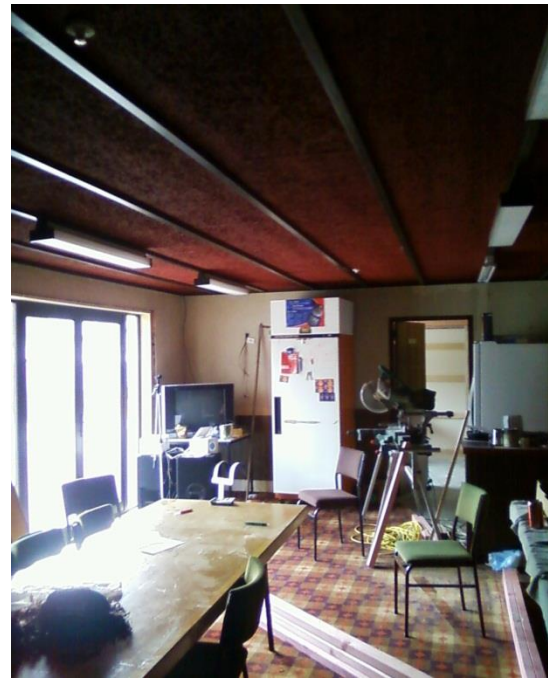
Building internal view.
