Louisson Courts BE 1026 EQ2

**Detailed Engineering Evaluation
Quantitative Assessment Report**

Louisson Courts

Date: December 2012
Reference: 6-QUCC1.74
Status: Final

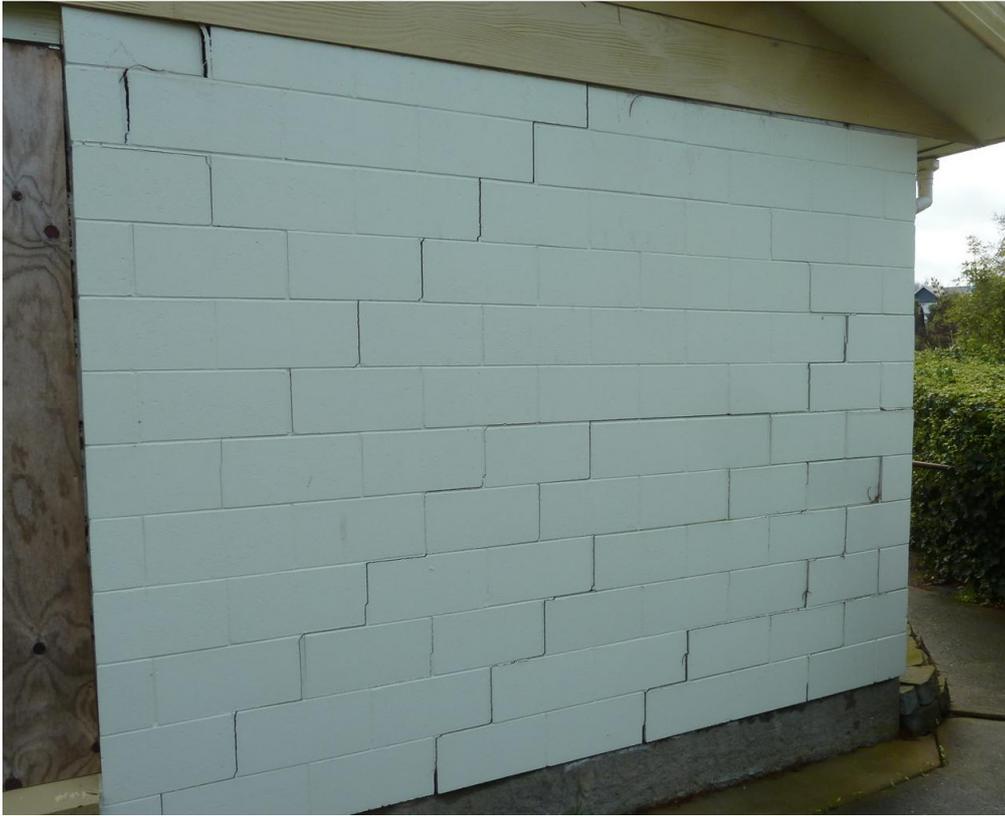
- Severe cracking to block veneers, with Unit 3 being particularly affected.
- Damage to timber truss members.

Photo 1: Cracking to block veneer

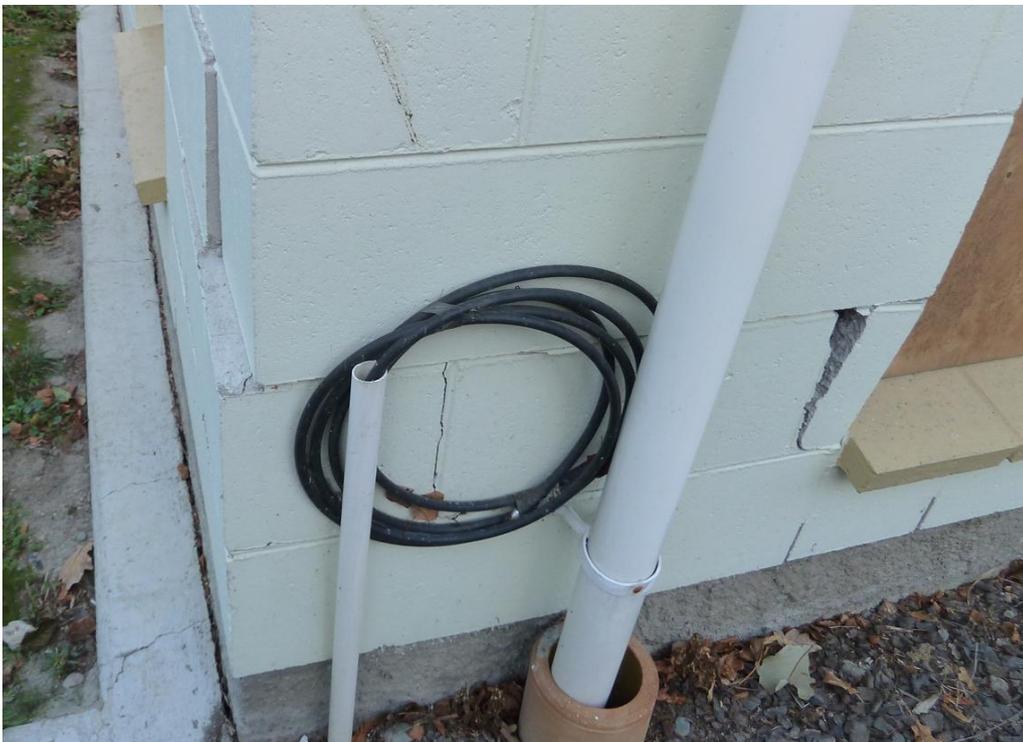
Photo 2: Cracking to block veneer

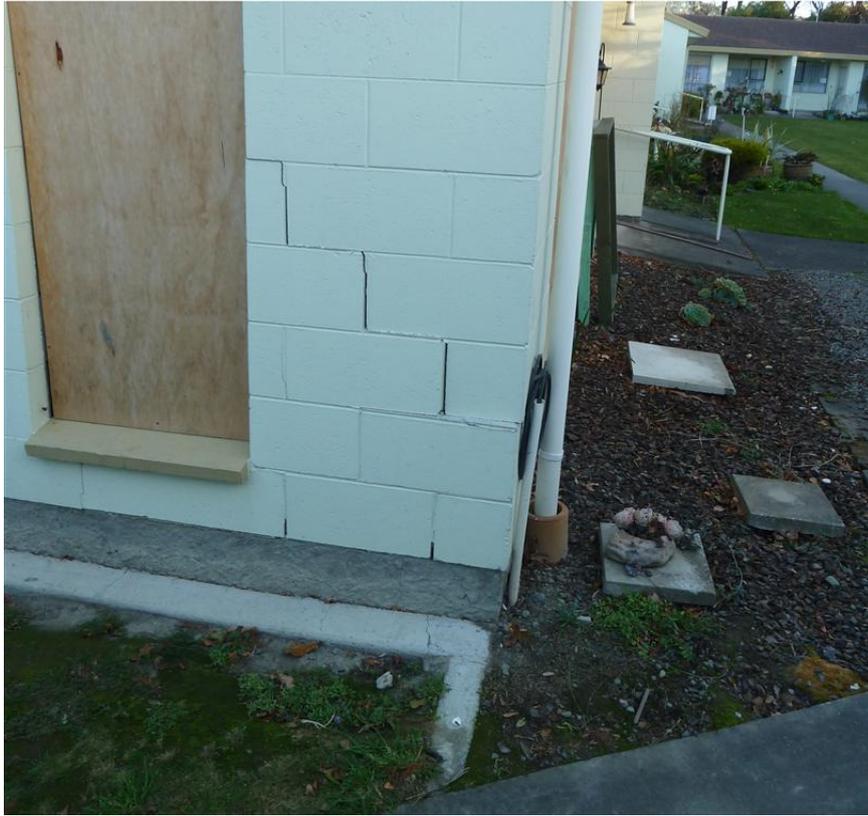
Photo 3: Cracking to block veneer

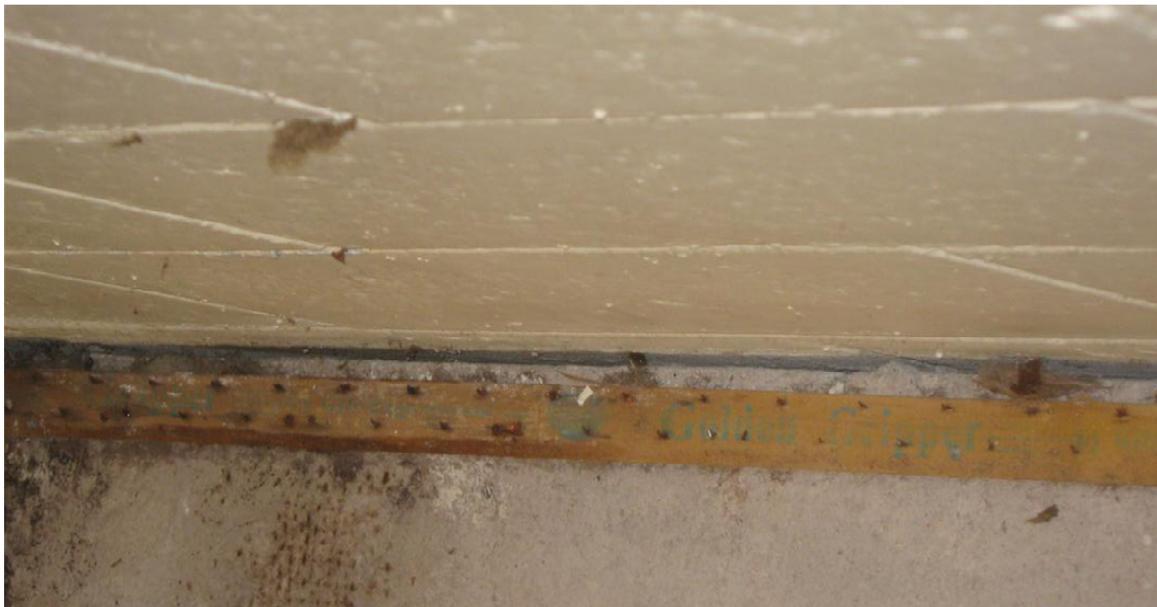
The concrete ground slabs are not tied to the foundation beams or the compartment walls.

Photo 4: Ground slab separation from the foundation beam

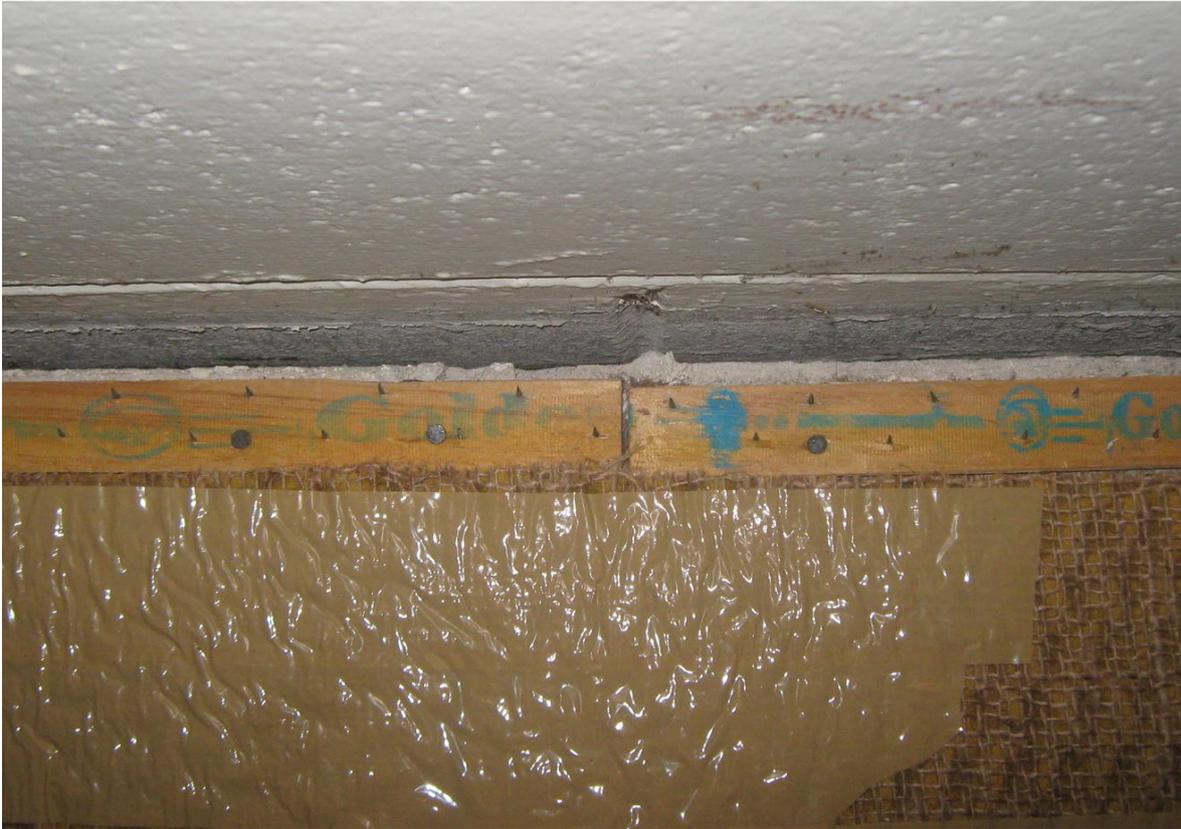
Photo 5: Ground slab separation from the foundation beam

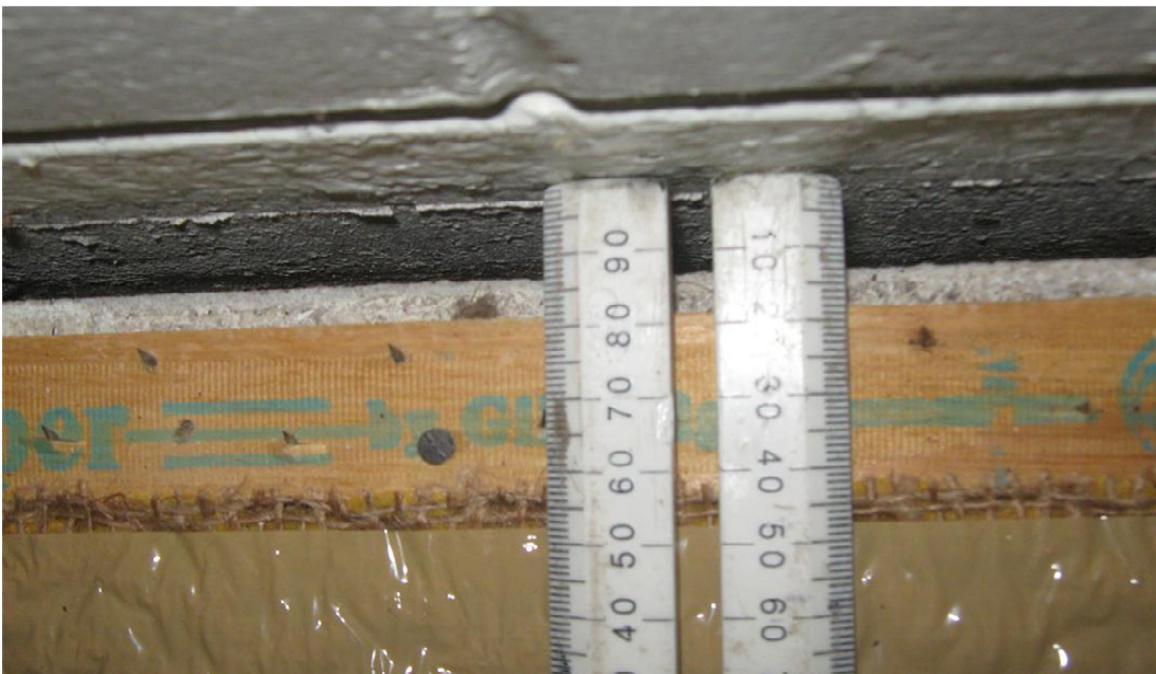
Photo 6: Ground slab separation from the foundation beam

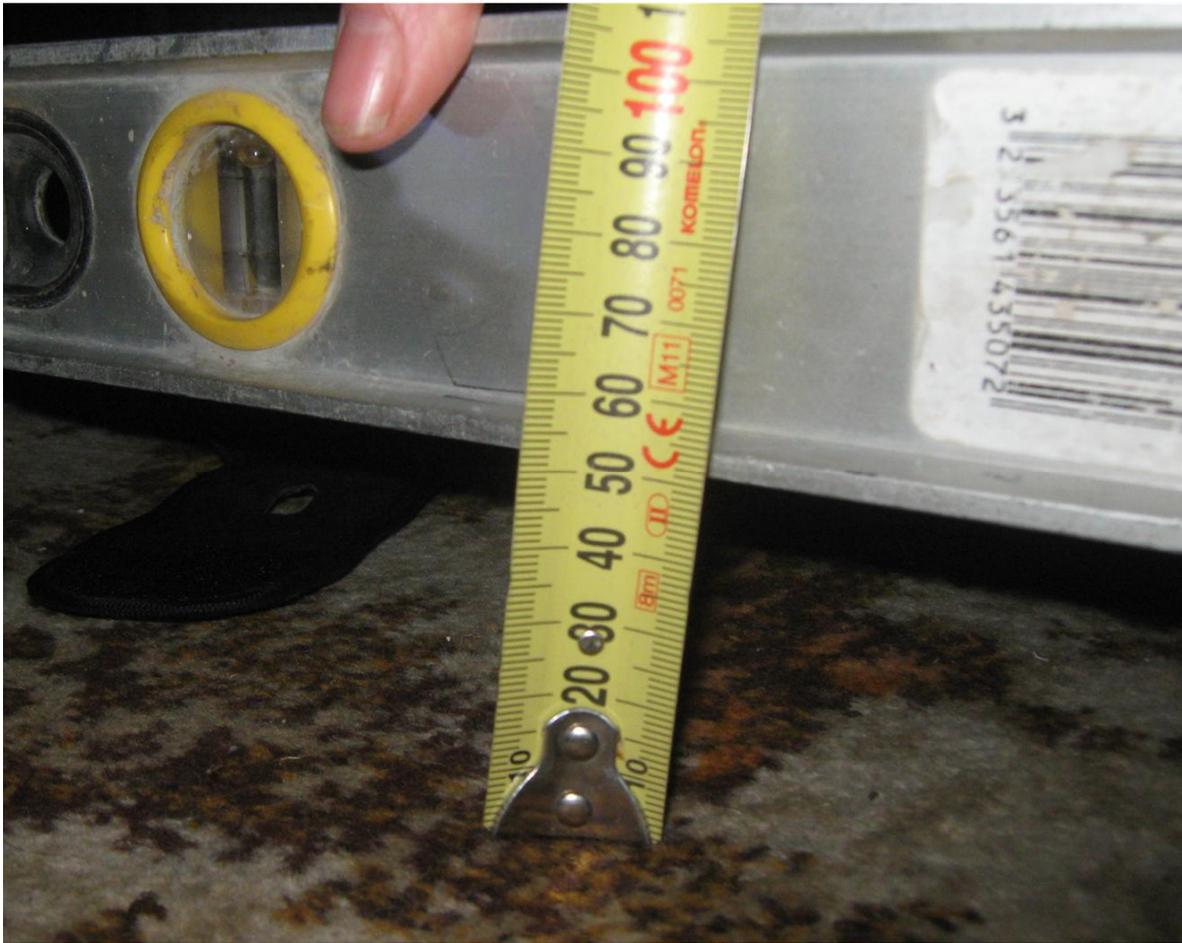
Photo 7: Ground floor settlement

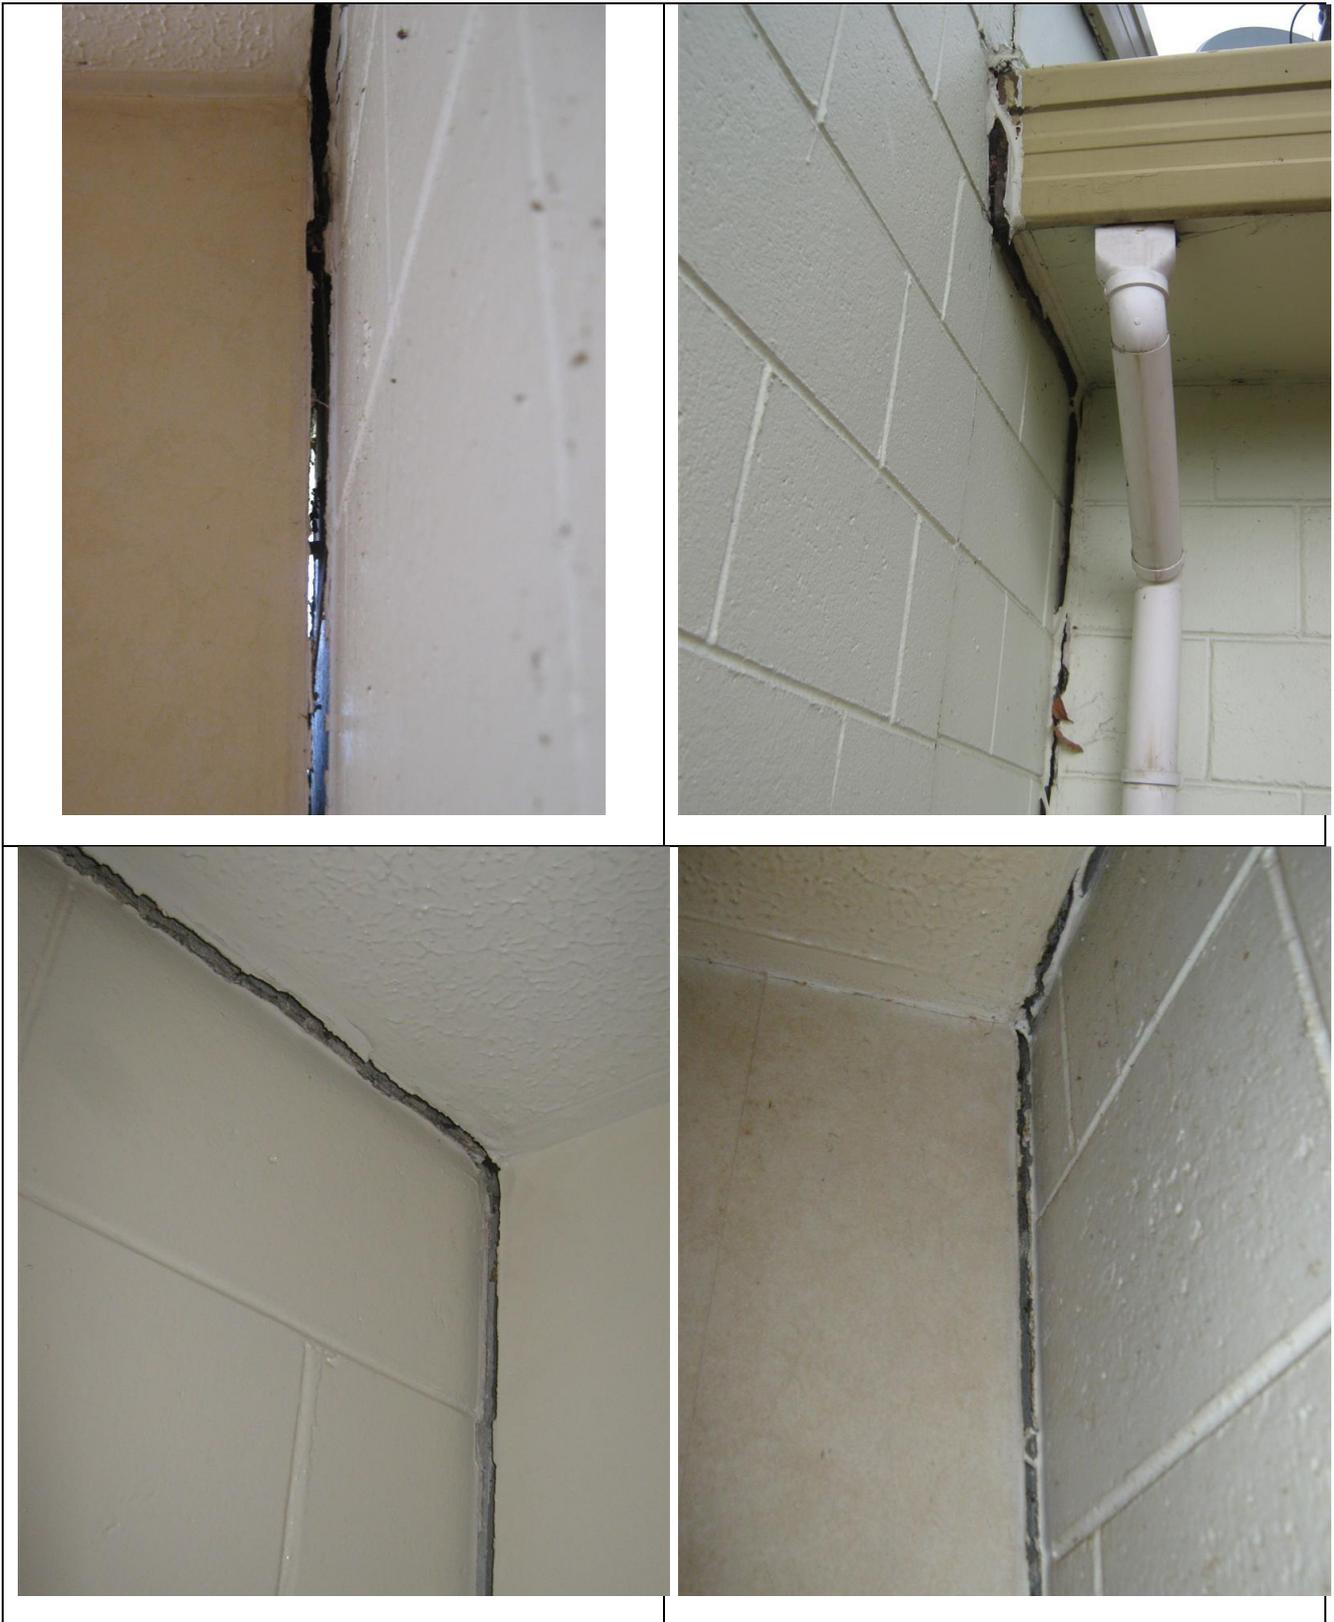
Photos 8 – 11: Blockwall separation

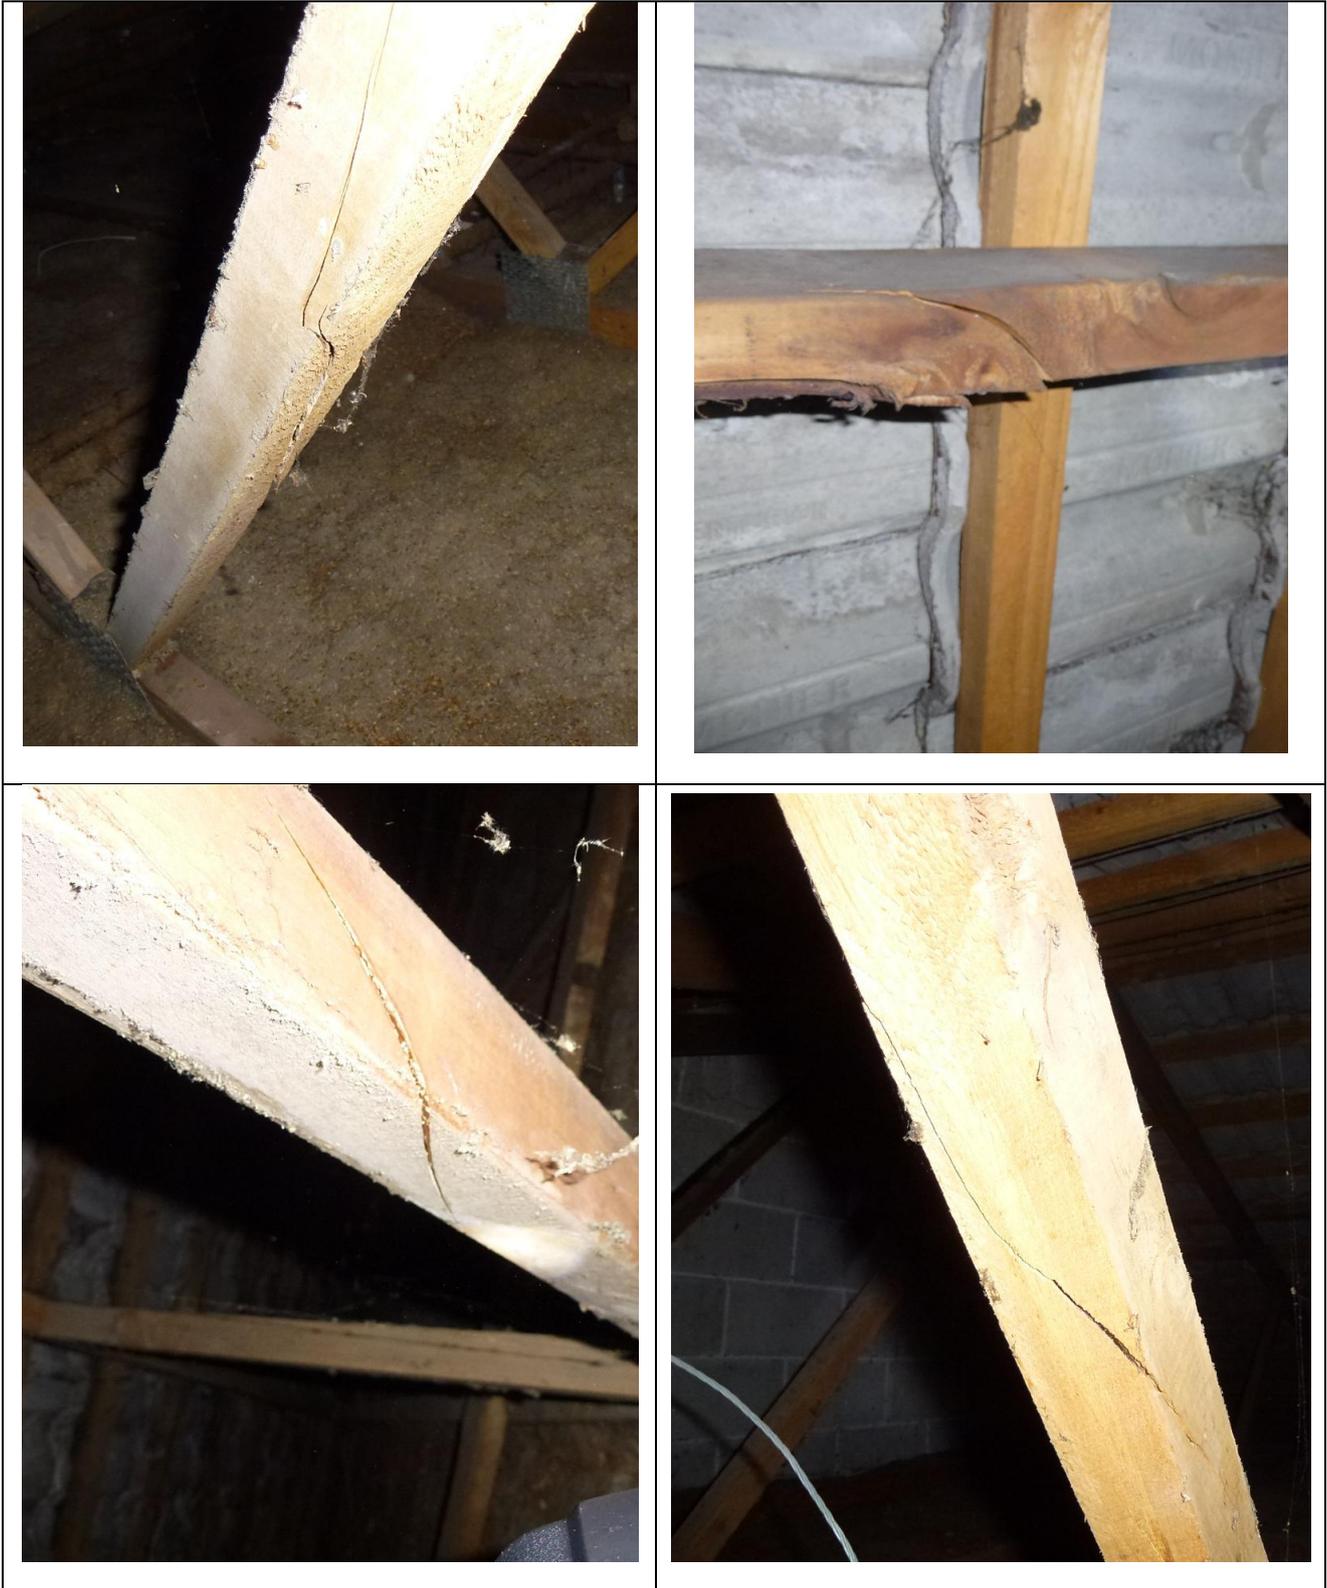
Photos 12 – 15: Breaking of roof trusses

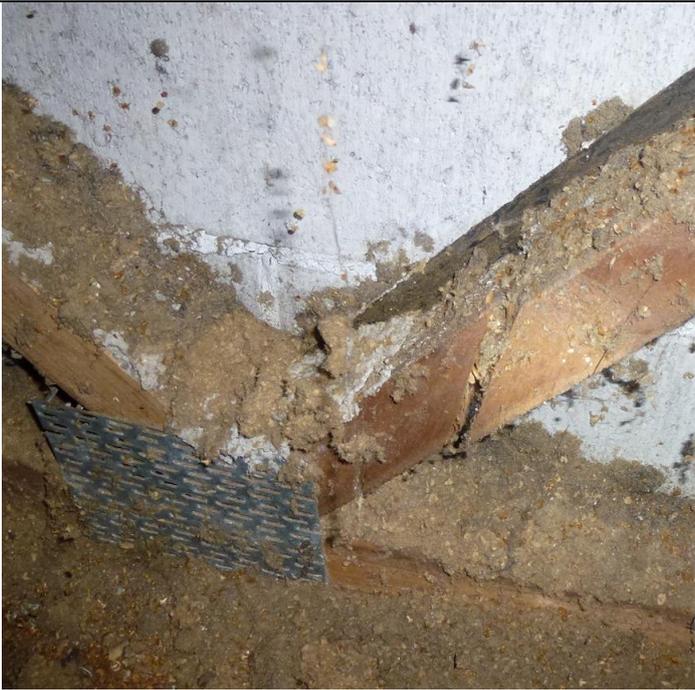
Unit 1

Photos 16 – 18: Breaking of roof trusses

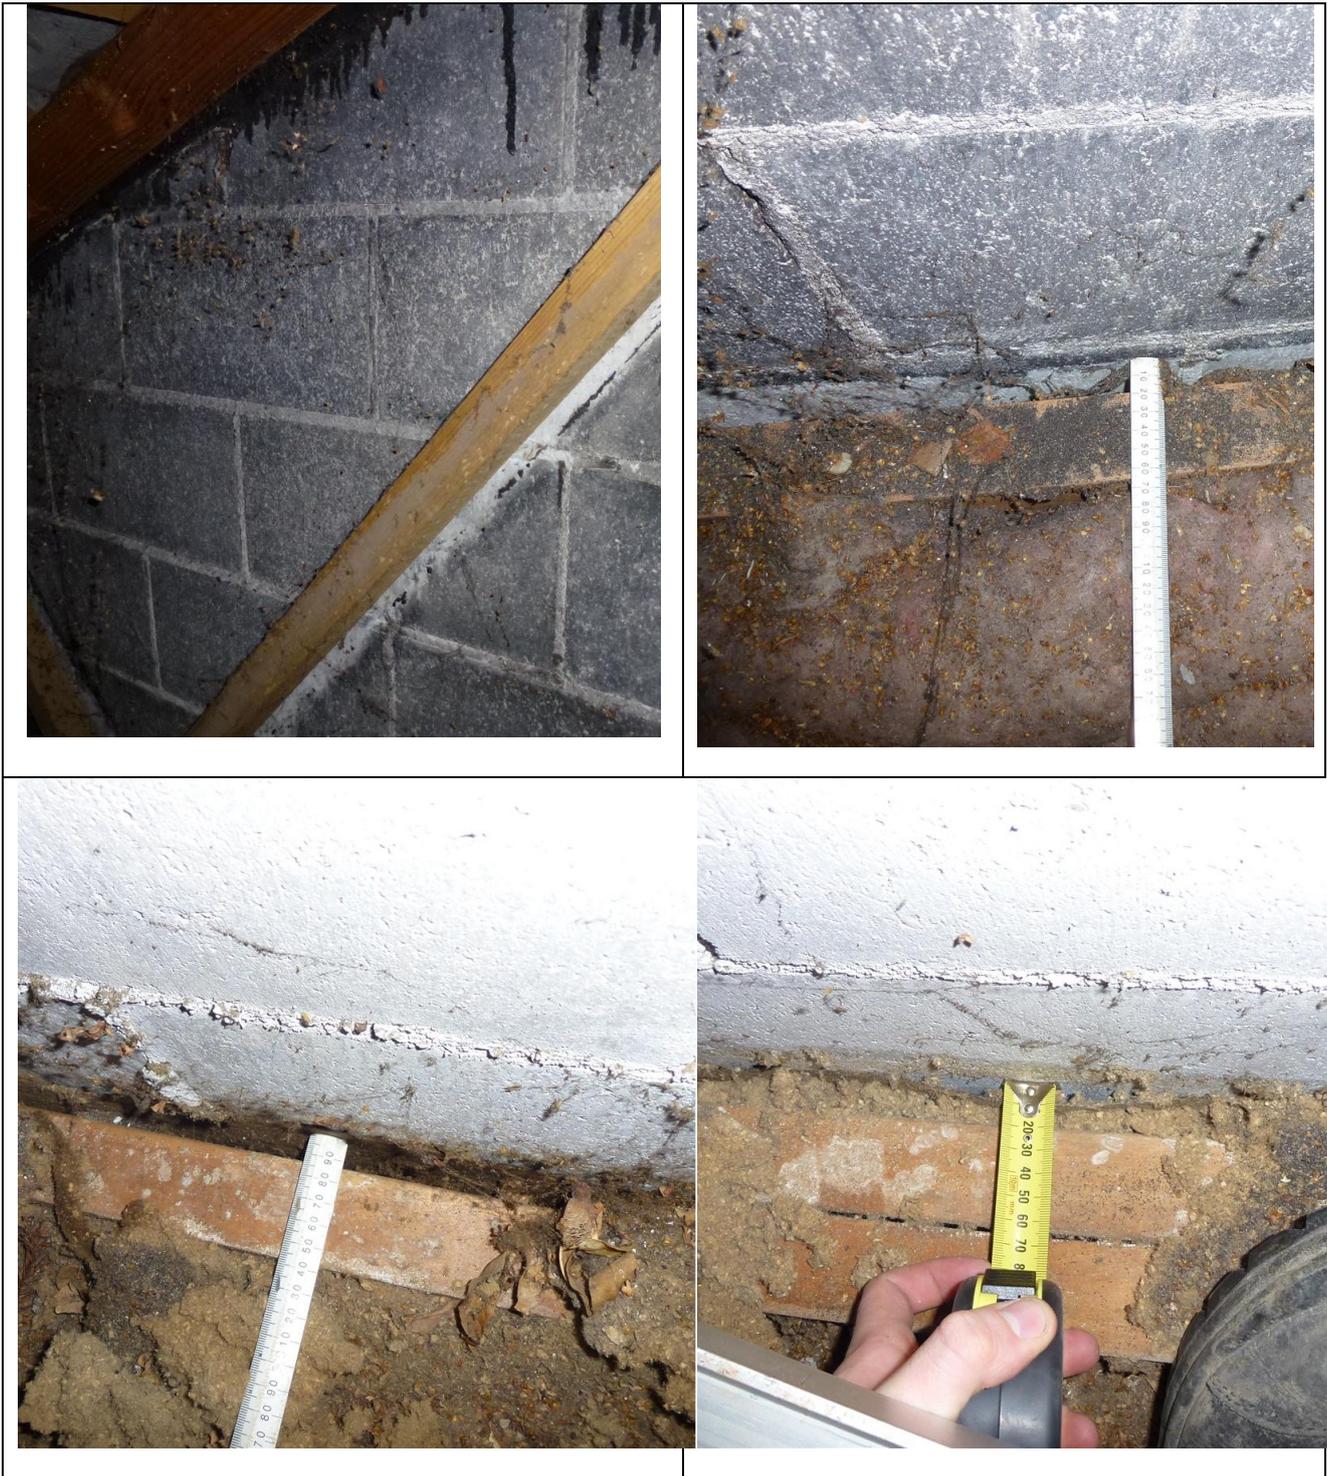
Photos 19 – 22: Blockwall separation

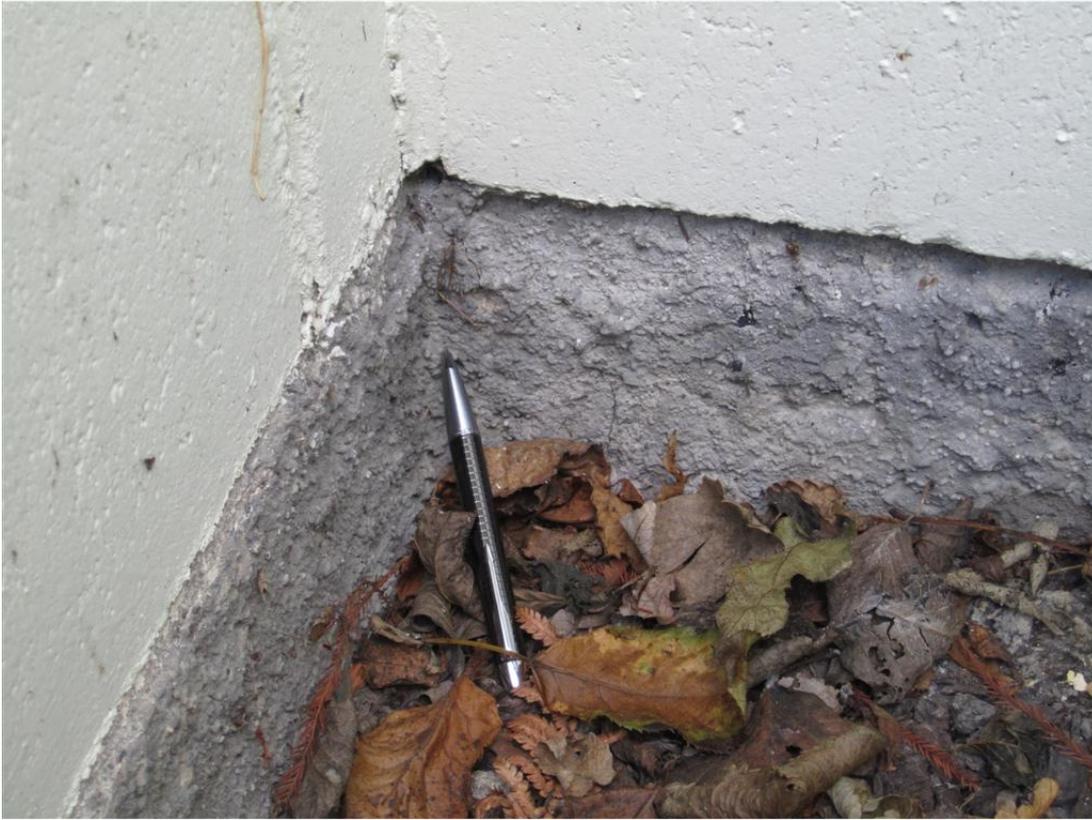
Photo 1: Hairline crack in foundation on south side of Unit 1 to 2

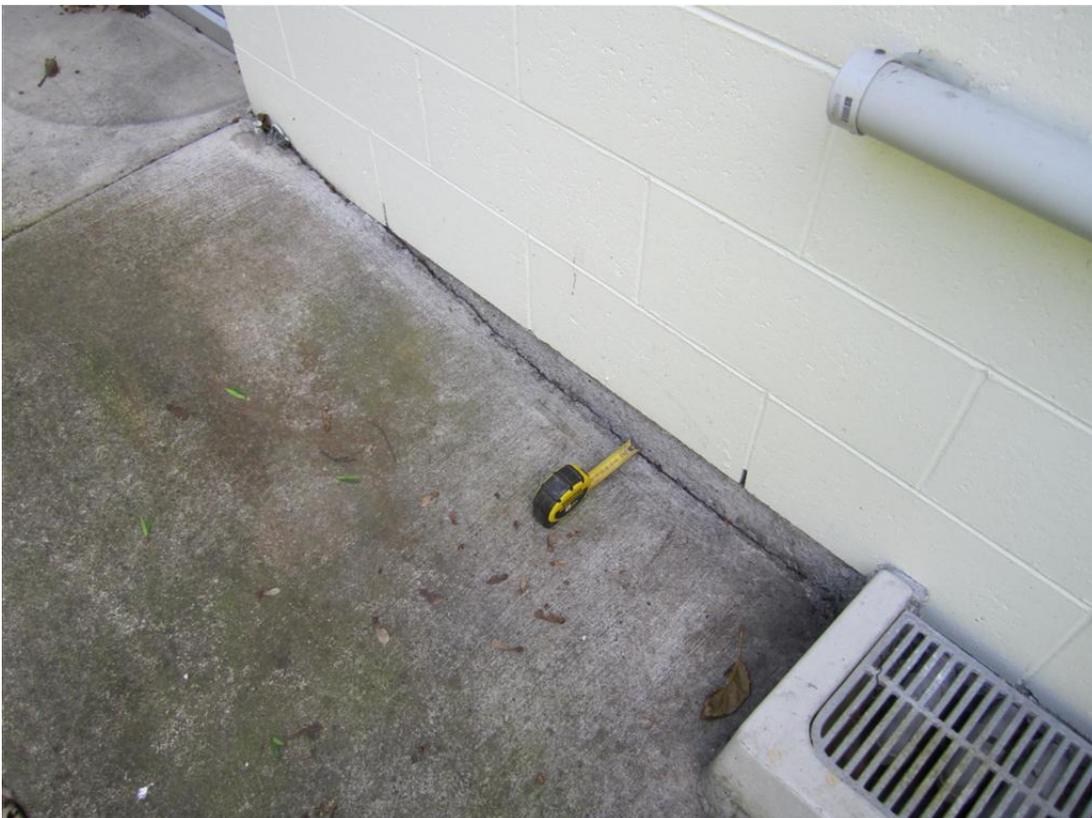
Photo 2: Slight separation (<math><5\text{mm}</math>) between foundation and concrete path

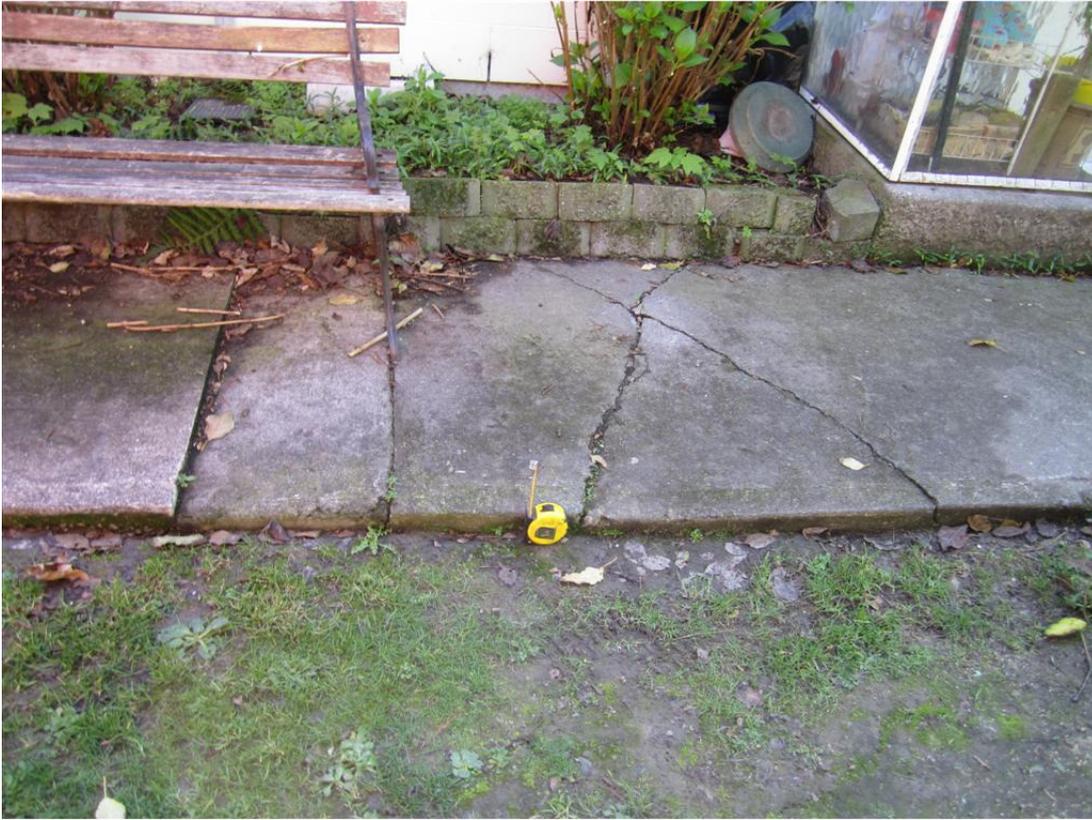
Photo 3: Cracks on path around south end of Units 1 to 2, with tilted blocks lining path.

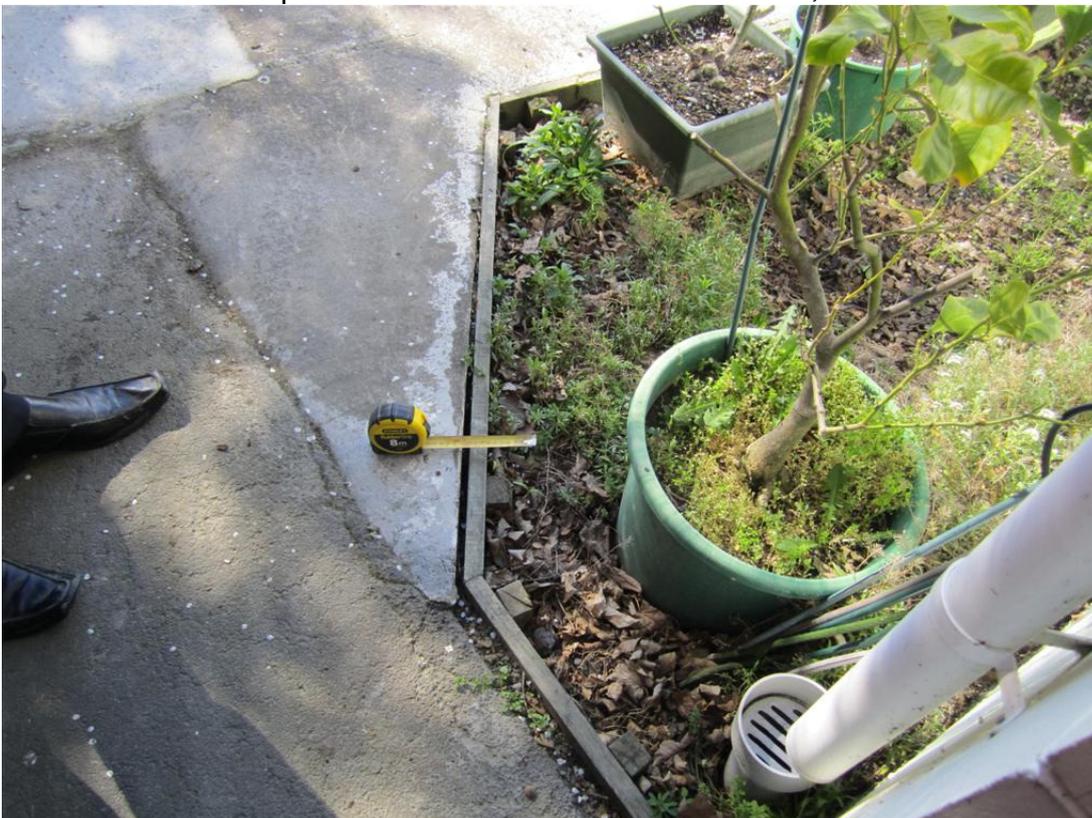
Photo 4: Crack (<1mm to 10mm wide) around path on north west end of Unit 1 to 2

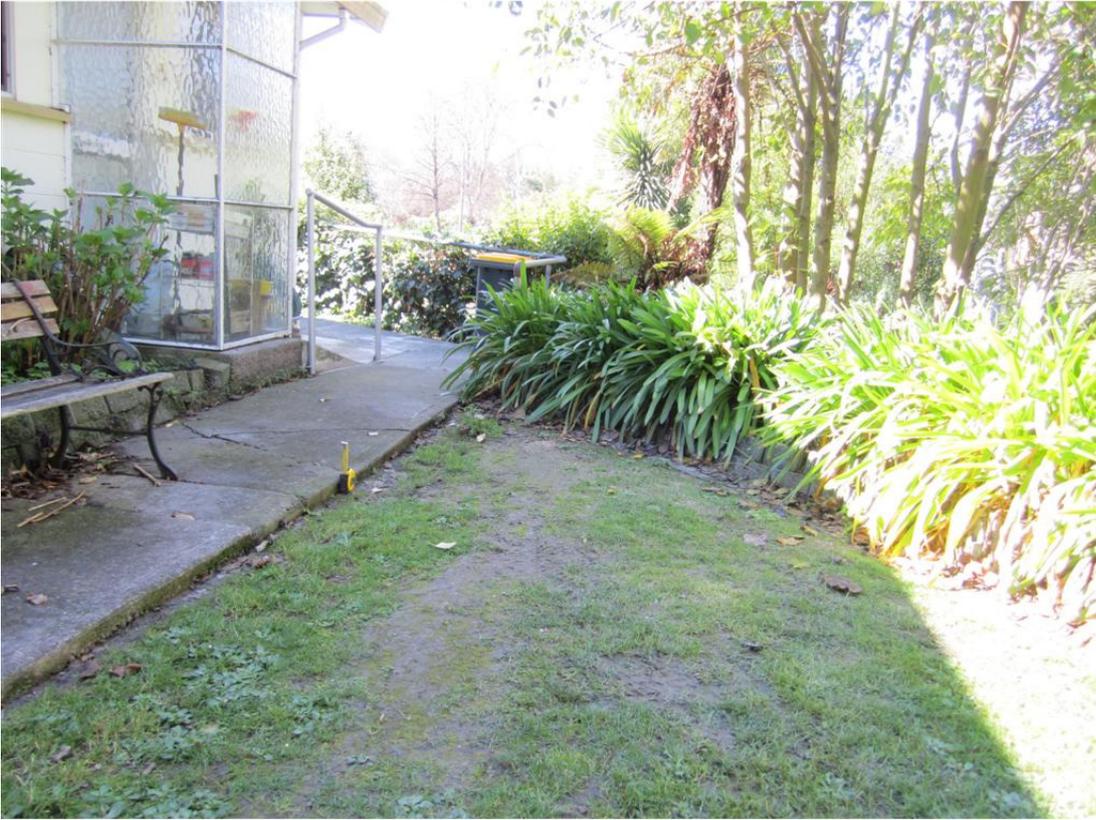
Photo 5: Difference in lawn and path levels on south side of unit 1 and 2

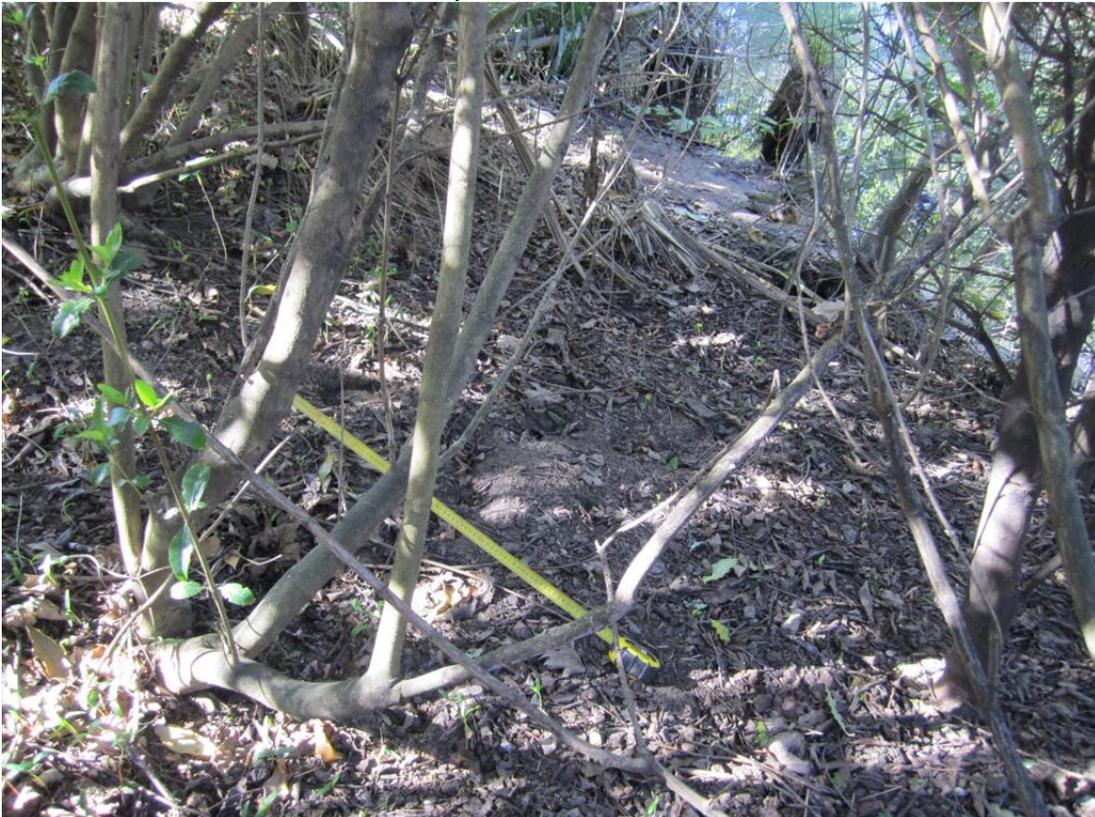
Photo 6: Suspected scarps / cracks on slope close to stream south of Units 1 and 2.

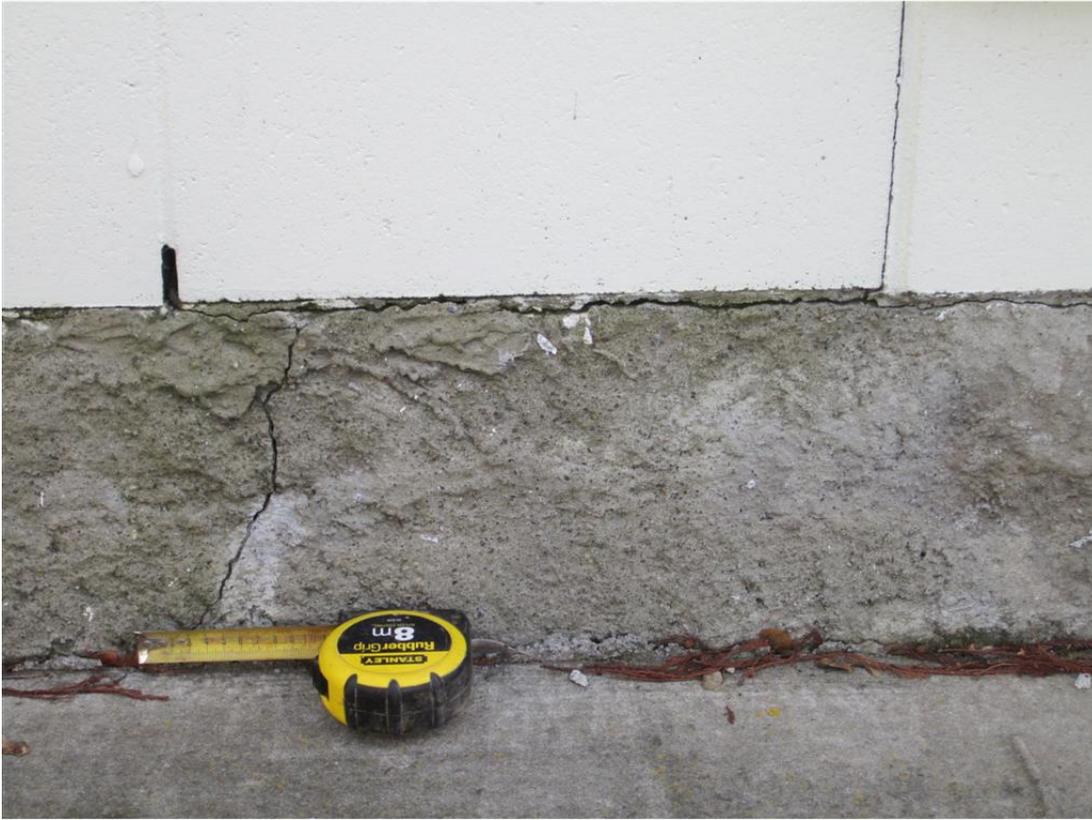
Photo 7: 2mm wide crack in foundation on southern end of Units 3 to 8

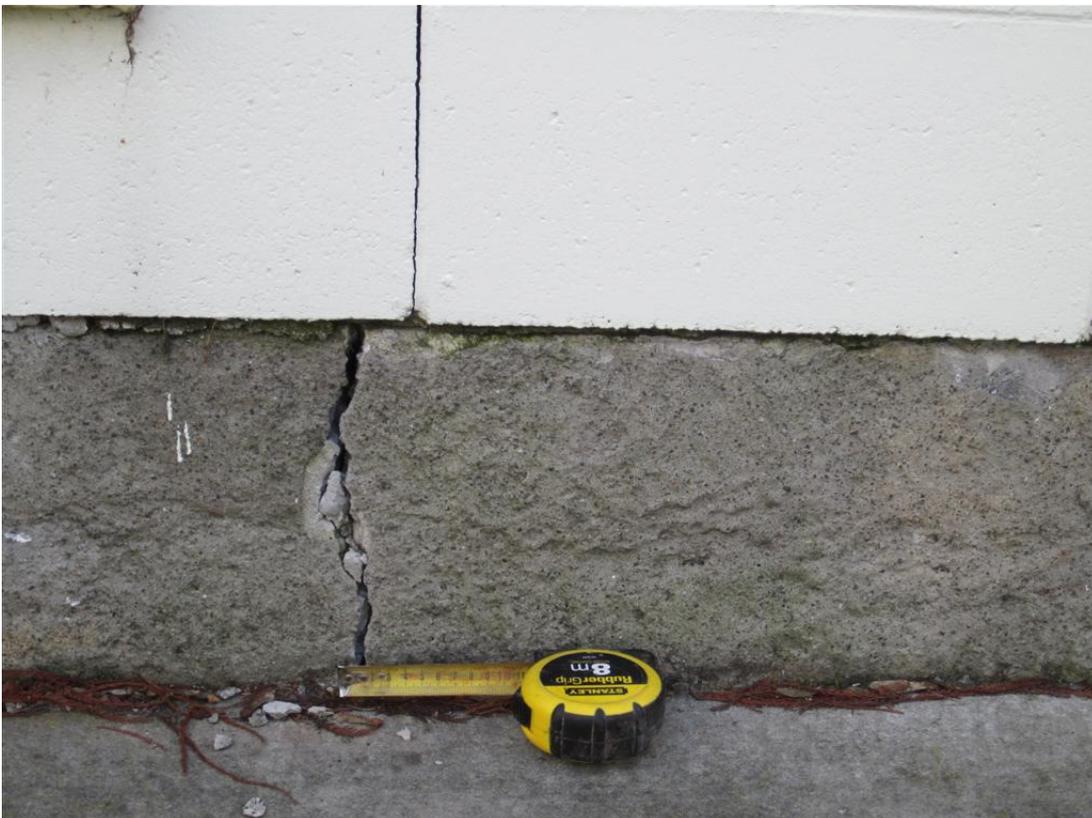
Photo 8: 6mm wide crack in foundation on southern end of Units 3 to 8

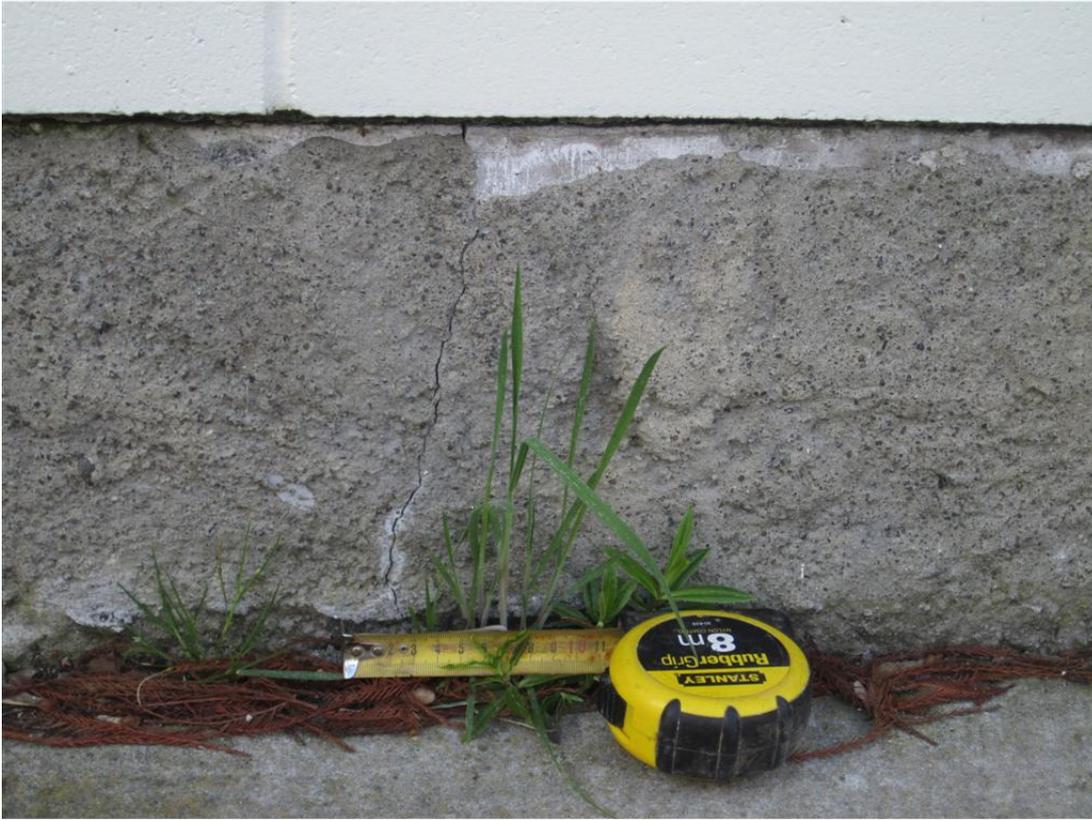
Photo 9: 1mm wide crack in foundation on southern end of Units 3 to 8

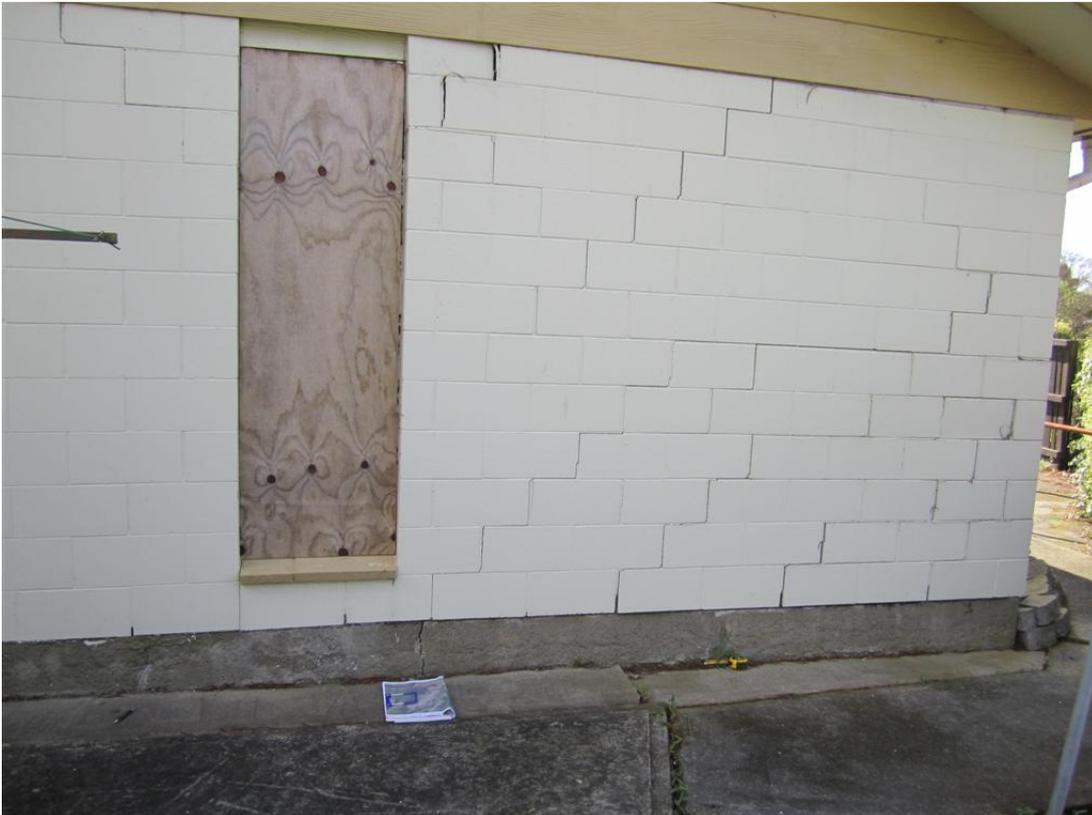
Photo 10: Step cracks on south side of Units 3 to 8

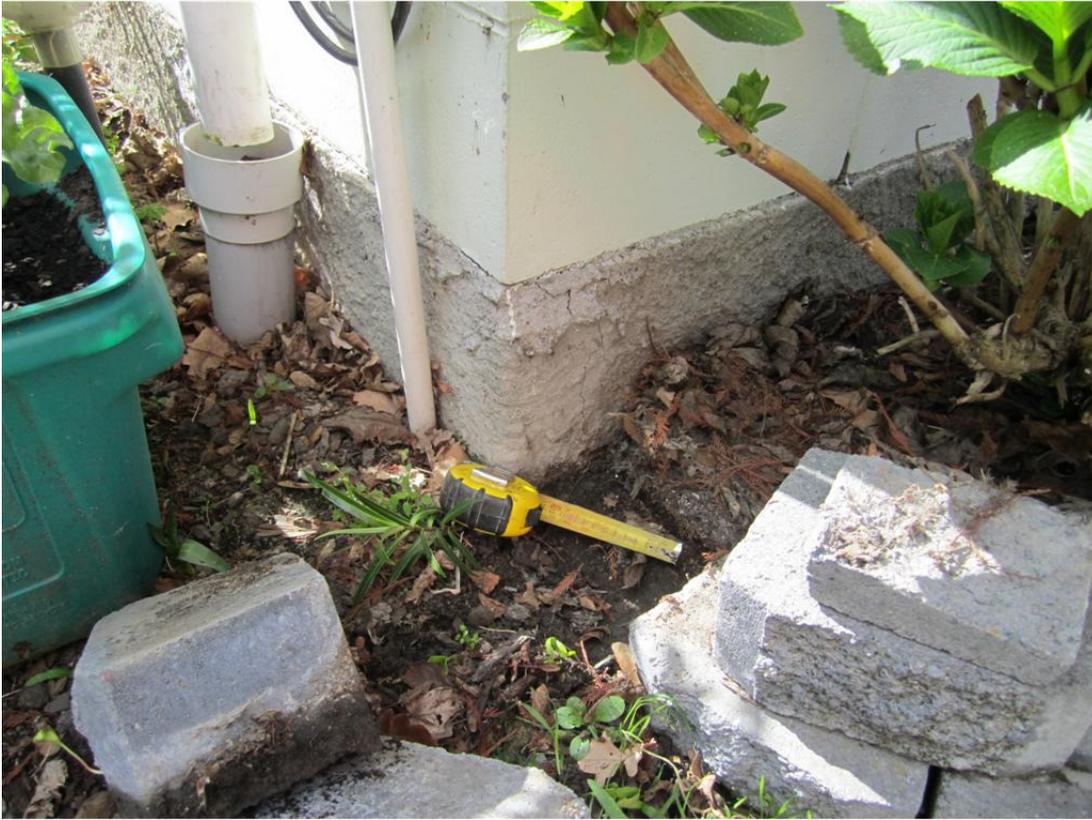
Photo 11: Hairline crack on south west corner of Units 3 to 8
