Louisson Courts BE 1026 EQ2

**Detailed Engineering Evaluation
Quantitative Assessment Report**

Louisson Courts

Date: December 2012
Reference: 6-QUCC1.74
Status: Final

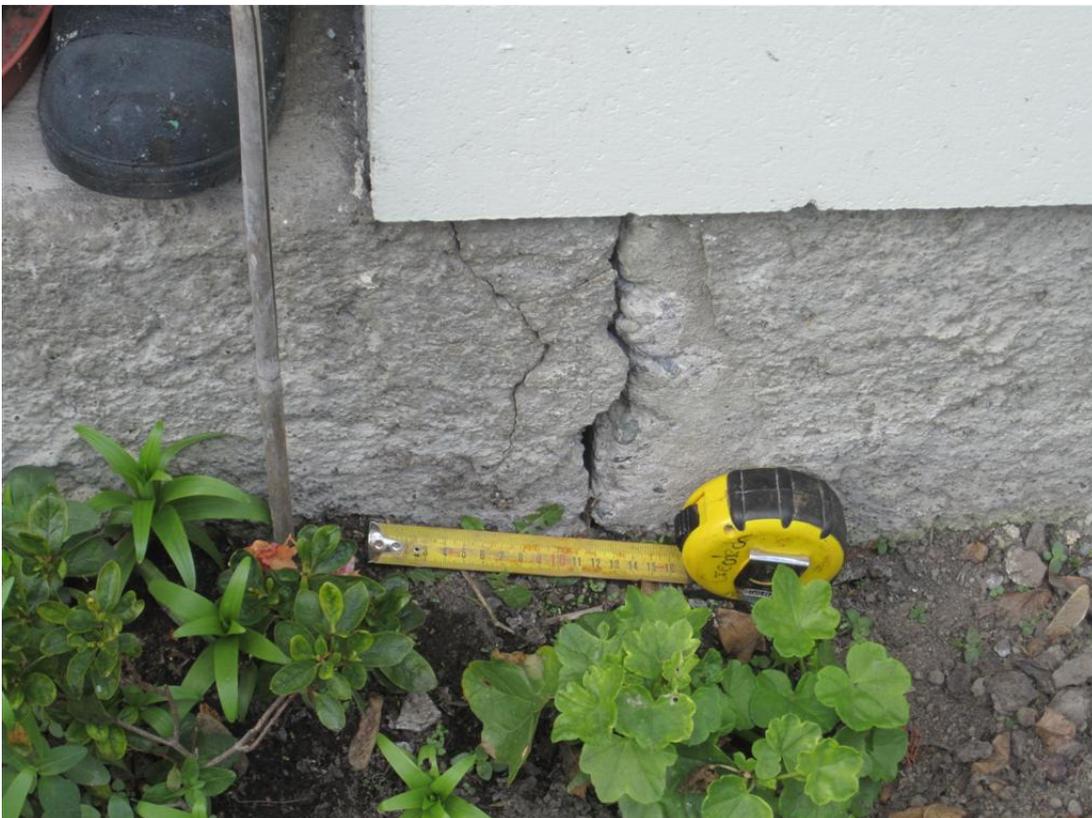
Photo 12: Cracks (up to 10mm wide) on west end of Units 3 to 8

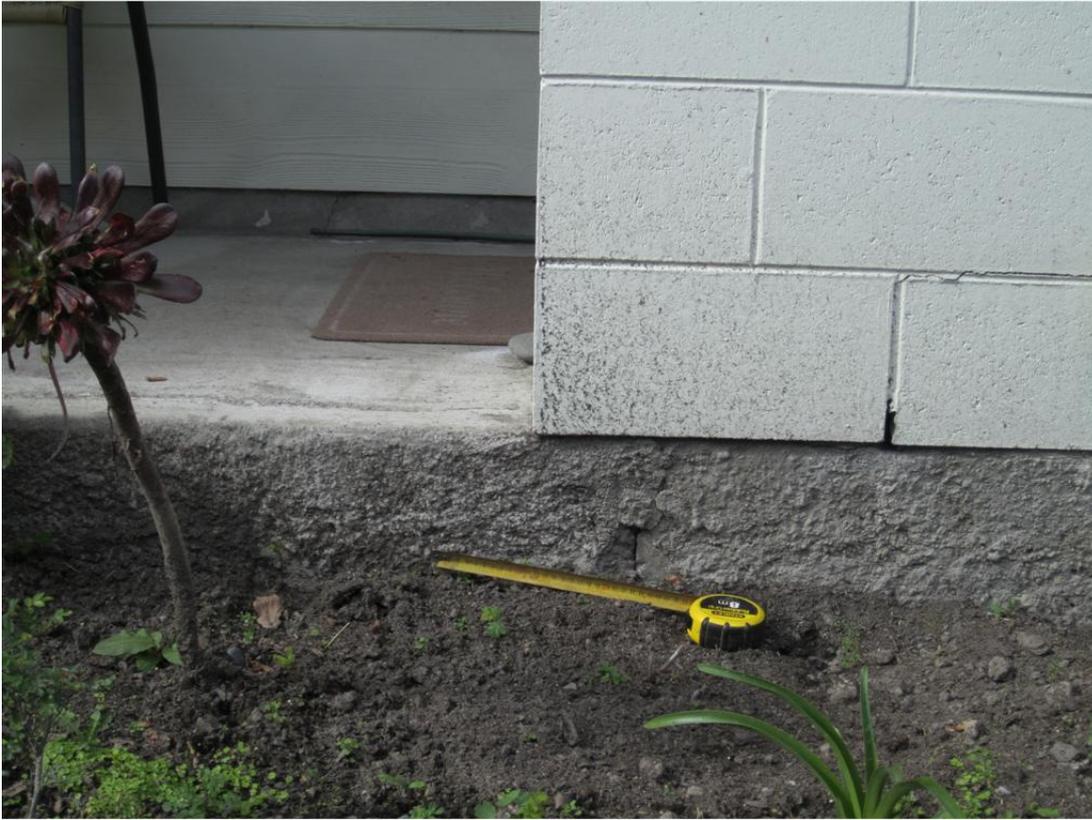
Photo 13: Hairline cracks on west end of Units 3 to 8

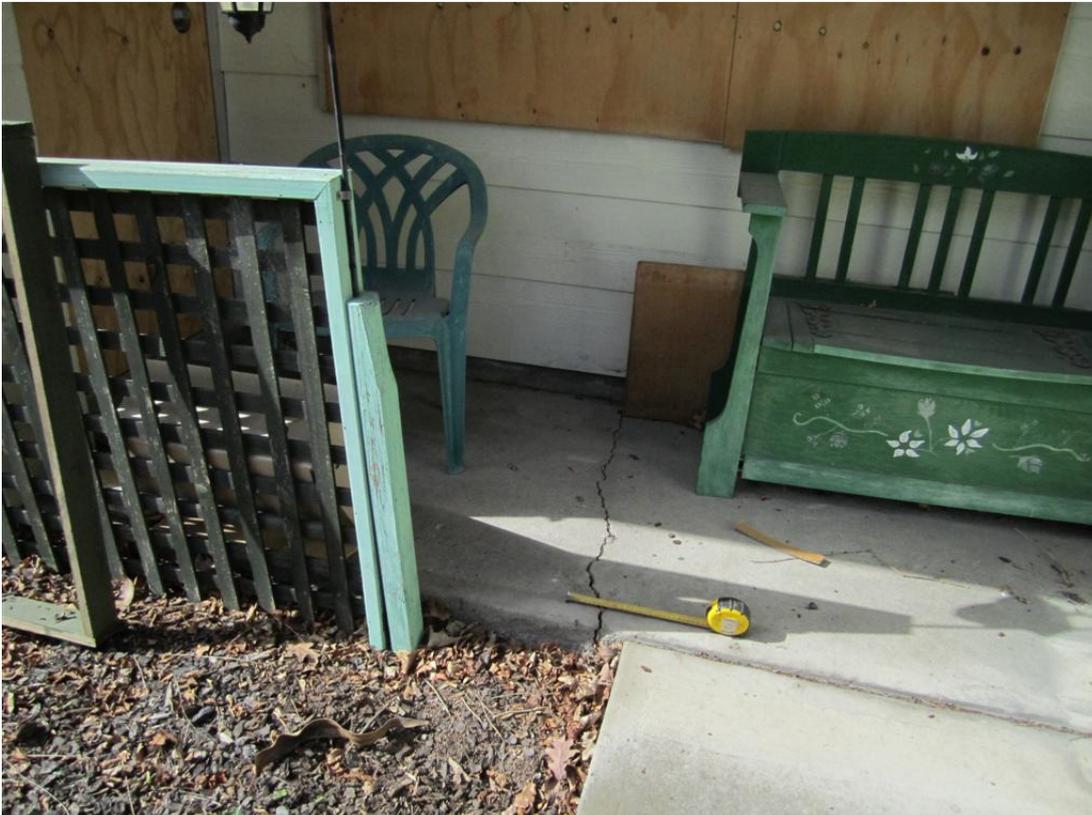
Photo 14: Crack (up to 4mm wide) on slab in north west part of Units 3 to 8

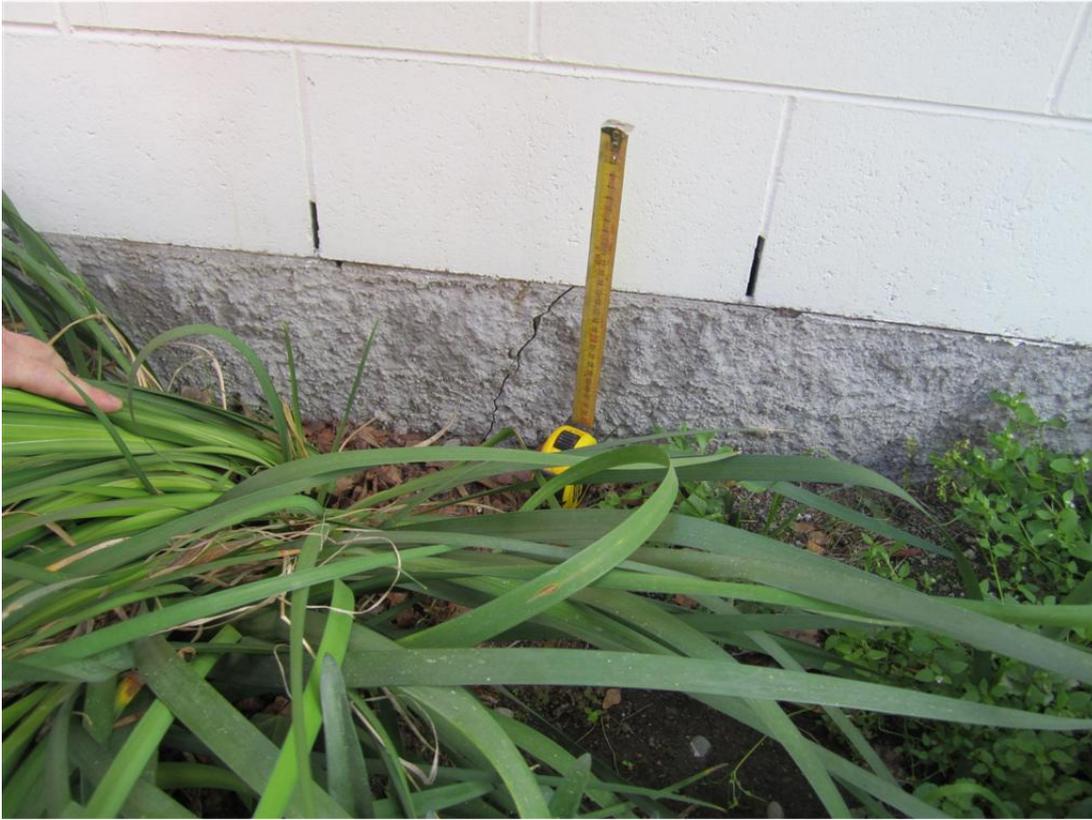
Photo 15: Crack (less than 5mm wide) on northern end of Units 3 to 8

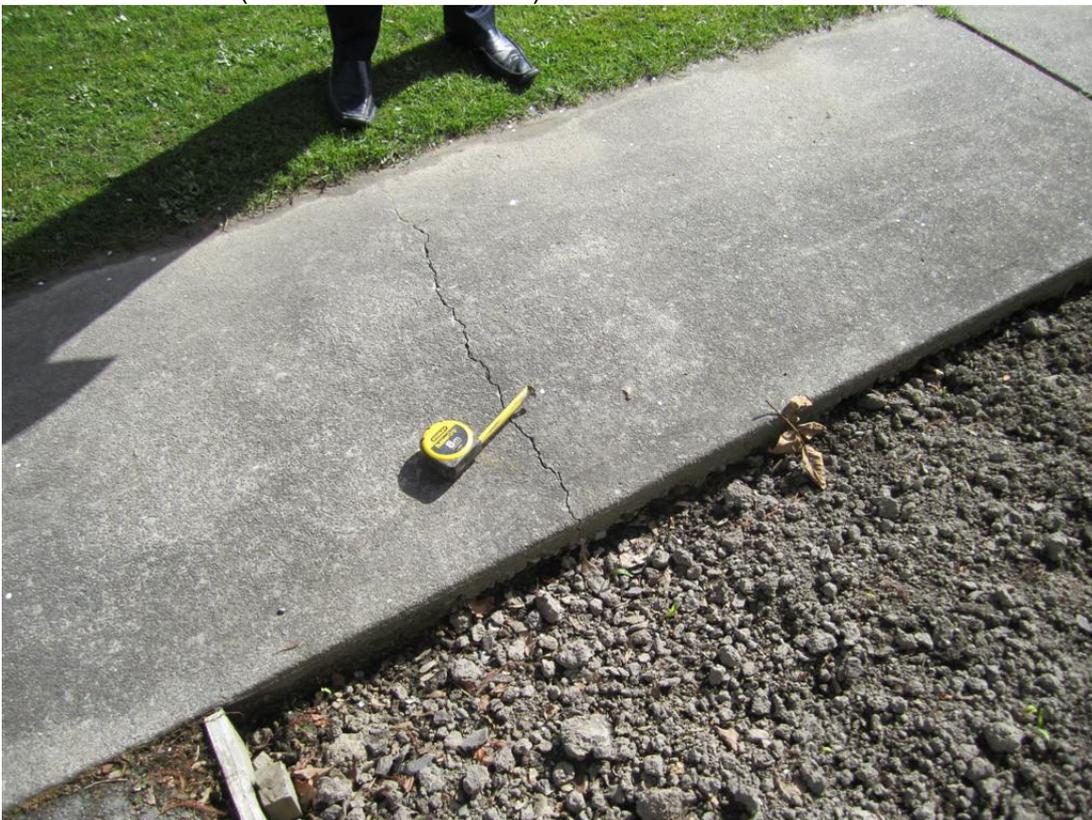
Photo 16: Crack (less than 5mm wide) in path close to south west part of Unit 3 to 8

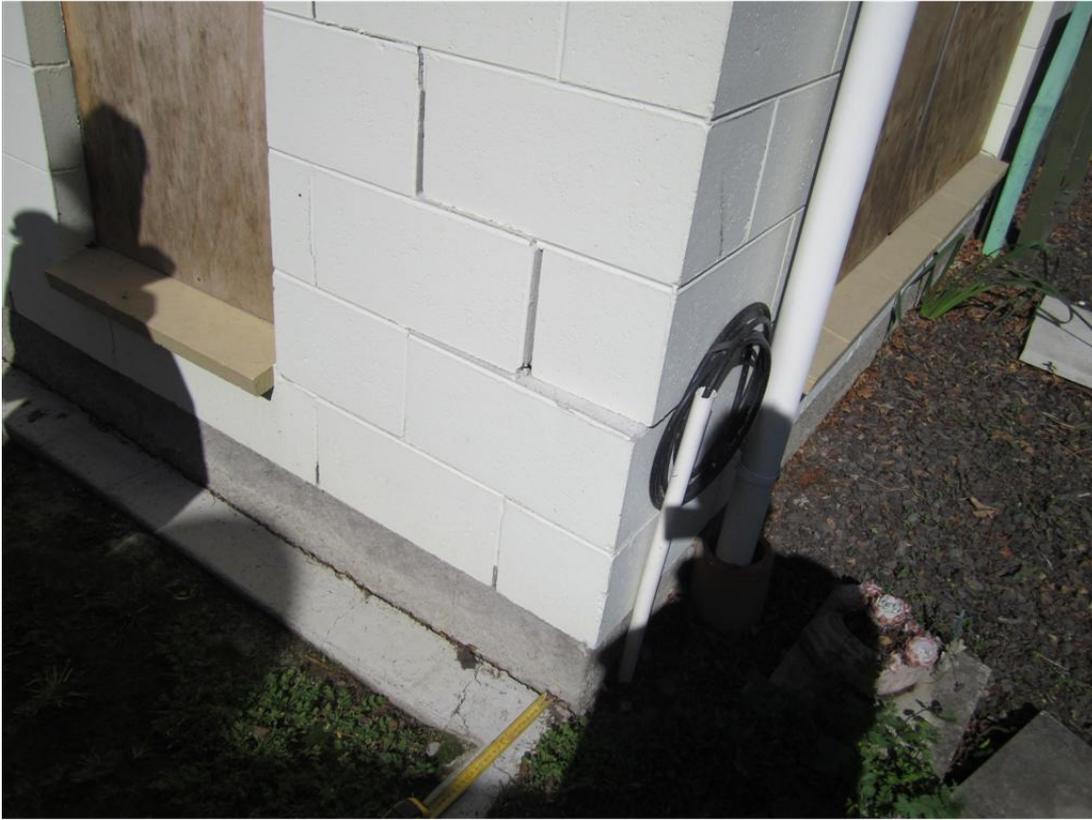
Photo 17: Separation on north west corner of unit 3 to 8

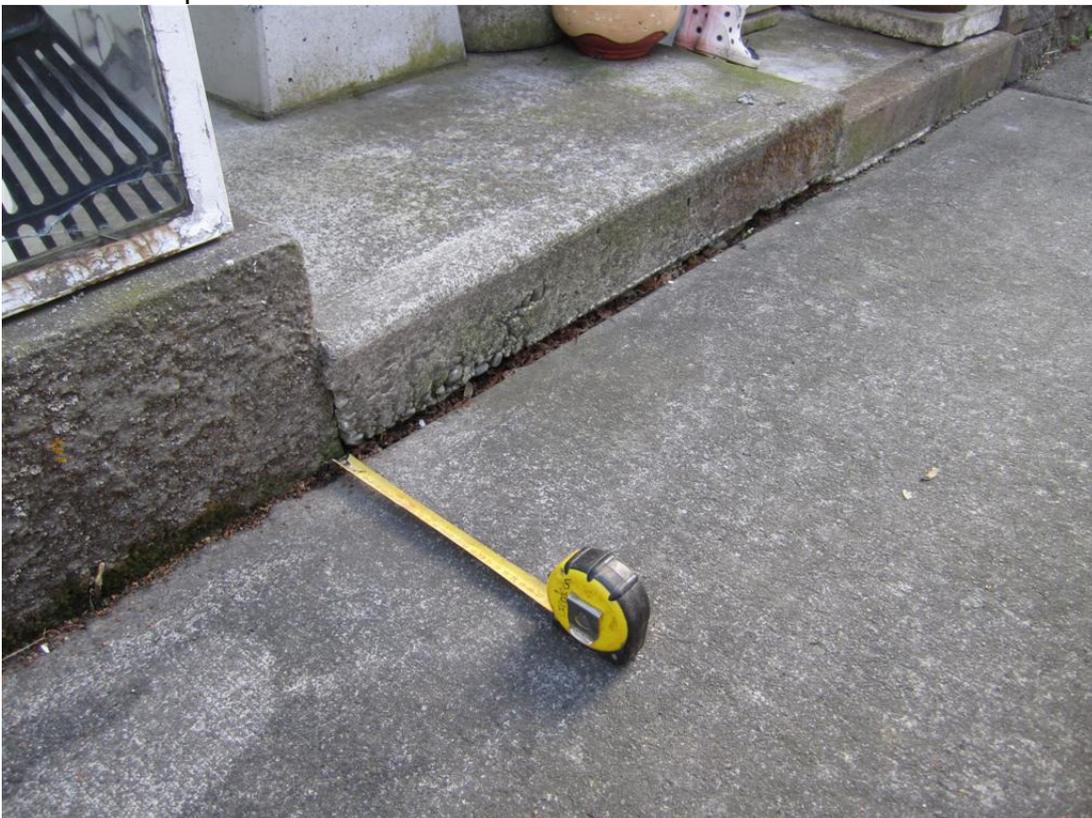
Photo 18: Slab separations on east end of Units 3 to 8

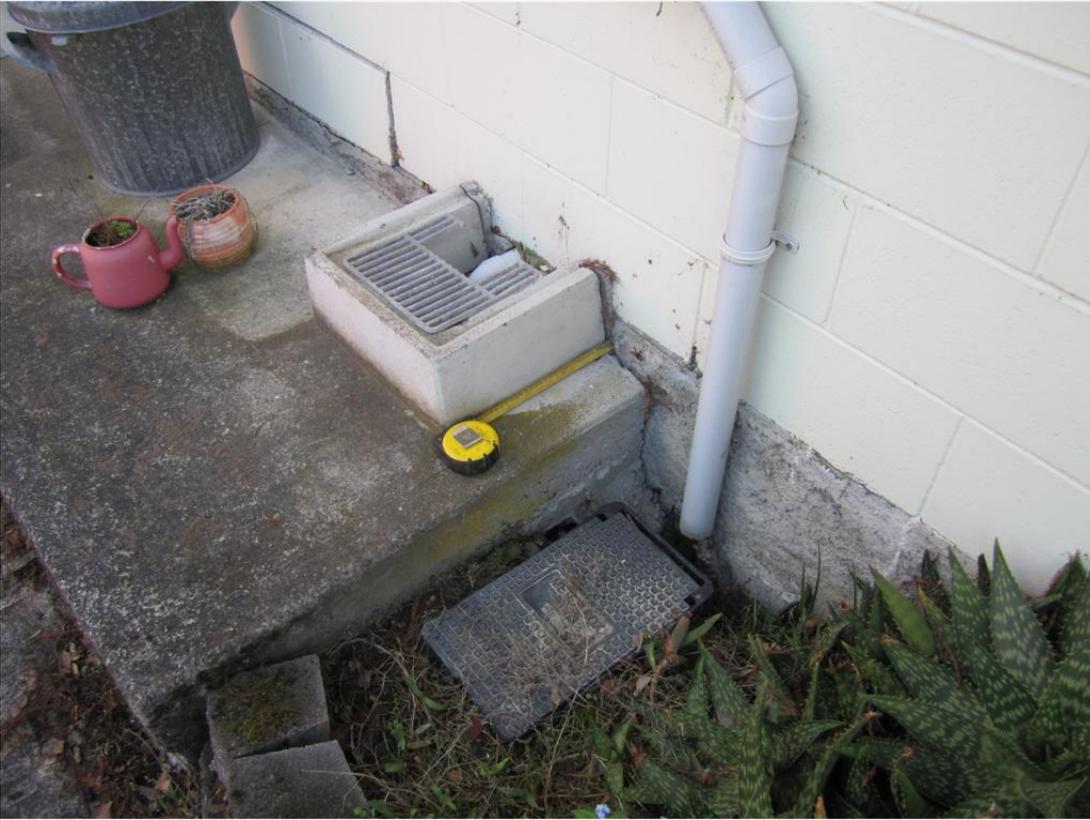
Photo 19: Slab separations on east end of Units 3 to 8

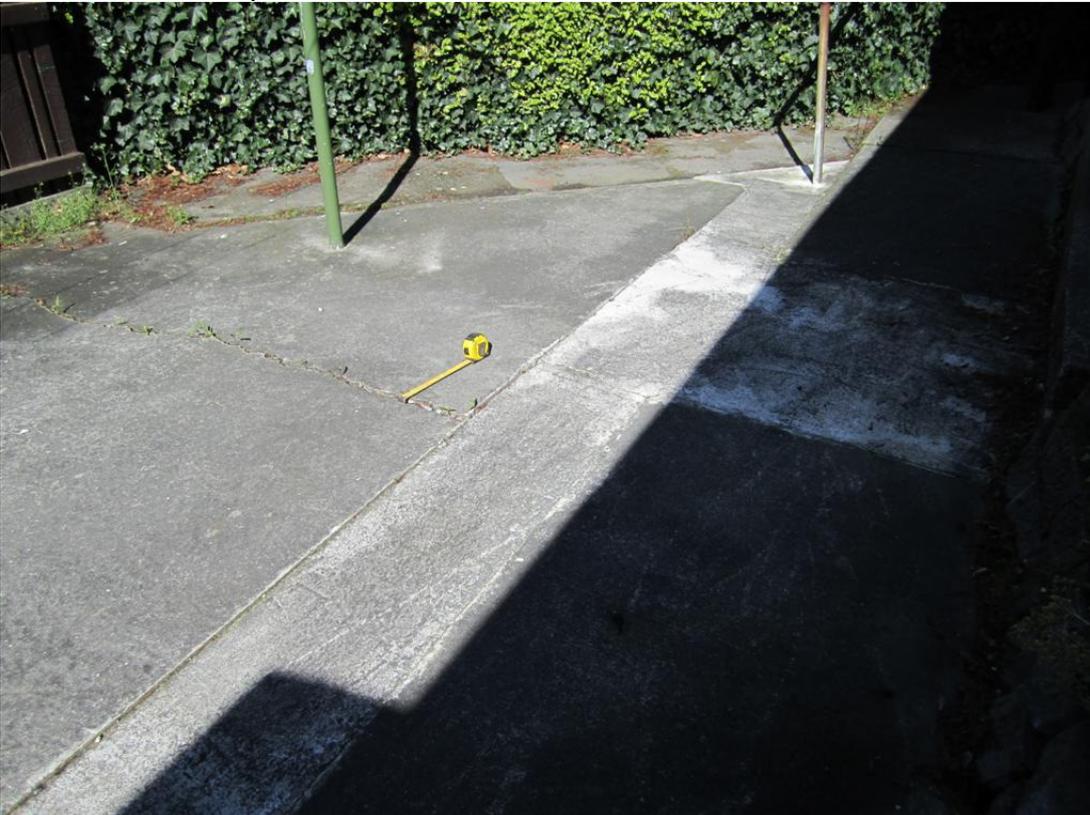
Photo 20: Paving slab distortion east of Units 3 to 8

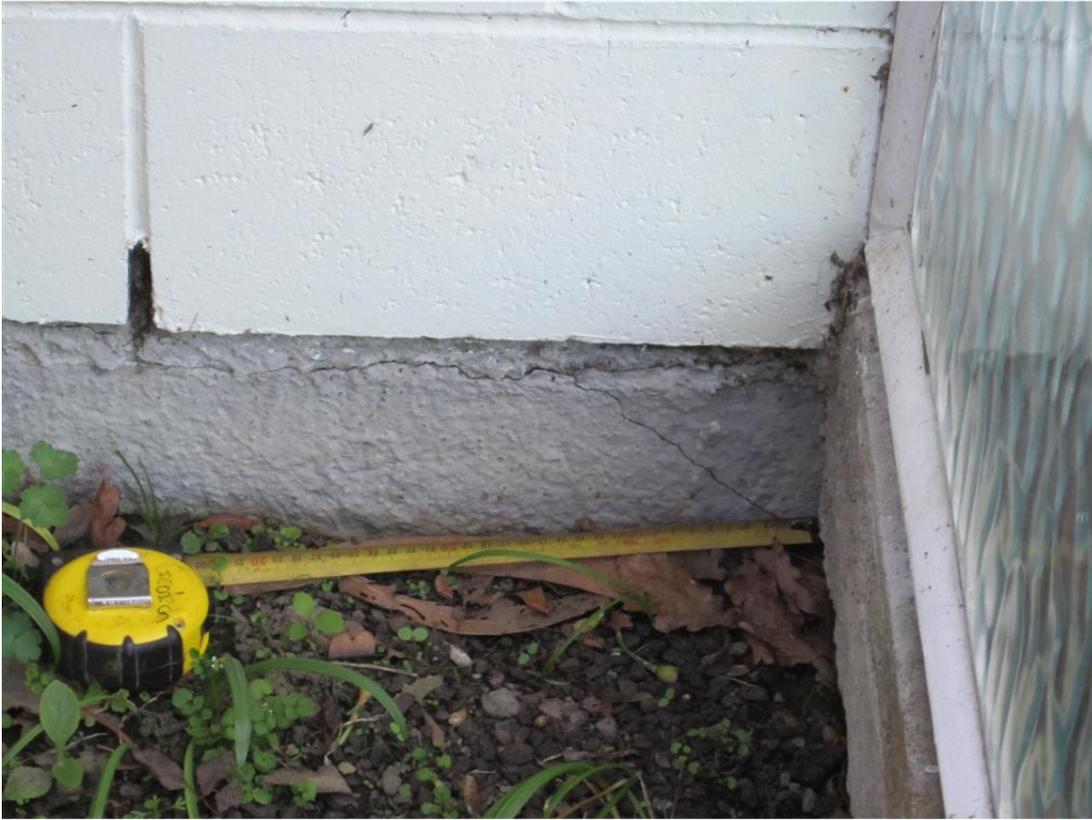
Photo 21: Crack (1mm wide) on south end of Units 9 to 13

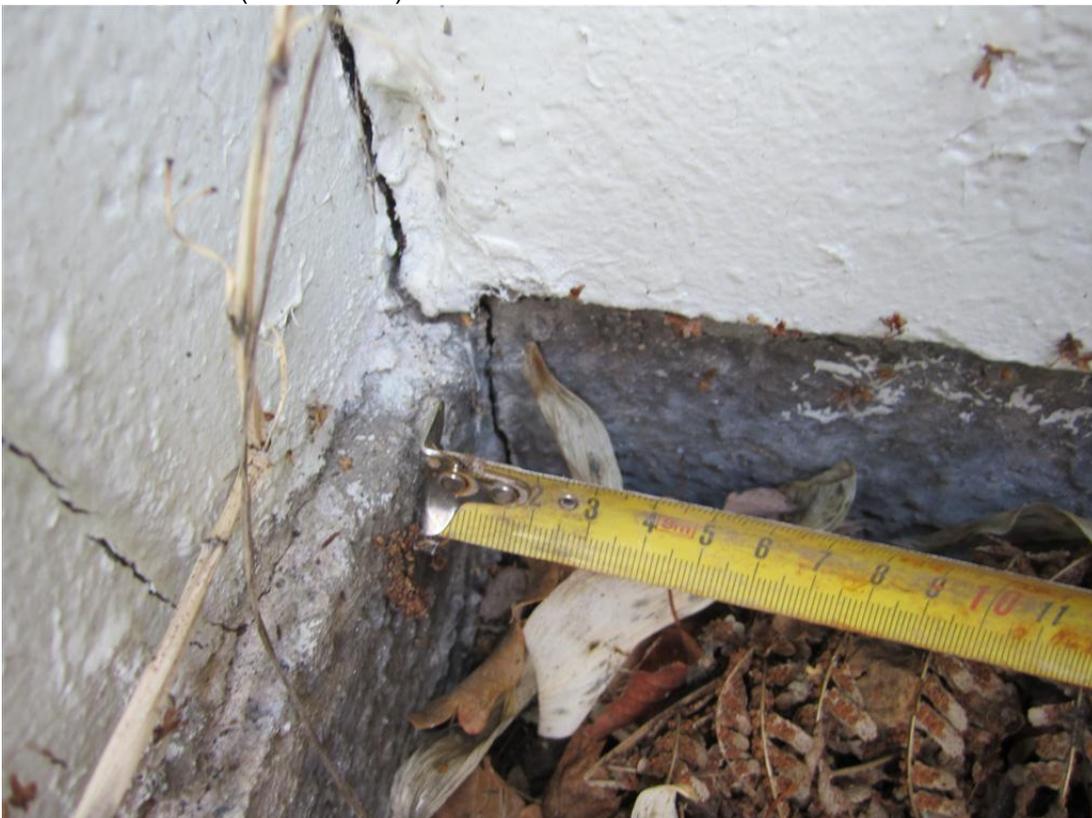
Photo 22: Crack (2mm wide) on south end of Units 9 to 13

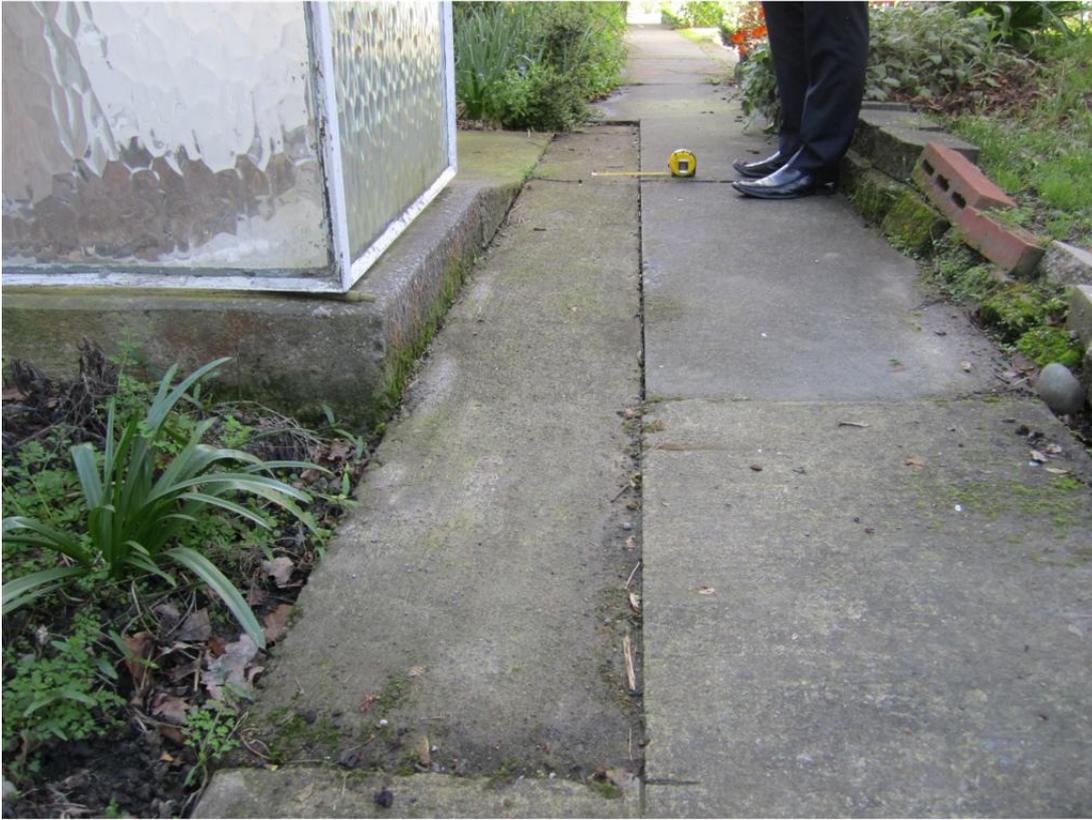
Photo 23: Distortion on path on south end of Units 9 to 13

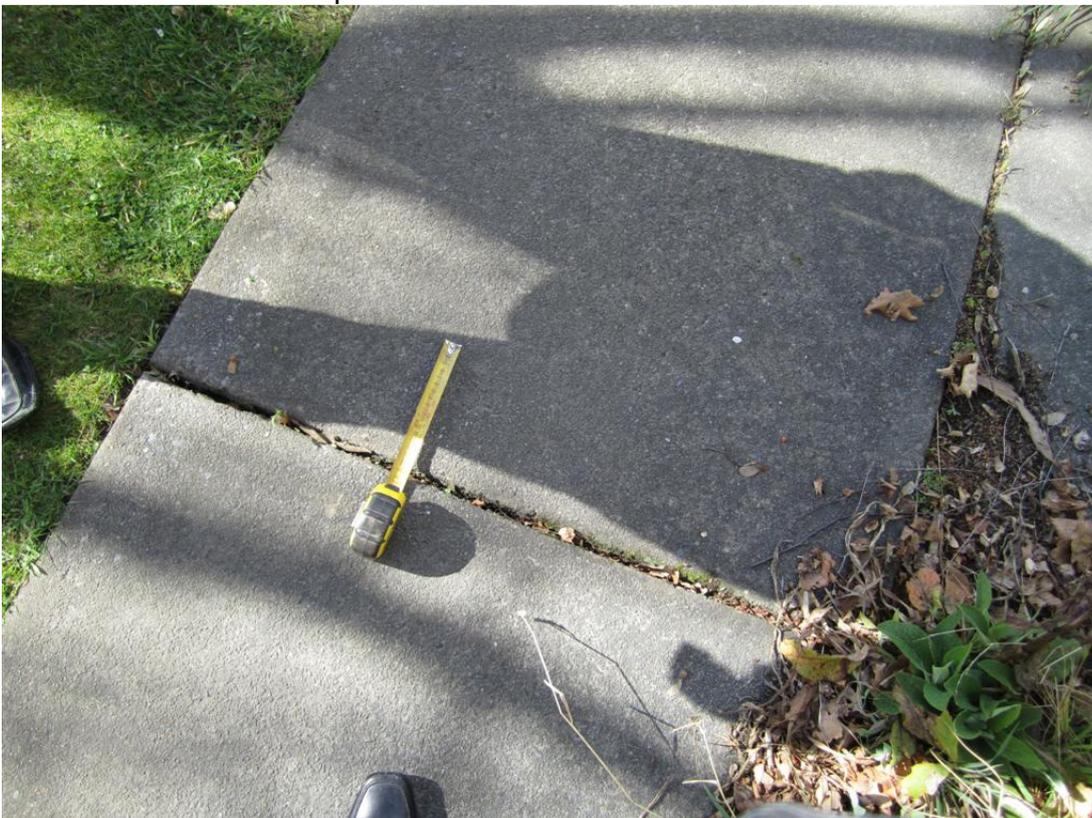
Photo 24: Separation of path slabs on north east end of Units 9 to 13

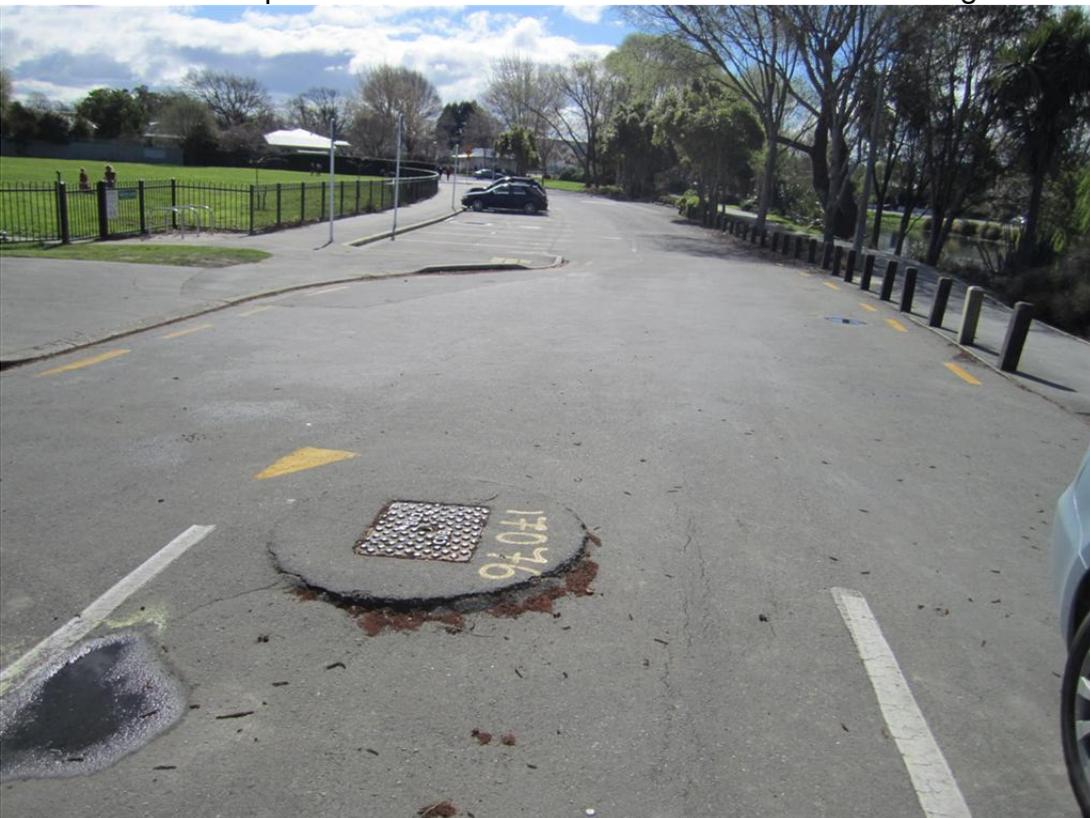
Photo 26: Manhole cover and chamber that has heaved 25mm-30mm.
