Fowl House
PRK 2635 BLDG 007
Detailed Engineering Evaluation
Qualitative Report
Version FINAL

51 Lower Styx Road, Styx River Reserve

Christchurch City Council

Date
23 May 2013

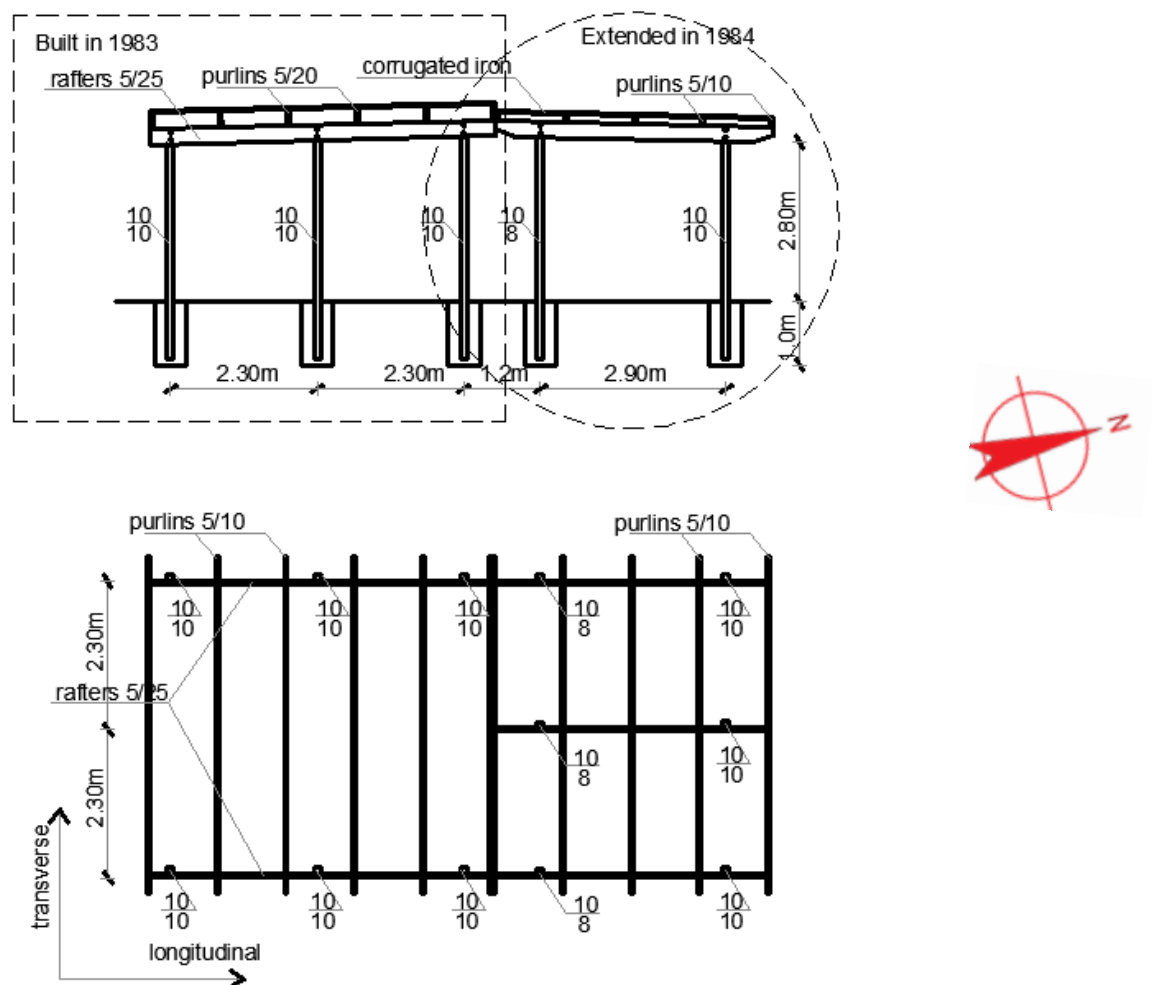
Figure 2 Plan Sketch of the PRIMARY Structure Showing Key Structural Elements

The structure built in 1983 consists of two timber frames at a spacing of 4.6m connected by the timber purlins. The roof is corrugated steel. Each frame consists of posts concreted into the ground (approx. depth of embedment 1m) connected by the timber rafters. The posts and rafters are connected by two 16mm bolts.

The extension of the structure constructed in 1984 consists of the three matching frames at 2.3m spacing.

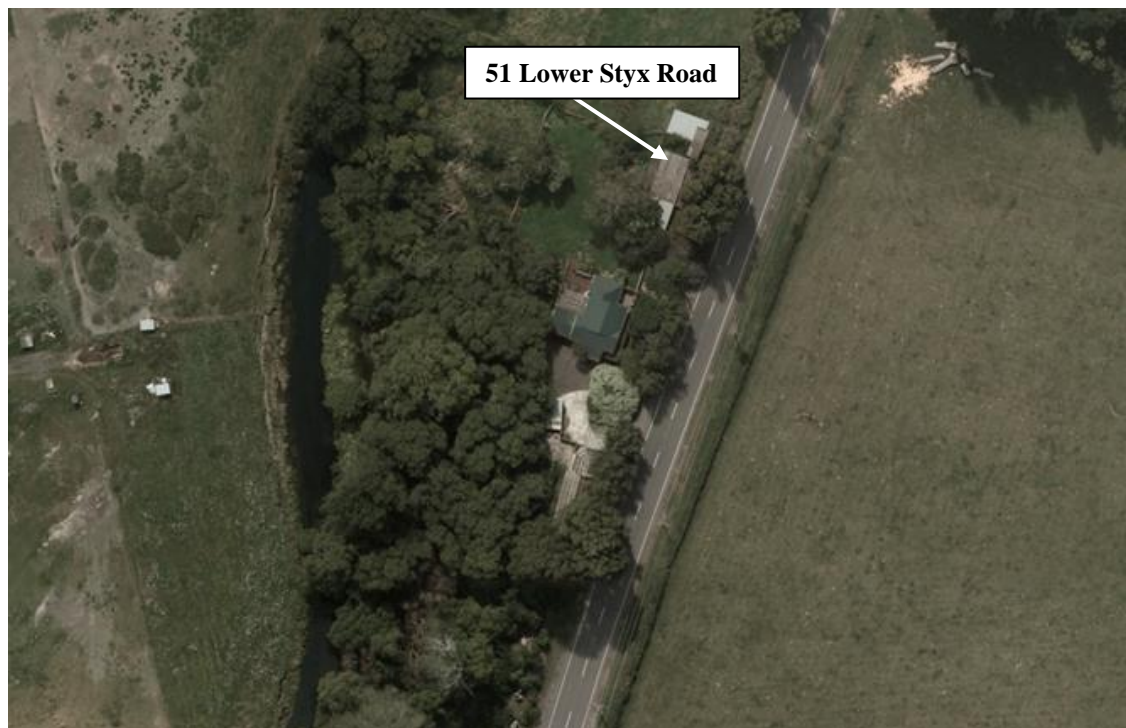
Figure 3 Post February 2011 Earthquake Aerial Photography ²

Aerial photography taken following the 22 February 2011 earthquake shows no signs of liquefaction visible within the property boundary as shown in Figure 3. However, liquefaction in the form of sand boils and lateral spreading is evident on the western side of the Styx River (subject property is to the east).

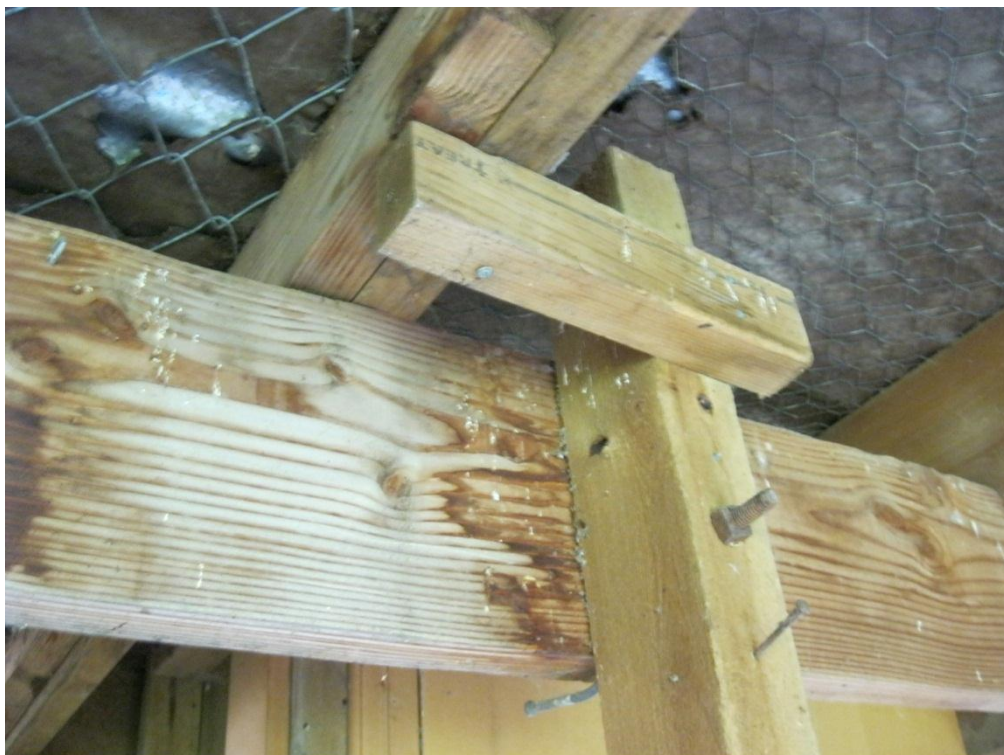
During the site inspection some settlement and cracking of the concrete tiles was noted. There were also some missing bolts in the connection between posts and rafters (see photograph 6). These missing bolts have been provided on the 16th August 2012 (See photograph 7-10).

Photograph 6 Missing bolts of the joint between rafters and timber post.

GHD have recommended that the missing bolts to the connections between the timber posts and rafters be provided in order to strengthen the building should CCC want to reinstate use of the building as a fowl house. Bolts were provided to a number of the connections throughout the fowl house on the 16th of August 2012.

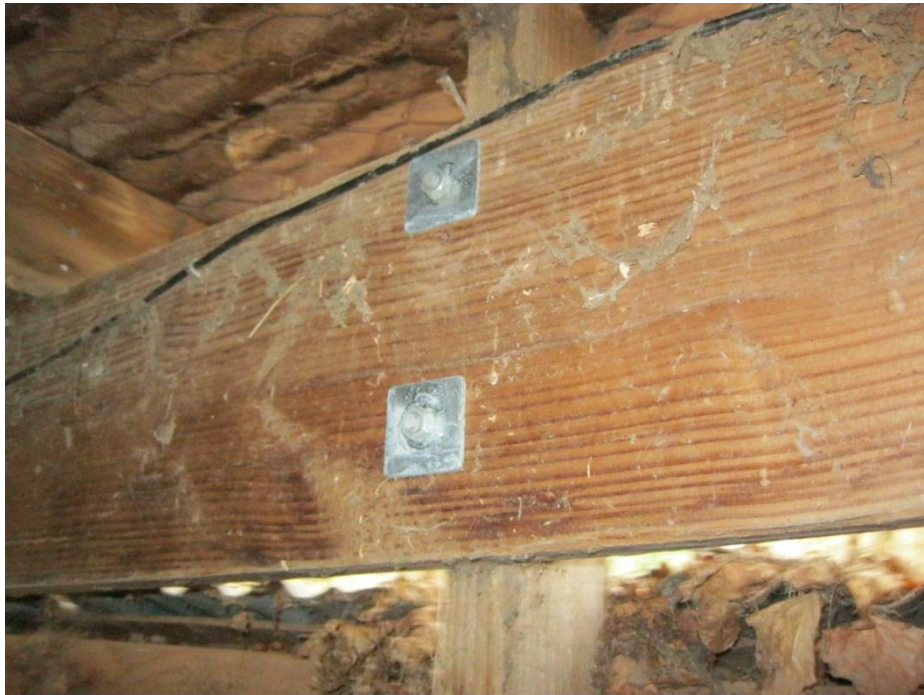
Photograph 7 A number of bolts provided to a connection.

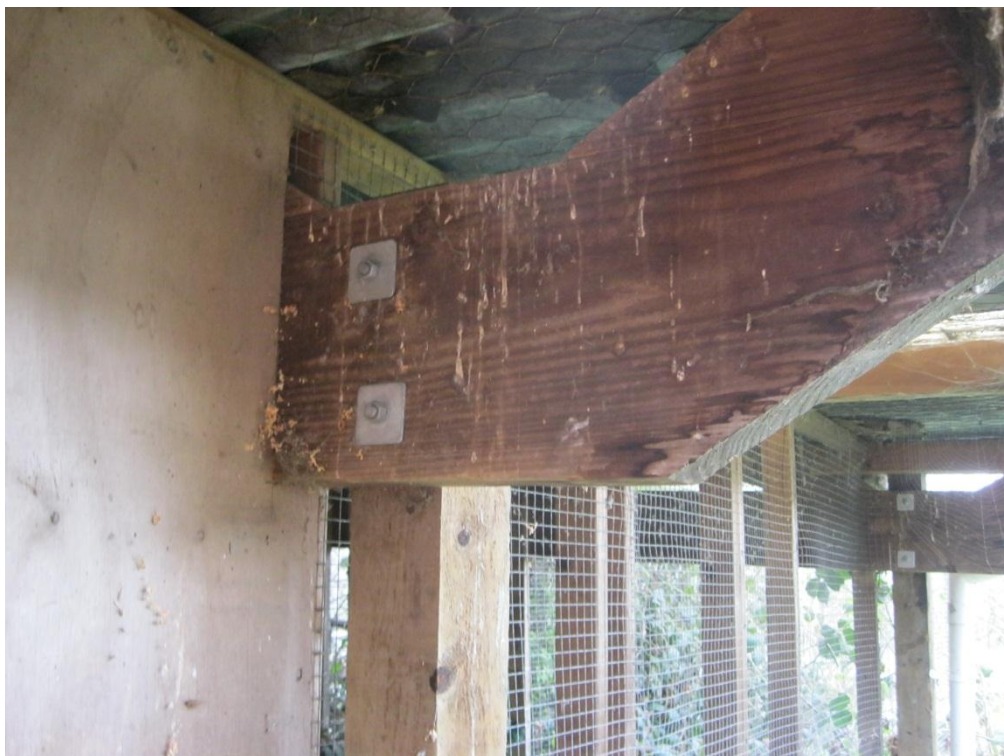
Photograph 8 Provision of bolts to the joint between rafters and timber post.

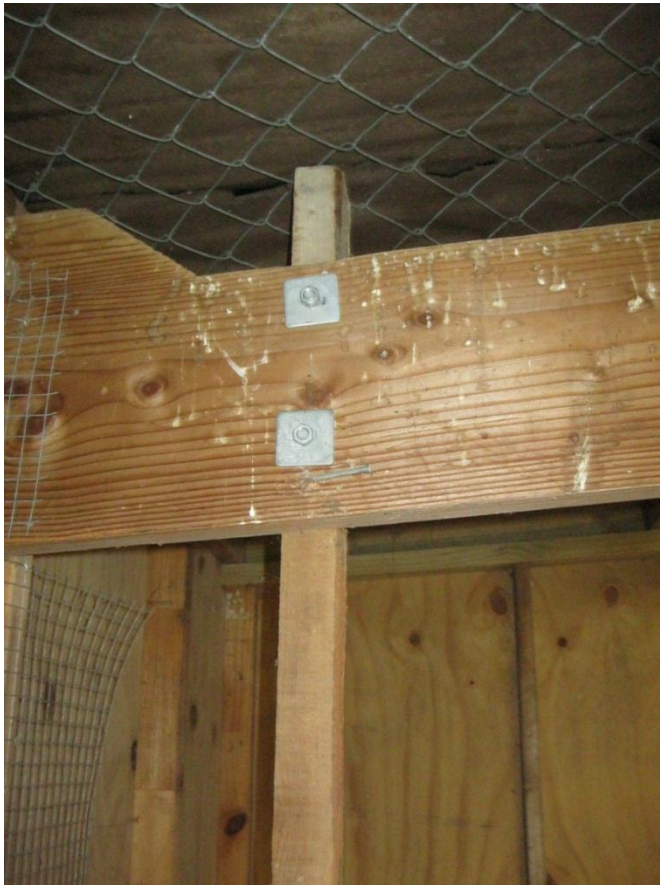
Photograph 9 Provision of bolts to the joint between rafters and timber post.

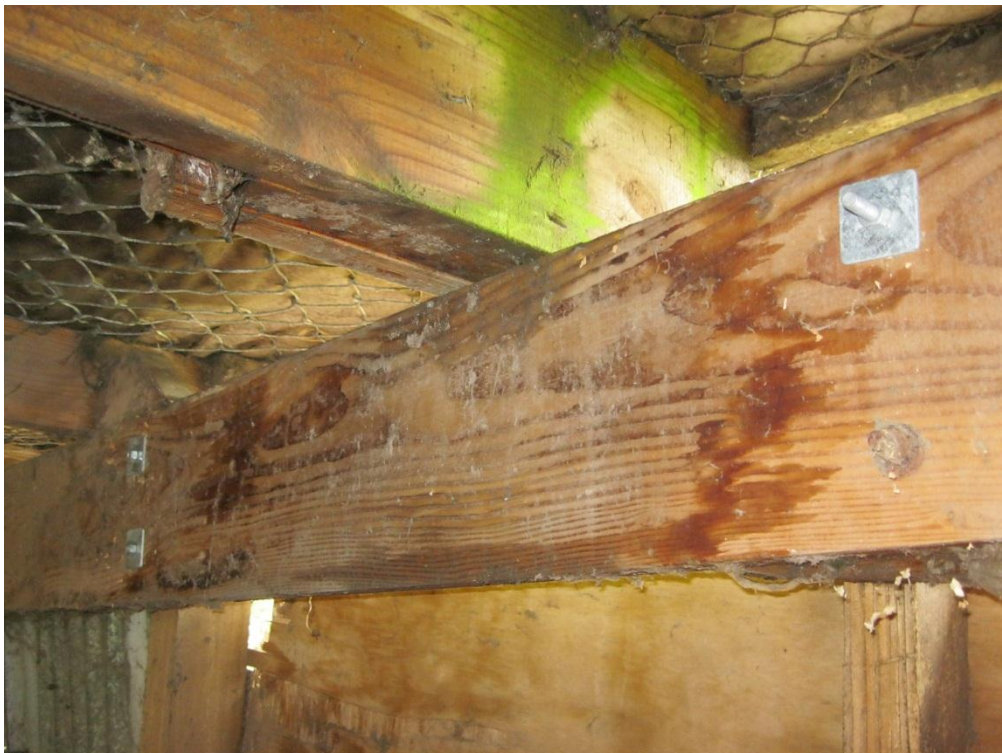
Photograph 10 Provision of bolts to the joint between rafters and timber post.
