Garage
PRK 2561 BLDG 002
Detailed Engineering Evaluation
Qualitative Report
Version Final

75 Lower Styx Road, Bottle Lake

Christchurch City Council

Date
14 May 2013

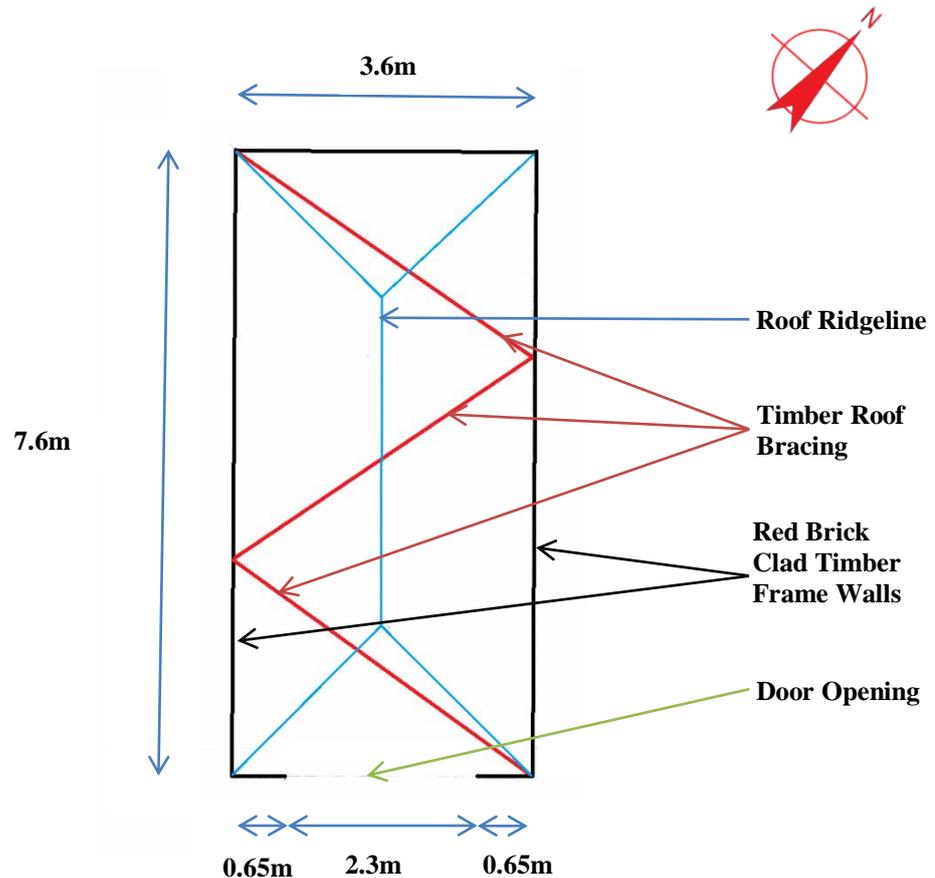
Figure 2 Plan Sketch Showing Key Structural Elements

The building is of lightweight timber frame construction, with red brick clad exterior walls. Wall ties tie the brick cladding to the timber wall studs. The roof structure consists of lightweight metal roofing fixed to timber sarking on timber roof trusses, supported at either end by the external load bearing timber framed walls. Foundations are concrete slab on grade.

Gravity loads are transferred from the metal roof cladding to the timber sarking and into the timber roof trusses. The roof trusses span between the external load bearing timber framed walls. The load bearing timber framed walls transfer the gravity loads to the ground slab.

The roof structure is braced by the timber sarking and diagonal timber bracing members. This system transfers lateral loads to the perimeter walls. The perimeter walls have diagonal timber bracing that transfers lateral loads to the ground slab.

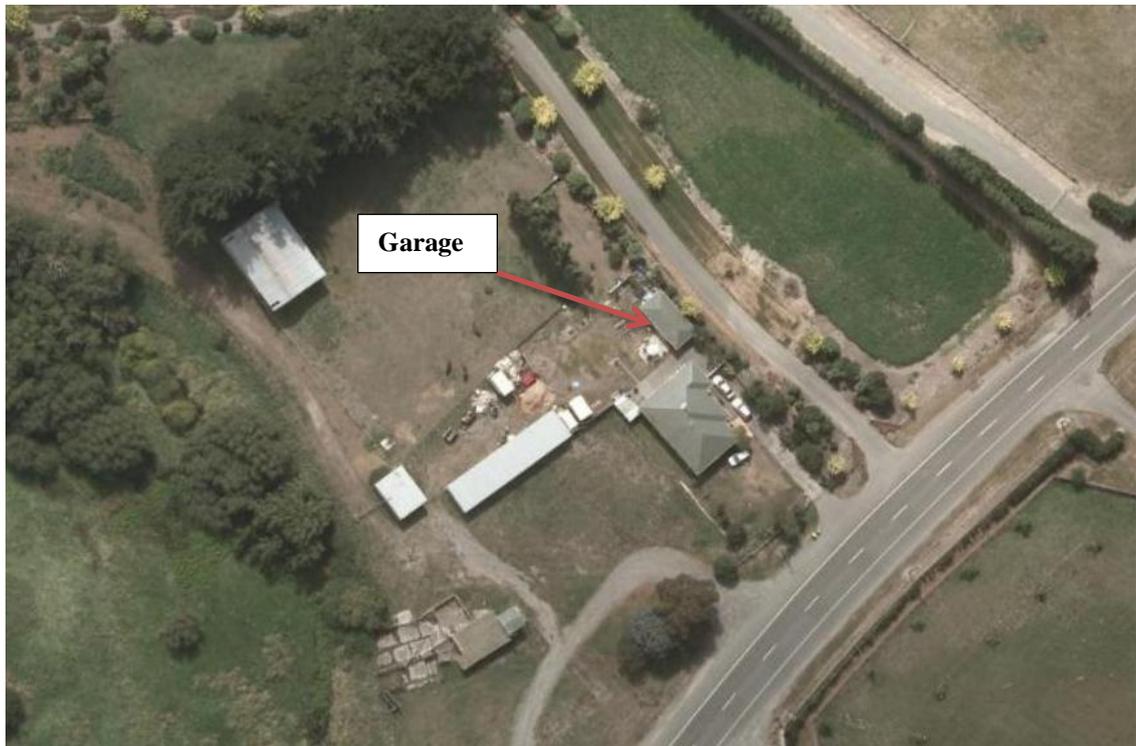
Figure 3 Post February 2011 Earthquake Aerial Photography ²

Aerial photography taken following the 22 February 2011 earthquake doesn't show clear signs of liquefaction (see Figure 3), however, liquefaction was observed close to the property.

Due to the anticipated presence of sand at the shallow depth, and the sites proximity to a local water course, it is considered possible that liquefaction will occur at the site. It is not clear from the post-earthquake aerial photography (Figure 3) whether liquefaction has occurred at the site, however, it was observed close to the property. The site is considered to have a moderate-high liquefaction potential at this stage of investigation.

It is recommended that three piezocone CPTs be conducted to target depths of 20m. This will allow a liquefaction assessment to be carried out.

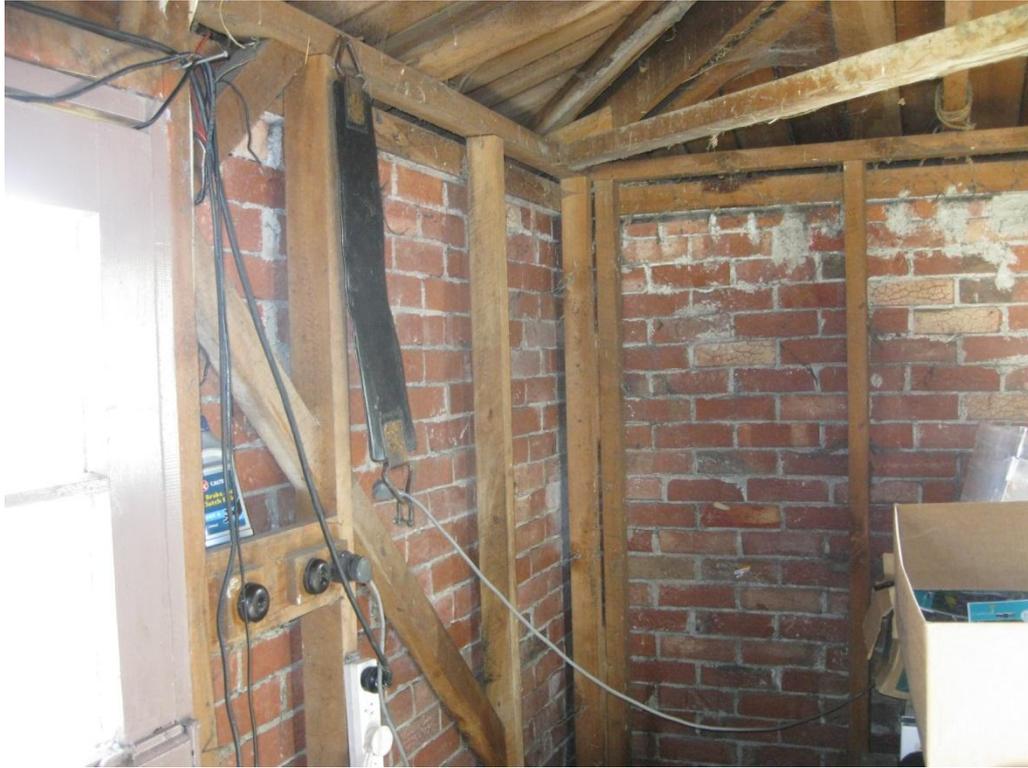
Photograph 5 View of the interior at the western corner of the building. No internal wall linings. Roof and wall bracing is clearly visible.

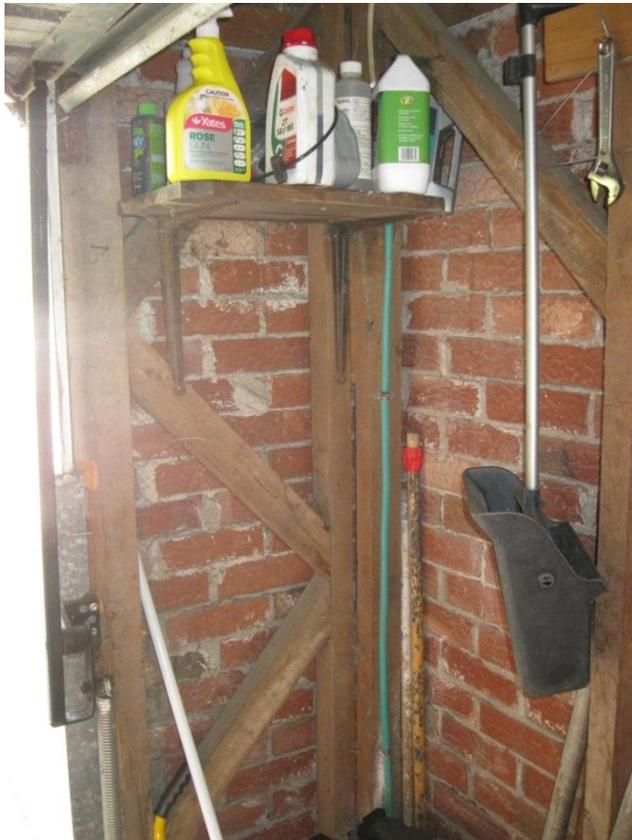
Photograph 6 Internal view of the southern corner of the building showing wall bracing.

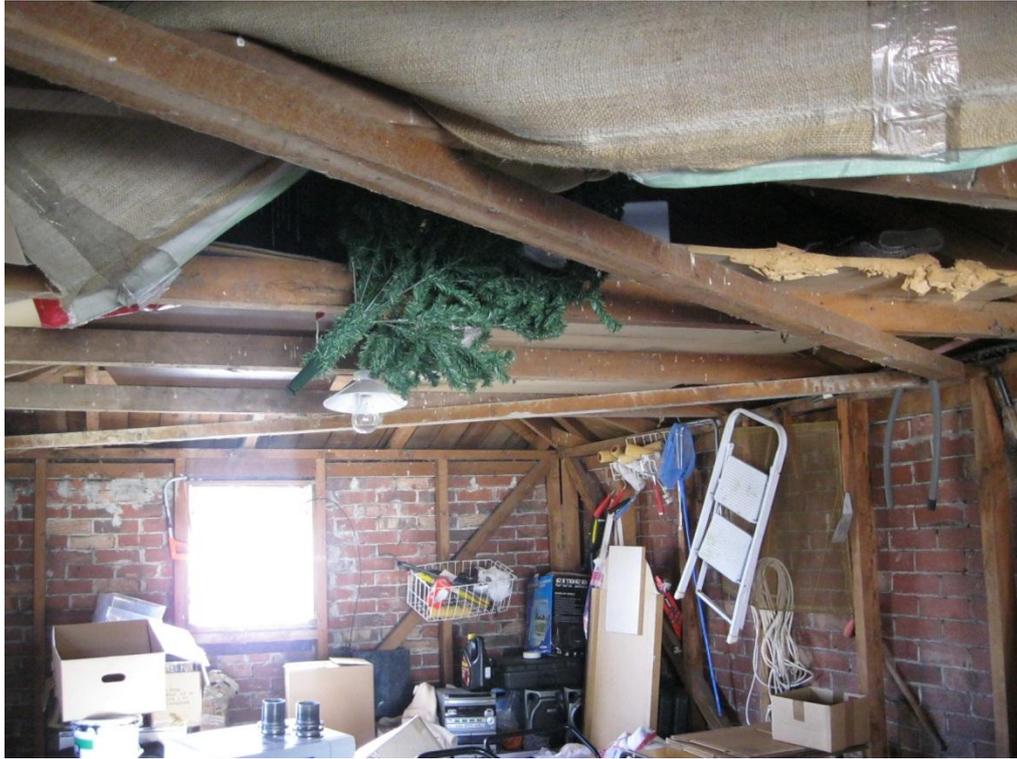
Photograph 7 Timber roof bracing and roof trusses visible.

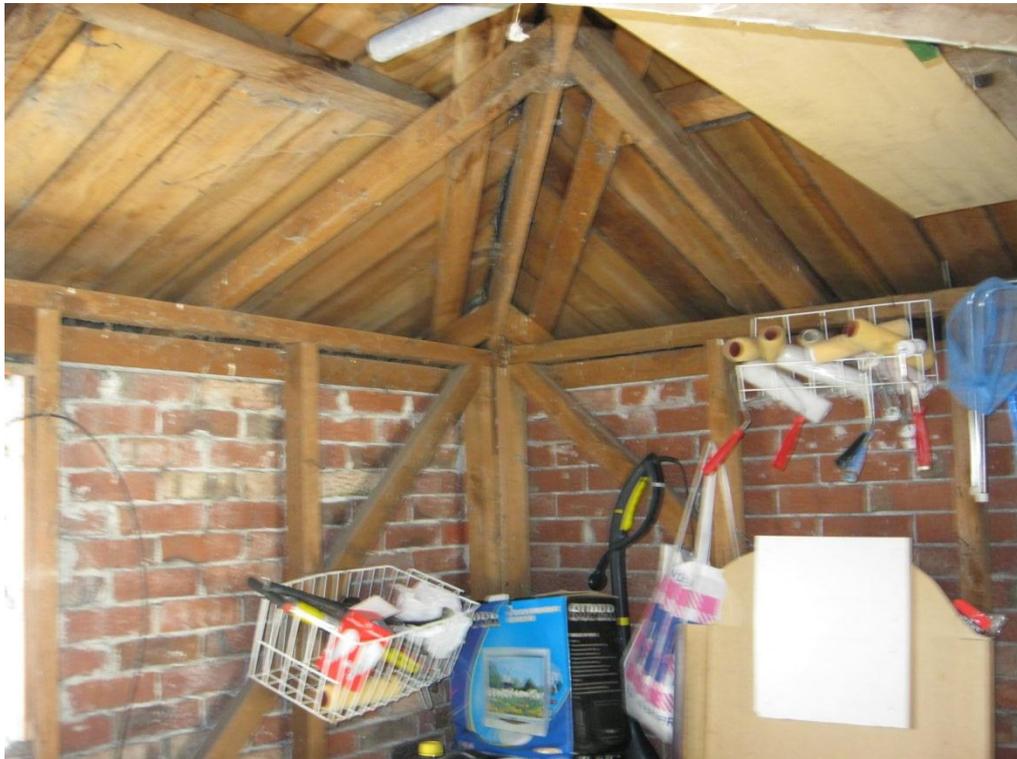
Photograph 8 Timber roof sarking and wall bracing clearly visible.
