Storage Shed
PRK 2561 BLDG 003 EQ2
Detailed Engineering Evaluation
Qualitative Report
Version FINAL

75 Lower Styx Road, Bottle Lake

Christchurch City Council

Date
12th December 2013

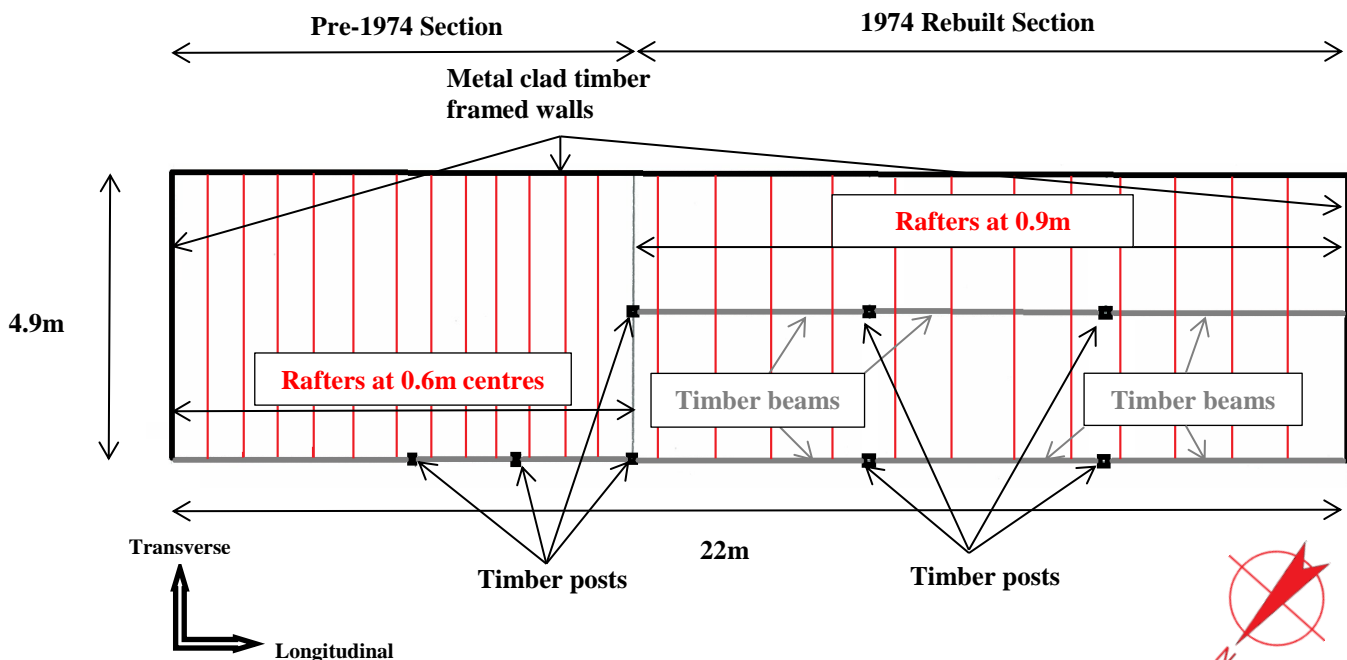
Figure 2 Plan Sketch Showing Key Structural Elements

It is not believed that the wall between the pre-1974 portion and the rebuilt section will provide any support in the transverse direction as cladding appears to be haphazard and inadequately fixed. Nominal diaphragm action of the roof cladding and timber sarking transfer lateral roof loads to the side walls. The side walls through diaphragm/sheet bracing action of the metal wall cladding will transfer the load to the ground.

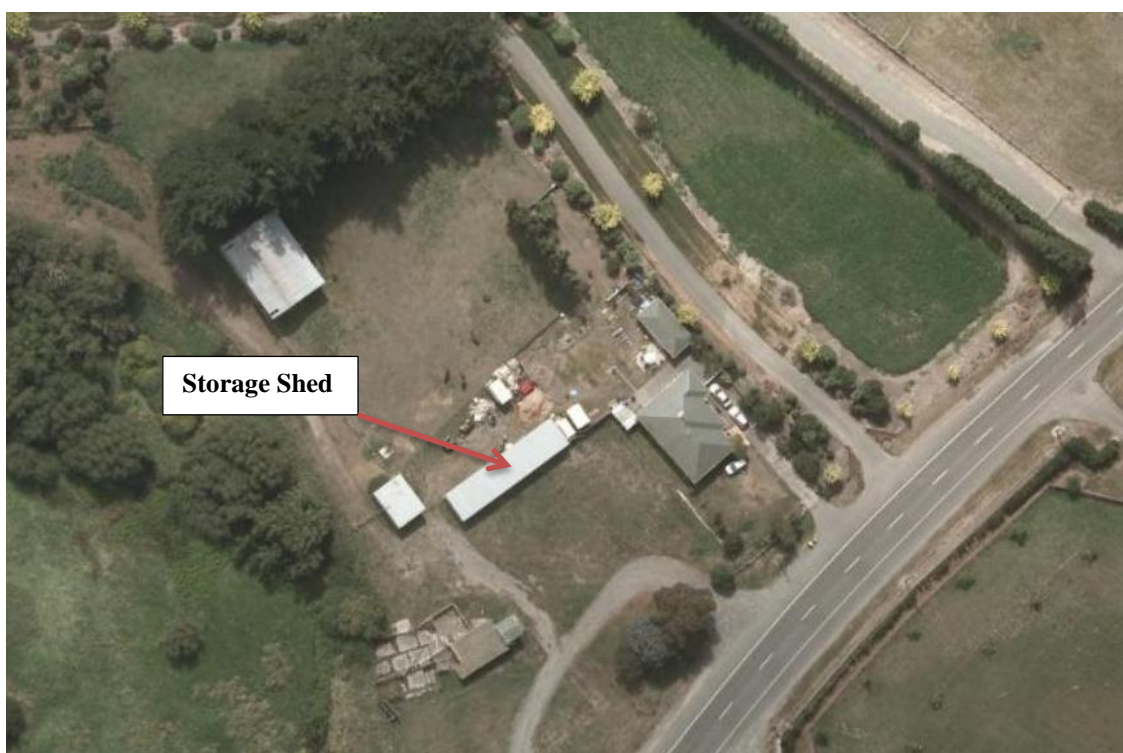
Figure 3 Post February 2011 Earthquake Aerial Photography ²

Aerial photography taken following the 22 February 2011 earthquake doesn't show clear signs of liquefaction (see Figure 3), however, liquefaction was observed close to the property.

Due to the anticipated presence of sand at the shallow depth, and the sites proximity to a local water course, it is considered possible that liquefaction will occur at the site. It is not clear from the post-earthquake aerial photography (Figure 3) whether liquefaction has occurred at the site, however, it was observed close to the property. The site is considered to have a moderate-high liquefaction potential at this stage of investigation.

It is recommended that three piezocone CPTs be conducted to target depths of 20m. This will allow a liquefaction assessment to be carried out.

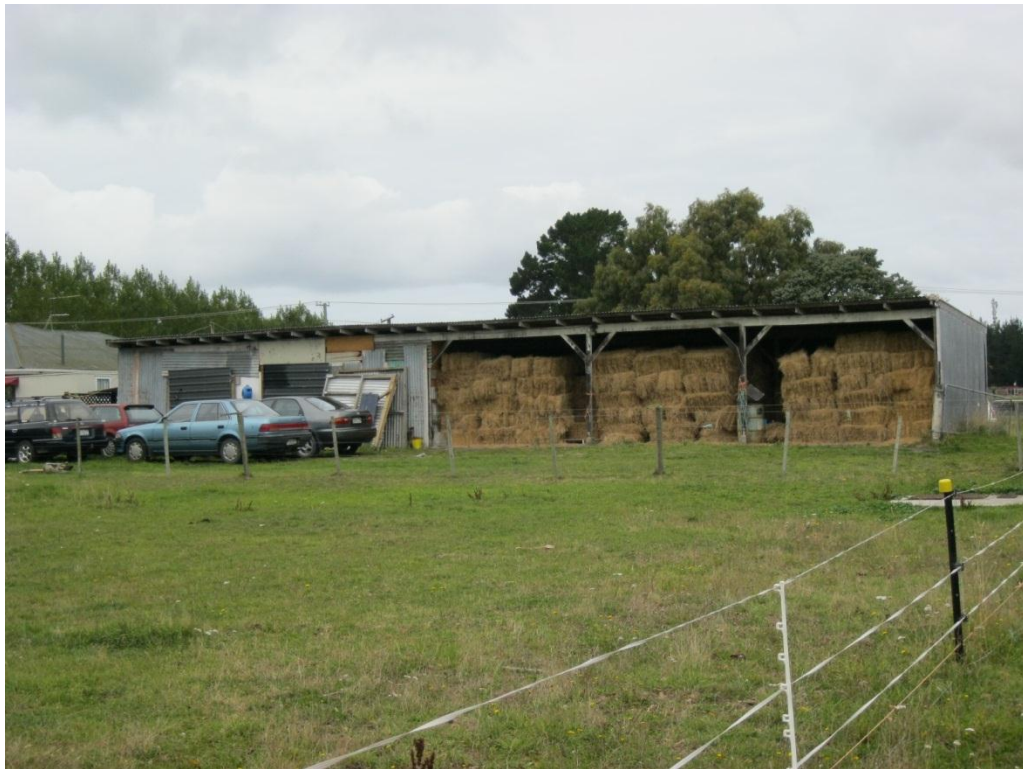
Photograph 2 View of the storage shed from the north-west. The 1974 rebuilt portion is to the right and original portion is to the left in this photo. A large opening is clearly visible.

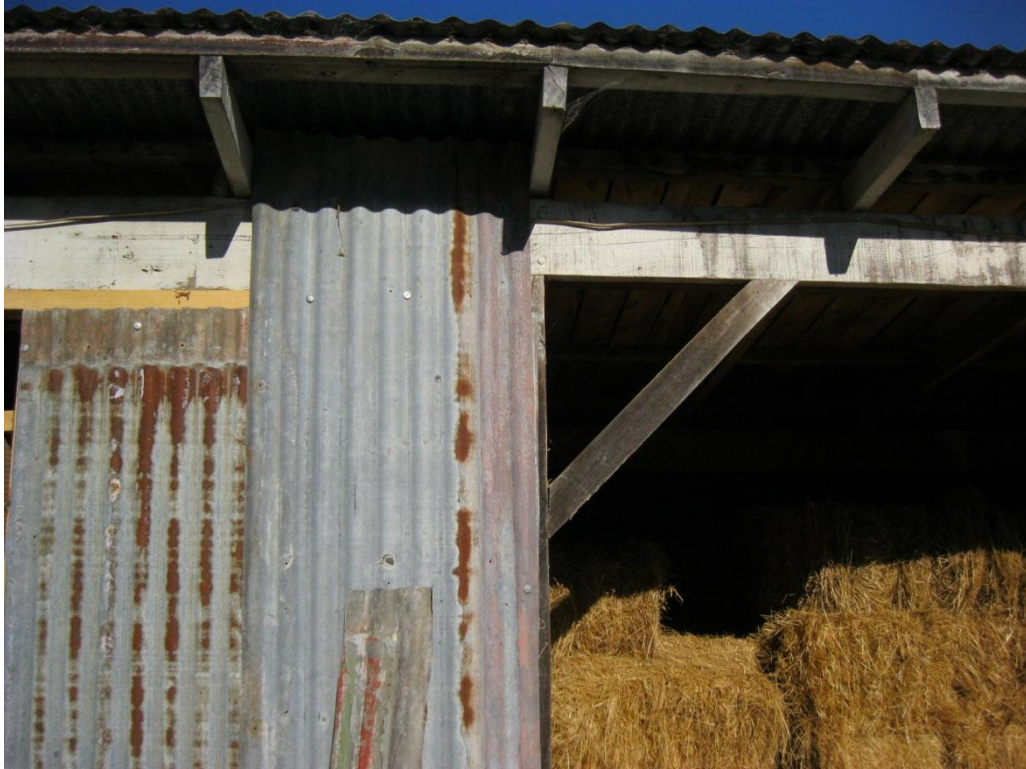
Photograph 5 Intersection of the original portion of the building on the left and the 1974 rebuild section on the right.

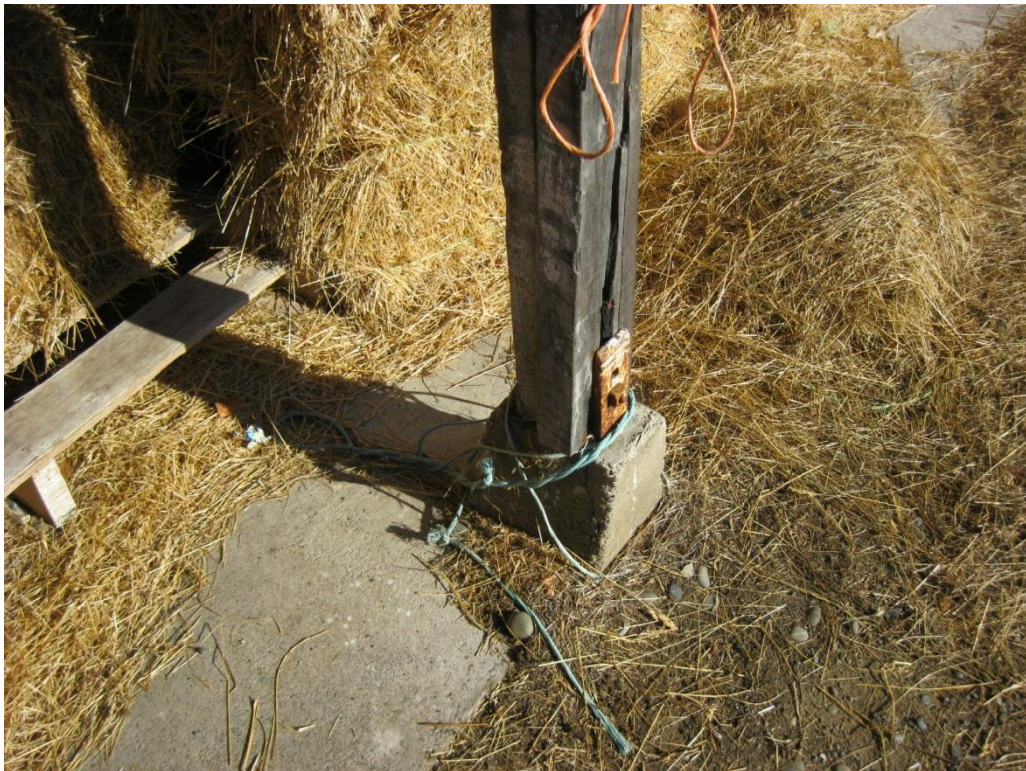
- ▶ No earthquake related damage was noted
- ▶ Cracking was noted to one of the timber posts along the north-west side of the building. It is suspected that this damage is as a result of an impact with a vehicle.

The only damage noted to the building was cracking to the timber posts along the north-west of the building but this is not believed to be as a result of the earthquakes. It is believed that this damage is as a result of an impact from a farm vehicle. See photograph 6. This damage has been taken into account when assessing the building by applying a 10% reduction to the % NBS of the building.

Photograph 6 Cracking to the timber post at the north-west wall. It is not believed to be earthquake related.

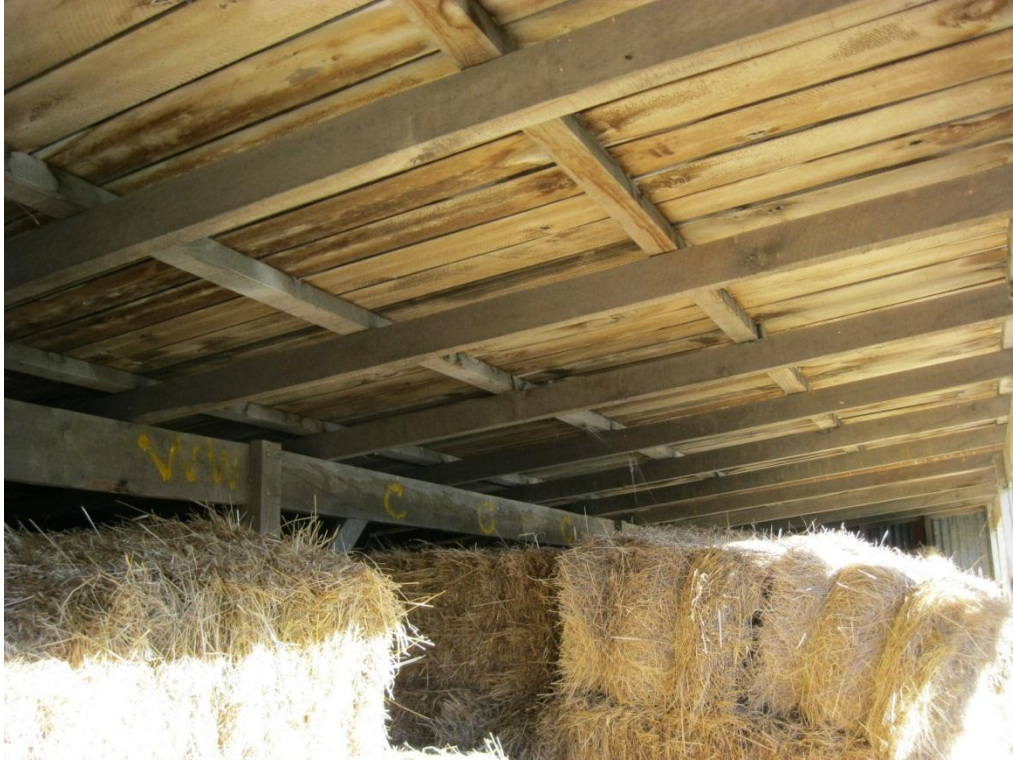
Photograph 7 Timber roof sarking on timber roof purlins on timber joists supported by the timber beam and post frame system.

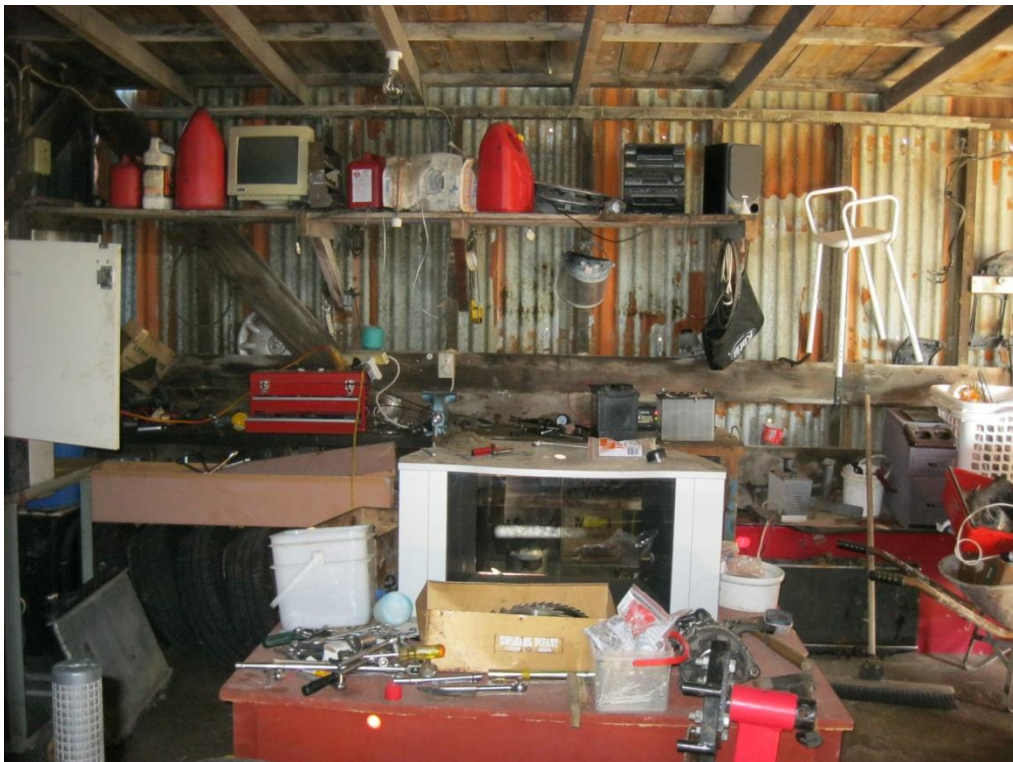
Photograph 8 Interior of the original portion of the building showing unbraced timber frame walls and roof.
