Lyttelton Information Centre

Detailed Engineering Evaluation

Quantitative Assessment Report

Date: October 2012
Reference: 6-QUCC1.02
Status: Final

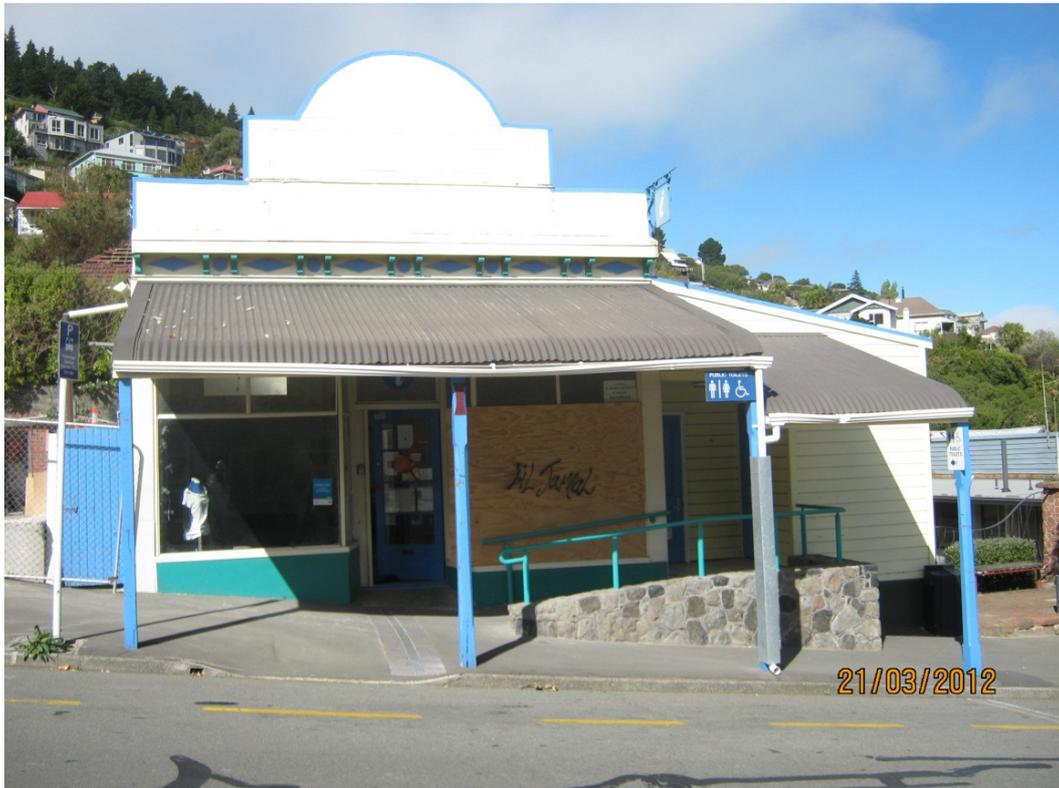
There are minor cracks at door openings in the wall linings. There are broken glass windows at the front and a crack in the window frame of the external wall, and cracked floor tiles in the public toilets area.

Photo 1: View of the building from the street. Broken window glass in the front

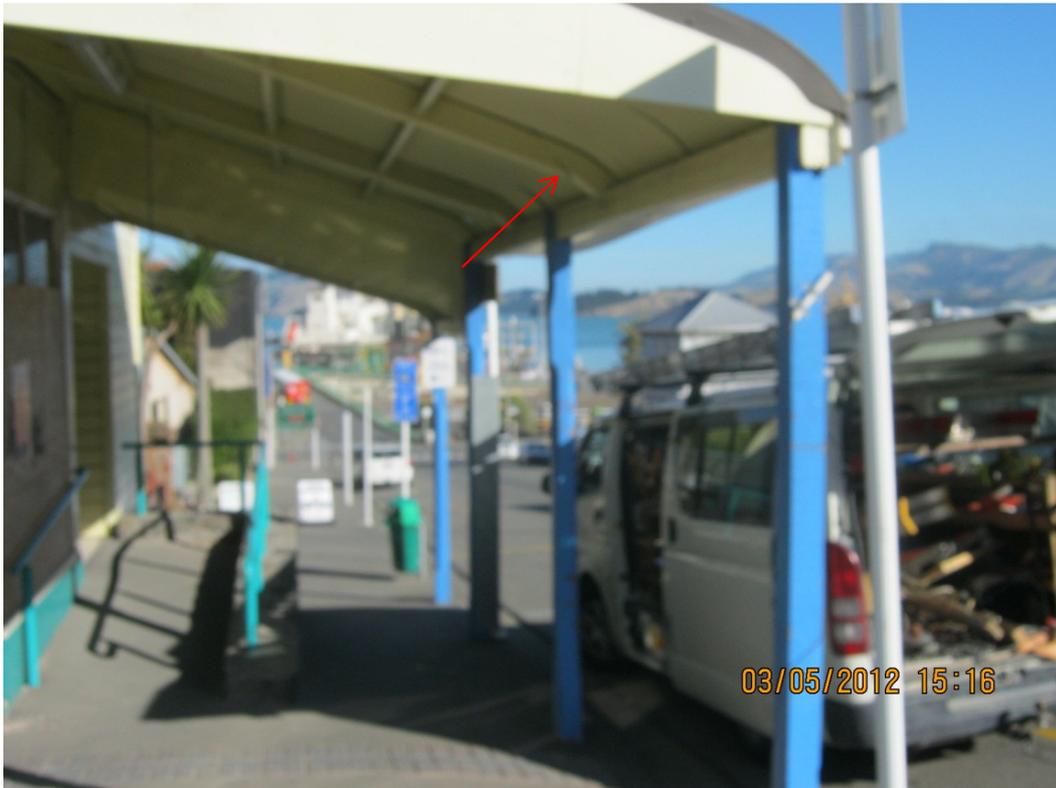
It was also noted that a verandah post was cracked, though this is more likely due to vehicle impact than earthquake forces. The splice in the verandah rafters were noted to be pulling apart, but again, this may not be earthquake damage.

Photo 3: View of Front canopy – splice at curve of rafter

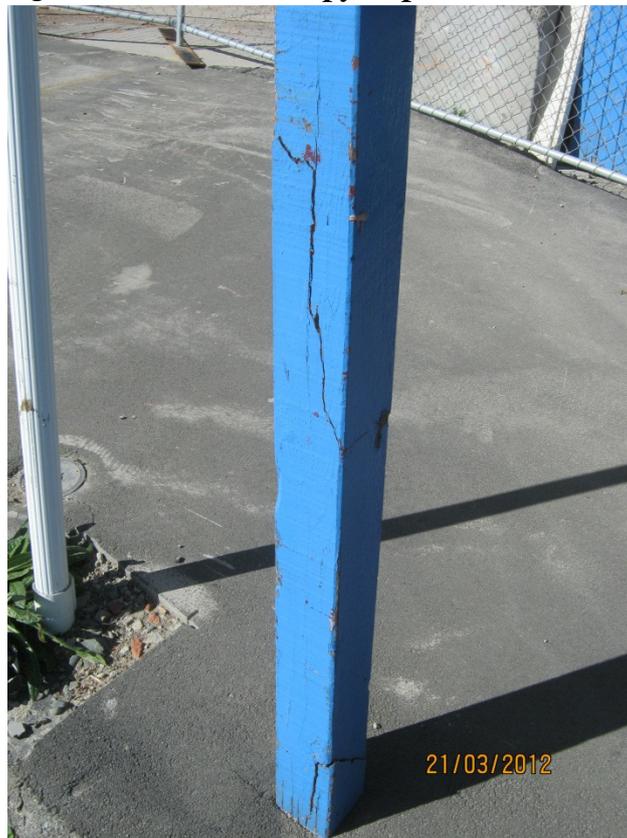
Photo 4: Cracked verandah post

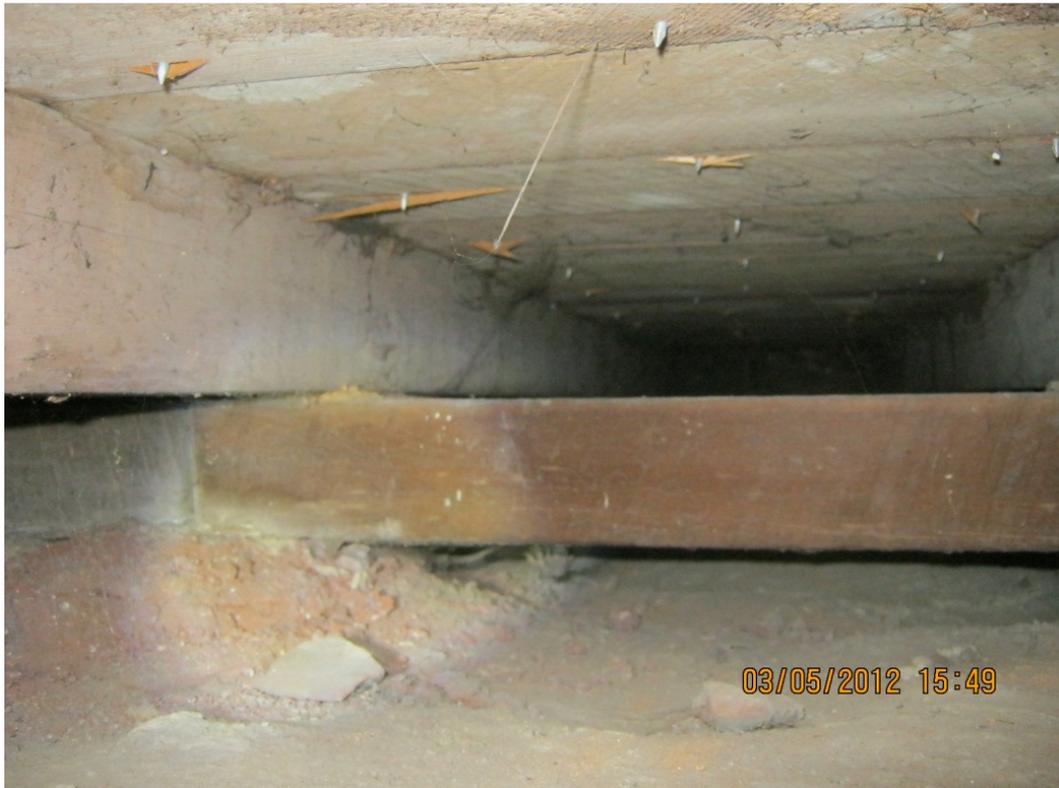
There was no sign of any hold-down connection between the rock piers and the timber bearers to transfer the lateral loads directly to the foundation.

As highlighted in Section **Error! Reference source not found.**, there is lack of connection between the bearers and the foundation to provide effective lateral load transfer. Although failure at this connection is unlikely, any failure would not result in collapse. This deficiency is not compliant with the Building Act and should be remedied as soon as possible.

Photo 5: Subfloor bearers on rock piers

The bearers should be fixed to the rock pier foundations or an alternative system installed, for example, new anchor piles at isolated locations at the building perimeter.

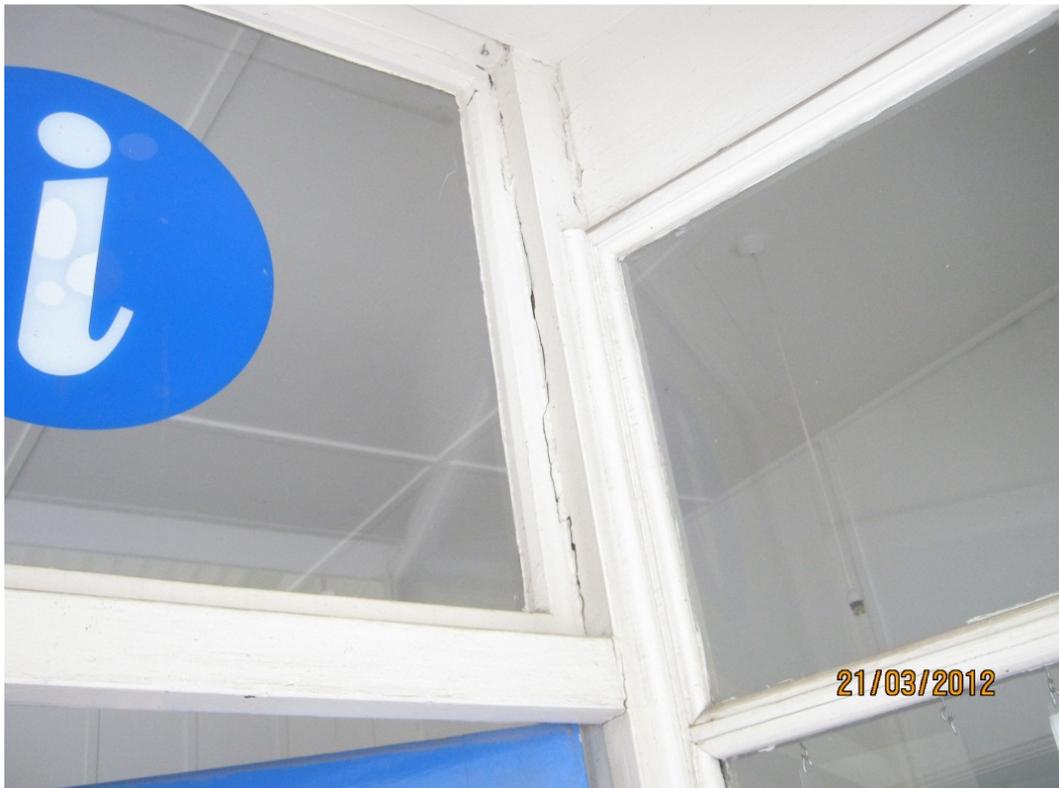
Photo 6: Crack in the window frame above the front door

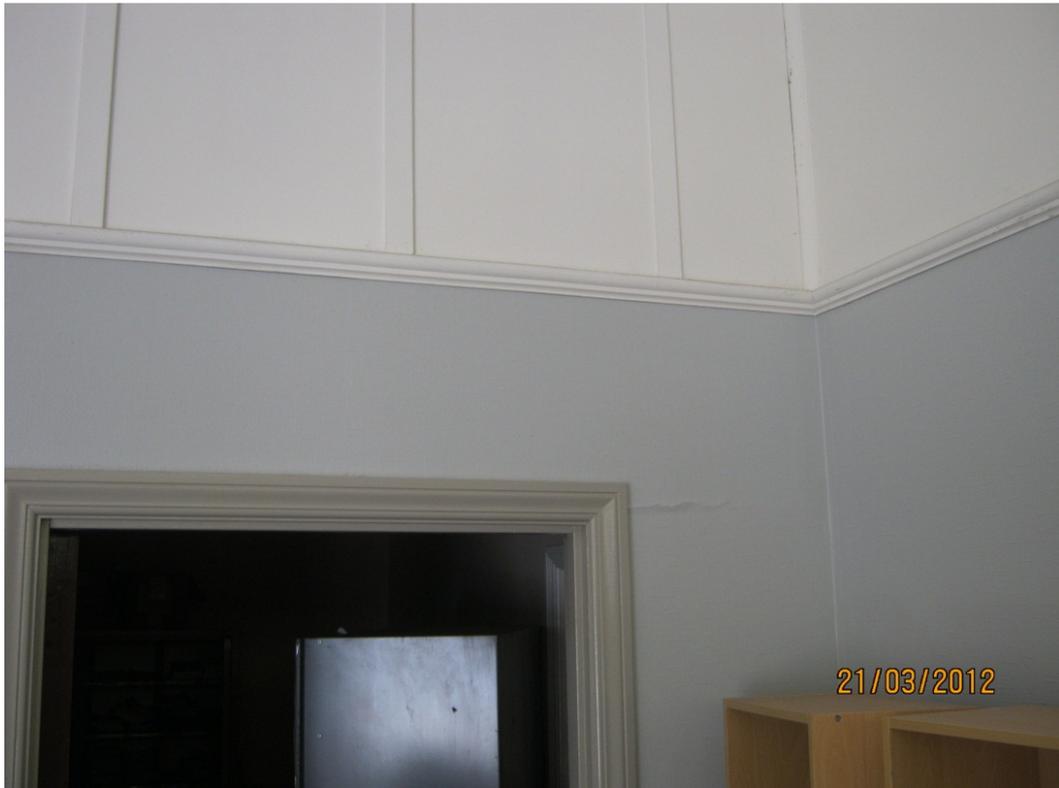
No major damage was identified. There are minor wall lining cracks at internal door openings, a crack in the front window frame and broken glass, and cracked floor tiles in the public toilets area.

Photo 7: Horizontal crack in the internal wall

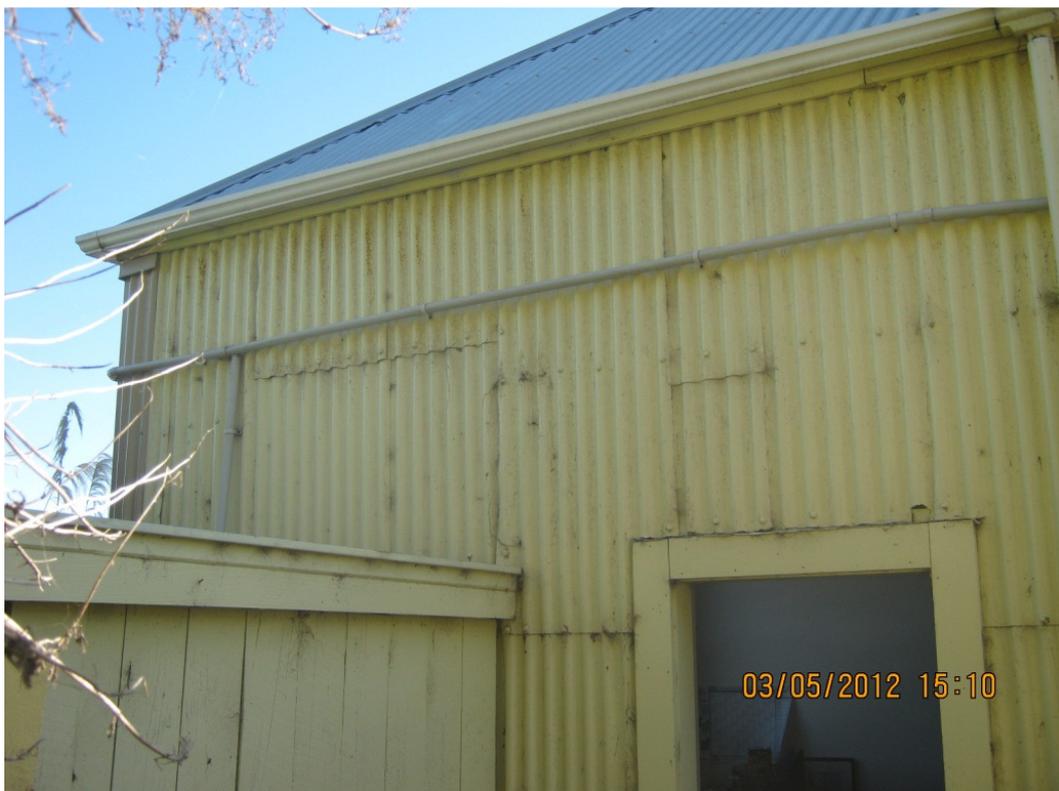
Some bulging of the rear wall was noted due to the shed pushing into the building from movement of the retaining wall at the rear.

Photo 8: View of the back of the building and adjacent shed

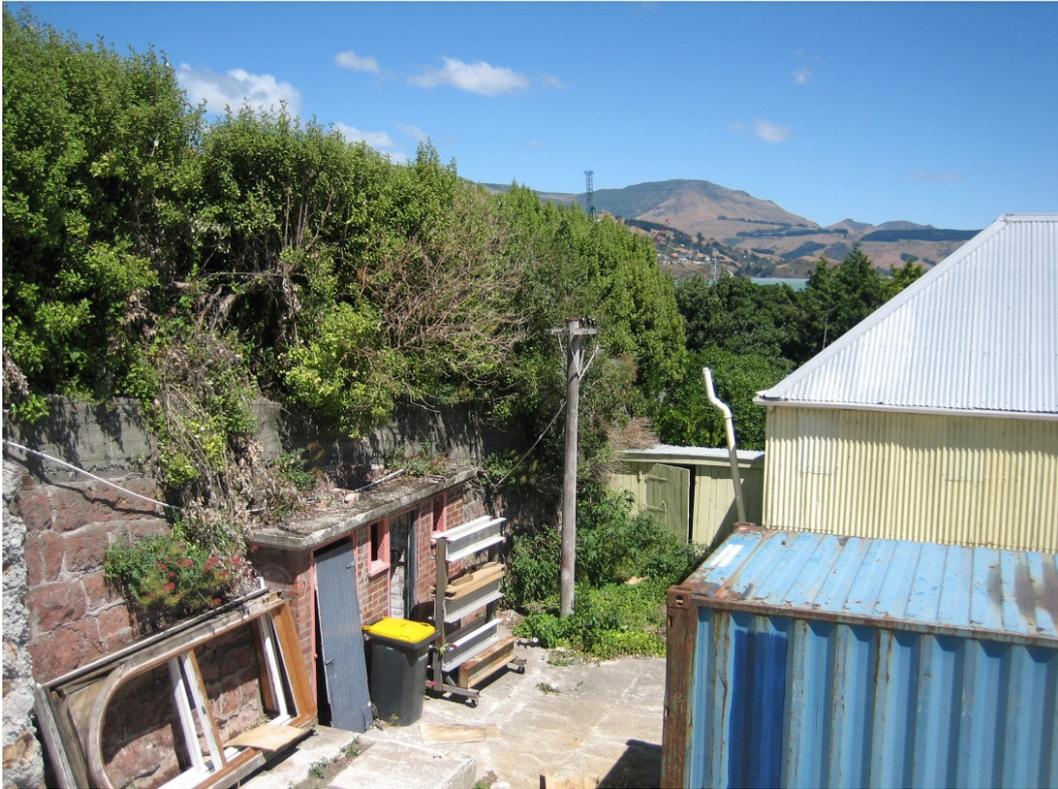
A small shed has been built as an annex to the building. The retaining wall has moved laterally approximately 30mm pushing the shed and thus damaging the main unit. Also, because of the horizontal accelerations during the earthquakes, minor cracking has appeared at the mortar joints within the retaining wall with crack widths of up to 10mm.

Photo 9: View of the retaining wall and shed at rear of the building

Minor cracking at the mortar joints in the dry stone retaining wall has occurred. We recommend that once the shed is demolished or a 200mm structural gap is installed, the dry stone retaining wall is reinspected by a Geotechnical Engineer to confirm the integrity.

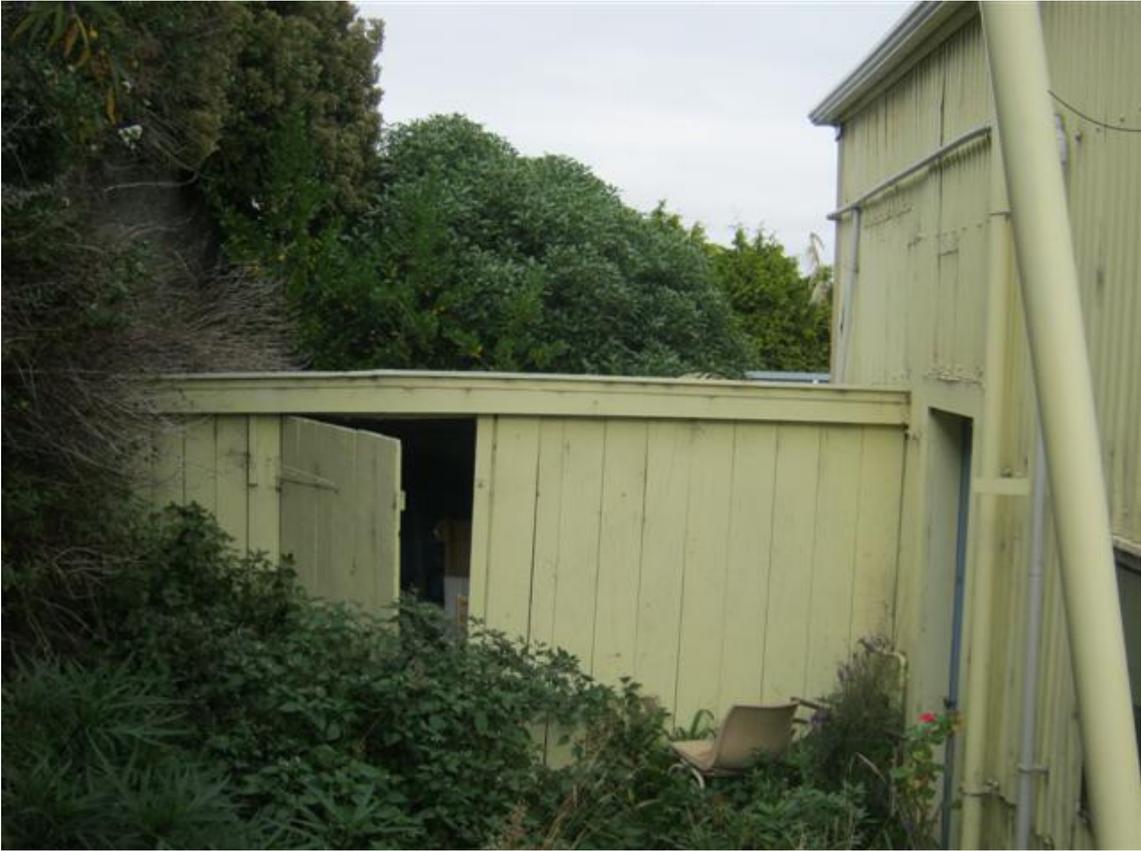
- The building has experienced differential settlement estimated to be up to 20mm;
- The building has suffered damage due to the annexed shed being pushed into the main building. There is no evidence of damage to foundations;

Photograph 1. Shed at the rear of the building

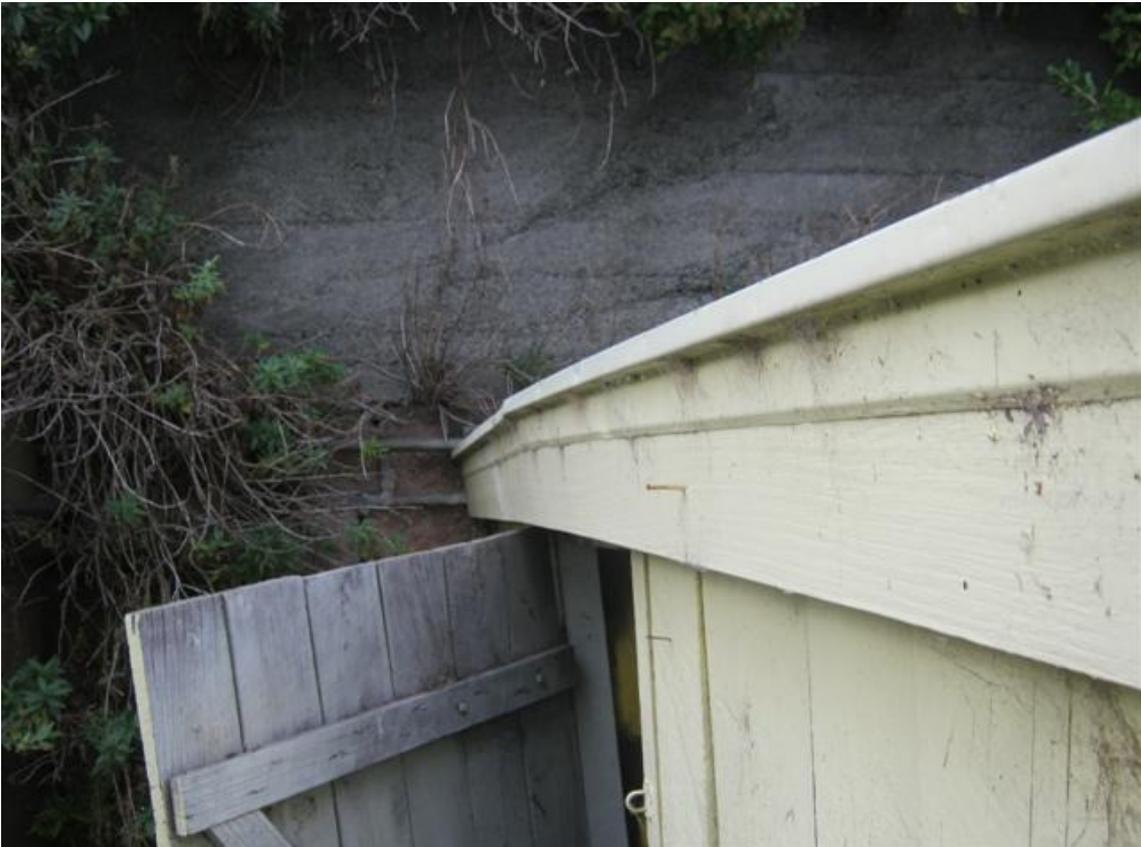
Photograph 2. Deformations along the roof of the shed

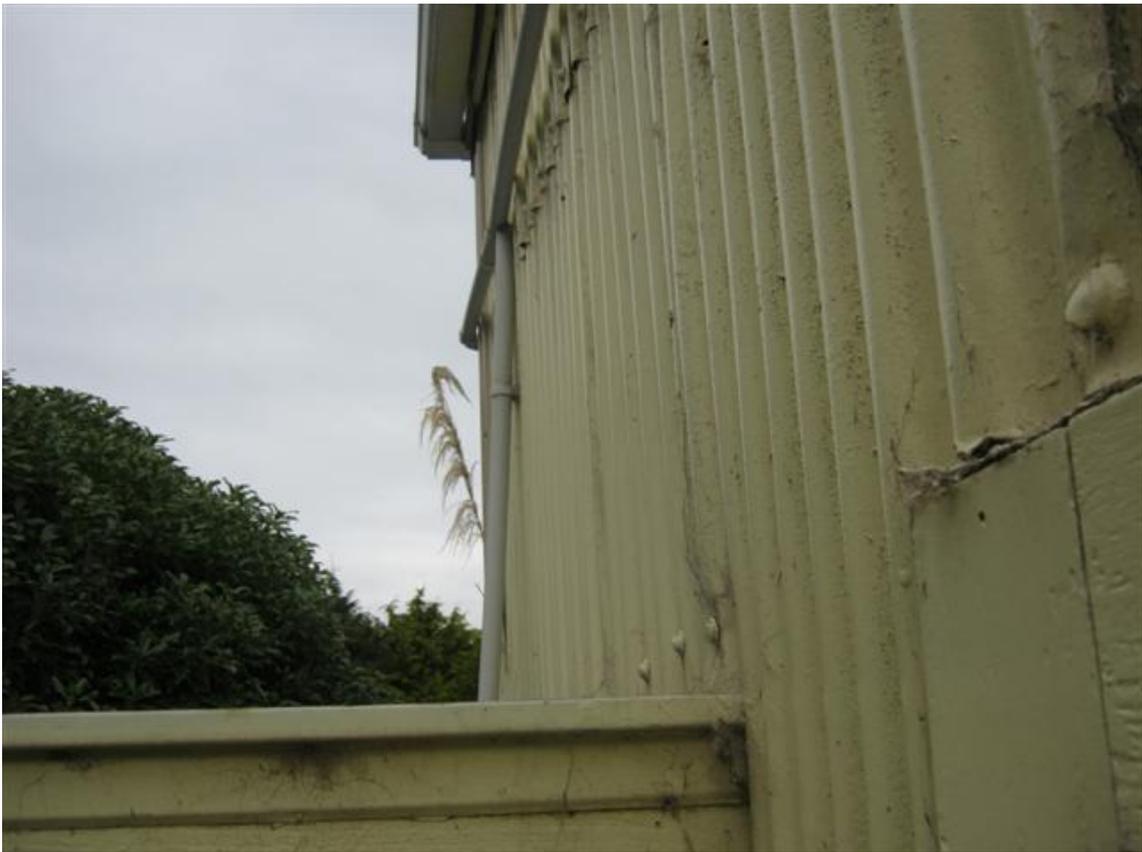
Photograph 3. Joint between the shed and building

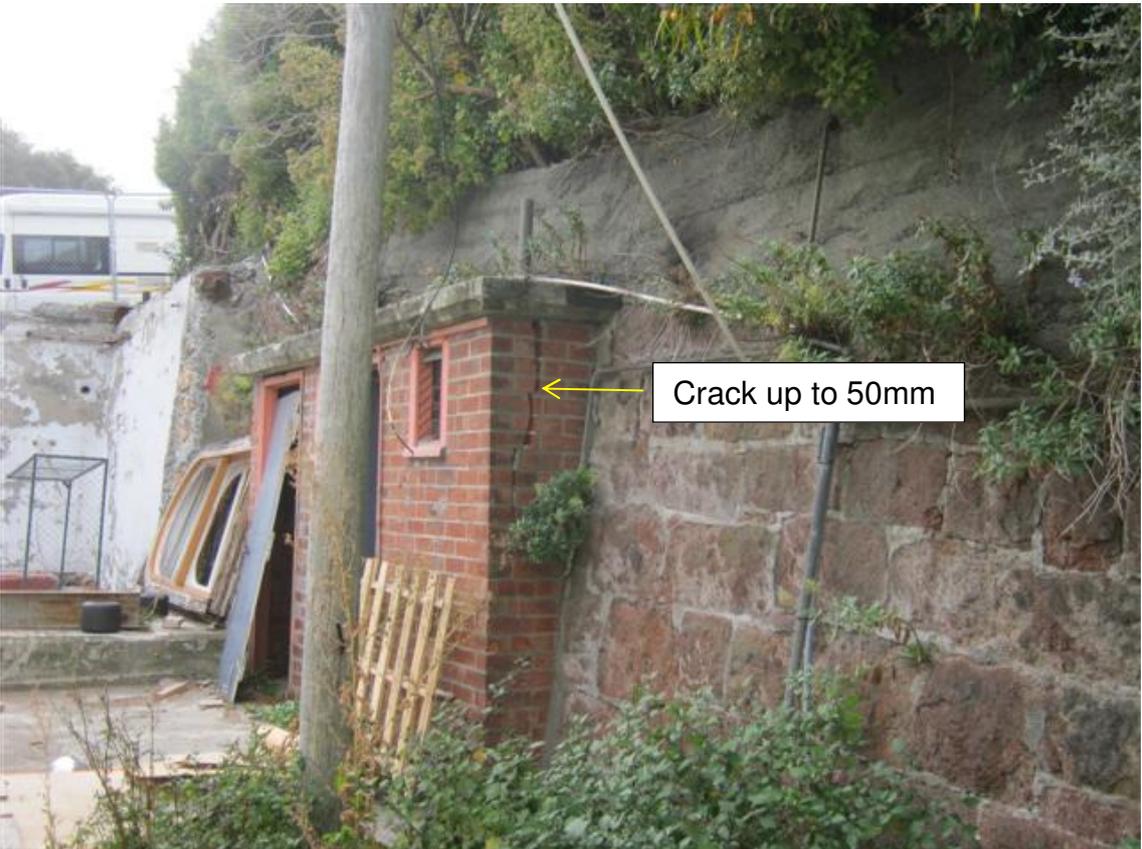
Photograph 4. Neighbouring structure cracks due to wall movement

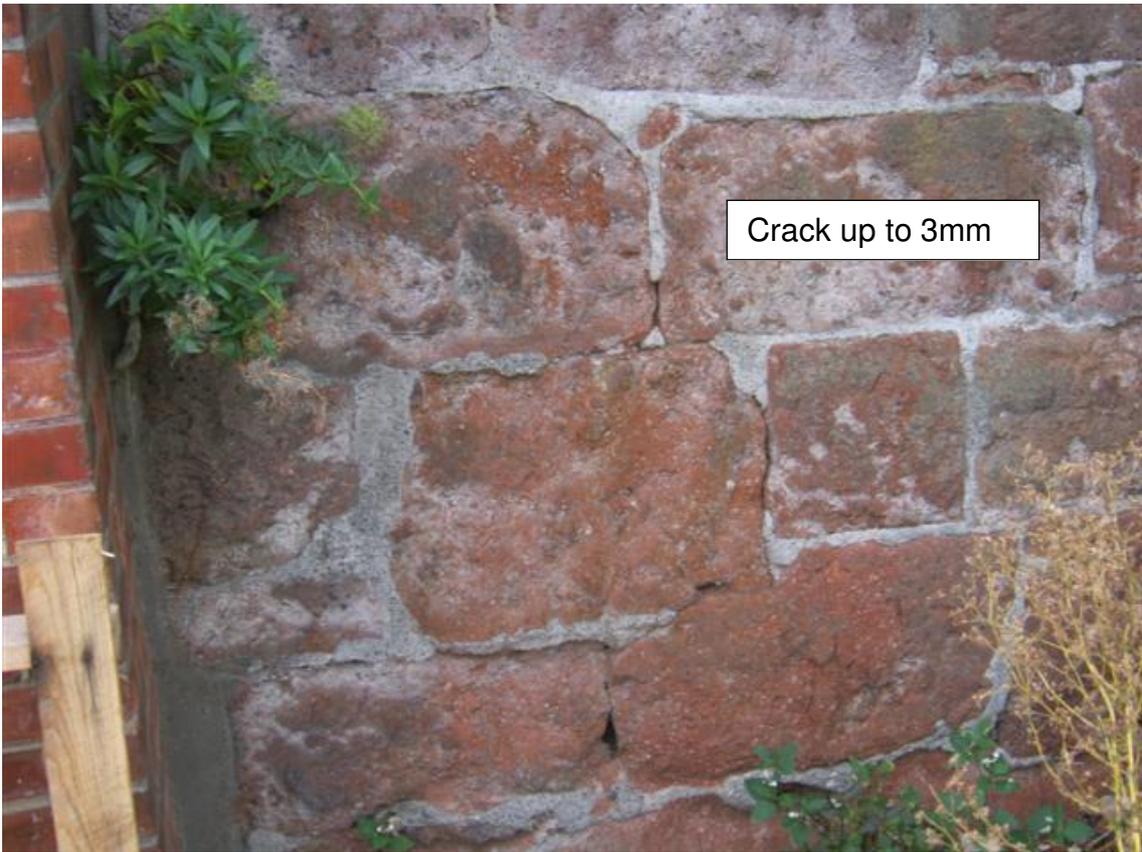
The retaining wall on the eastern boundary is constructed of stone blocks and is approximately 6m high at its highest point and lowers to about 4m height. The top 1.0 metre of the wall is formed of concrete. Due to the earthquake events, cracks have appeared in the wall, at the mortar joints and measure approximately 10mm in width.

Photograph 5. Wall cracks

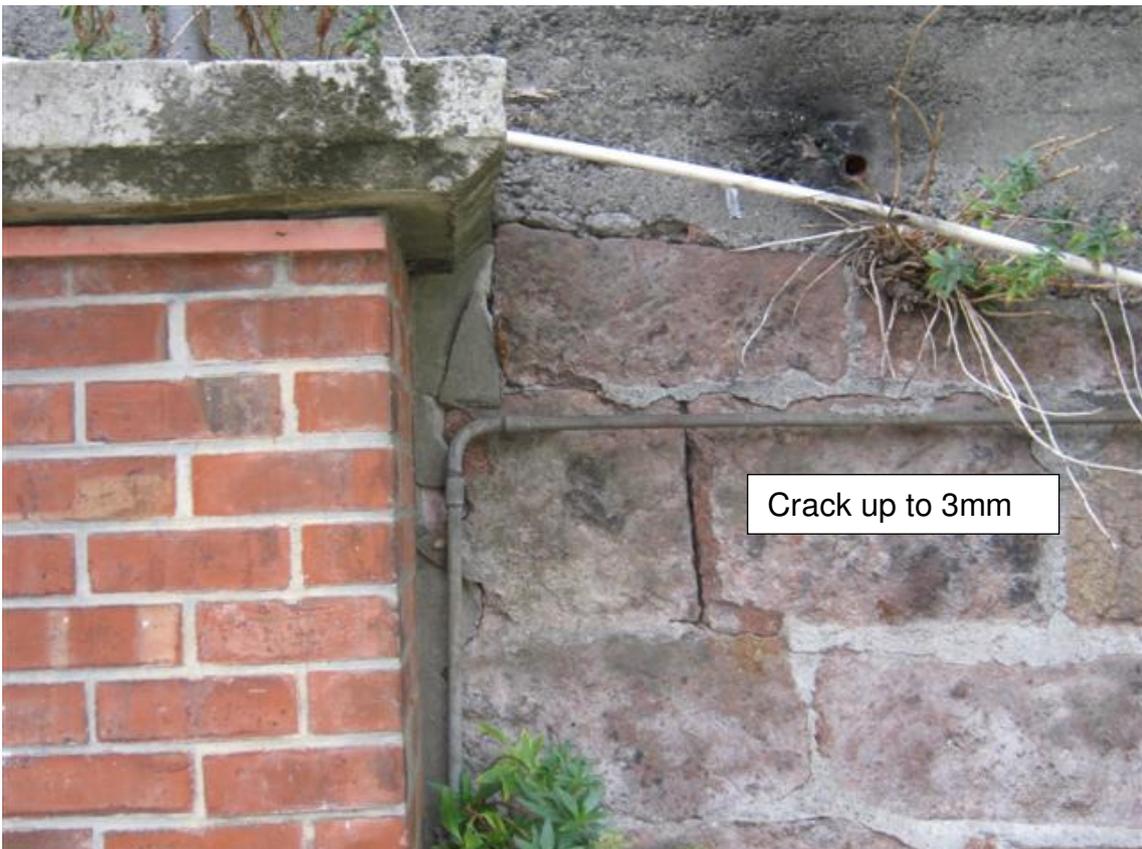
Photograph 6. Wall cracks

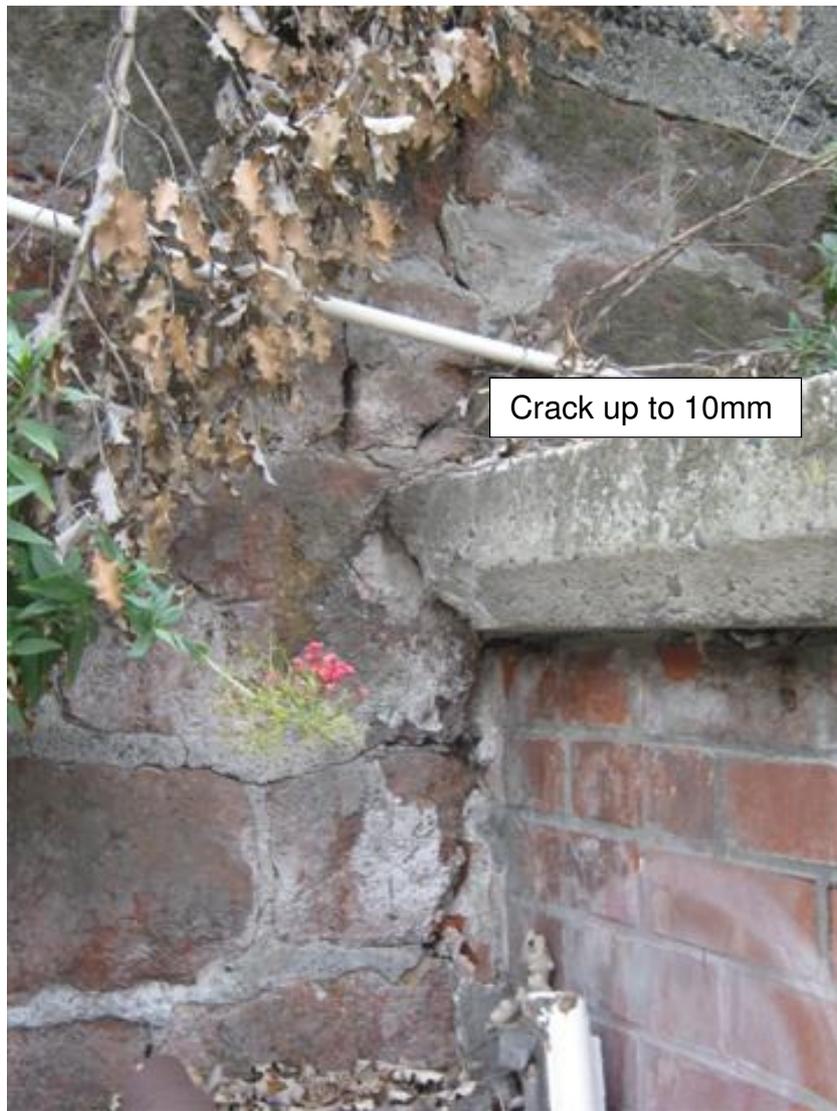
Photograph 7. Wall cracks
