**Macfarlane Park Pavilion**  
**PRK\_0663\_BLDG\_001 EQ2**  
Detailed Engineering Evaluation  
Quantitative Report  
Version FINAL

130 Skipton St  
Mairehau

Christchurch City Council

**Date**  
15 March 2013

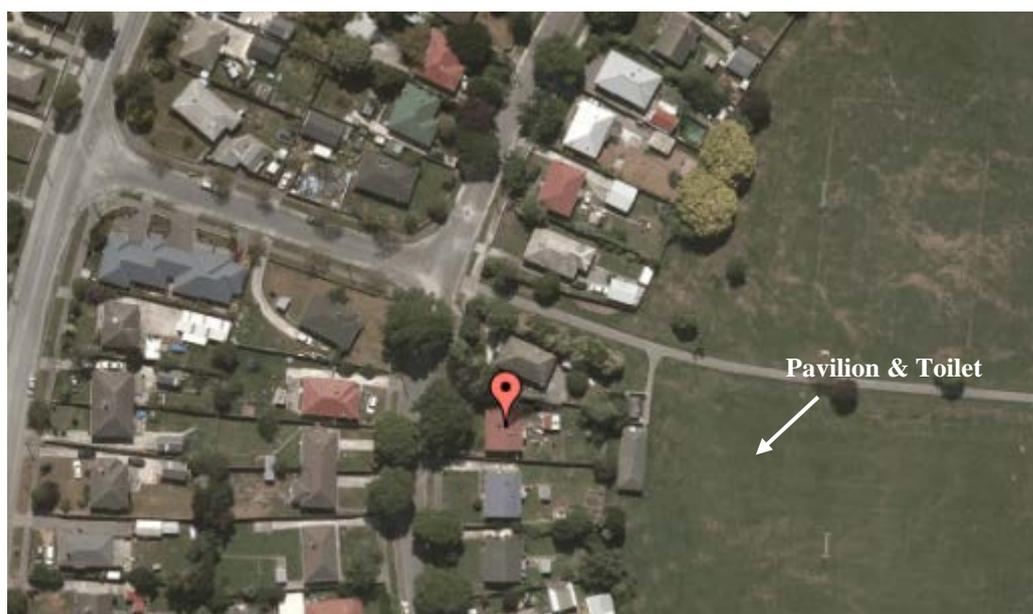
Figure 3 Post February 2011 Earthquake Aerial Photography<sup>2</sup>

Aerial photography taken following the 22 February 2011 earthquake shows minor to moderate signs of liquefaction close to the site, as shown in Figure 3.

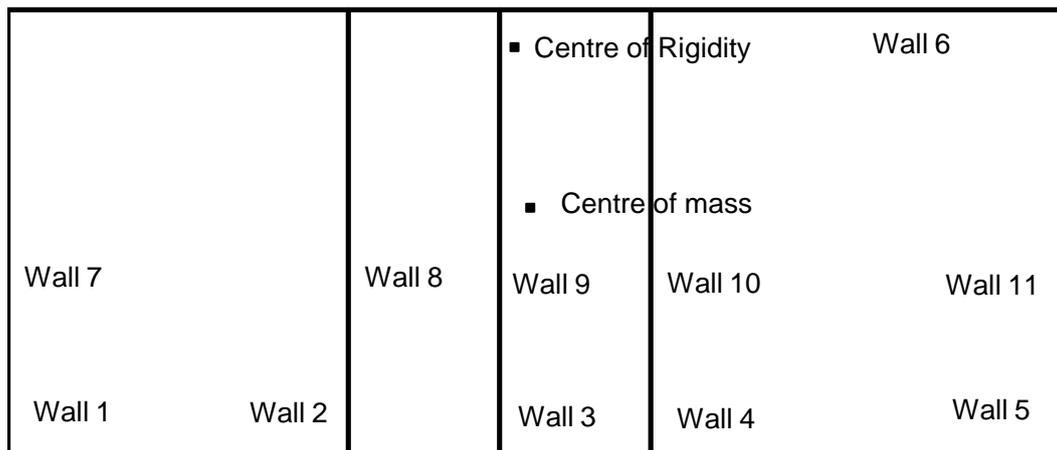
**Figure 4 Plan Details and Wall Locations**

The results of the in plane analysis and subsequent earthquake designation under the NZSEE guidelines are listed below in Table 4. Walls 1-5 fail due to rocking failure while the remainder of the walls fail through diagonal tension.

Following a detailed assessment, the pavilion has been assessed as achieving 29 %NBS. Under the New Zealand Society for Earthquake Engineering (NZSEE) guidelines the building is considered an Earthquake Prone. No critical structural weaknesses or collapse hazards have been identified in the building.

As the structure has been assessed to have a %NBS less than 33% NBS, it is deemed to be Earthquake Prone. It is recommended that masonry wall strengthening options be explored and implemented to bring the %NBS of the building up to a minimum of 67% NBS in accordance with Christchurch City Councils earthquake Prone buildings policy and the NZSEE guidelines.

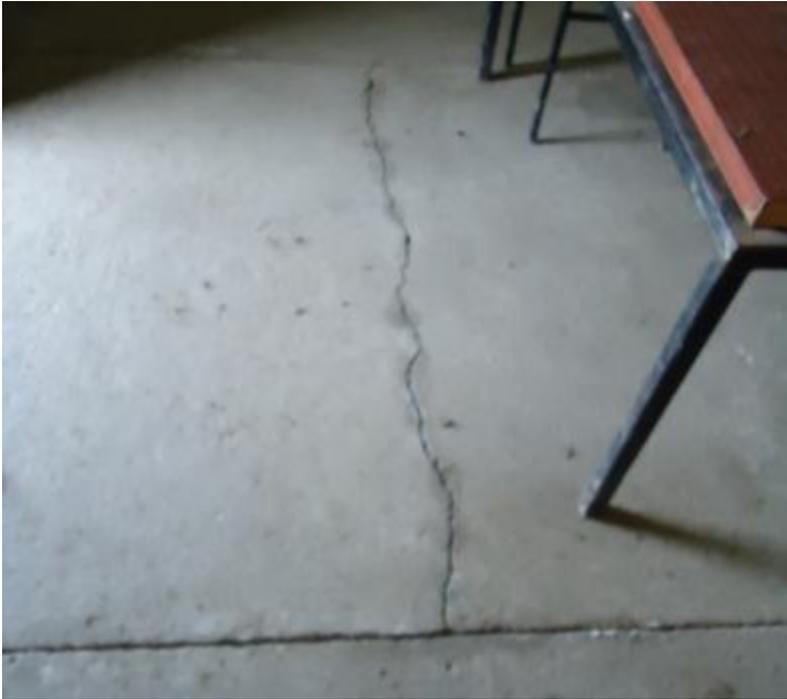
Cracking was observed in a section of the floor slab and minor heave was observed. However this cracking is not believed to affect the structural system of the building, see Photo 5 in Appendix A.

**Photograph 5 Cracking to slab.**

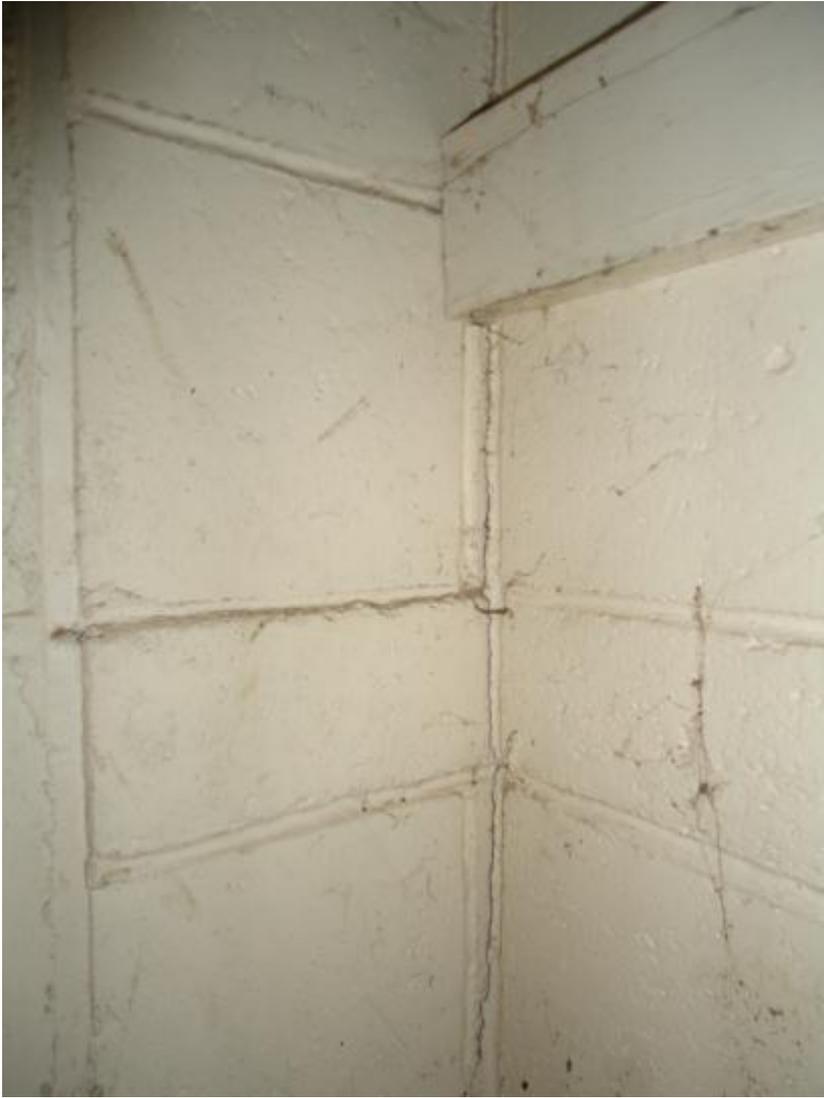
Cracking was observed in the block work walls where they met perpendicular to each other. Wall junctions do not appear to be adequately keyed in together, see Photo 6 in Appendix A.

Cracking was observed in the block walls where they meet perpendicular to each other. Wall junctions do not appear to be adequately keyed in together, see Photo 6 in Appendix A.

**Photograph 6 Cracking to block wall at connection.**
