MacGibbon Place Housing Complex PRO 1131

**Detailed Engineering Evaluation
Quantitative Assessment Report**

**20 Manhire Street, Spreydon,
Christchurch 8024**

Date: August 2013
Reference: 6-QC373.00
Status: Final

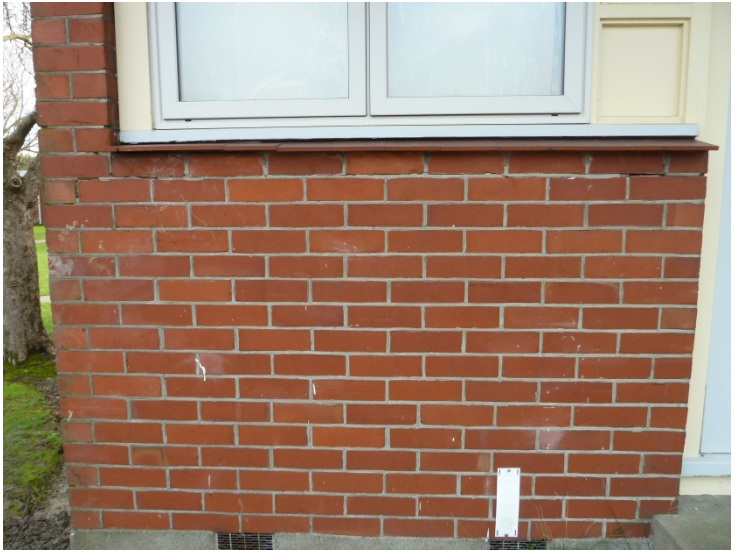
6	Cracking to veneers (Unit 8)

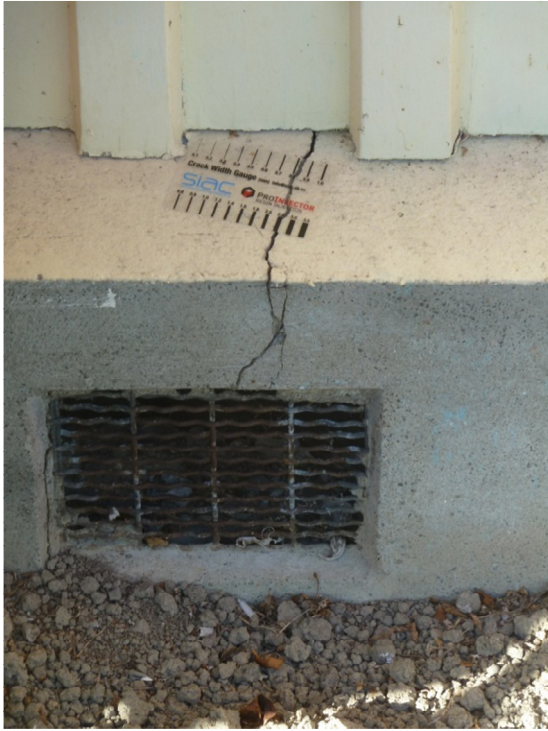
In all block units 0.1-1mm wide cracks can be observed in the concrete perimeter wall, these are commonly located around the sub floor ventilation gaps (photo 7). Access to view the timber subfloor framing was limited to a visual assessment through a floor access hatch in Unit 2 and showed no damage.

7	Cracking in ring foundation at vents (all units)

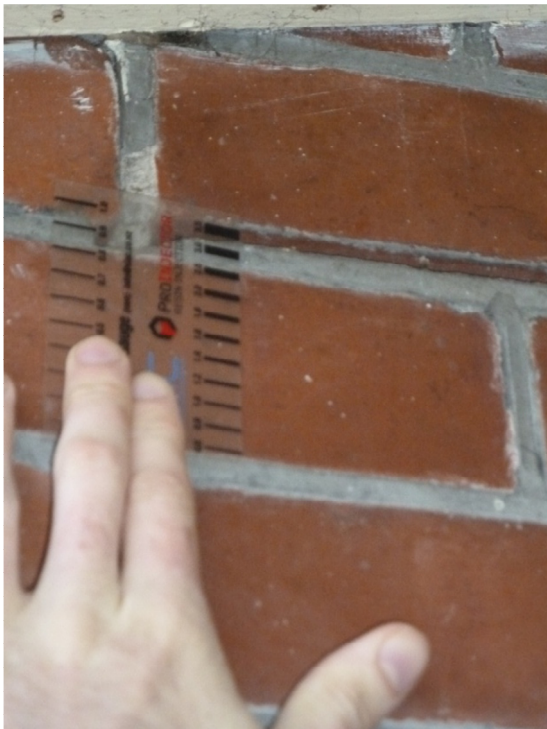
Cracking of the mortar and in the brick veneer exterior cladding of the screen wall was observed on many units (Photos 8-10). This form of damage is widespread throughout the units.

8	Cracking at top of external screening walls (almost all units)

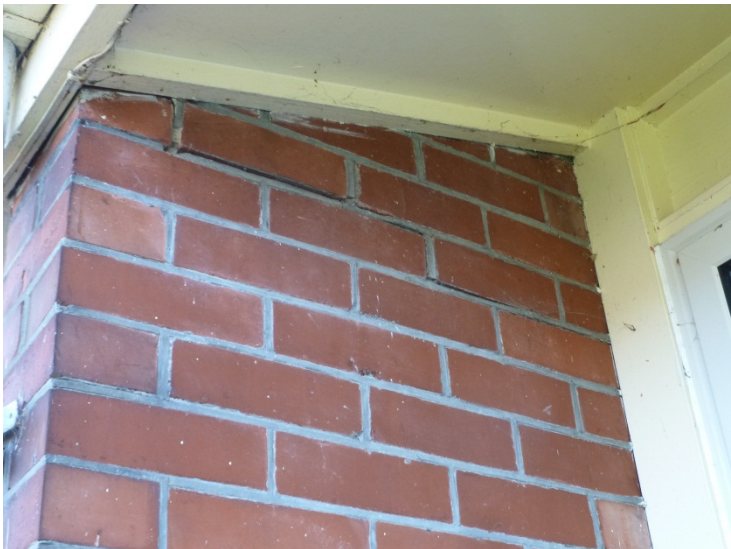
9	Cracking at top of external screening walls (almost all units)

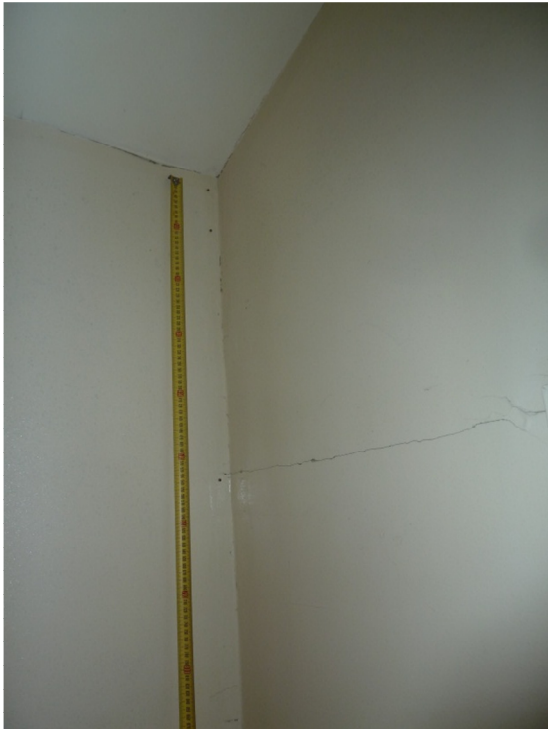
Some cracking of GIB ceiling diaphragms and wall linings (Photos 11-14) was observed in many of the units, particularly surrounding window and door openings. This was consistent throughout all the units visited.

13	Cracking in bathroom (most units)

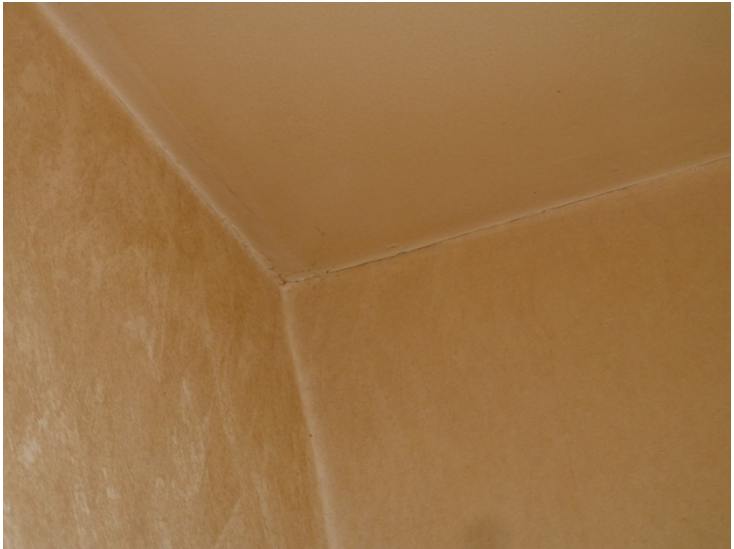
14	Cracking in corners between wall and ceiling GIB (most units)
