6 March 2012

**Our Ref: 120228/S1**

**RE: ORION NZ LIMITED**  
**218 MANCHESTER STREET, CHRISTCHURCH**  
**STRUCTURAL CONDITION OF THE CAR PARK BUILDING**

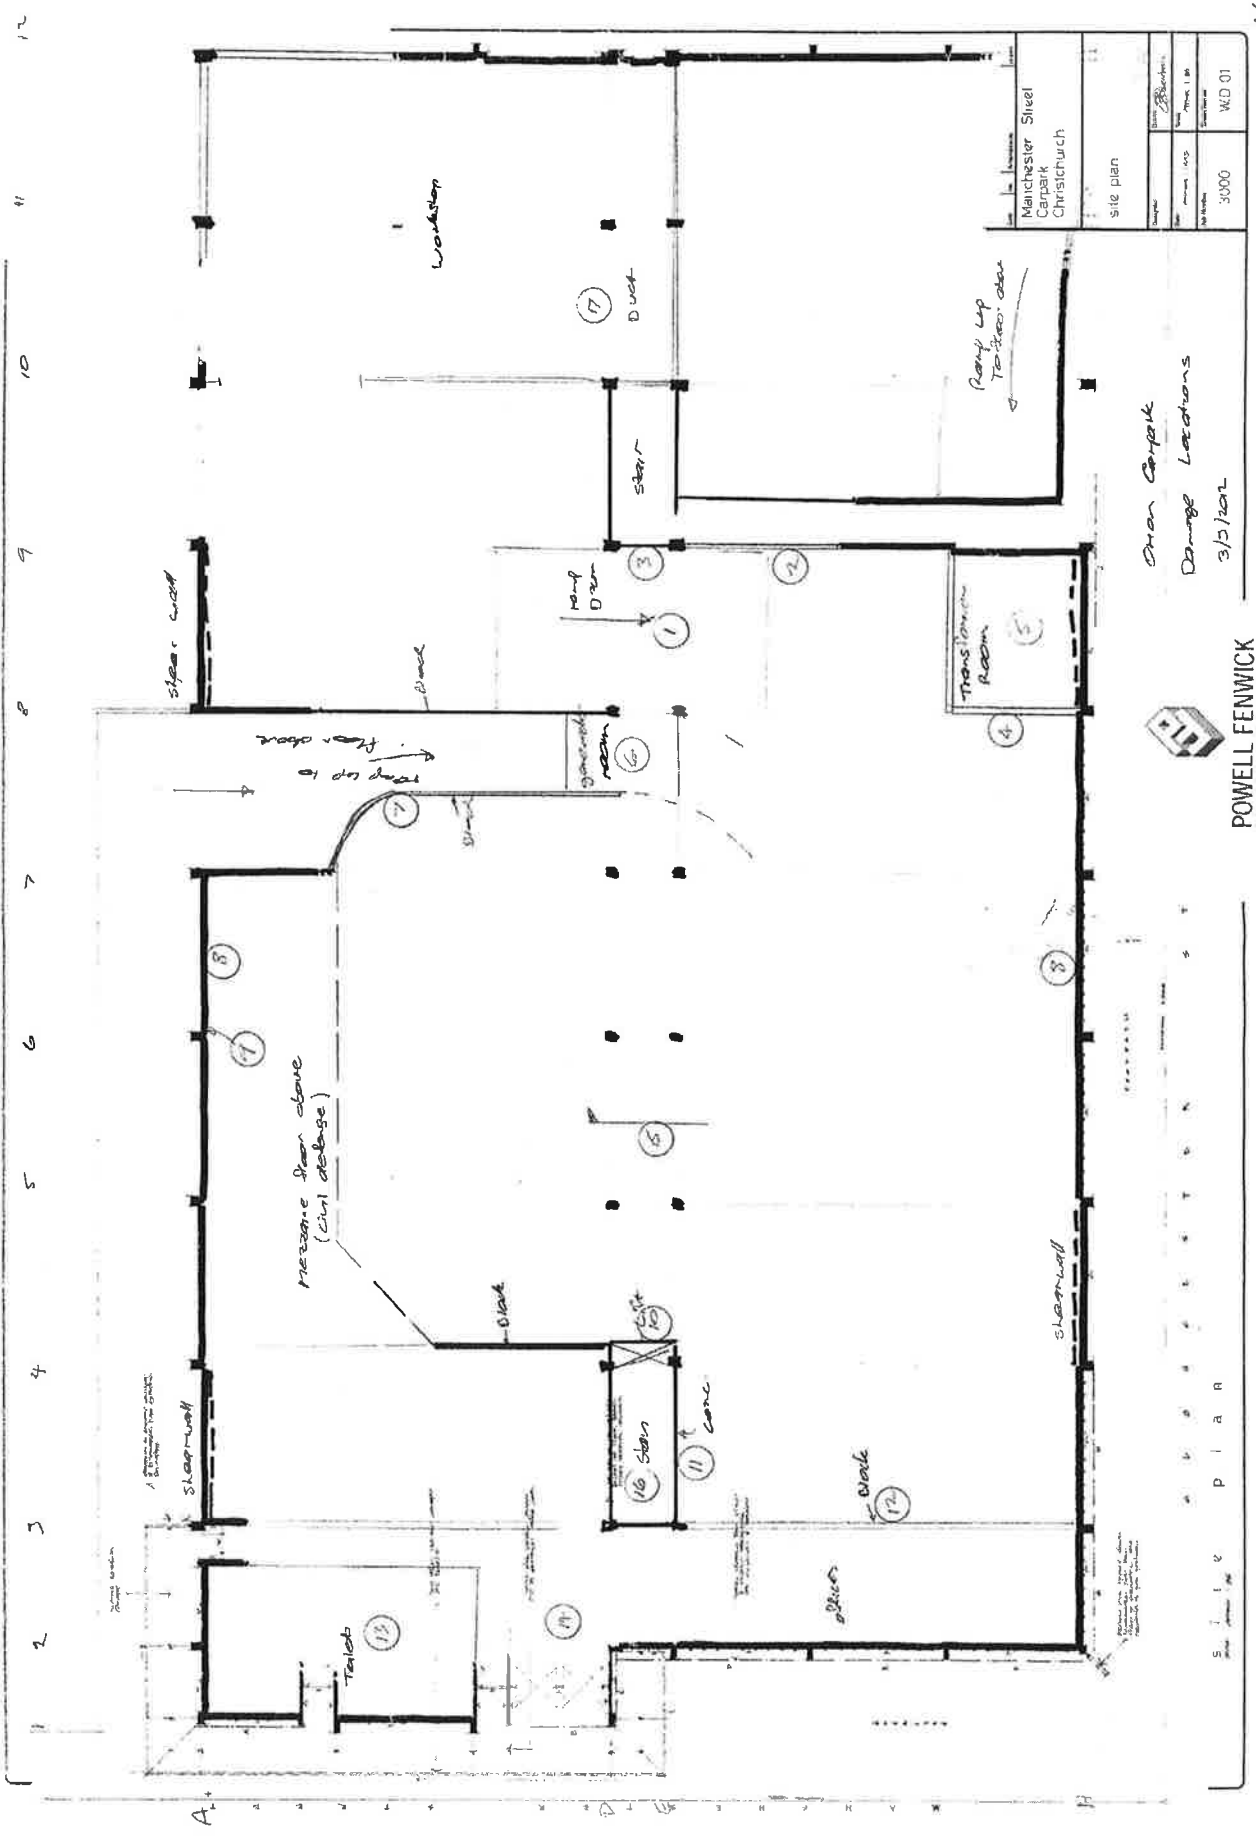
Plan of damage locations

Refer to the attached marked up plan for location of the damage.

1. North side ramp from the ground to the upper level has separated from the upper floor. Cracking to the north ramp ground floor midpoint between the supports.

2. Gap formed between the non load bearing concrete masonry walls and the beams above.
3. Shear cracking to the insitu concrete wall adjacent to the entry ramp.

4. Step cracking to the unreinforced masonry wall surrounding the transformers plus 6 mm translation of bricks.
5. Cracking to the ground floor where the centre of the floor has risen.

6. The ramp support beam visible in the generator room has significant cracking to the end supports. The beam has subsequently been propped with SHS steel columns.

7. Step cracking and translation of the masonry wall that forms the side of the ramp to the floor above. This wall is a double skin 90 mm concrete masonry columns with 200 mm masonry bond beams at various levels. There is also damage where the wall intersects the columns.

8. Vertical cracking at the centre of the exterior low level insitu concrete walls, typically midway between columns in numerous locations. (only some locations are indicated on the plan)

9. Spalling of column concrete where it intersects the short walls noted in 9 above.
10. Shear cracking to the concrete wall.
11. Vertical cracking to the concrete walls.

12. Settlement of the floor slab has created a 25-30 mm gap between the beam and the masonry wall below.
13. Minor cracking to the plasterboard walls in the amenities area. Delaminating of the plaster coating to the columns in the toilets.

14. Cracking to the concrete walls in the entry foyer.
15. Step in the floor at the intersection of the centre concrete strip and the main floor. This central strip is the main foundation support for the centre columns and as such is supported on piles. Orion staff have advised that the floor falls in this area is greater than prior to the earthquake. It is not possible to confirm this however the level change indicates that there has been movement in the floor.

16. Extensive diagonal shear cracking to the concrete wall in the north south direction and minor cracking to the walls in the east west direction. The landing to the stairs above has cracking to the underside.

17. The electrical duct at the north end of the workshop now has a 5 mm step indicating either the floor has settled or the duct has risen.

- Injection grout the damaged concrete wall at location 3. As this would not have been a designed shear wall, full replacement would not be required to reinstate the building.

- Replace the brick walls surrounding the transformer room. This could be constructed of concrete masonry or timber depending on operational requirements. If this wall cannot be removed for operational reasons, then an external strengthening systems may be required. This could consist of a spray on concrete or perhaps a carbon fibre wrap to stabilize the brick. Alternatively, timber and plywood walls could be constructed each side to support the brickwork.

- Epoxy injection of the cracking to the floor in the transformer room. Ideally, the floor should be replaced however this may not be practical considering the rooms use.

- Re leveling the main floor would require removal of the existing slab and constructing a new one to eliminate the step at location 15. Alternatively a floor topping system such as Sika Monotop could be used to feather the floor to eliminate the steps.

- Additional strengthening plates to the ends of the beam in the generator room to provide lateral support. If the temporary steel posts are to be removed, additional steel beams could be added adjacent to the existing beam. Reinstating the ramp back to the condition prior to the earthquakes would require demolition of most of the ramp and beam and a new ramp constructed.

- The gap between the masonry walls (item 7 and 12) to be filled with a compressible material for example polystyrene as previously. The lateral restraint of these walls will need to be checked.

- Replace the damaged masonry units at location 7, 12 and in the ex civil defense areas. Allowance should be made for separation of these walls from the main structure.

- Epoxy injection of the cracking above 0.2 mm wide in the concrete walls.
- Replacement of the floor slab in the workshop to eliminate the step at the electrical duct or feather the surface with Sika Monotop or equal.
