Christchurch City Council

Marwick Place Housing Complex PRO 0442

**Detailed Engineering Evaluation
Quantitative Assessment Report**

**53 Daniels Road, Papanui,
Christchurch, 8051**

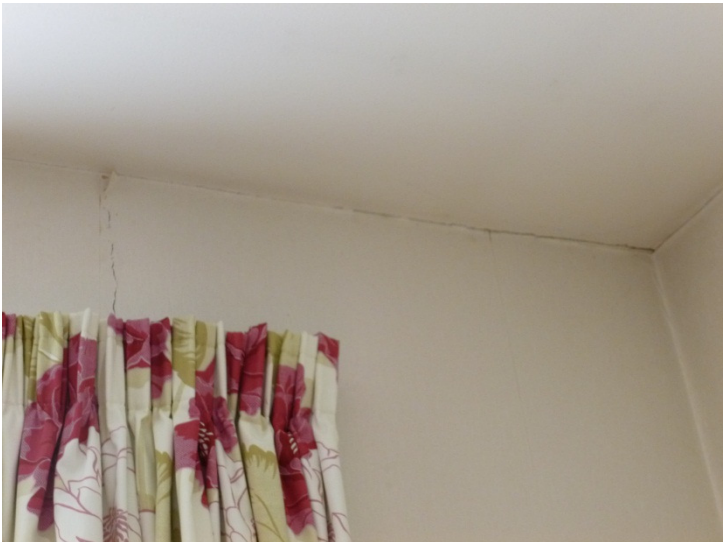
Minor cracking in the plasterboard was observed, typically above door frames, window frames and in the ceiling.

13.	Typical plasterboard cracking above windows and at roof line

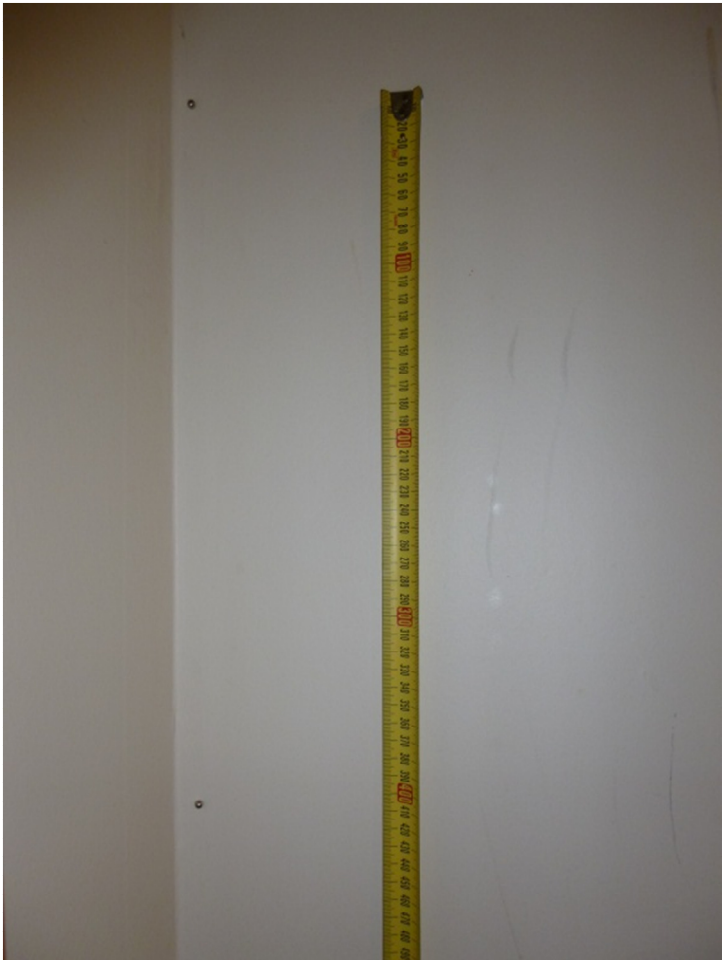
The internal lining nail spacings were measured on site to vary between 150-450mm.

14.	450mm nail spacing (Unit 6)

Increasing the number of nails in the plasterboard will improve the strength in some of the buildings.

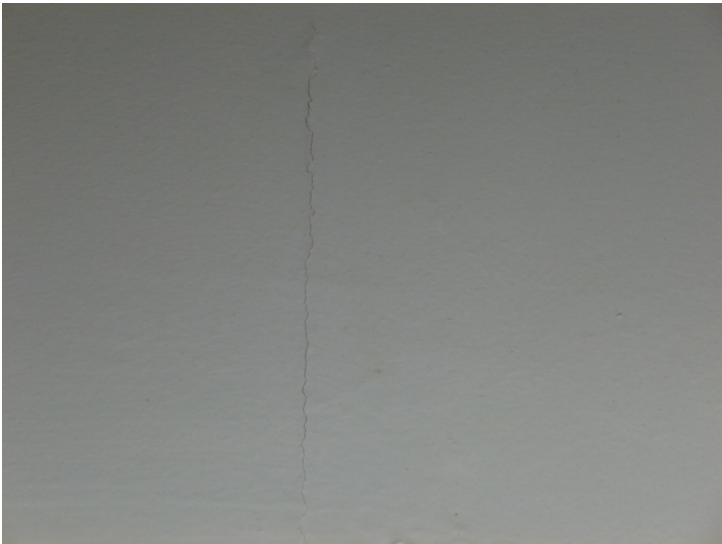
15.	Typical crack in ceiling diaphragm

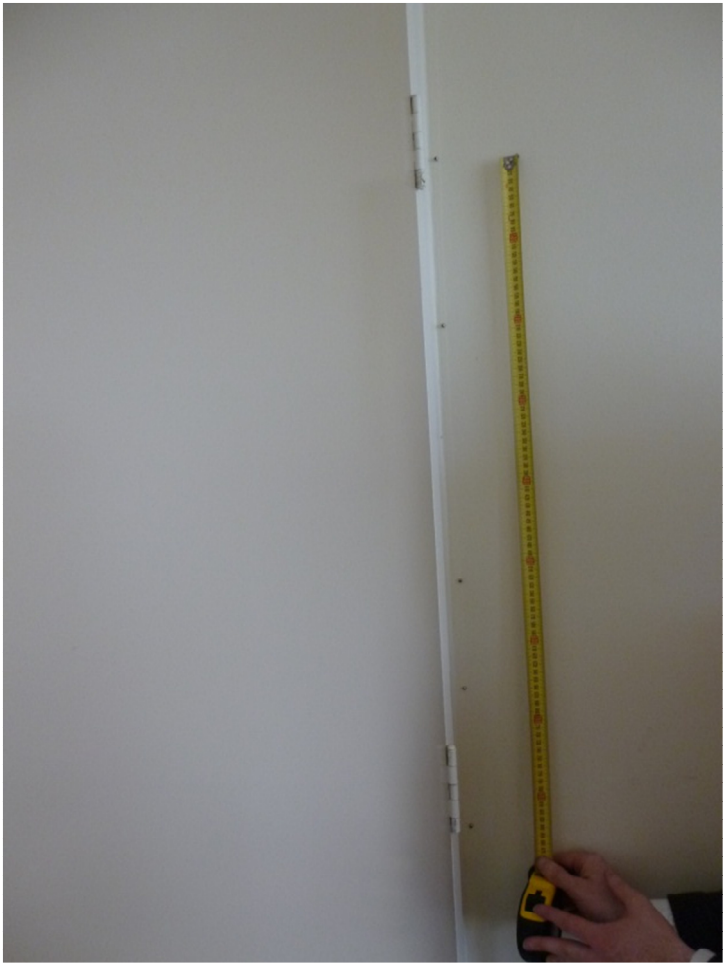
16.	150-350 mm nail spacing (Unit 12)

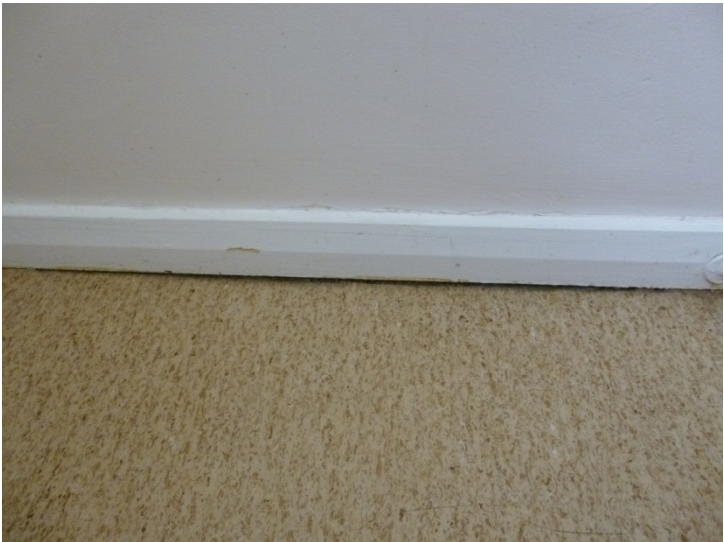
17.	Separation of skirting board and floor

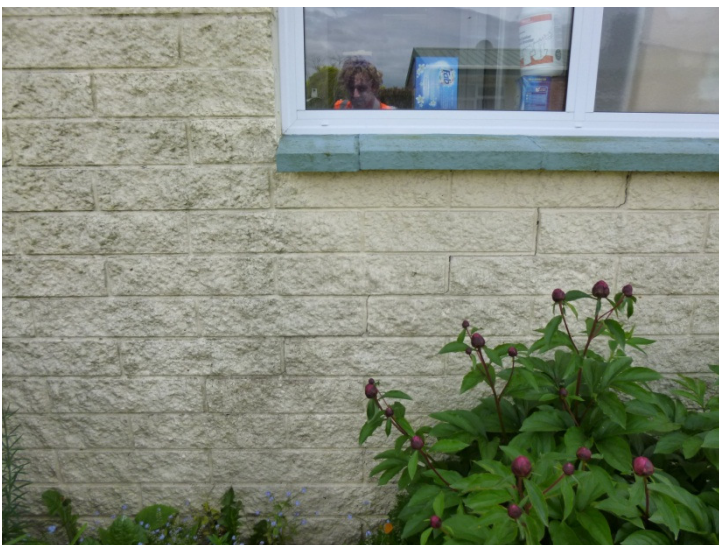
Hairline cracking was observed in the veneers. The blocks with concrete block veneers suffered increased damage. A 2mm crack was observed in the veneer of Unit 15 (photo 21). Loose bricks in situ were observed at height at the end of Blocks E and F (photo 18). Cracks were observed in the concrete patio entrances (photo 20).

21.	2mm stepped crack in Unit 15 veneer

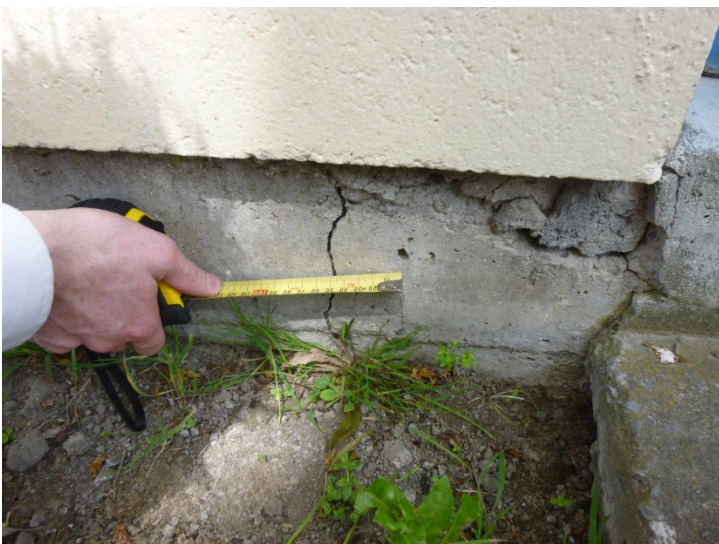
Hairline cracks were observed in the foundations, typically under windowsill areas. A 2-3mm crack was observed in the foundation of Unit 18 (photo 22).

22.	2mm foundation crack in Unit 18

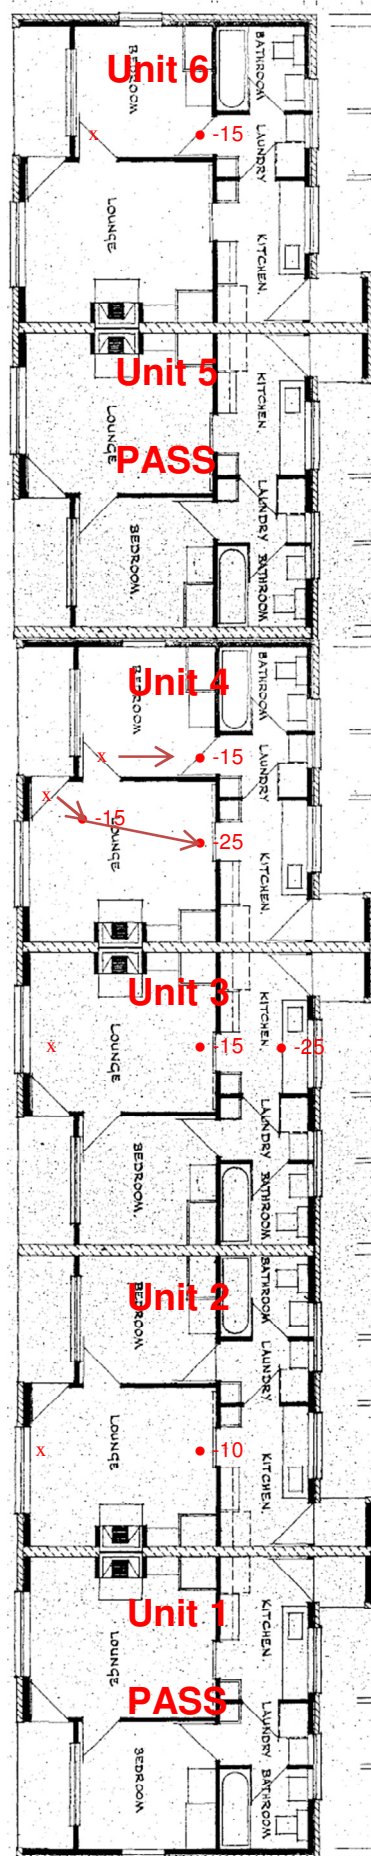
Block A

Block	Unit No.	Comment	Maximum Fall
A	1	Pass	-
	2	Pass	-
	3	Pass	-
	4	Fail	10.0 mm/m
	5	Pass	-
	6	Fail	5mm/m
B	7	Pass	-
	8	Pass	-
	9	Pass	-
	10	Pass	-
C	11	Pass	-
	12	Pass	-
	14	Pass	-
	15	Fail	14.7 mm/m
D	16	Fail	7.5 mm/m
	17	Fail	5.8 mm/m
	18	Pass	-
	19	Pass	-
E	20	Pass	-
	21	Fail	5 mm/m
	22	Pass	-
	23	Fail	7.6 mm/m
F	24	Fail	6.7 mm/ m
	25	Fail	5.9 mm/m
	26	Fail	5.2 mm/m
	27	Pass	-
