City Care Milton Street Depot Plant Maintenance Workshop, Part 1 & 2 Detailed Engineering Evaluation BU 1141-002 EQ2 Quantitative Report

14 June 2013

City Care Milton Street Depot – Plant Maintenance Workshop, Part 1 & 2 BU 1141-002 EQ2

Detailed Engineering Evaluation Quantitative Report – SUMMARY Version 1

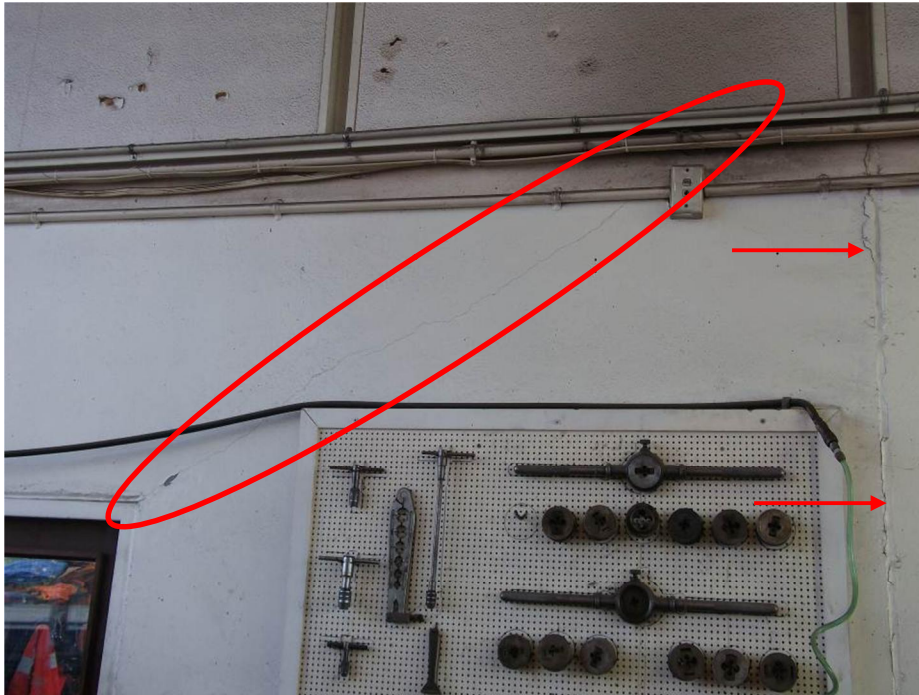
Photo 5: Typical cracking to concrete shear walls.

Description of Damage: Cracking to concrete shear walls and movement joints, with some spalling at movement joint.

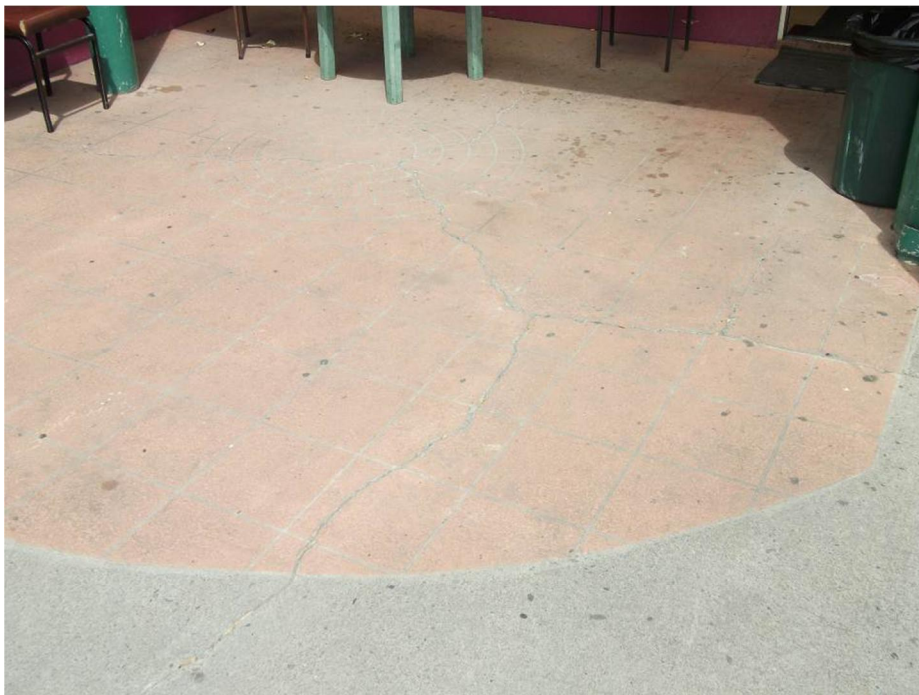
Photo 6: Typical slab cracking

Description of Damage: Cracking to concrete slab at Fleet Services entrance.

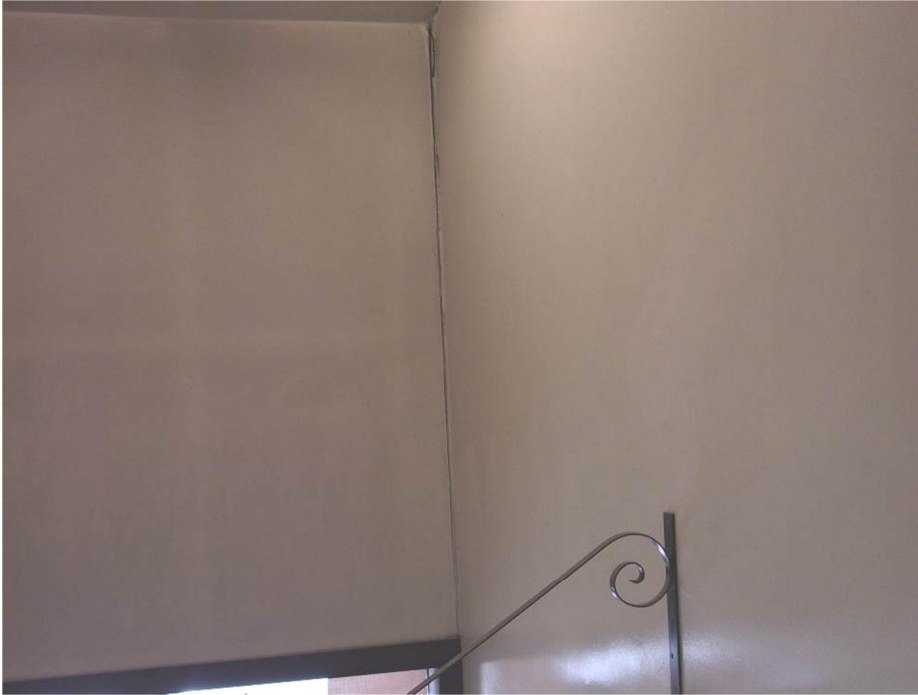
Photo 7: Movement between concrete wall and timber wall.

Description of Damage: Damage from movement between concrete wall and timber wall.

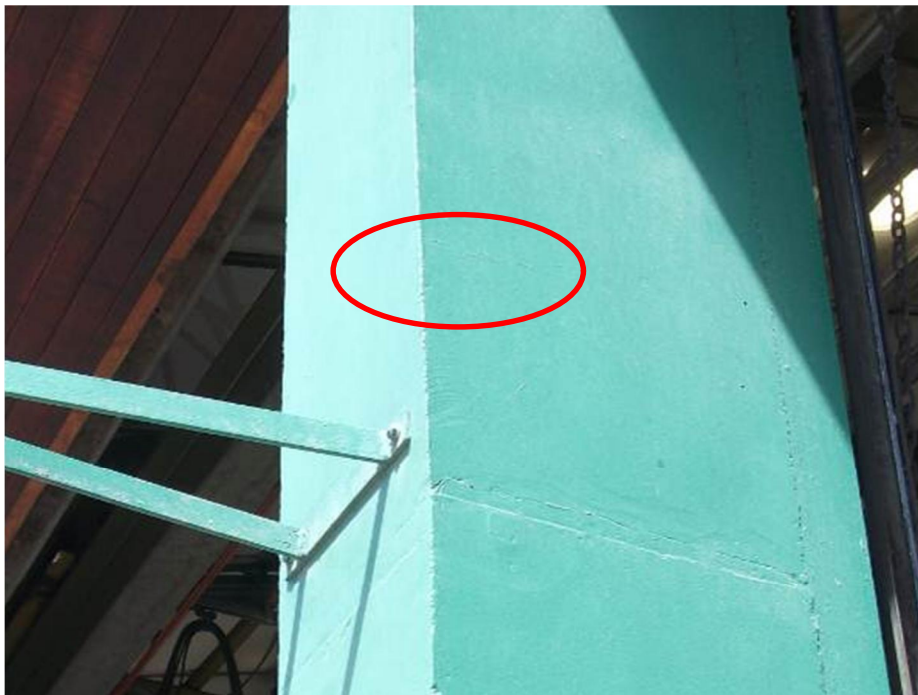
Photo 8: Typical cracking to concrete encasement of column.

Description of Damage: Cracking to column concrete encasement.

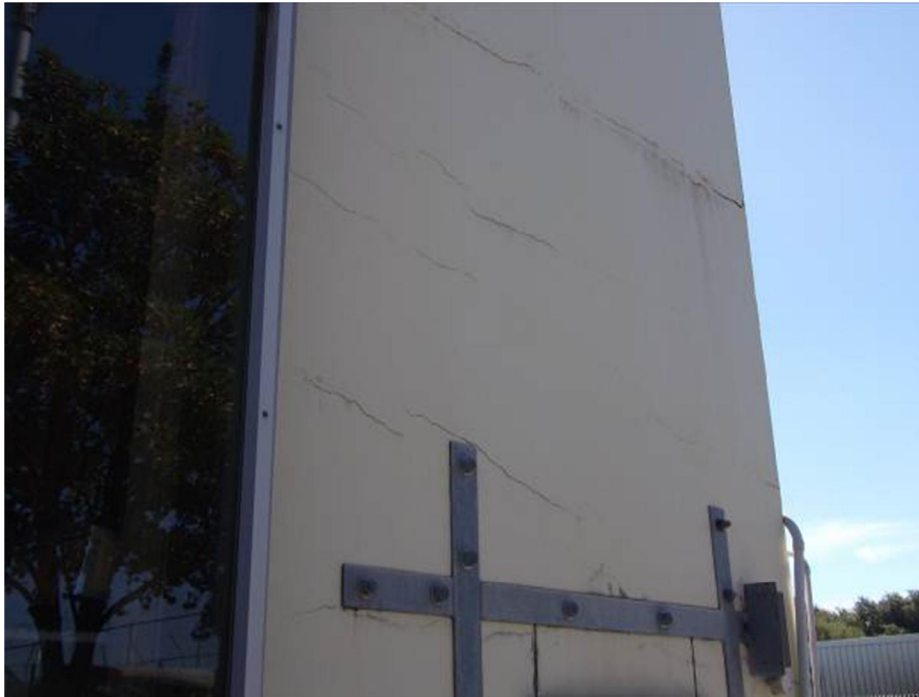
Photo 9: Typical cracking to concrete shear walls at corners of building.

Description of Damage: Cracking to concrete shear walls.

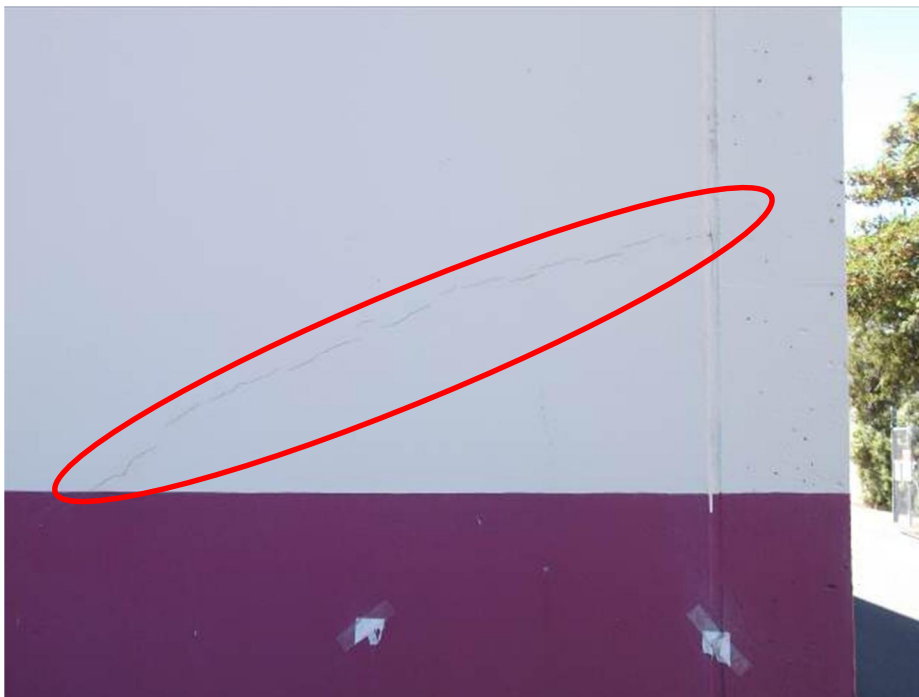
Photo 10: Typical cracking to concrete shear walls at corners of building

Description of Damage: Shear crack in concrete shear wall.

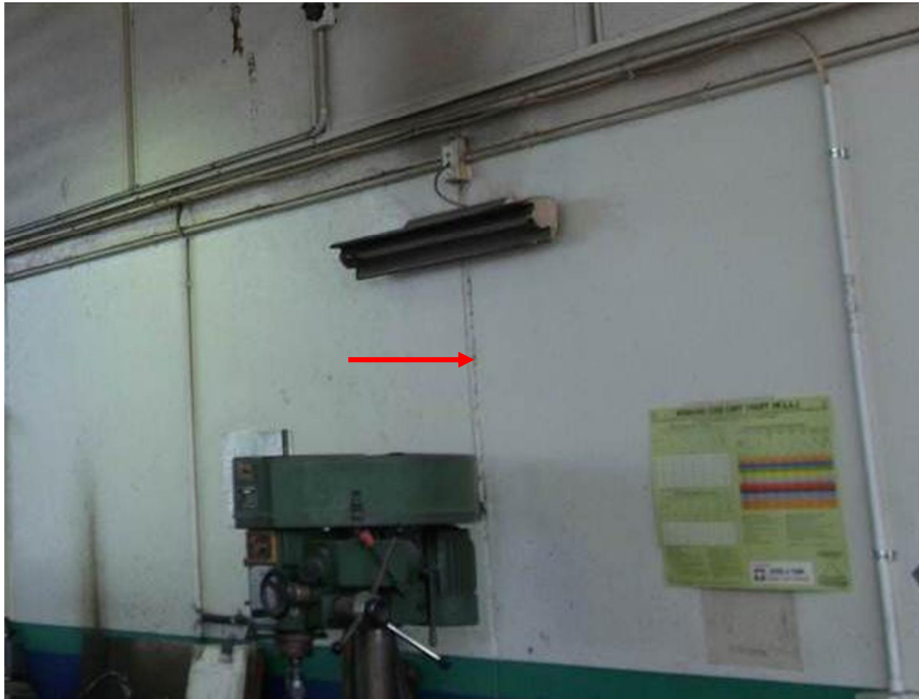
Photo 11: Typical cracking along movement joints

Description of Damage: Cracking to vertical movement joints.

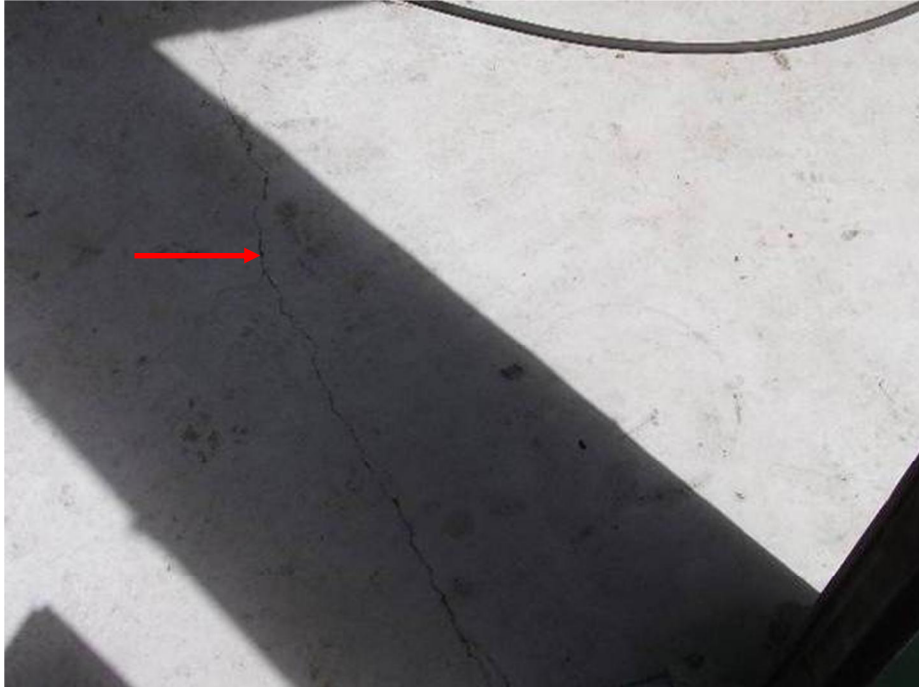
Photo 12: Typical slab cracking

Description of Damage: Cracking to concrete slab.

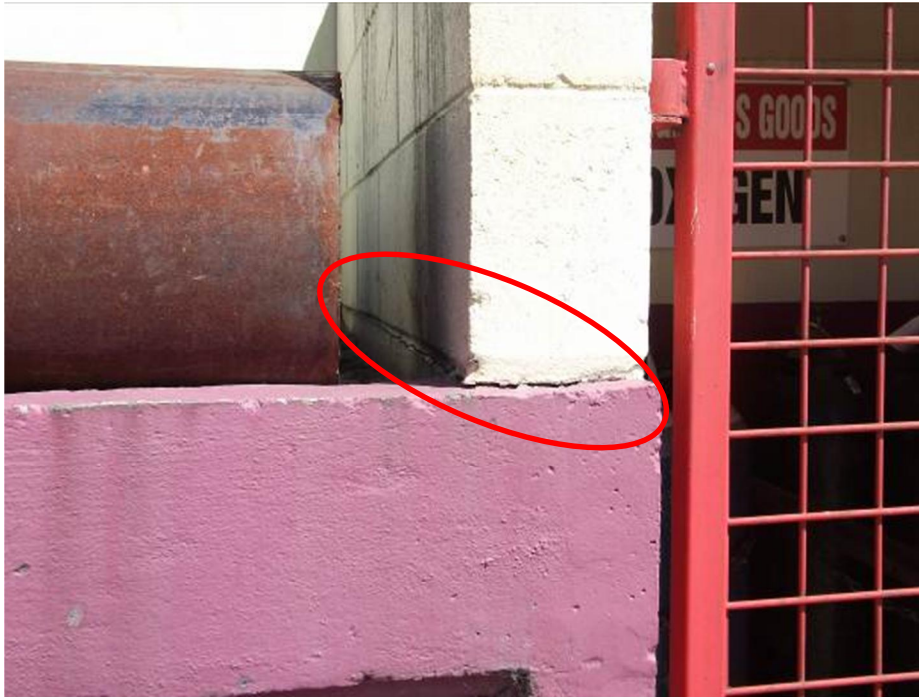
Photo 13: Cracking to oxygen tank storage blockwork

Description of Damage: Cracking to blockwork mortar.
