City Care Milton Street Depot – Vehicle Garage / Bitumen Sprayer Detailed Engineering Evaluation PRO_1141_010 EQ2 Quantitative Report

City Care Milton Street Depot Vehicle Garage/Bitumen Sprayer PRO_1141_010 EQ2

Detailed Engineering Evaluation Quantitative Report – SUMMARY Version 1

245 Milton Street
Sydenham
Christchurch

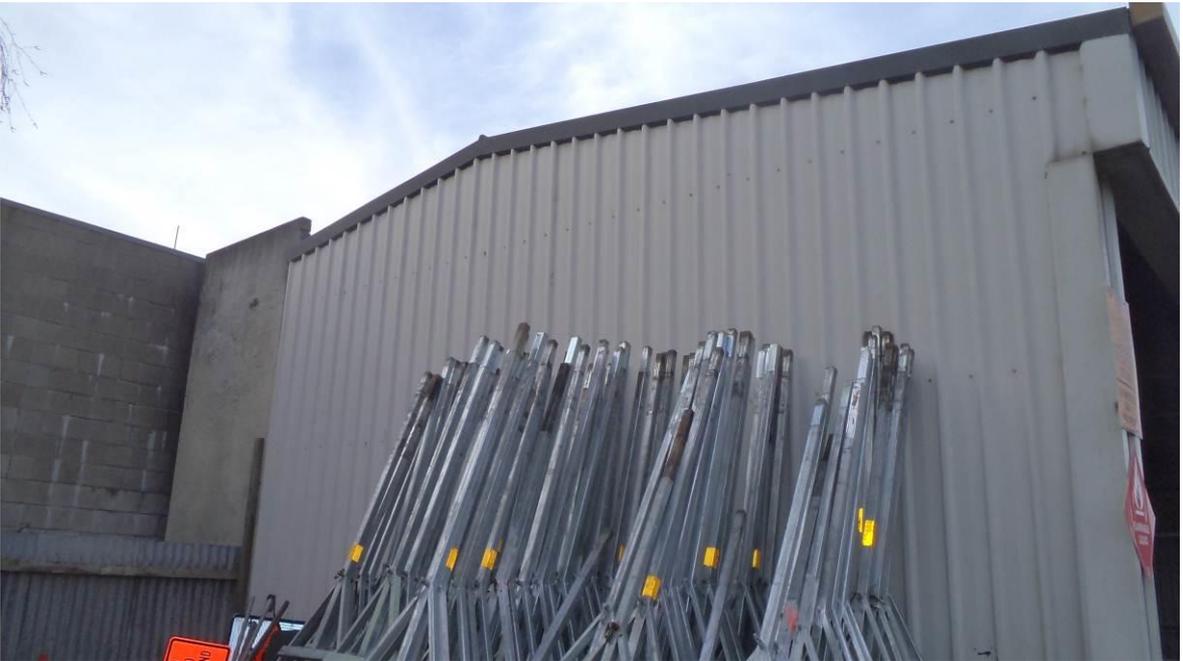
The Vehicle Garage/Bitumen Sprayer is adjacent to a row of shops. The eastern concrete wall is parallel to the shop's western block wall and is of similar height to the building (see Photo 2 in Appendix A). The separation between the walls is in the order of 200 mm. From the amount of wall that was able to be viewed during the visual inspection of the Vehicle Garage/Bitumen Sprayer, it does not appear to currently be a hazard to this building.

Photo 2: Exterior view of north elevation with adjacent blockwall.

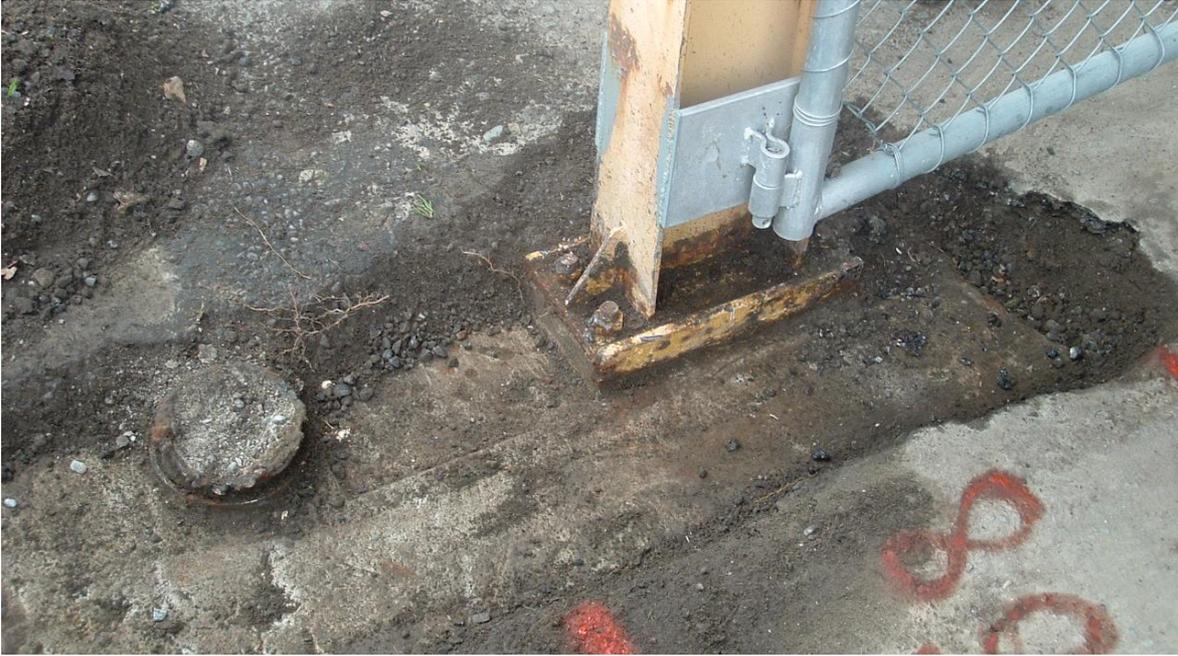
- n Pad footing size under western portal frame columns of 1600 mm x 800 mm x 650 mm.
- n Strip footing size under northern and southern end wall precast panels of 1900 mm x 400 mm x 1300 mm. This is based on the information provided from site investigations and is believed to be the minimum dimensions of the foundation. Should further investigations show a greater extent of foundations, the %NBS will be higher.

Photo 5: Typical western portal frame column foundation.

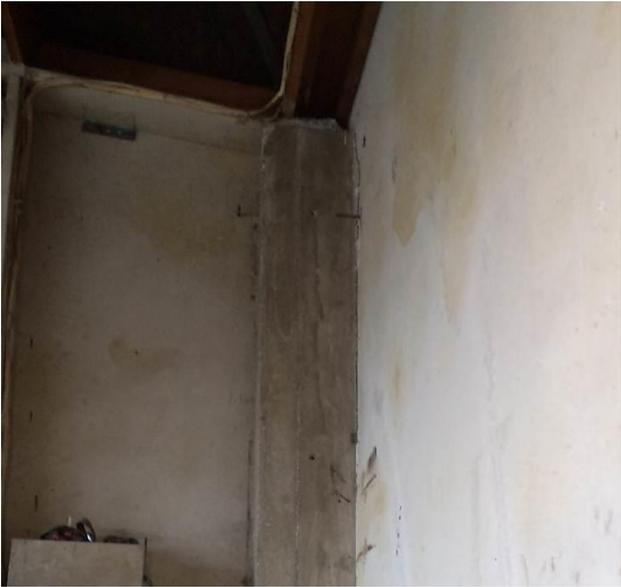
- n Minor diagonal cracks on east precast tilt panels.
- n Minor movement between the concrete encased steel columns and the precast concrete tilt panels.

Photo 6: Internal concrete column and precast tilt panel.
Damage Description: Movement between precast panel and concrete column.

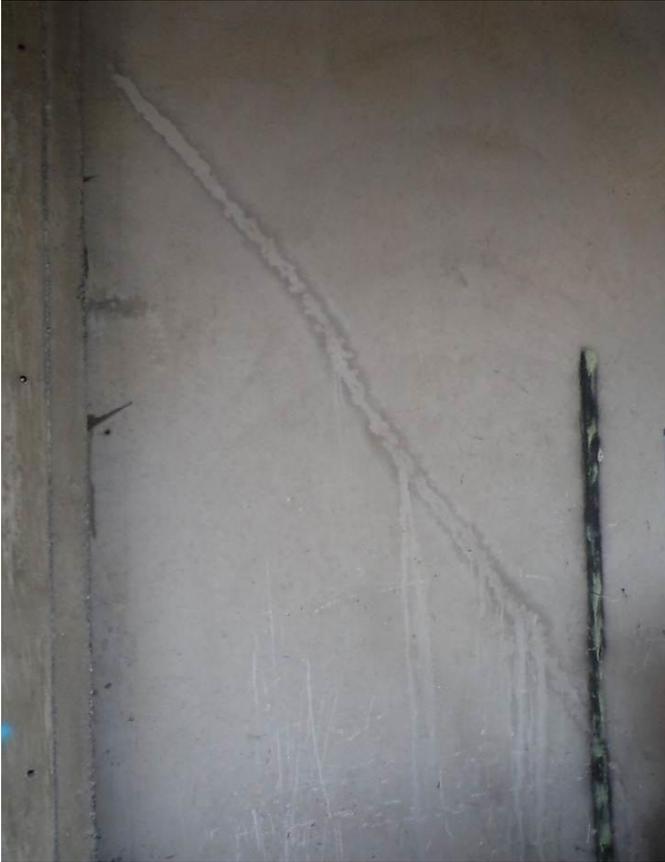
Photo 7: East precast tilt panel wall damage

Damage type					Comment
	Unknown	Minor	Moderate	Major	
					inspection.
concrete walls		ü			Minor movement was observed between the concrete rear shear walls and the concrete corner columns. Minor diagonal cracking was observed to the precast concrete wall panels.
cracking to concrete floors					No damage observed during visual inspection.
bracing					No damage observed during visual inspection.
cladding /envelope					No damage observed during visual inspection.
building services	ü				No inspection of services was carried out.
other

Damage Description: Diagonal cracking observed to the precast panel

Recommendations		Level of repair/strengthening required: <input type="text" value="minor structural"/>	Describe: <input type="text" value="minor shear cracks to panels"/>
Building Consent required: <input type="text" value="no"/>		Interim occupancy recommendations: <input type="text" value="full occupancy"/>	Describe: <input type="text" value=""/>
Along		Assessed %NBS before: <input type="text" value="100%"/>	If IEP not used, please detail assessment methodology: <input type="text" value="Force-based Quantitative Assessment"/>
		Assessed %NBS after: <input type="text" value="100%"/>	
Across		Assessed %NBS before: <input type="text" value="37%"/>	
		Assessed %NBS after: <input type="text" value="37%"/>

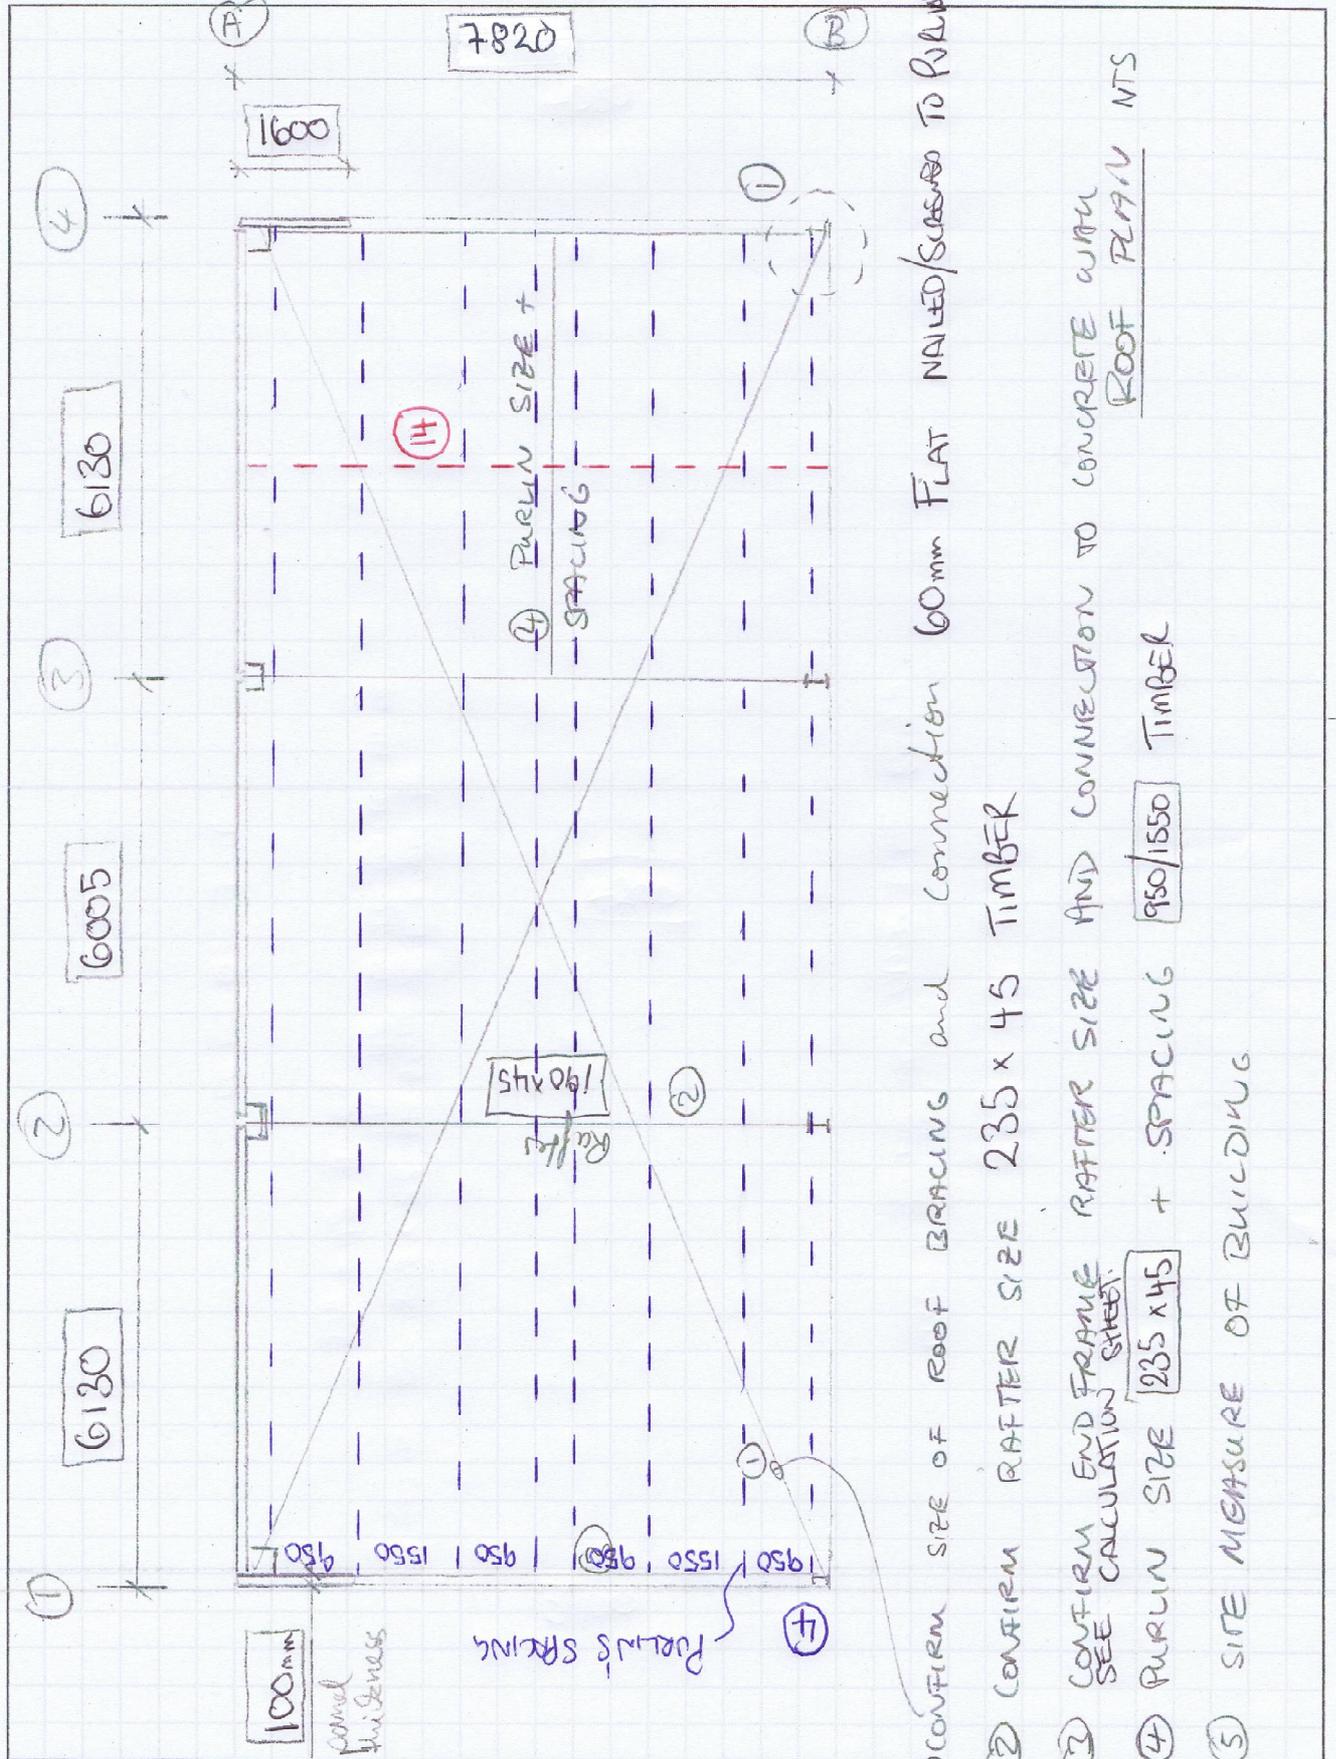
MILTON PLAN 1

- ① CONFIRM SIZE OF ROOF BRACING AND CONNECTION 60mm FLAT NAILED/SCREWED TO RAFTERS
- ② CONFIRM RAFTER SIZE 235 x 45 TIMBER
- ③ CONFIRM END FRAME RAFTER SIZE AND CONNECTION TO CONCRETE WITH SEE CALCULATION SHEET
- ④ PURLIN SIZE 235 x 45 + SPACING 950/1550 TIMBER
- ⑤ SITE MEASURE OF BUILDING

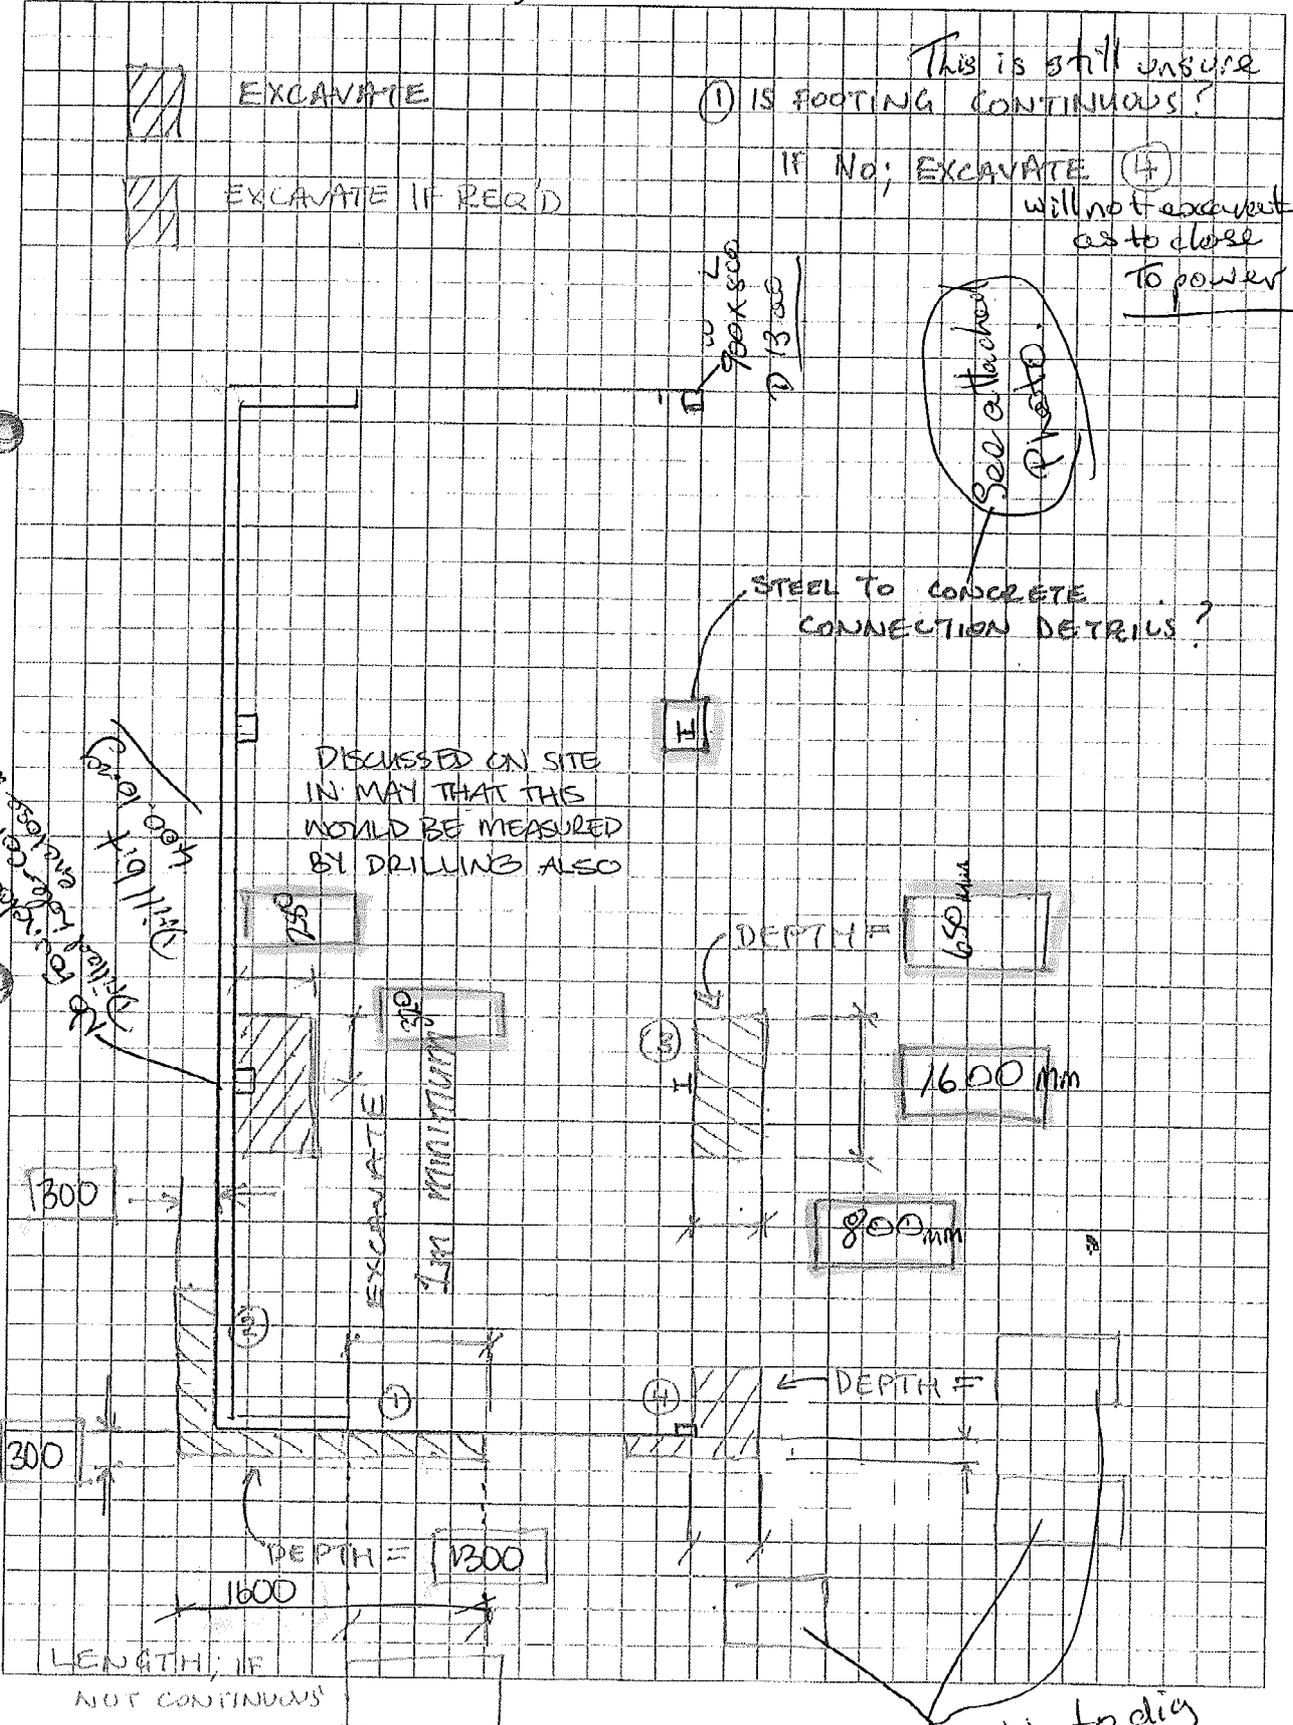
Attached is the plan for the truck shelter, the bitumen shed is the foundation is 1.3 deep, 0.300 wide, from the back corner 1.600 long. The length of the concrete foundation was found by drilling holes 0.200 deep in a straight line. Hope this is okay. Can we fill in the holes now that this is completed.
